ORNL/TM-13128

**EXAMINATION OF BABCOCK AND WILCOX TUBES AFTER EXPOSURE  
IN AN INDUSTRIAL WASTE INCINERATOR**

**Date Published: June 1996**

**Prepared by the  
OAK RIDGE NATIONAL LABORATORY  
Oak Ridge, Tennessee 37831-6285  
managed by  
LOCKHEED MARTIN ENERGY RESEARCH CORPORATION  
for the  
U.S. DEPARTMENT OF ENERGY  
under contract DE-AC05-96OR22464**

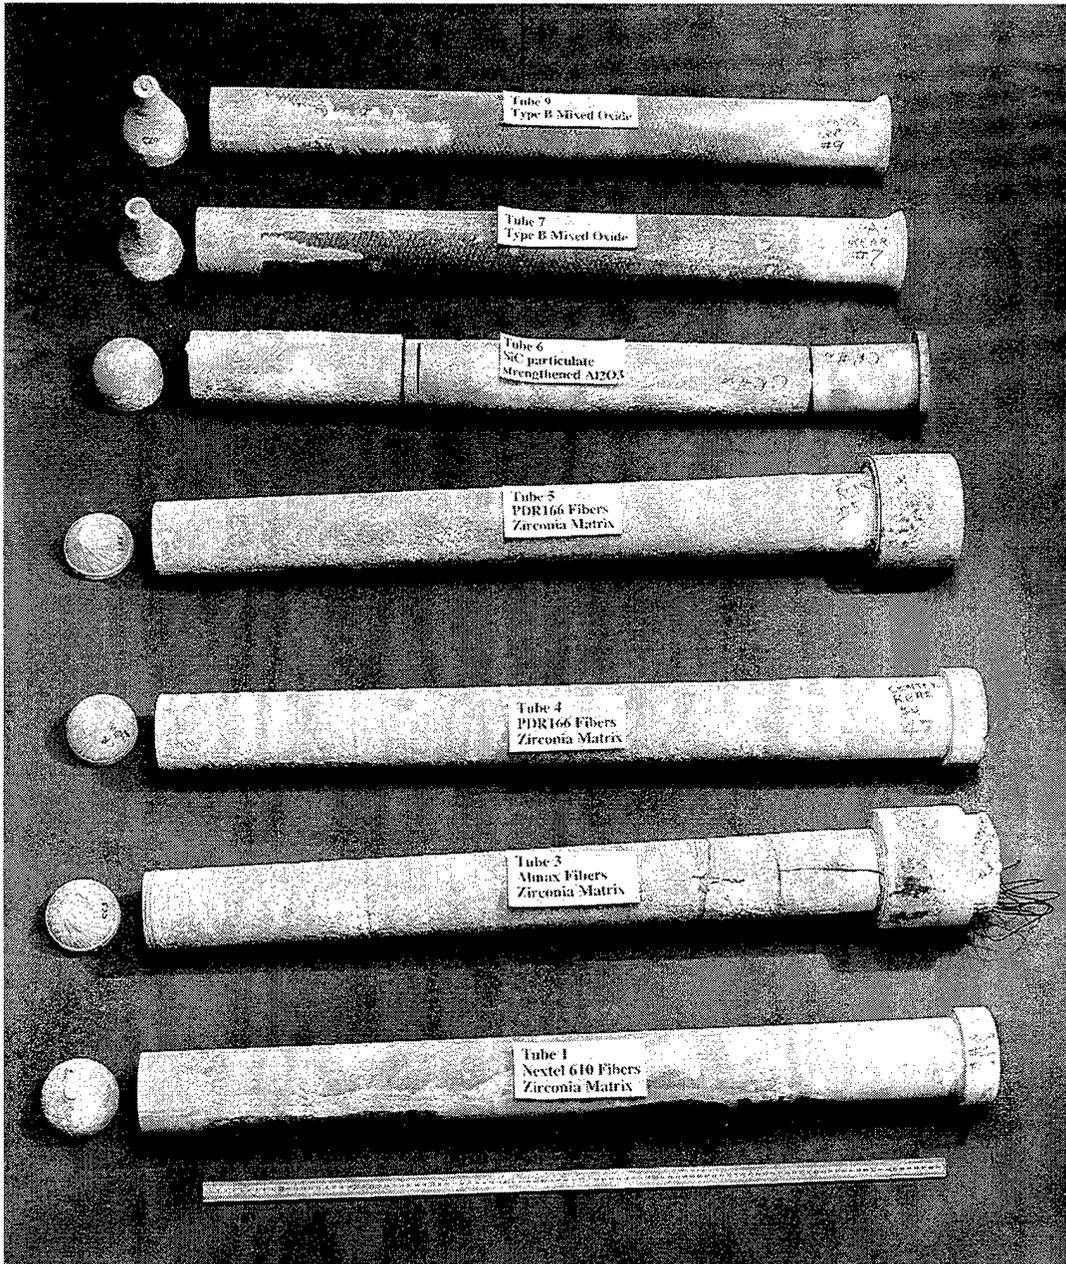
Fig. 1. Tubes exposed in DuPont hazardous waste incinerator. Sections used for c-ring samples have been cut from near the closed end of the tubes.

All tubes that were exposed in the incinerator were closed at one end and were flared or had a flange at the other end. In order to expedite the examination, no photographs were taken of the tubes when they were received at ORNL, but they all had some surface deposits ranging in color from tan to light grey that were presumed to have resulted from deposition during exposure in the incinerator. The exposed tubes are shown in Fig. 1 after removal of a section from near the bottom of each tube to provide samples. The unexposed tube section that was supplied later is shown in Fig. 2.

Most of the surfaces of the tubes that had been exposed to the incinerator environment had rough, loosely adhering surface deposits. There was no visible evidence of matrix or fiber damage, but some delamination or lack of internal bonding was apparent for the PRD166/zirconia samples and the Almax/zirconia samples.

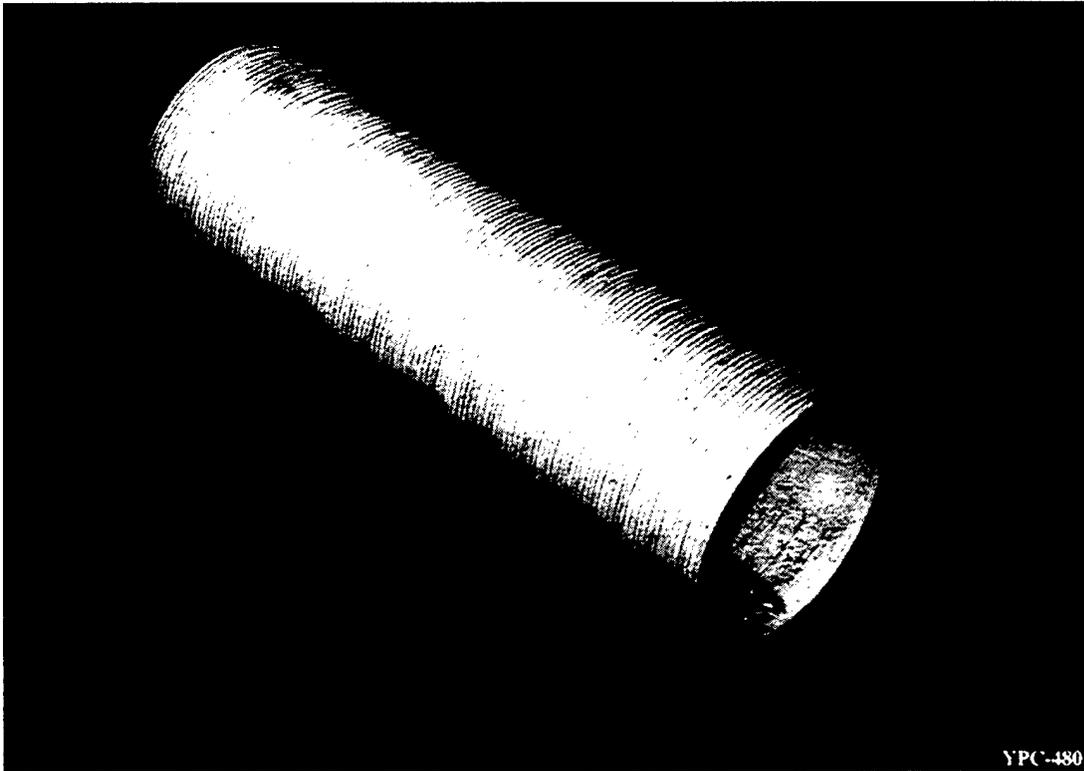
Fig. 2. Unexposed piece of PRD166/zirconia tubing used as reference material in examination.

During the preparation of the c-ring samples, it was evident that a lack of cohesion existed between some of the fiber layers. This lack of bonding was evident during the microstructural examination and is shown on micrographs taken near the center of some of the samples. The untested c-rings were visually examined to identify any significant features. Tube 1 showed a regular repeating pattern in the woven structure of the helically wrapped ceramic fibers. Tubes 3, 4, and 5 had a middle layer of low-angle ( $\pm 15^\circ$ ) helically wound fibers with inner and outer layers of hoop-wrapped fiber that did not show the repeating pattern of several of the other tubes. Tube 6 showed no evidence of fibers; the relatively thick wall and the surface layers were characteristic of DuPont Lanxide Composites (DLC) silicon carbide particulate-strengthened alumina. Tubes 7 and 9 appeared to be helically wound ceramic fiber composite tubes, but conversations with a manufacturer's representative<sup>4</sup> indicated the original fibers had been intentionally degraded by thermal processing, leaving a structure that had the appearance of fibers but none of the structural attributes of a ceramic fiber composite.

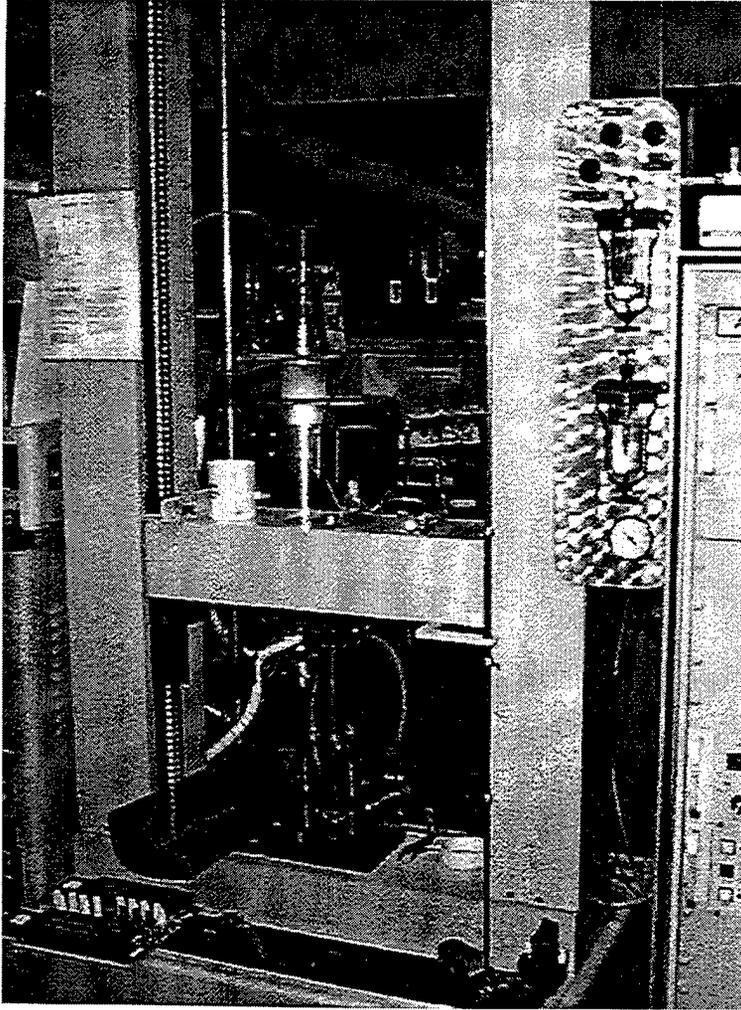
**Fig. 3.** Twin-screw electromechanical test machine used for room-temperature c-ring tests.

The c-ring samples were compression tested at room temperature in a commercially available, twin-screw, electromechanical test machine (manufactured by Applied Test Systems, Butler, Pennsylvania) using a cross-head speed of 0.02 in./min. At least four samples of each material were tested. The test system is shown in Fig. 3, and a sample being tested in the system is shown in Fig. 4. For this configuration, the maximum tensile stress is developed at the midspan of the outer surface. The expression used to relate compressive load to this maximum stress<sup>5</sup> is strictly valid for linear elastic, isotropic materials. For the fiber-reinforced materials examined in this study, the reported strength values should be used for comparative purposes only. In fact, the factors affecting the validity of flexure tests of continuous fiber-reinforced composites apply to the case of the compressively loaded c-ring.

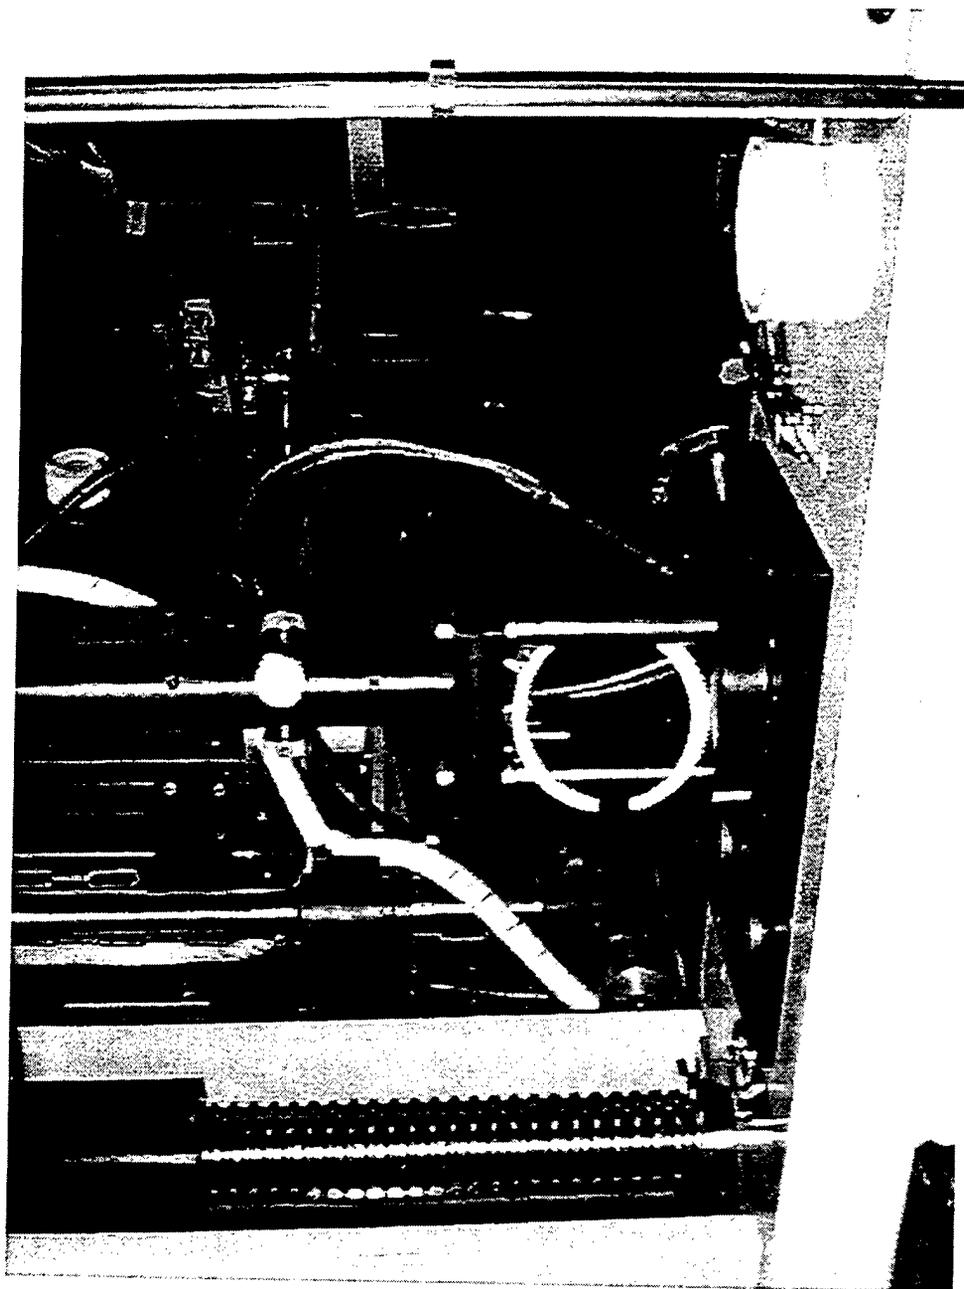
Fig. 4. C-ring sample being compression tested in electromechanical test machine.

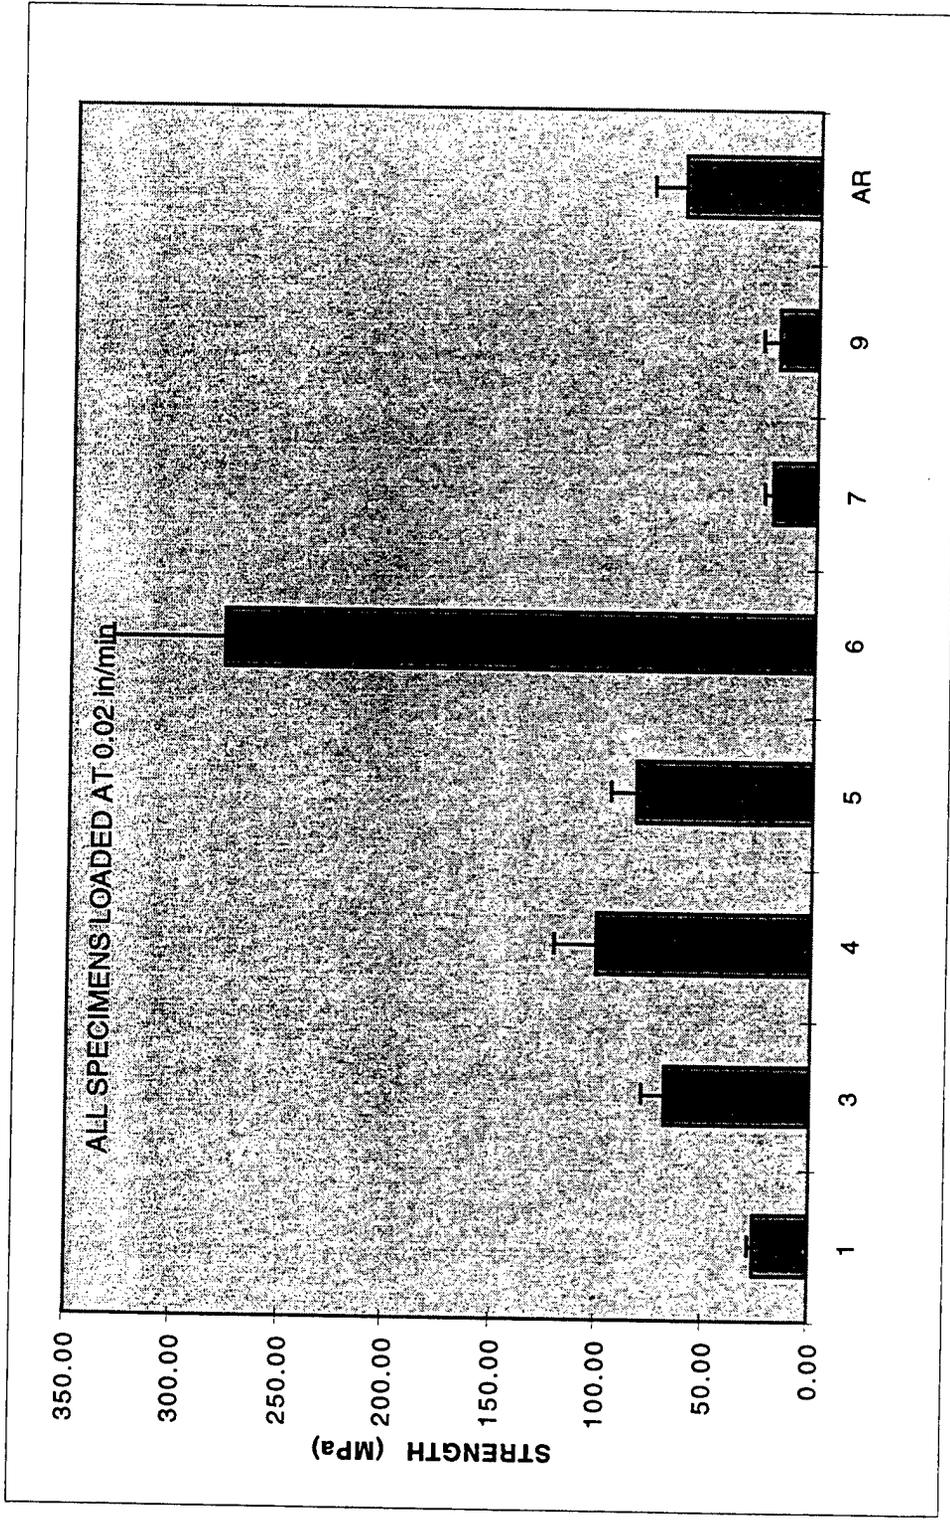
Fig. 5. Average strengths and standard deviations calculated from c-ring compression tests of ceramic composite materials exposed in industrial waste incinerator.

The results of all the compression tests are summarized in Table 2, where the results for each individual test are given along with the average and the standard deviation. A graphical comparison of these results is given in Fig. 5, which shows that tube 6 was by far the strongest; it demonstrated a strength more than twice that of all other materials tested.

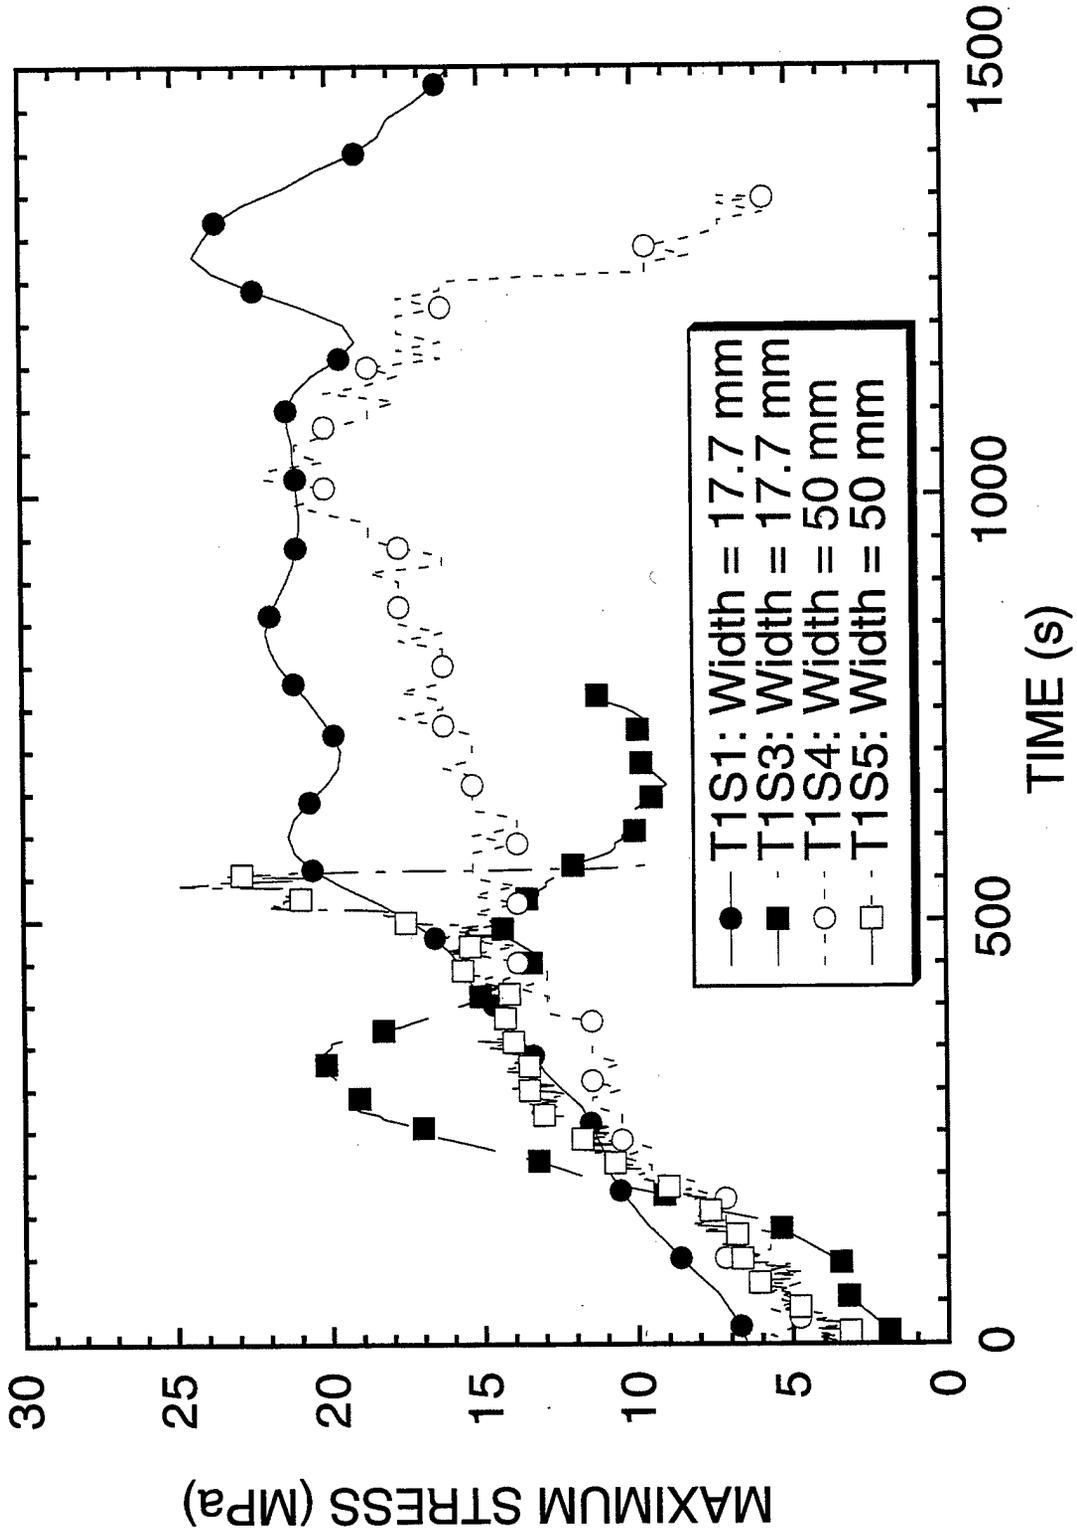
TUBE 1

Fig. 6. Loading curves for c-ring compression tests conducted on Nextel 610/zirconia tube (Babcock & Wilcox designation-tube 1).

For tube 1, two samples were prepared and tested with the standard 17.8 mm width while two others were fabricated to be approximately 50 mm wide. The loading curves for all four of the tests are shown in Fig. 6. No effect of sample width on the maximum strength was seen, and, in fact, the standard deviation was the smallest for all the materials tested. This material combination was the weakest of the ceramic fiber-ceramic matrix composite materials, and this weakness is most likely due to the fiber architecture that contains helically wrapped, but no hoop-wrapped, fibers.

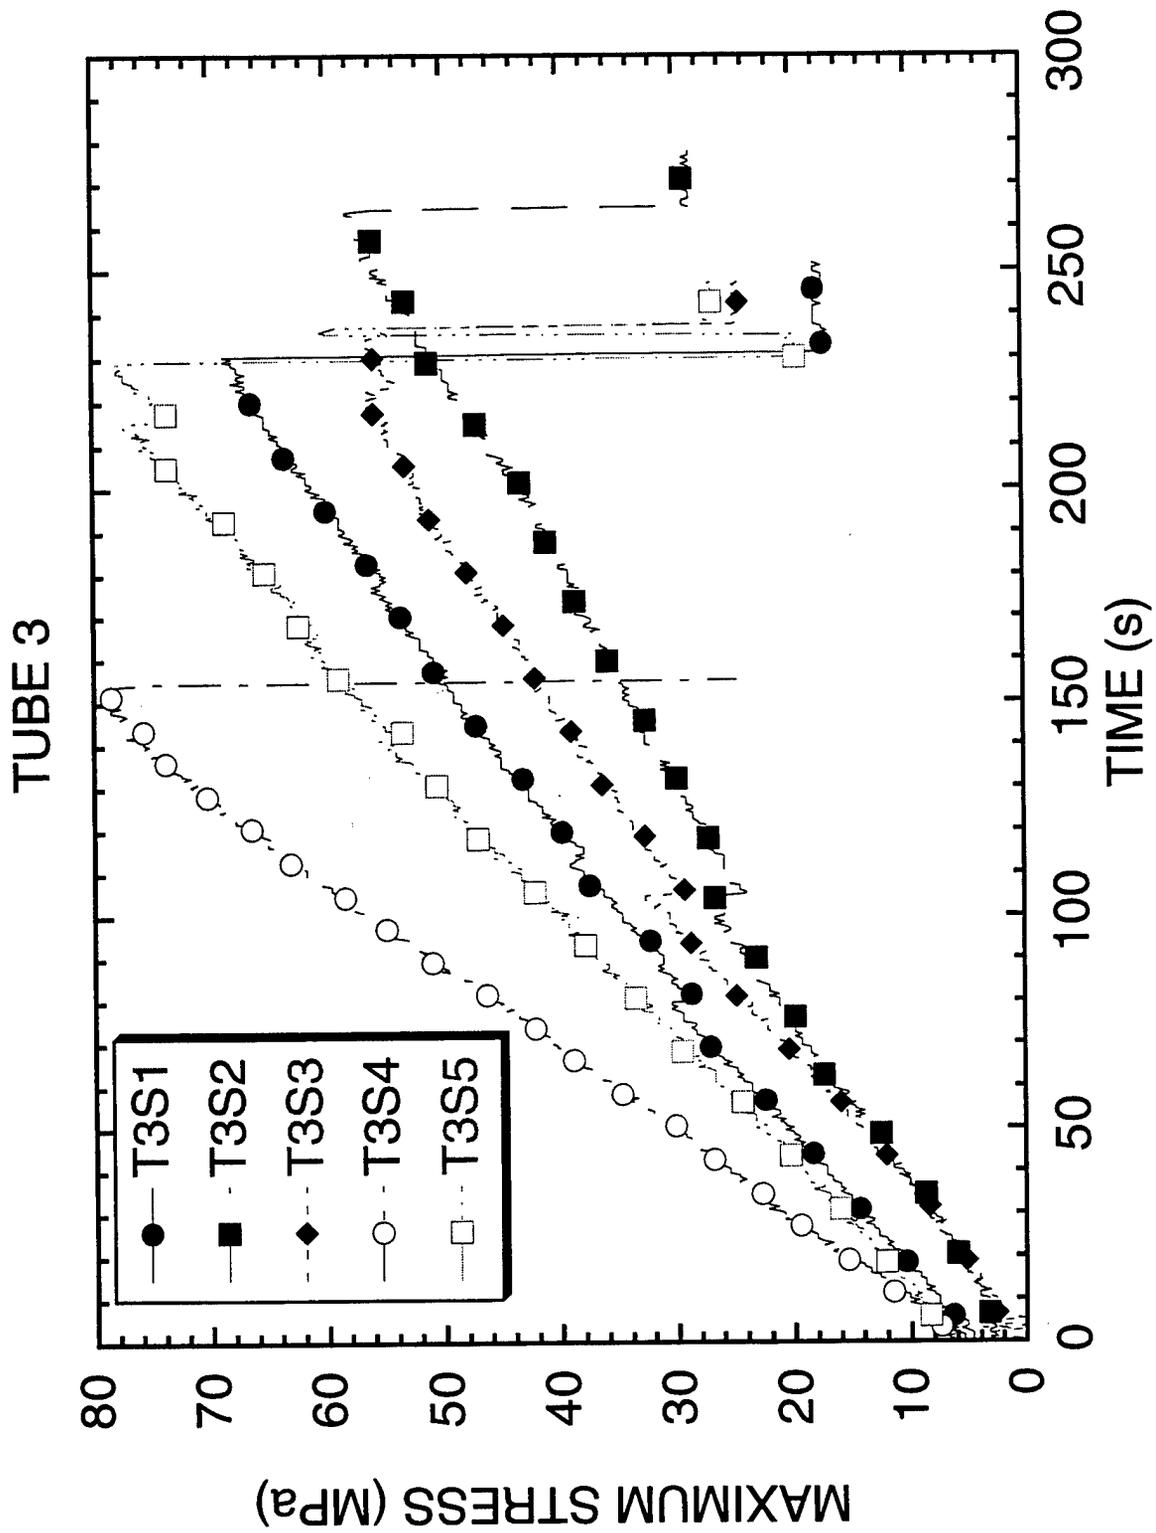
Fig. 7. Loading curves for c-ring compression tests conducted on Almax/zirconia tube (Babcock & Wilcox designation-tube 3).

Five samples from tube 3 were tested, and the variation in strength was relatively limited, especially considering the apparent presence of incomplete bonding in the tube wall. Depending on the orientation of the unbonded areas during compression testing, significant strength reductions can result. The loading curves for the five samples are shown in Fig. 7.

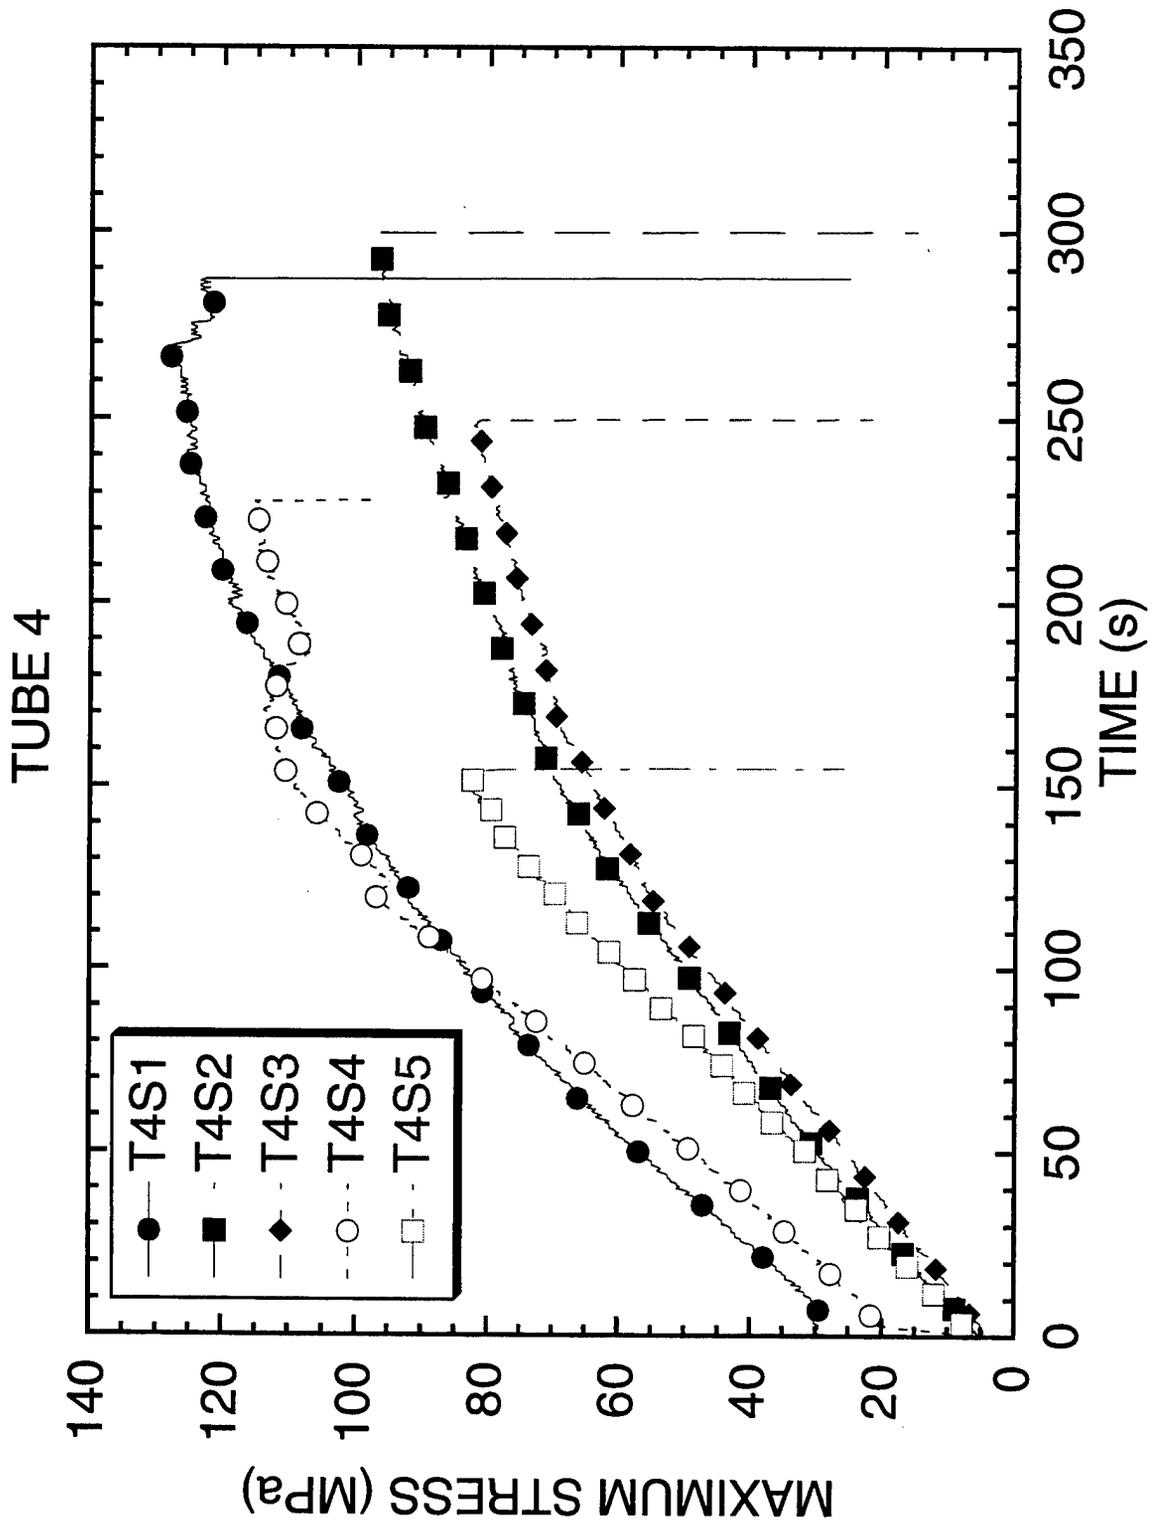
Fig. 8. Loading curves for c-ring compression tests conducted on PRD166/zirconia tube (Babcock & Wilcox designation-tube 4).

Tubes 4 and 5 were constructed of the same material, and five and four samples, respectively, were tested. Loading curves for the two tubes are shown in Figs. 8 and 9. These curves show that two samples from tube 4 were significantly stronger than the other samples of this material while tube 5 had one sample that was noticeably weaker than the other samples of this material. Although there was appreciable variation in the measured strengths, this material was the second strongest of all materials tested and the strongest of the ceramic fiber/ceramic matrix combinations tested.

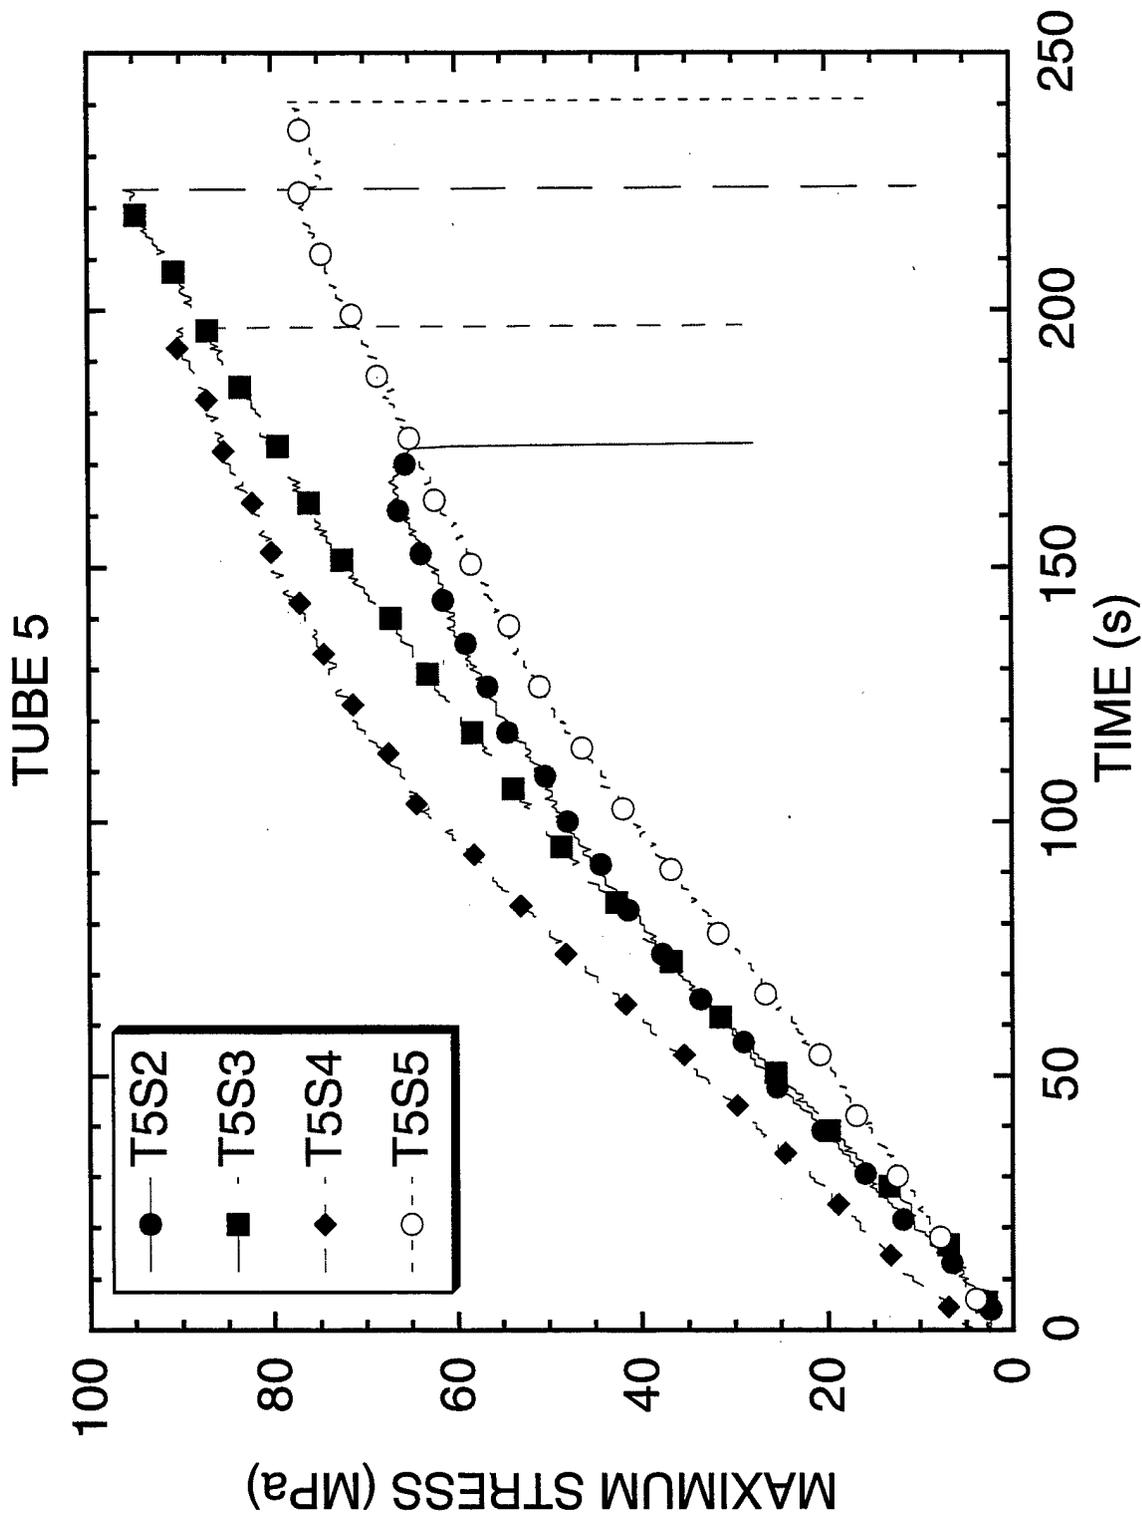
Fig. 9. Loading curves for c-ring compression tests conducted on PRD166/zirconia tube (Babcock & Wilcox designation-tube 5).

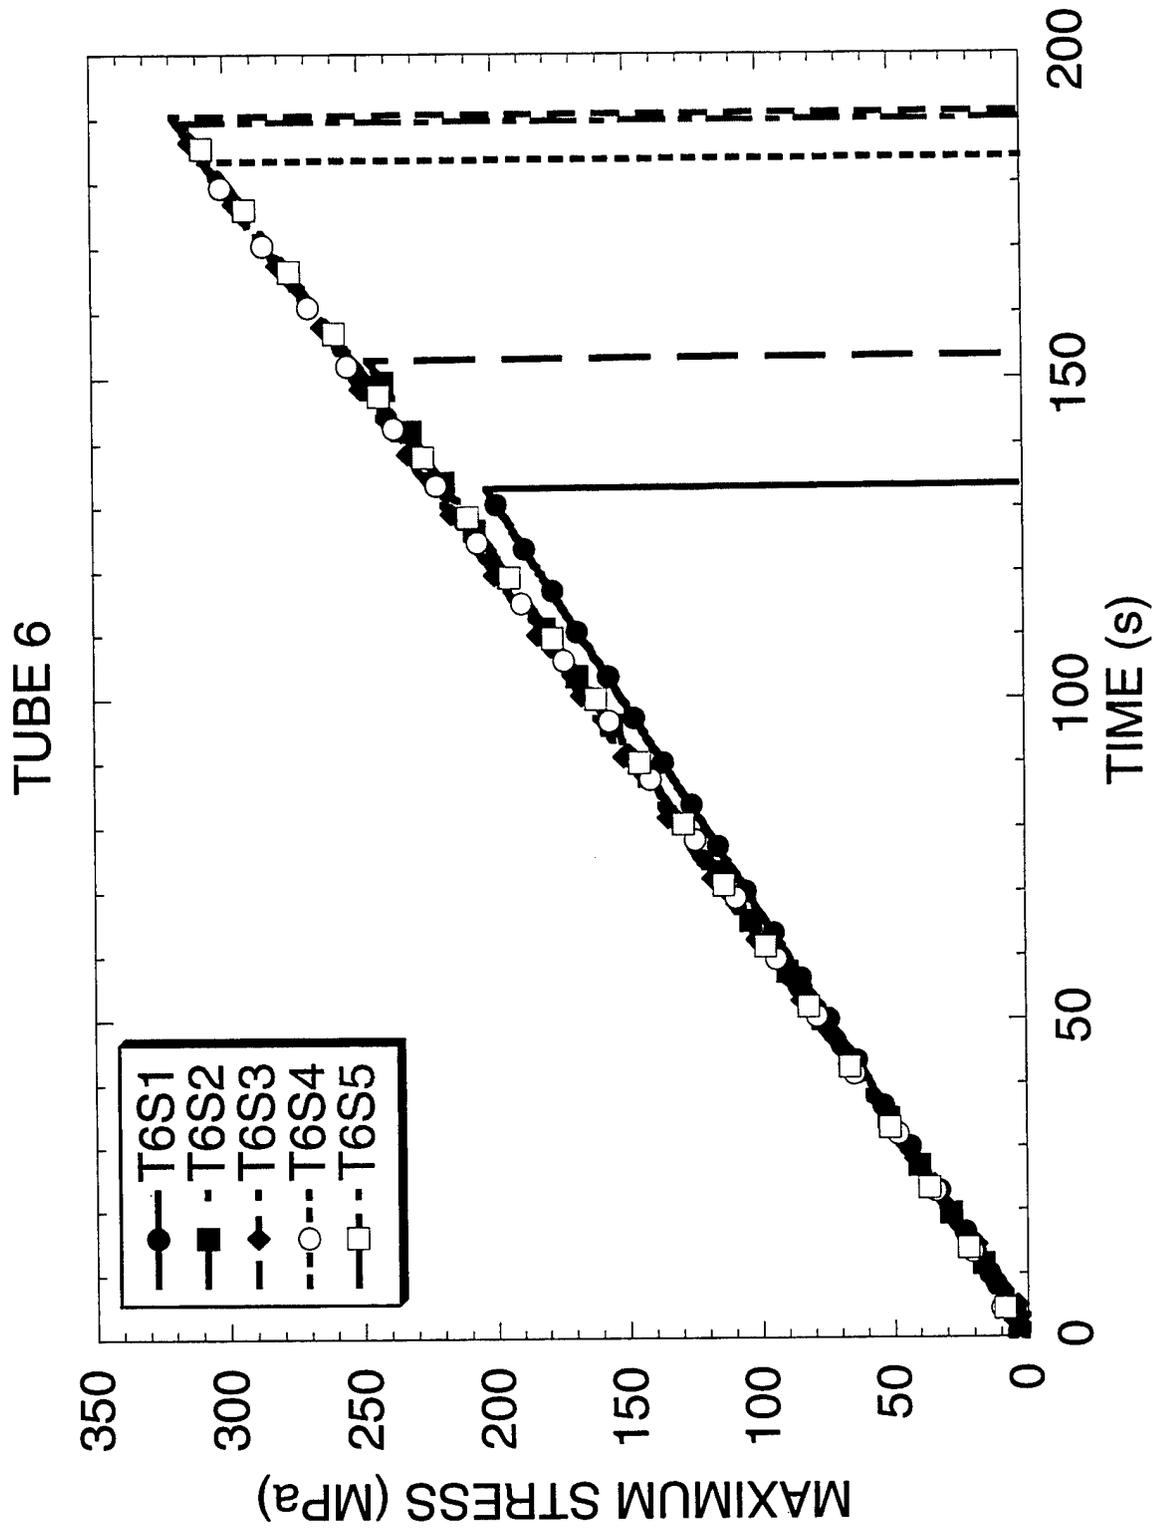
Fig. 10. Loading curves for c-ring compression tests conducted on  $\text{SiC-Al}_2\text{O}_3$  tube (Babcock & Wilcox designation-tube 6).

The strongest material in these tests was the particulate-strengthened material used for tube 6. Five samples were tested and the loading curves are shown in Fig. 10. Two of these samples failed at loads considerably lower than the failure loads for the other three samples, and this accounted for the relatively large standard deviation for this material.

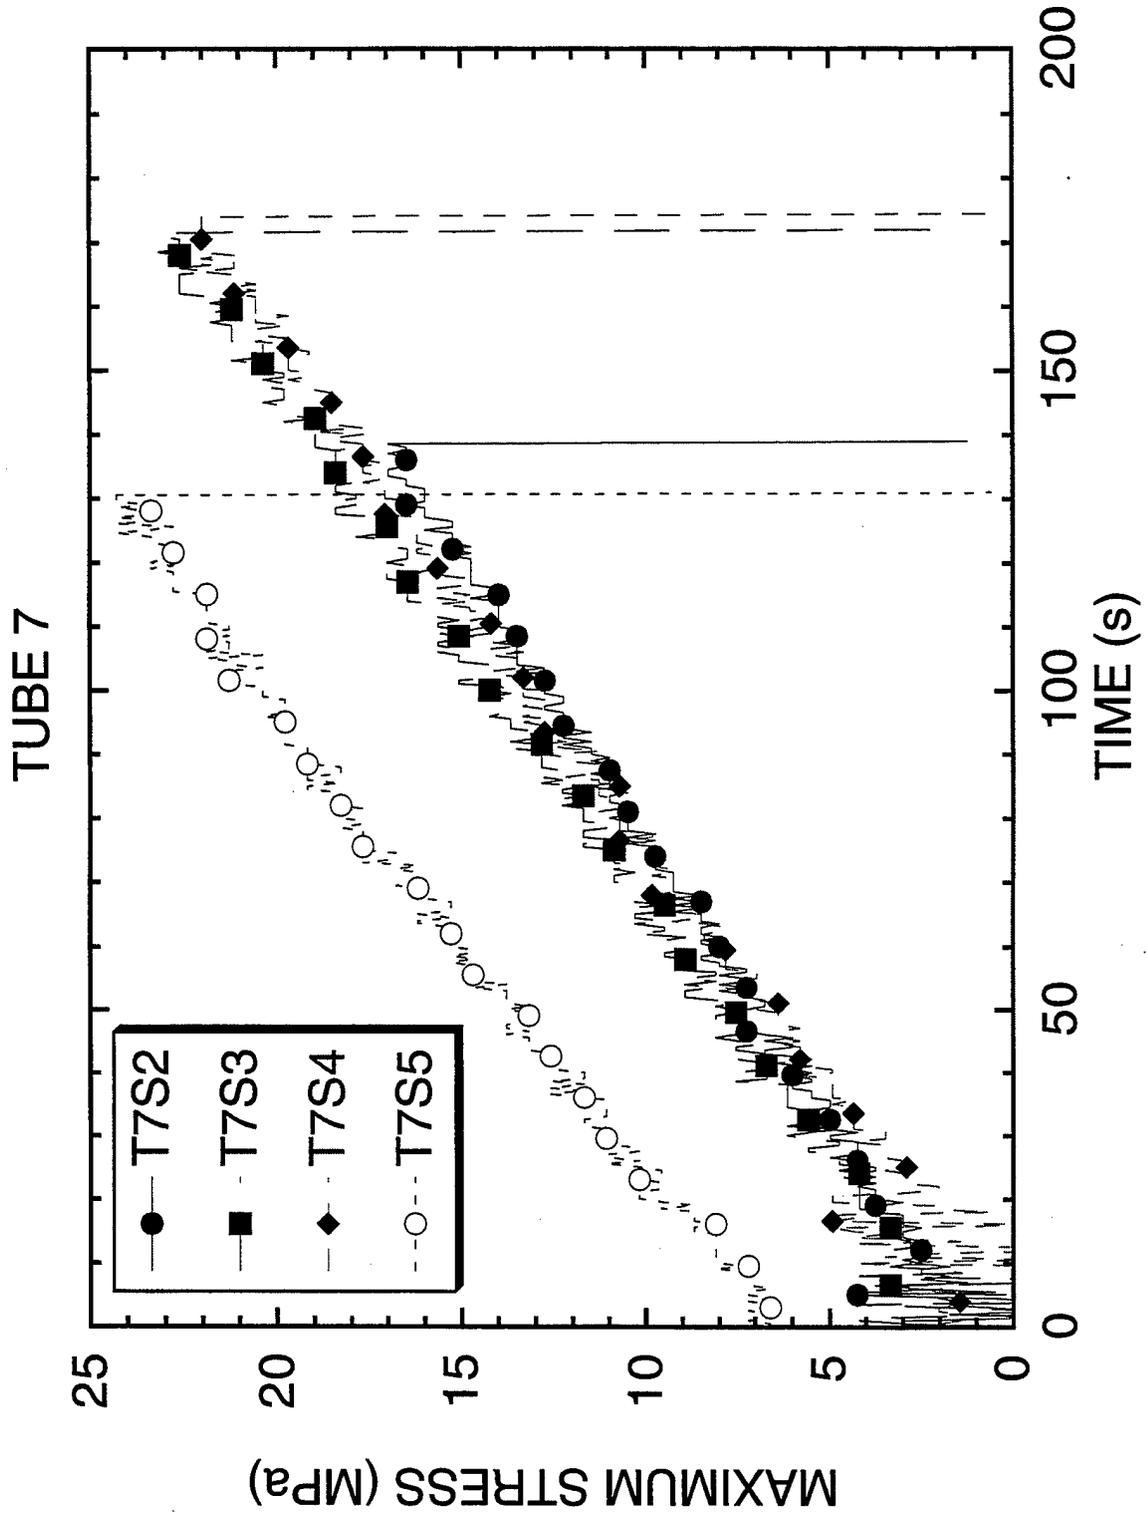
Fig. 11. Loading curves for c-ring compression tests conducted on mixed-oxide tube (Babcock & Wilcox designation-tube 7).

The weakest material tested was that used for tubes 7 and 9, and results of the c-ring compression tests are shown in Figs. 11 and 12. Four samples of each tube were tested, and one sample was considerably weaker than the other seven. Although this material had the appearance of a ceramic fiber/ceramic matrix composite, the thermal treatment given the tubes resulted in a highly microcracked structure that had high thermal shock resistance but low strength.<sup>4</sup>

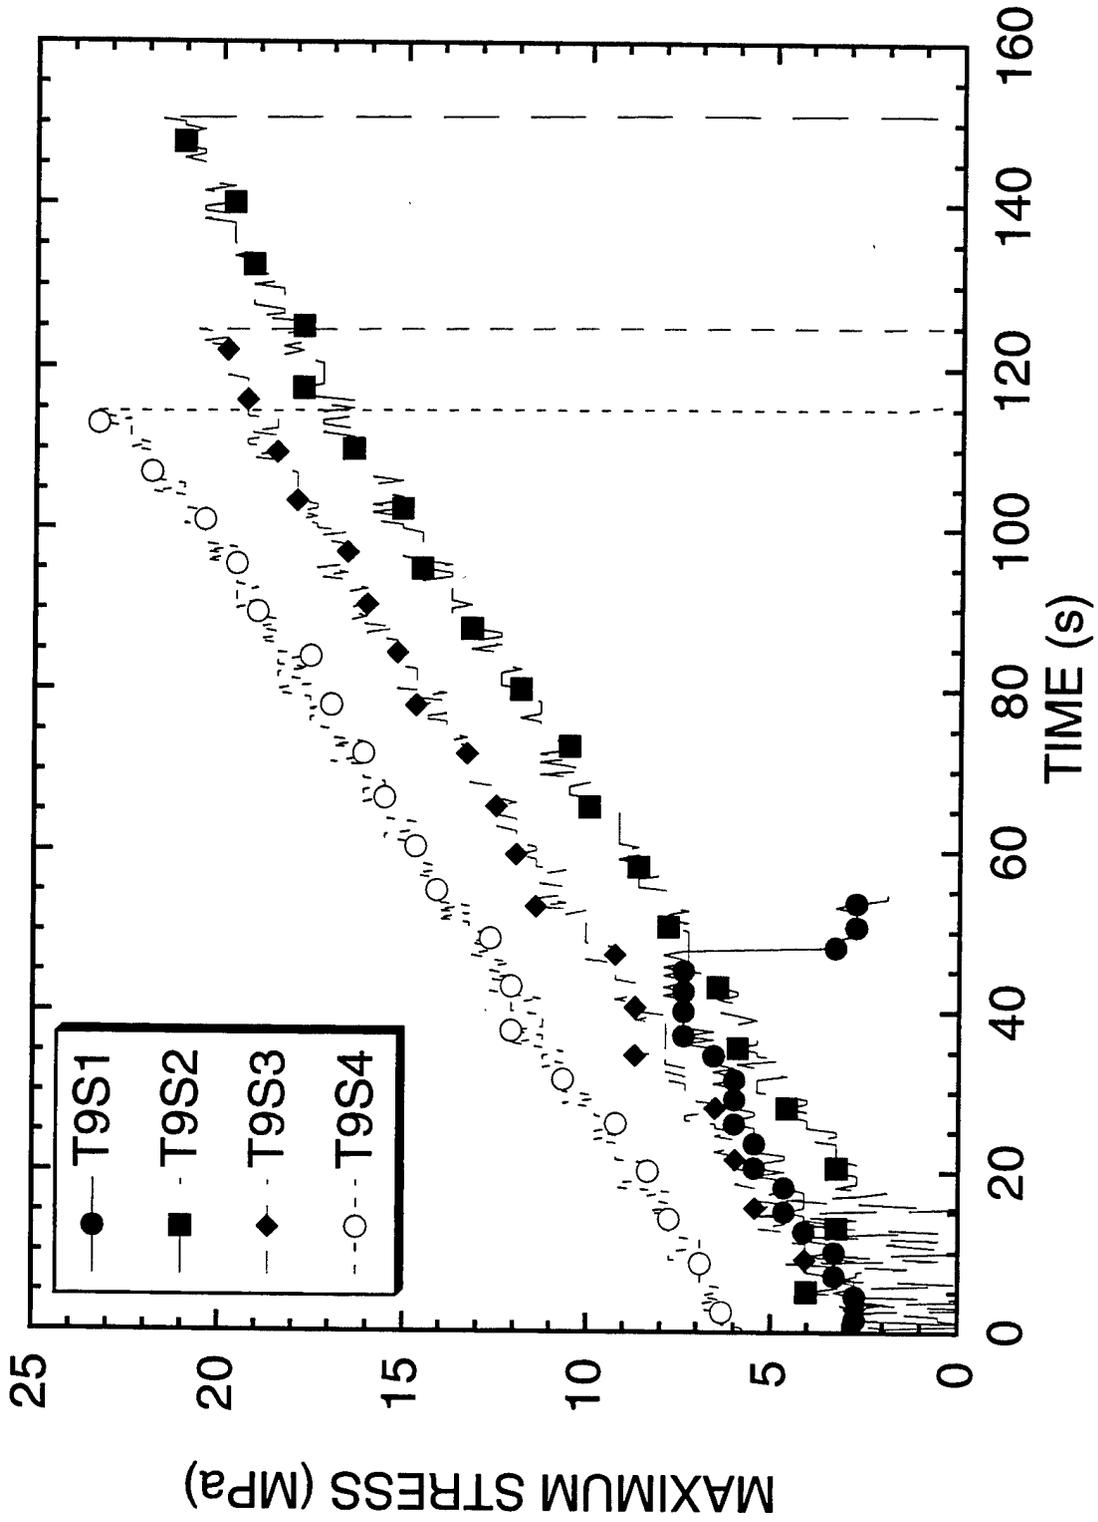
# TUBE 9

Fig. 12. Loading curves for c-ring compression tests conducted on mixed-oxide tube (Babcock & Wilcox designation-tube 9).

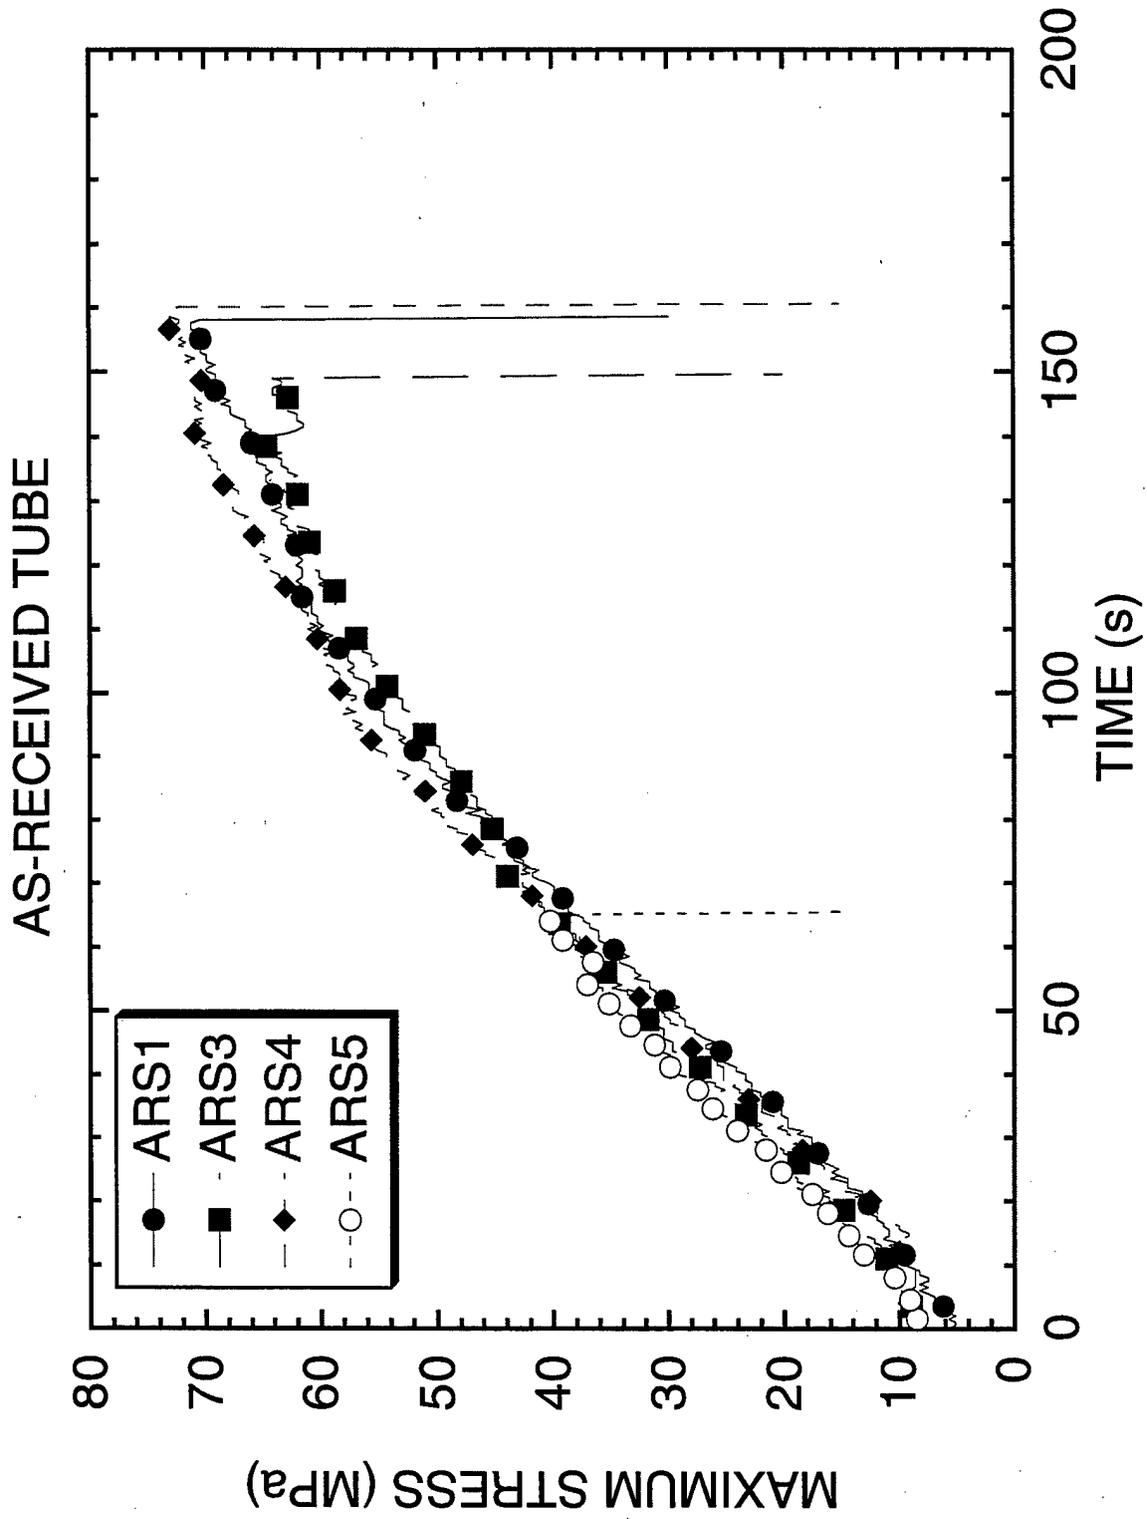
Fig. 13. Loading curves for c-ring compression tests conducted on unexposed PRD166/zirconia tube (Babcock & Wilcox designation-tube AR).

C-rings from an unexposed tube of the same material as tubes 4 and 5 were tested, and the loading curves from these tests are shown in Fig. 13. One of these c-rings was considerably weaker than the other three; however, all of these c-rings were weaker than seven of the eight exposed samples that were tested.

Without complete data from c-ring tests on unexposed samples of all these materials, it is impossible to say if exposure to the incinerator environment affected the strength of the composites. Tests of the unexposed PRD166/zirconia sample resulted in a lower strength than measured on the exposed samples, so it appears that exposure did not degrade the strength of the PRD166/zirconia composite. Likewise, for the silicon carbide particulate-strengthened alumina, unpublished results from other incinerator corrosion studies<sup>6</sup> indicate that the strength of this composite was not significantly degraded by the incinerator exposure.
