ORNL/TM-13128

**EXAMINATION OF BABCOCK AND WILCOX TUBES AFTER EXPOSURE  
IN AN INDUSTRIAL WASTE INCINERATOR**

**Date Published: June 1996**

**Prepared by the  
OAK RIDGE NATIONAL LABORATORY  
Oak Ridge, Tennessee 37831-6285  
managed by  
LOCKHEED MARTIN ENERGY RESEARCH CORPORATION  
for the  
U.S. DEPARTMENT OF ENERGY  
under contract DE-AC05-96OR22464**

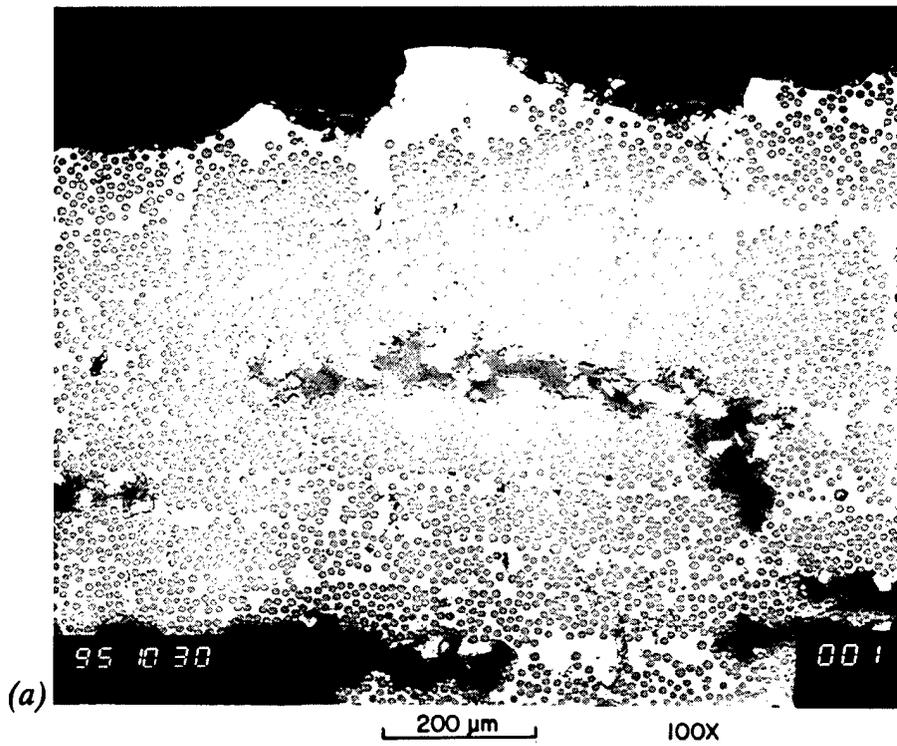
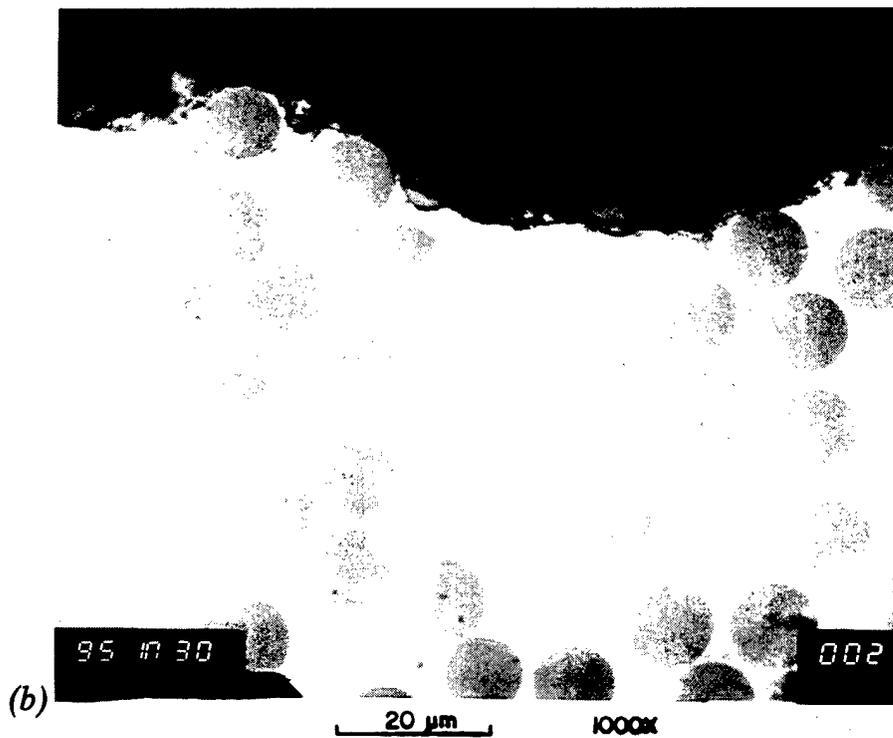
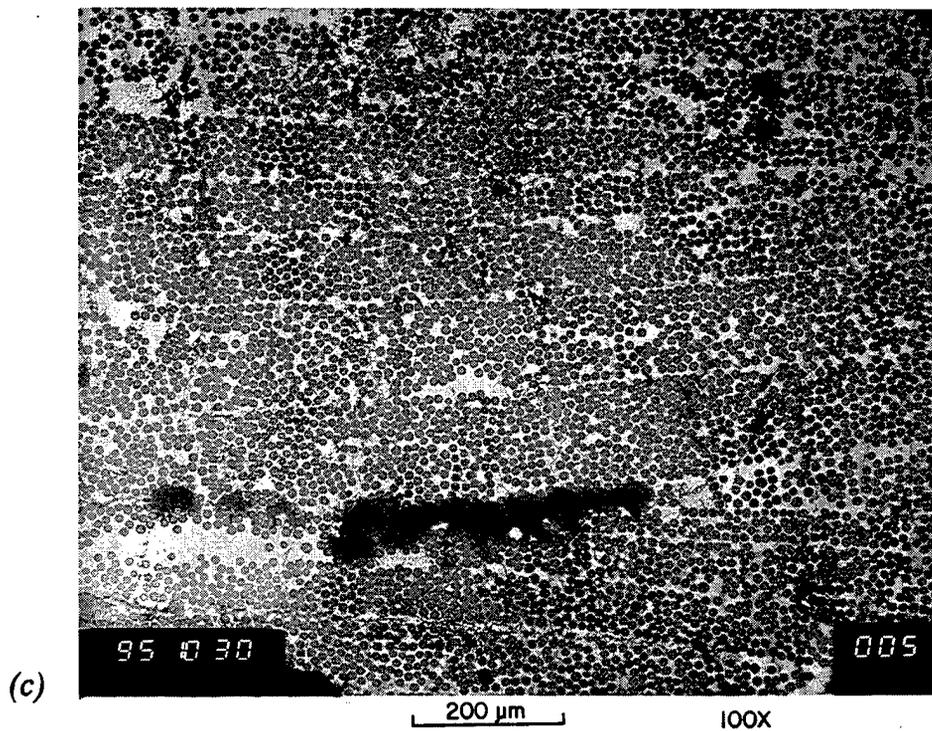
Fig. 14. Photomicrographs at (a) low and (b) high magnification of the tube's outer surface and (c) an area near the center of the Nextel 610/zirconia sample.

**Fig. 14 (continued).** Photomicrographs at (a) low and (b) high magnification of the tube's outer surface and (c) an area near the center of the Nextel 610/zirconia sample.

Micrographs of the Nextel 610/zirconia sample shown in Fig. 14 show some porosity a short distance below the surface. From the higher magnification picture, there is no evidence that the fibers at and near the surface were degraded by any reaction with the environment. The micrograph taken near the center of the sample also shows some porosity in this sample.

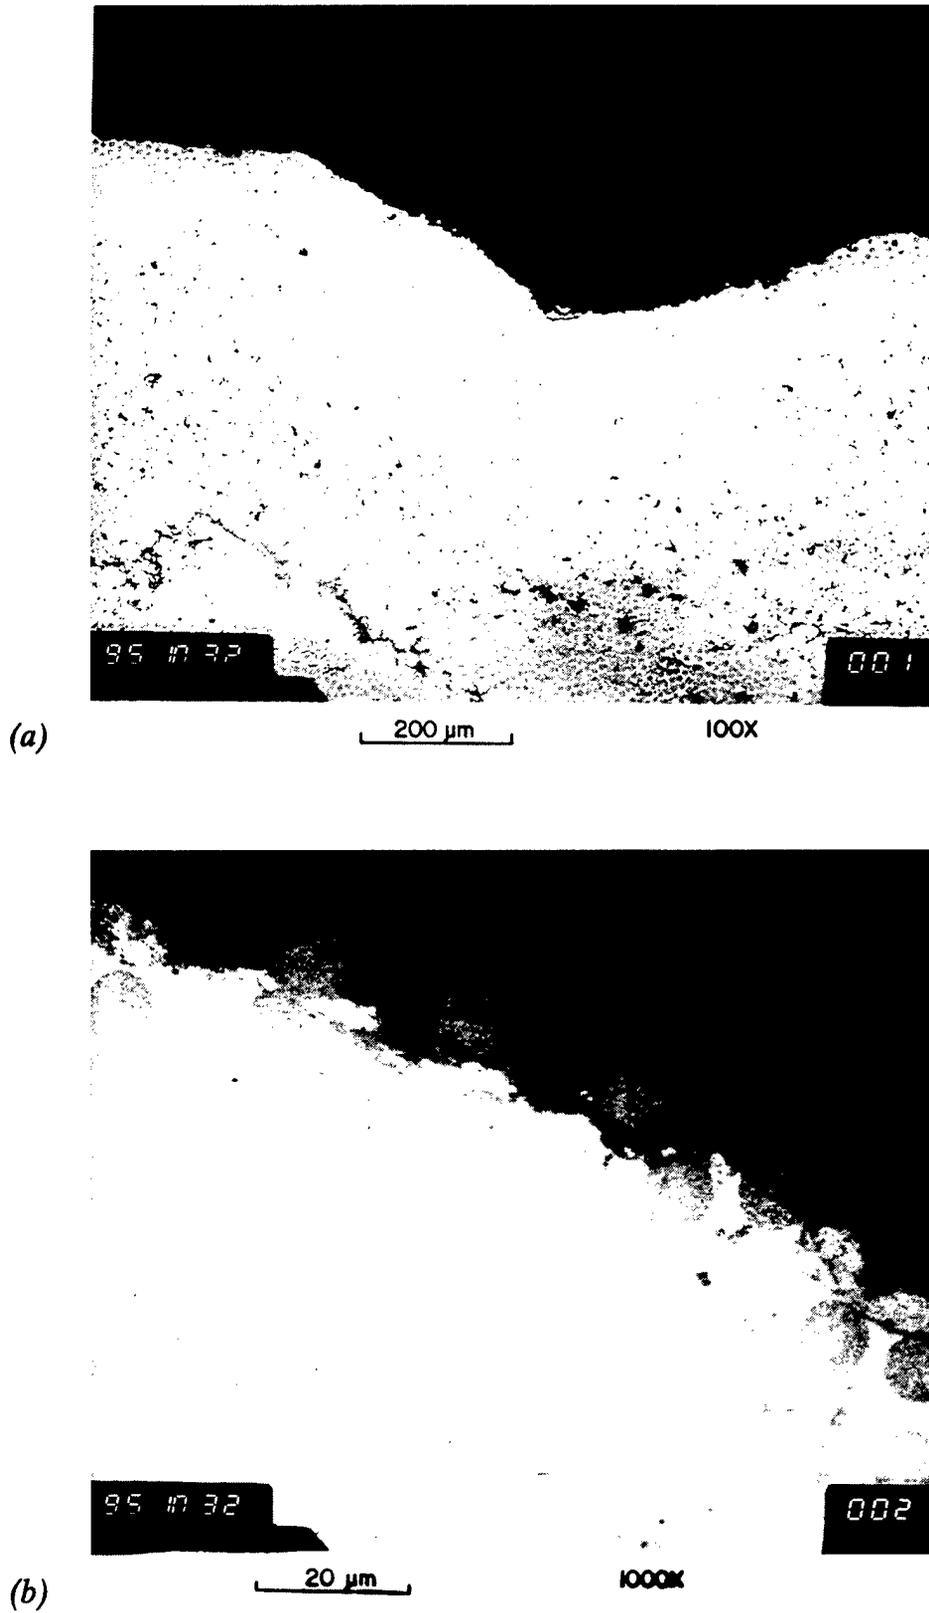
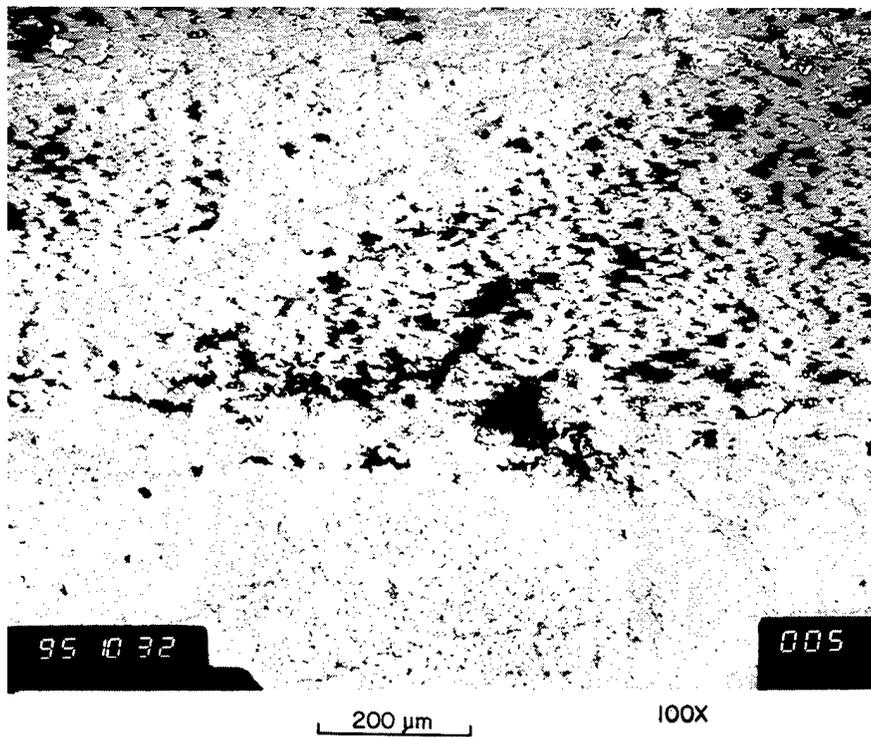
Fig. 15. Photomicrographs at (a) low and (b) high magnification of the outer surface and (c) an area near the center of the wall of the Almax/zirconia sample (tube 3).

**Fig. 15** (continued). Photomicrographs at (a) low and (b) high magnification of the outer surface and (c) an area near the center of the wall of the Almax/zirconia sample (tube 3).

The Almax/zirconia sample is shown in Fig. 15, and, as with the Nextel/zirconia, there is no evidence of a reaction of the fibers near the surface of the sample with the components of

the incinerator environment. The micrograph taken near the center of the sample shows a significant amount of porosity.

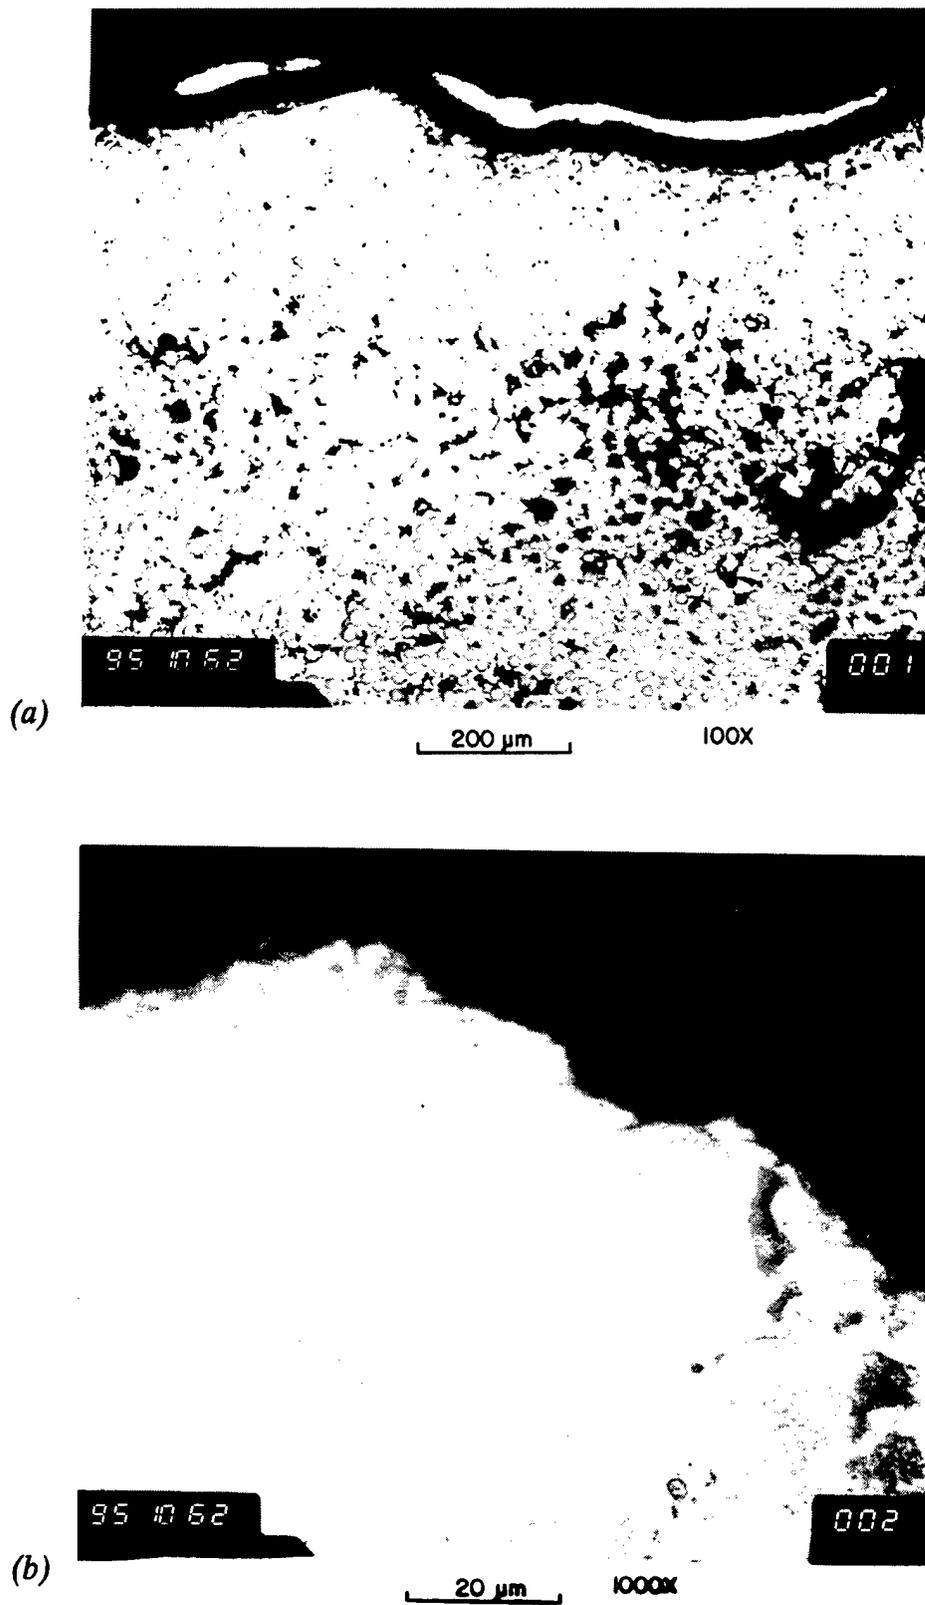
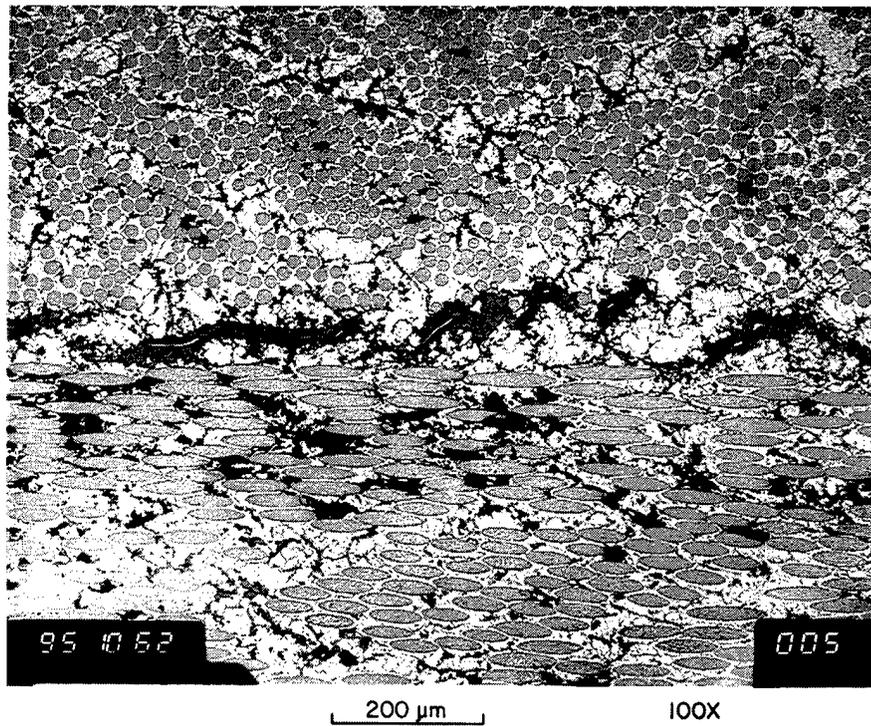
Fig. 16. Photomicrographs at (a) low and (b) high magnification of the tube's outer surface and (c) an area near the center of the wall of the PRD166/zirconia tube (tube 4).

(c) Fig. 16 (continued). Photomicrographs at (a) low and (b) high magnification of the tube's outer surface and (c) an area near the center of the wall of the PRD166/zirconia tube (tube 4).

Samples from two tubes of PRD166/zirconia were examined, and micrographs of samples from these tubes are shown in Figs. 16 and 17. The sample from tube 4, shown in the first of these figures, has some porosity near the surface, but there is no evidence of degradation of the fibers that could have resulted from interaction with the environment. The micrograph taken near the center of the sample shows some generally dispersed porosity with evidence of substantial porosity near the interface between two bundles of fibers.

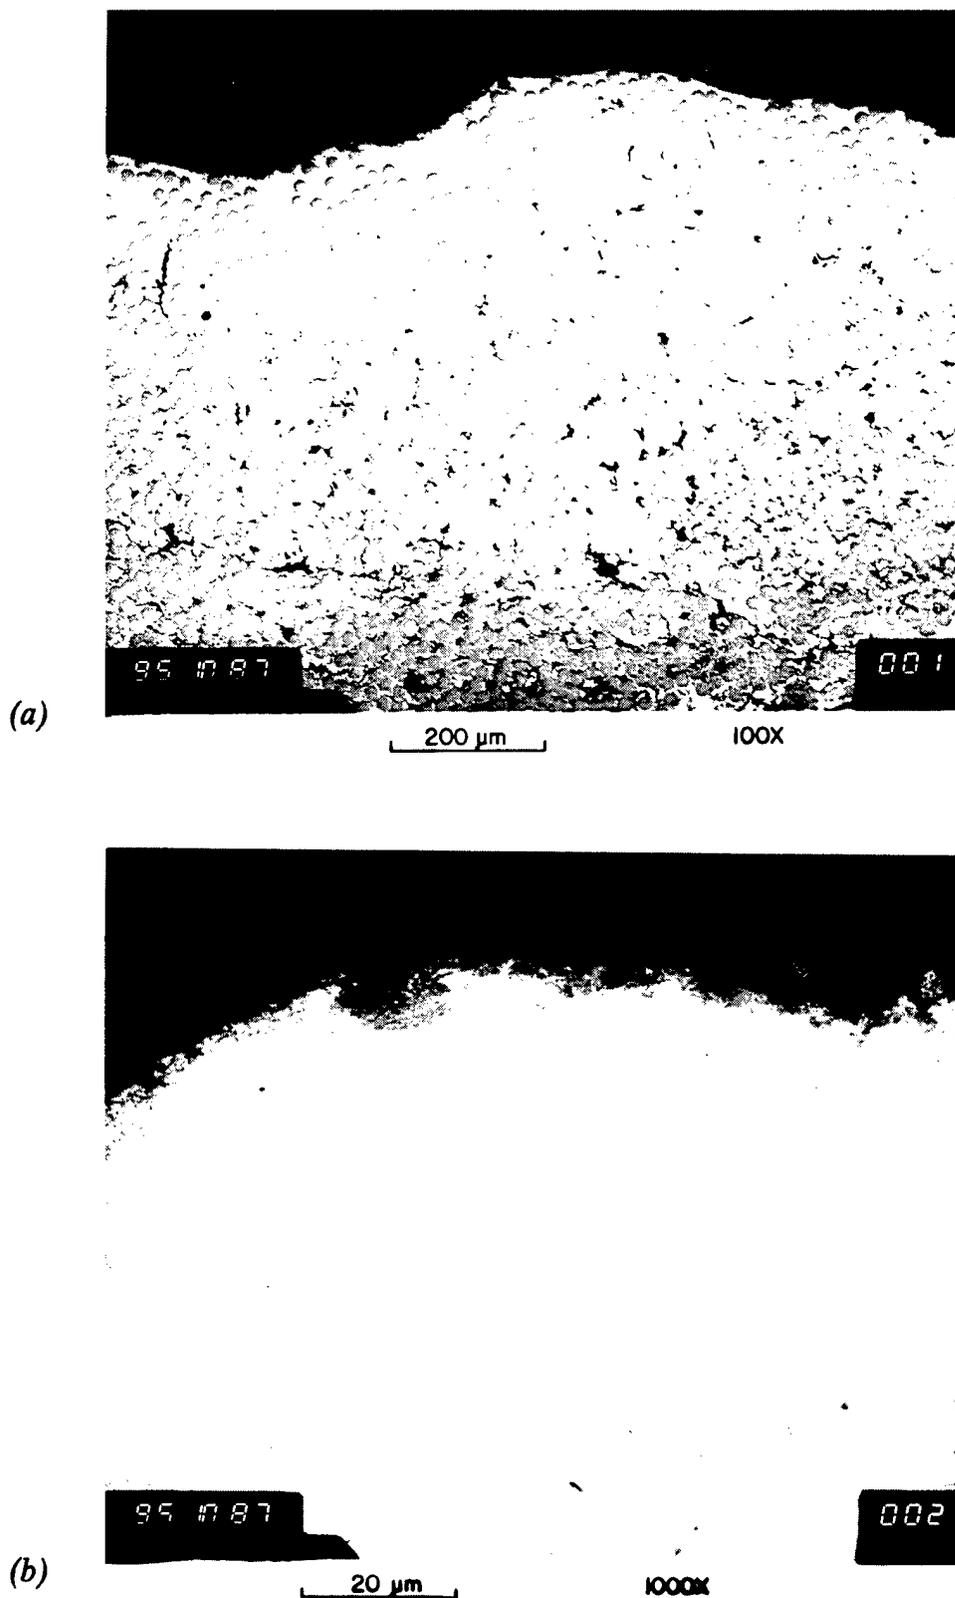
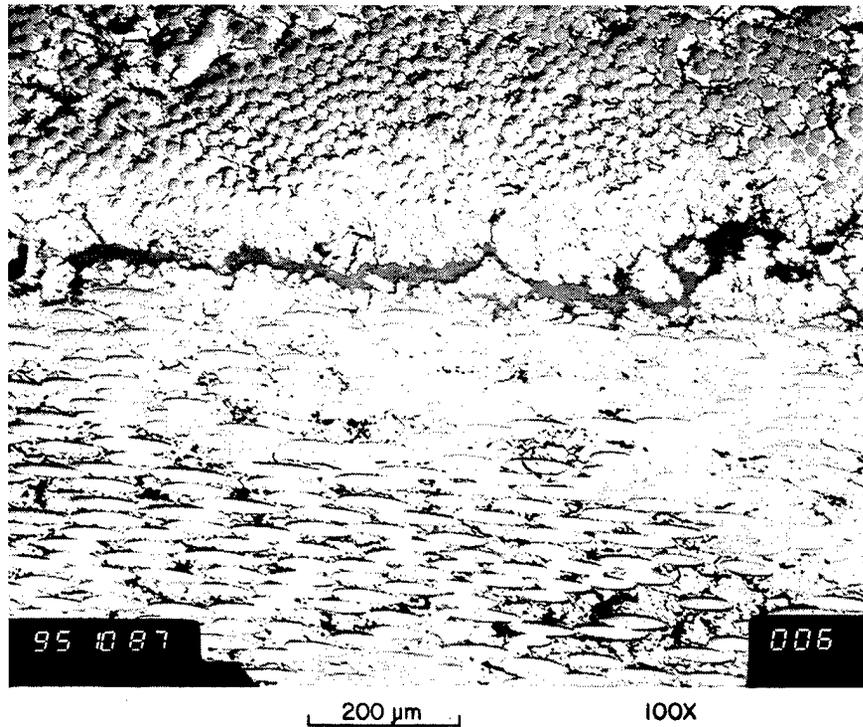
Fig. 17. Photomicrographs at (a) low and (b) high magnification of the tube's outer surface and (c) an area near the center of the wall of the PRD166/zirconia tube (tube 5).

(c)  
Fig. 17 (continued). Photomicrographs at (a) low and (b) high magnification of the tube's outer surface and (c) an area near the center of the wall of the PRD166/zirconia tube (tube 5).

The second PRD166/zirconia tube, tube 5, is shown in the micrographs of Fig. 17, and again there is a small amount of porosity, but in this case the fiber nearest the surface has an indication over half the cross section that it is reacting with the environment. The micrograph of the center of the sample shows porosity along the interface between fiber bundles.

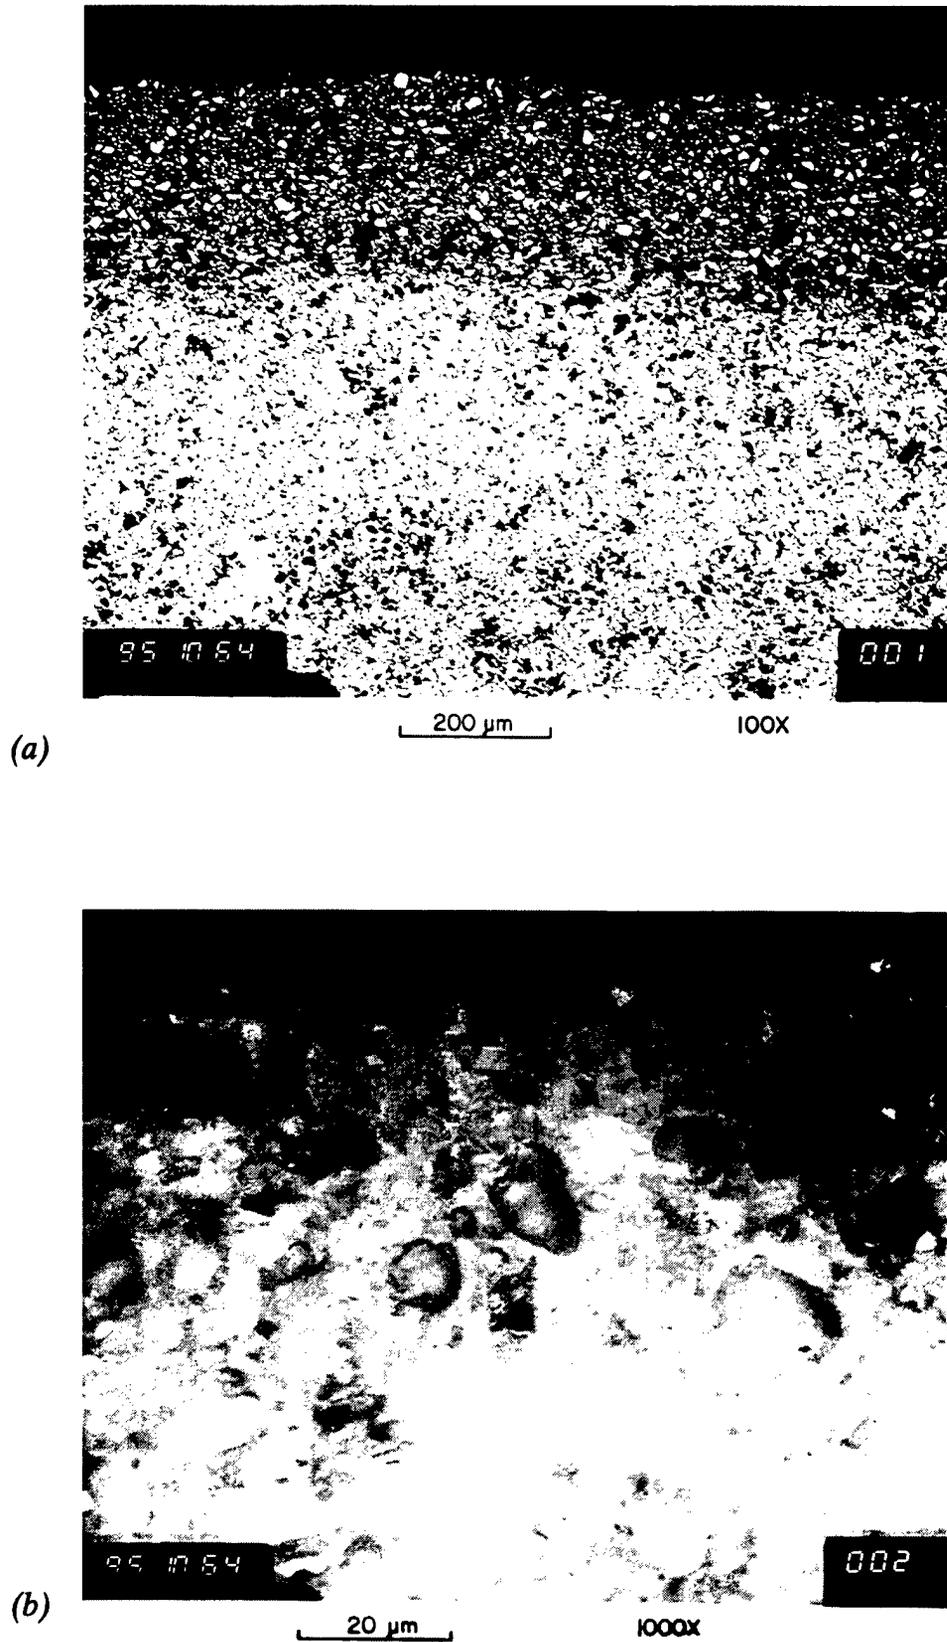
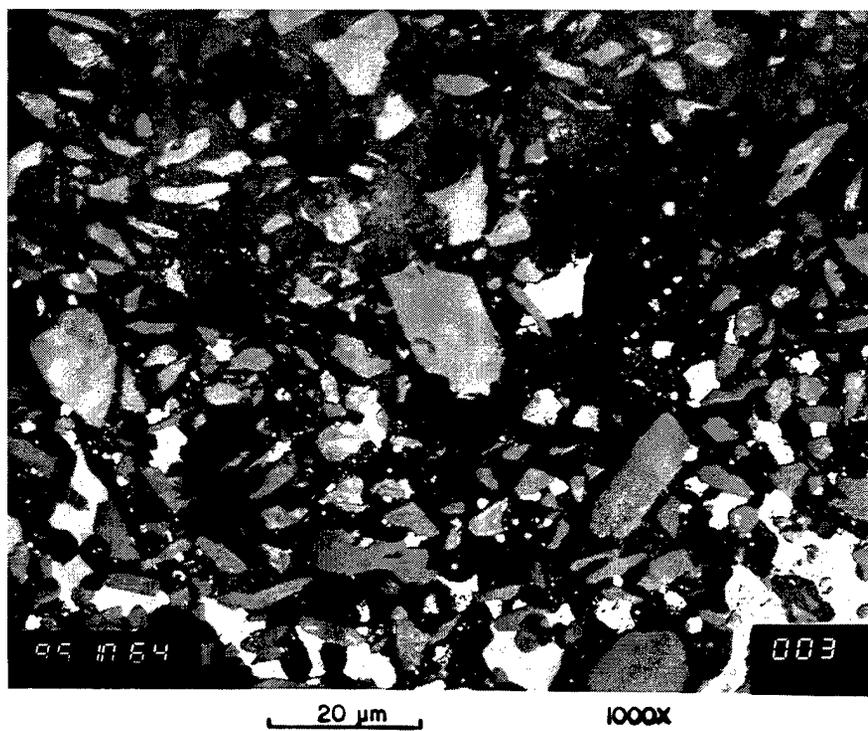
Fig 18. Photomicrographs at (a) low and (b) high magnification of the tube's outer surface and (c) an area a short distance below the outer surface of the  $\text{SiC}_p\text{-Al}_2\text{O}_3$  tube.

Fig. 18 (continued). Photomicrographs at (a) low and (b) high magnification of the tube's outer surface and (c) an area a short below the outer surface of the  $\text{SiC}_p\text{-Al}_2\text{O}_3$  tube.

Micrographs of the silicon carbide particulate-strengthened alumina tube are shown in Fig. 18. The surface of this sample has an apparently adherent surface deposit below which is the  $\text{SiC}_p\text{-Al}_2\text{O}_3$  matrix. This subsurface material has essentially no pockets of unreacted aluminum alloy, but farther into the sample, the matrix contains an aluminum-rich alloy [the lightest grey material in Fig. 18(c)] along with the SiC particles. There is some porosity throughout the sample, but the pores are fairly well dispersed and quite small in size.

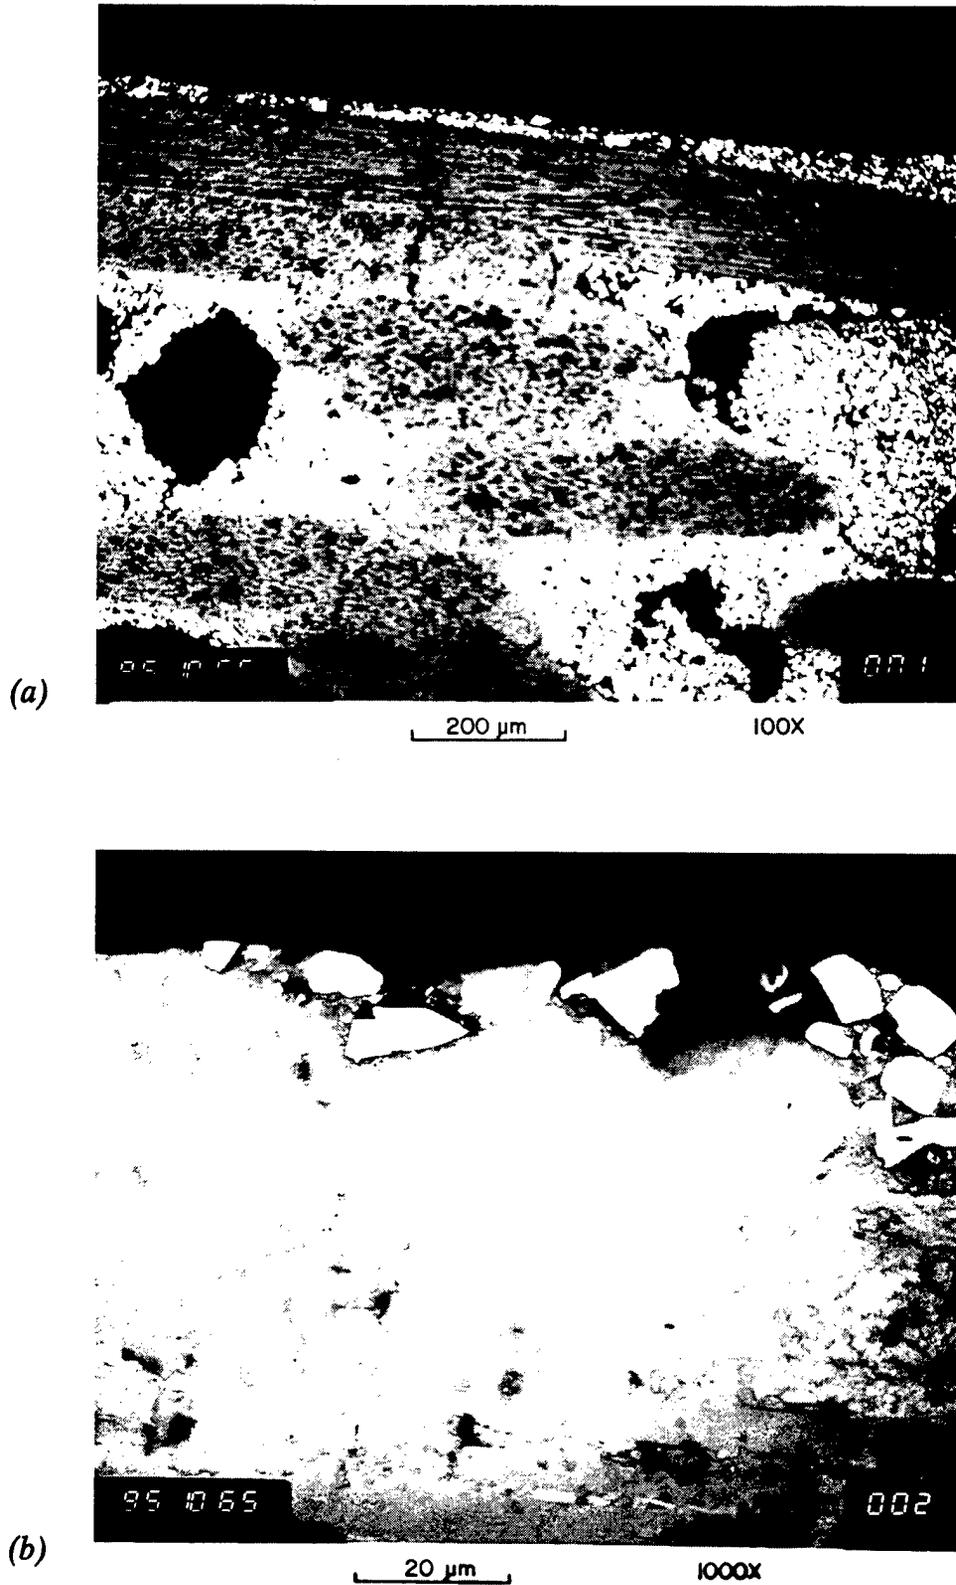
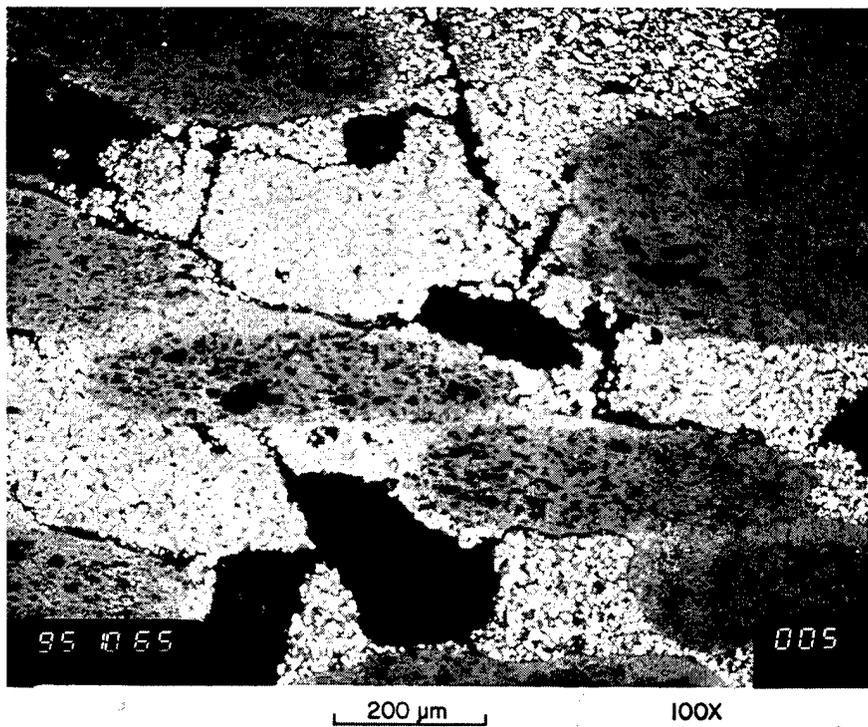
Fig. 19. Photomicrographs at (a) low and (b) high magnification of the outer surface and (c) an area near the center of the wall of the mixed-oxide tube (Babcock & Wilcox designation-tube 7).

**Fig. 19 (continued).** Photomicrographs at (a) low and (b) high magnification of the outer surface and (c) an area near the center of the wall of the mixed-oxide tube (Babcock & Wilcox designation-tube 7).

Samples from each of the two tubes, tubes 7 and 9, composed of the mixed oxide are shown in Figs. 19 and 20, respectively. Figure 19 reveals dark regions in the microstructure of tube 7, containing degraded fibers, with an appreciable amount of porosity and lighter regions that contain angular particles in a matrix. There is also a significant amount of relatively large porosity in the lighter regions. No evidence of interaction of the tube components with the environment is apparent, and the micrograph taken near the center of the sample shows the same structure as the outer surface of the sample with regard to porosity and the light- and dark-colored areas.

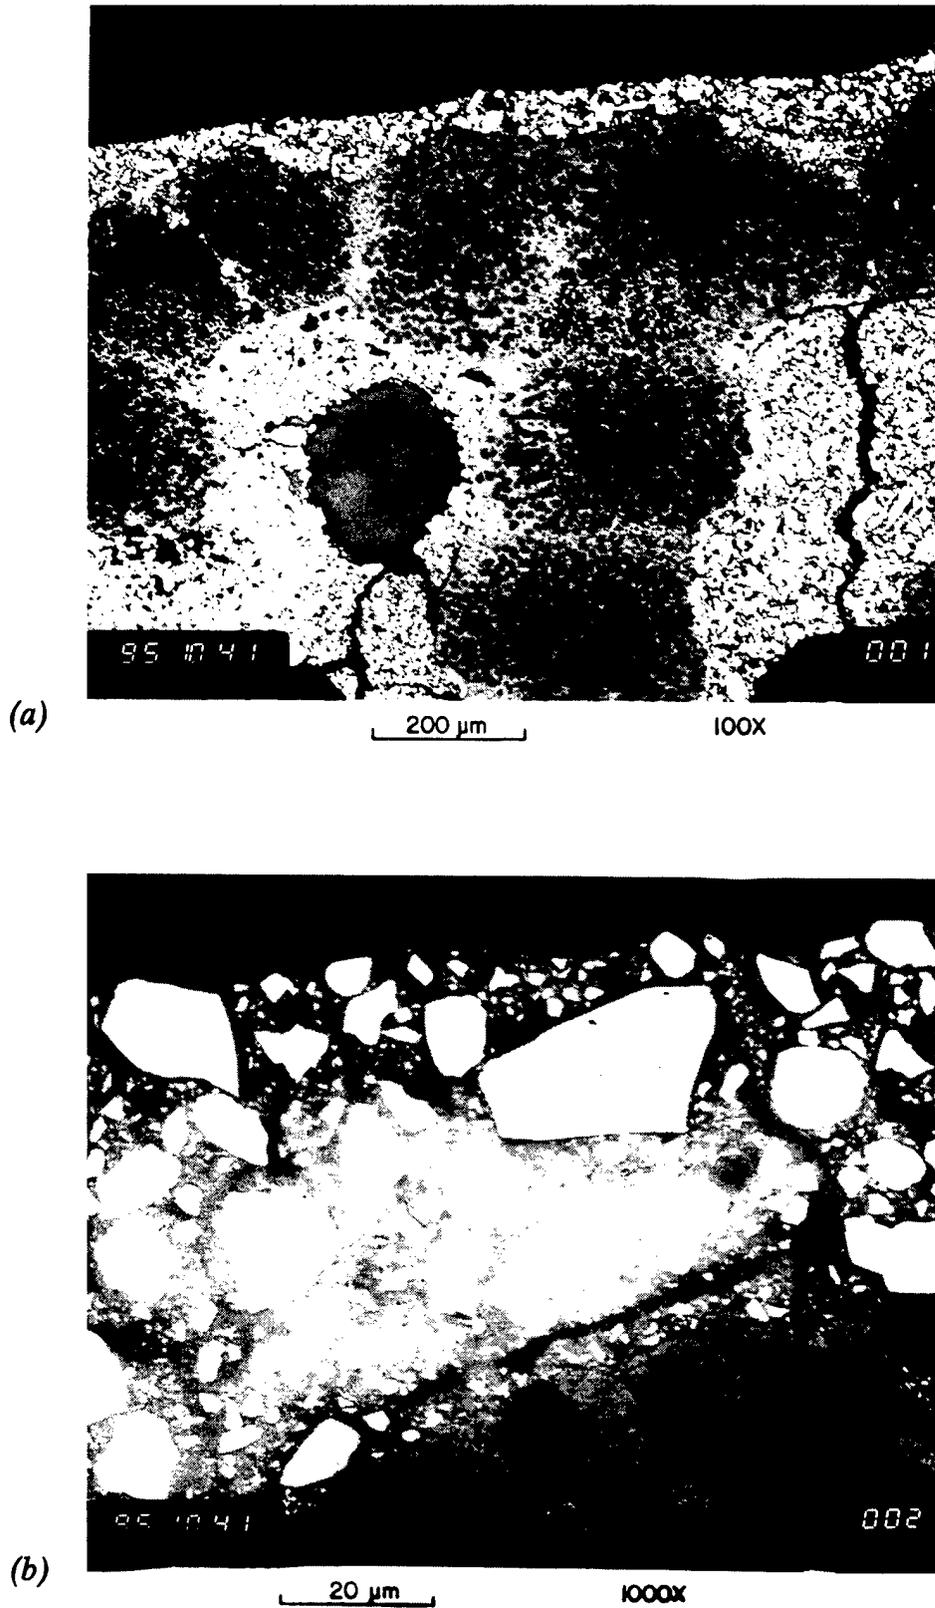
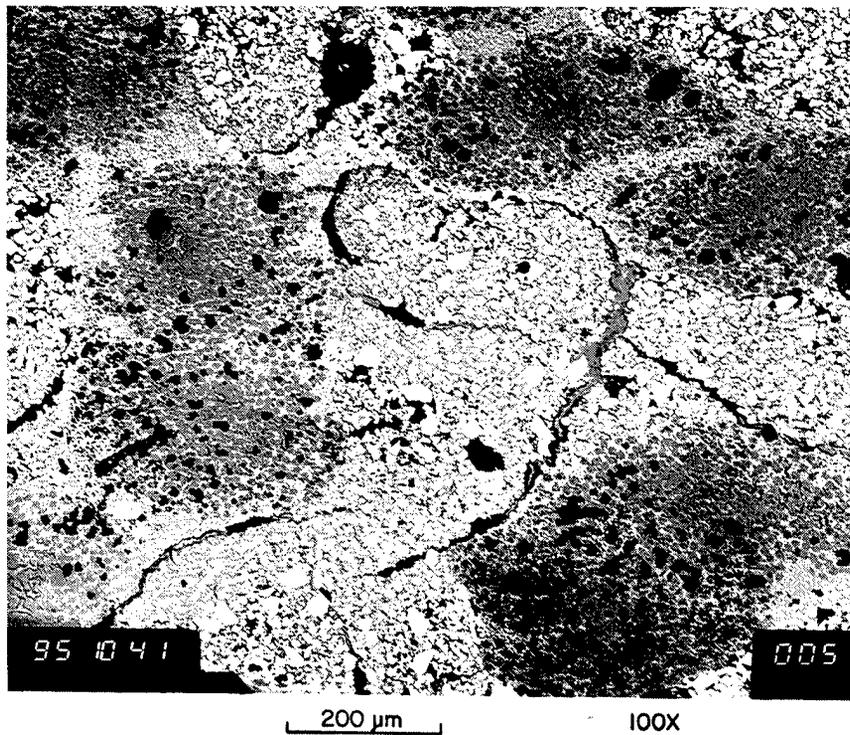
Fig. 20. Photomicrographs at (a) low and (b) high magnification of the tube's outer surface and (c) an area near the center of the wall of the mixed-oxide tube (Babcock & Wilcox designation-tube 9).

**Fig. 20 (continued).** Photomicrographs at (a) low and (b) high magnification of the tube's outer surface and (c) an area near the center of the wall of the mixed-oxide tube (Babcock & Wilcox designation-tube 9).

Micrographs of the sample from tube 9 are shown in Fig. 20. These micrographs show the same features as seen in Fig. 19 including the porous, dark regions that contain degraded fibers; the light region containing angular particles; and large pores. Again, no evidence of reaction with the environment can be found.

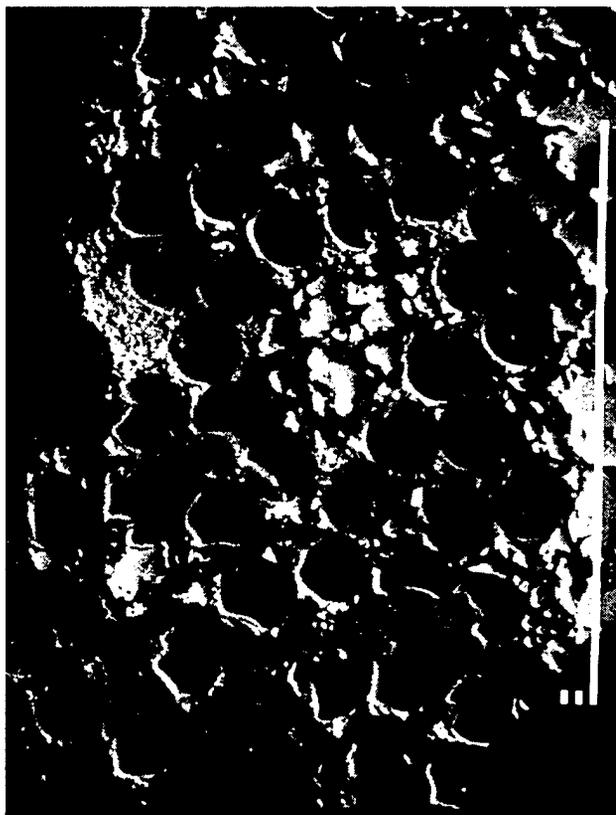
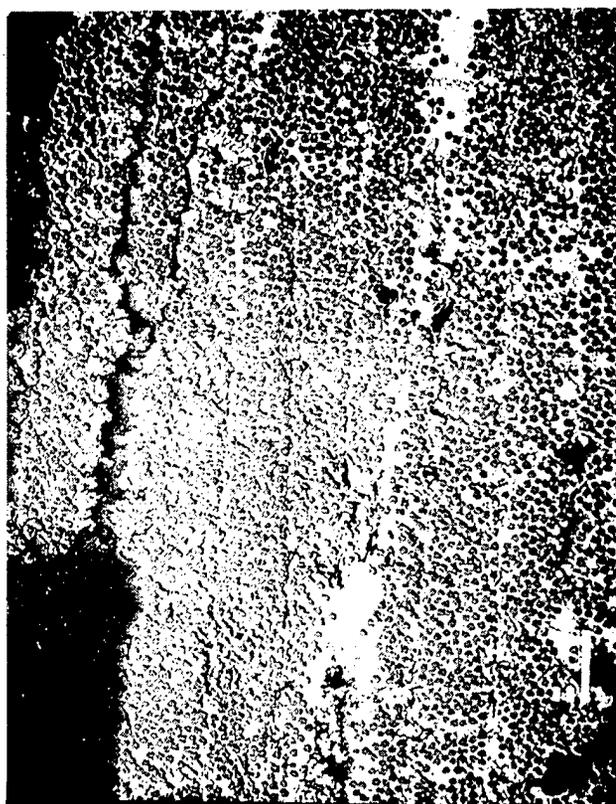
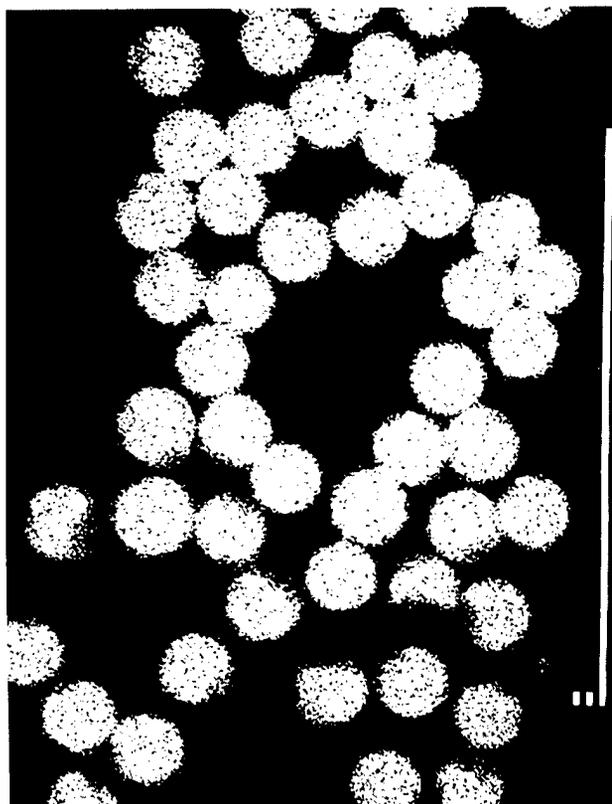
Fig. 21. Back-scattered electron image and Al, Zr, and Si elemental dot maps for Nextel 610/zirconia sample.

Figure 21 (continued) Back-scattered electron image and Al, Zr and Si elemental dot maps for Nextel 610/zirconia sample.

Examination of the samples of Nextel 610/zirconia showed the composite was composed of a zirconia matrix surrounding alumina fibers as presented in Fig. 21. Neither the transverse nor longitudinal sections showed any significant evidence of interaction between the gases in the incinerator environment and the composite materials. Deformation of the alumina fibers near the edge of the mounted samples was apparently due to chipping of the loosely supported fibers during grinding and polishing. An aluminum map does not indicate a loss of aluminum from the deformed fibers. A slightly elevated concentration of the scale constituents was found along the edge of the specimens, but only silicon appeared to intrude into the matrix of the sample. This silicon is most likely a contaminant resulting from the polishing operation.

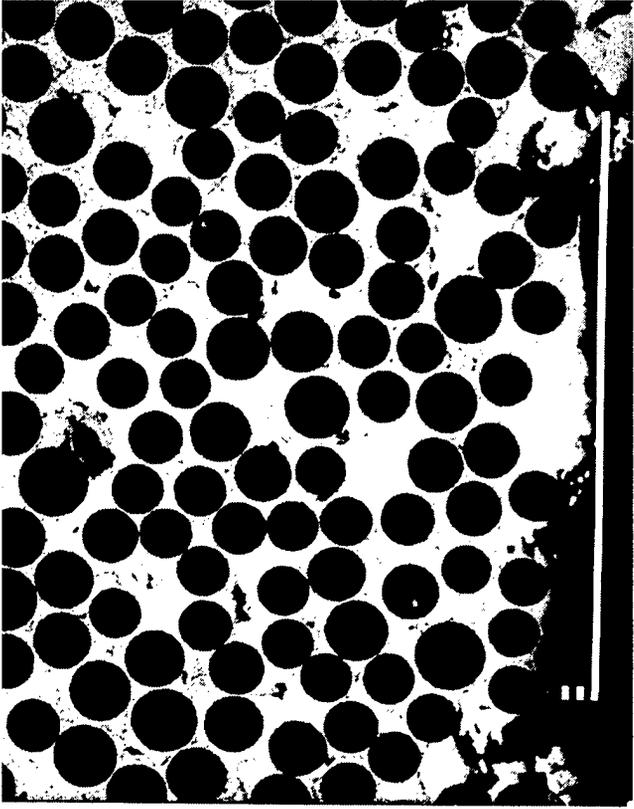
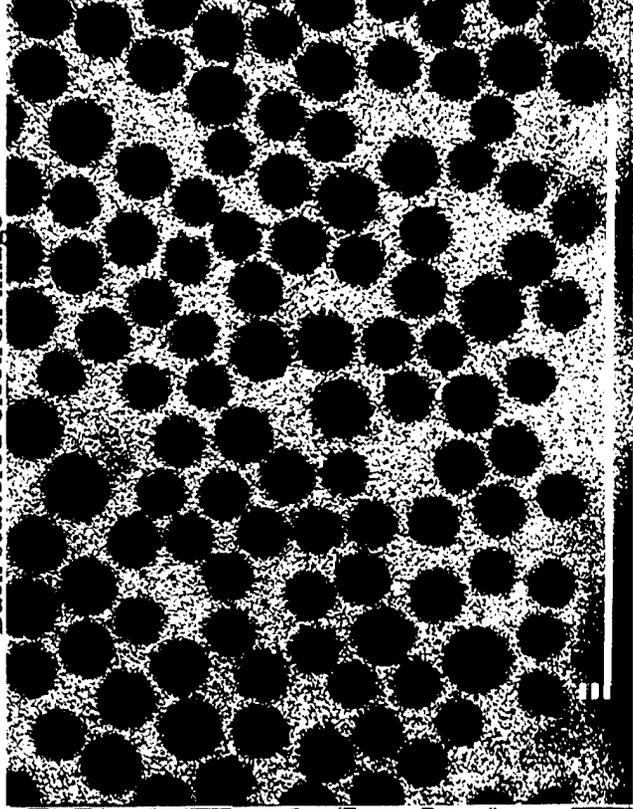
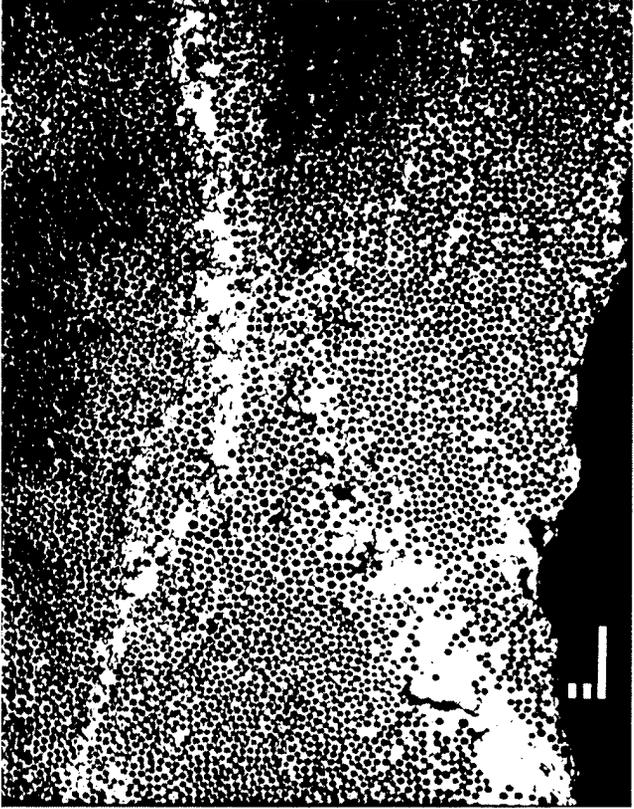
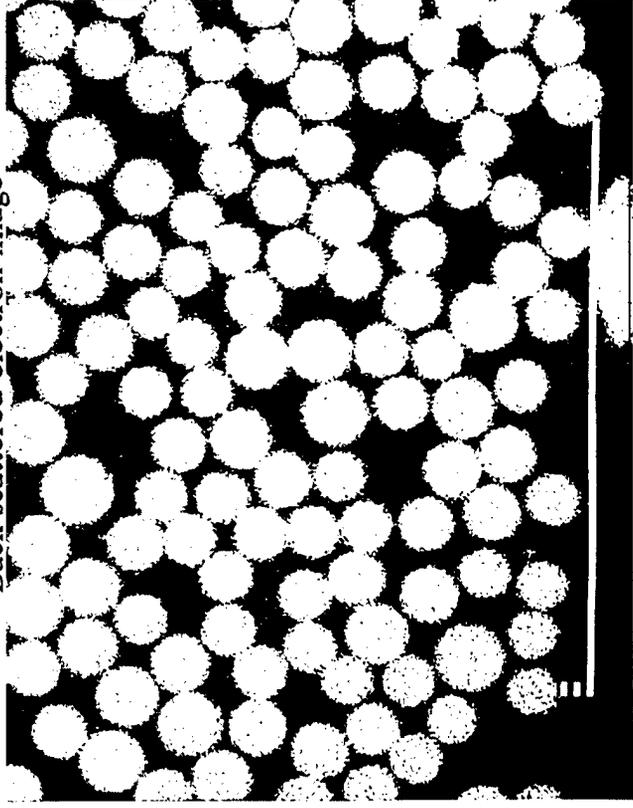
Figure 22 Back-scattered electron image and Al, Zr and Si elemental dot maps for Almax/zirconia sample.

Figure 22 (continued) Back-scattered electron image and Al, Zr and Si elemental dot maps for Almax/zirconia sample.

The Almax/zirconia composite was composed of a zirconia matrix with alumina fibers as shown in Fig. 22. No significant interaction between the incinerator gases and the composite materials was observed. Near the center of one of the samples, elevated levels of K, Ca, Na, and S were detected. However, more extensive examination led to the conclusion that these elements were present as a result of contamination rather than diffusion or interaction.

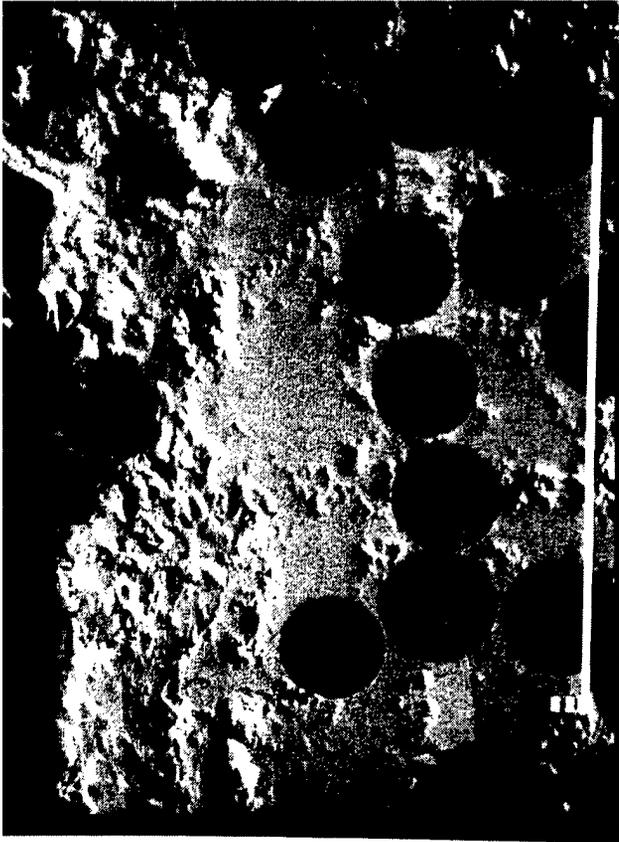
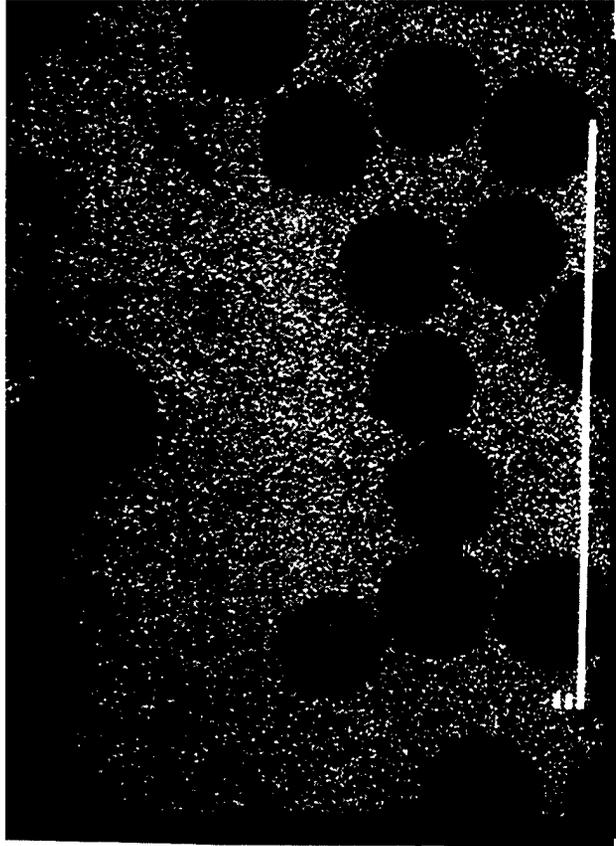
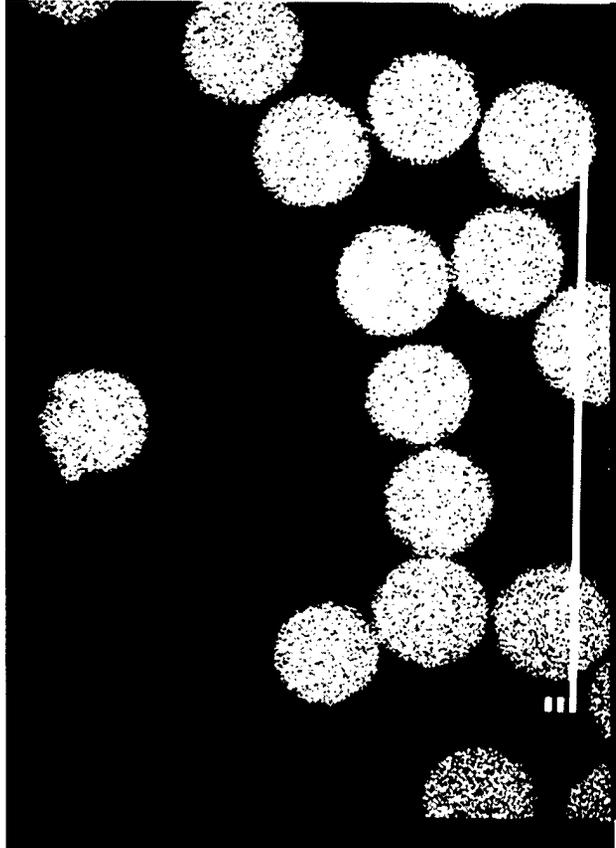
Figure 23 Back-scattered electron image and Al, Zr, Si, K, and P elemental dot maps for PRD166/zirconia tube 4.

Figure 23 (continued) Back-scattered electron image and Al, Zr, Si, K, and P dot maps for PRD166/zirconia tube 4.

Samples from two PRD166/zirconia tubes were examined, and there were significant differences in the observations. Analysis of one of the samples (see Fig. 23) indicated the composite was composed of a zirconia matrix with fibers of alumina containing a low concentration of zirconia. No evidence of significant interaction was observed between the composite material and the incinerator gases. However, some intrusion of K and P was detected near the surface.
