ORNL/TM-13128

**EXAMINATION OF BABCOCK AND WILCOX TUBES AFTER EXPOSURE  
IN AN INDUSTRIAL WASTE INCINERATOR**

**Date Published: June 1996**

**Prepared by the  
OAK RIDGE NATIONAL LABORATORY  
Oak Ridge, Tennessee 37831-6285  
managed by  
LOCKHEED MARTIN ENERGY RESEARCH CORPORATION  
for the  
U.S. DEPARTMENT OF ENERGY  
under contract DE-AC05-96OR22464**

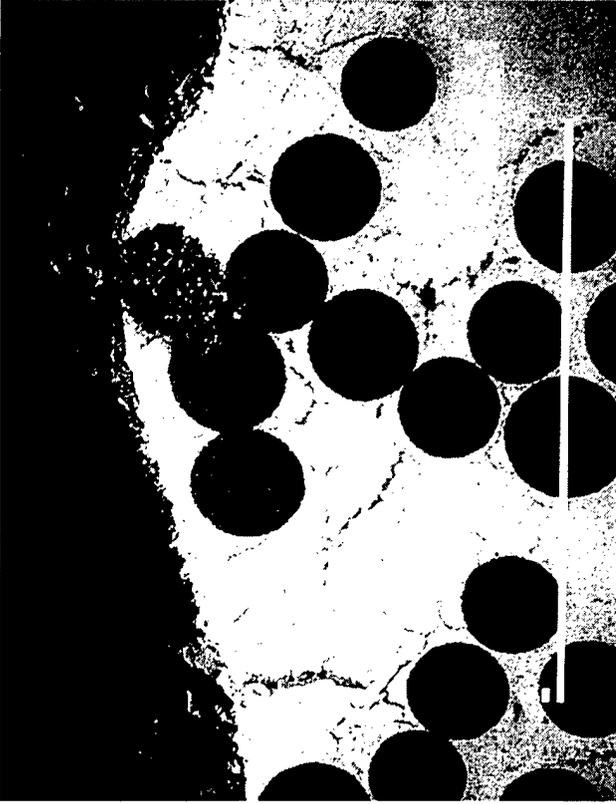
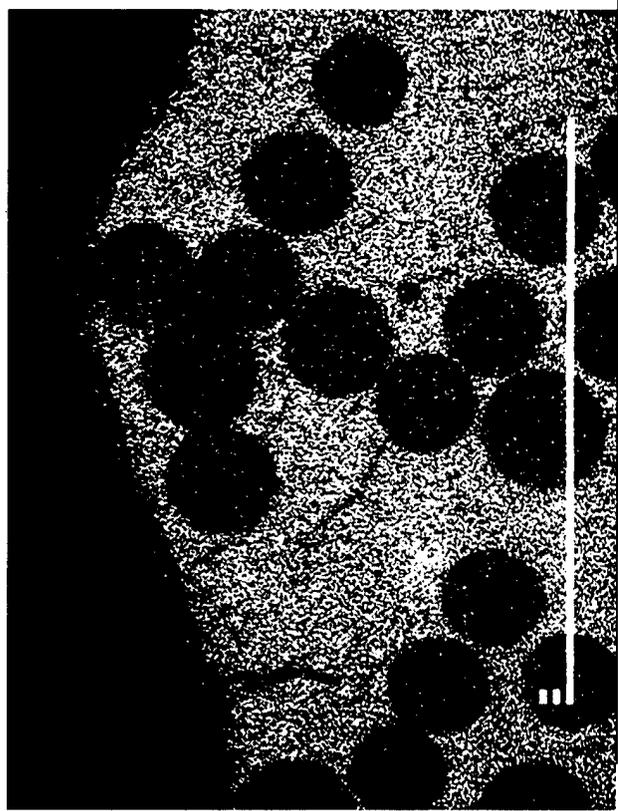
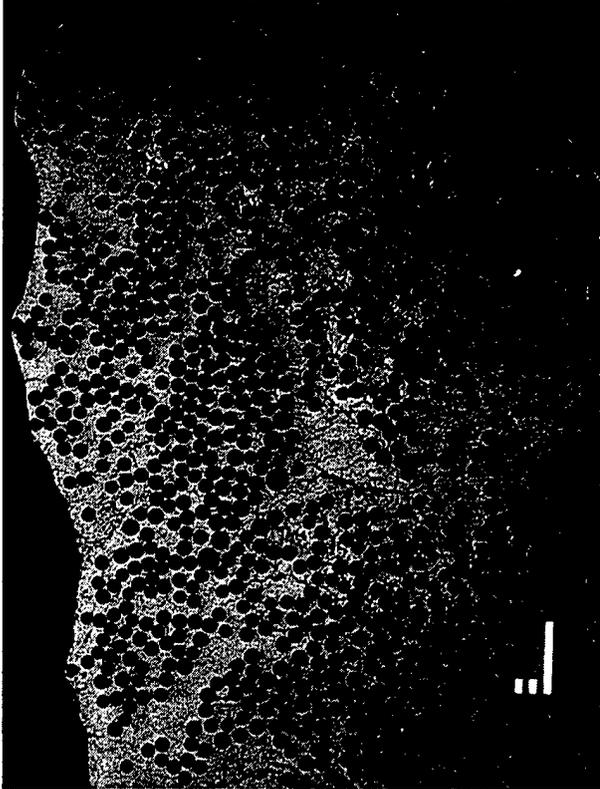
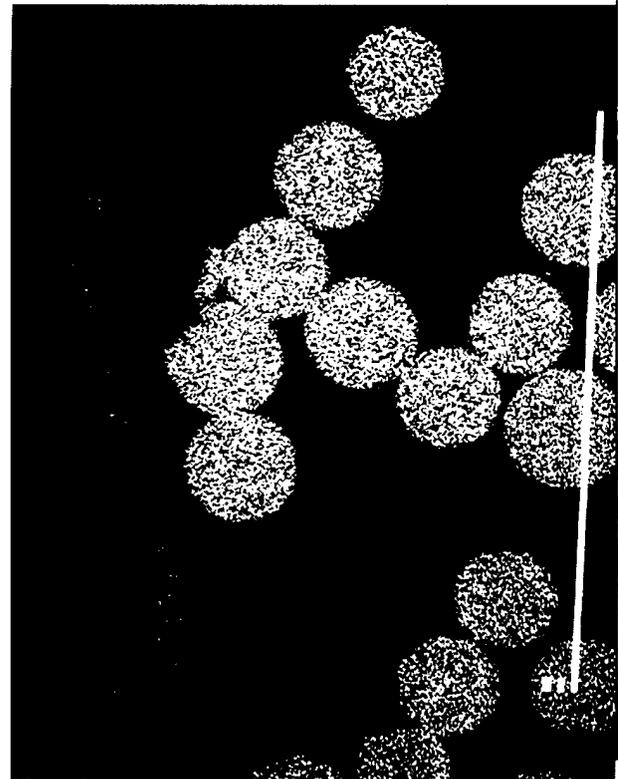
Figure 24 Back-scattered electron image and Al, Zr, Si, K, and P dot maps for PRD166/zirconia sample (tube 5).

Figure 24 (con't) Back-scattered electron image and Al, Zr, Si, K, P and Y dot maps for PRD166/zirconia sample (tube 5).

The second PRD166/zirconia tube had the same composition of the phases as the sample just described (see Fig. 24); however, two types of reaction between the incinerator gases and the composite material were indicated. Fibers that had their surfaces exposed showed areas of aluminum depletion and deposits of K, P, Si, Ca and S in the alumina-depleted location. Segregation of Y from the matrix to form a thin Y-P- rich layer along the surface was observed. The Y-P was also observed to segregate along thin lines that penetrated well into the zirconia matrix.

The electron microprobe was also used to further study the distribution of Y in the samples, and particularly in the PRD166/zirconia samples. A recheck of the first PRD166/zirconia tube showed that Y was present in the zirconia matrix of that sample, but it was not segregated in the manner observed in the second of the PRD166/zirconia samples. Examination of the unexposed sample of PRD166/zirconia showed that Y was present in the matrix of the sample, but it was not segregated to surfaces, cracks, or any other microstructural feature. A check of the other ceramic fiber/ceramic composite samples examined in this study showed no Y was present in the Nextel 610/zirconia sample, but Y was present in the Almax/zirconia sample.

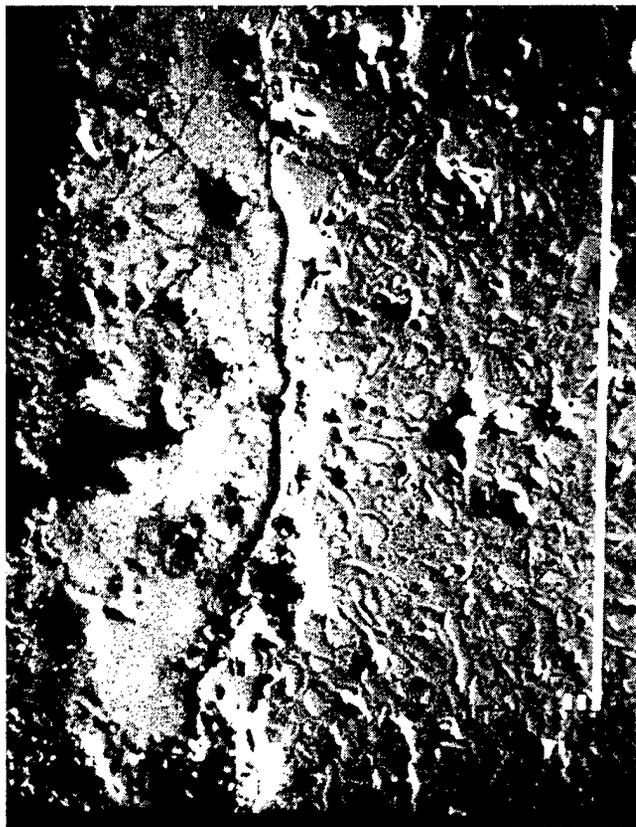
Figure 25 Back-scattered electron image and Al, Zr, Si, K, and P dot maps for the SiC<sub>p</sub>-Al<sub>2</sub>O<sub>3</sub> sample.

Figure 25 (con't) Back-scattered electron image and Al, Si, K, P, Ti and C dot maps for the SiC<sub>F</sub>-Al<sub>2</sub>O<sub>3</sub> sample.

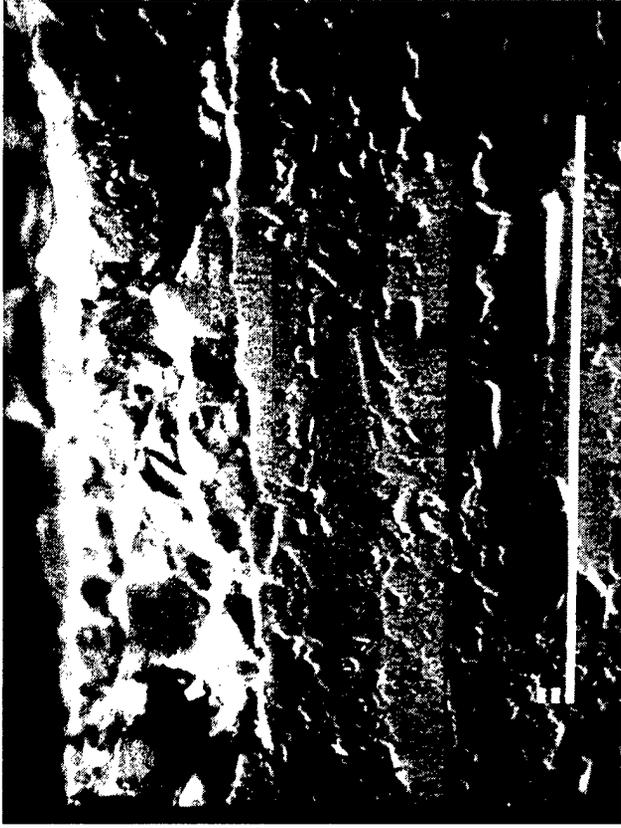
Figure 26 Back-scattered electron image and Al, Si, Mg, K, and C dot maps for the mixed oxide sample.

Figure 26 (continued) Back-scattered electron image and Al, Si, K, P, Ti and C dot maps for the mixed oxide sample.

The composite identified as Type B mixed oxide consisted of the remnants of fibers of Si, Mg, and Al in an alumina matrix along with regions, including the outer surface, as shown in Fig. 26, that contained Si and C. No significant interaction was observed, but an increased concentration of Na and P was detected between the outer surface layer and the composite. Some small spots rich in K were observed in the matrix.
