ORNL/TM-13566

**Homogeneous Reactor
Experiment (HRE) Pond
Cryogenic Barrier Technology
Demonstration: Pre-Barrier
Subsurface Hydrology and
Contaminant Transport
Investigation**

March, 1998

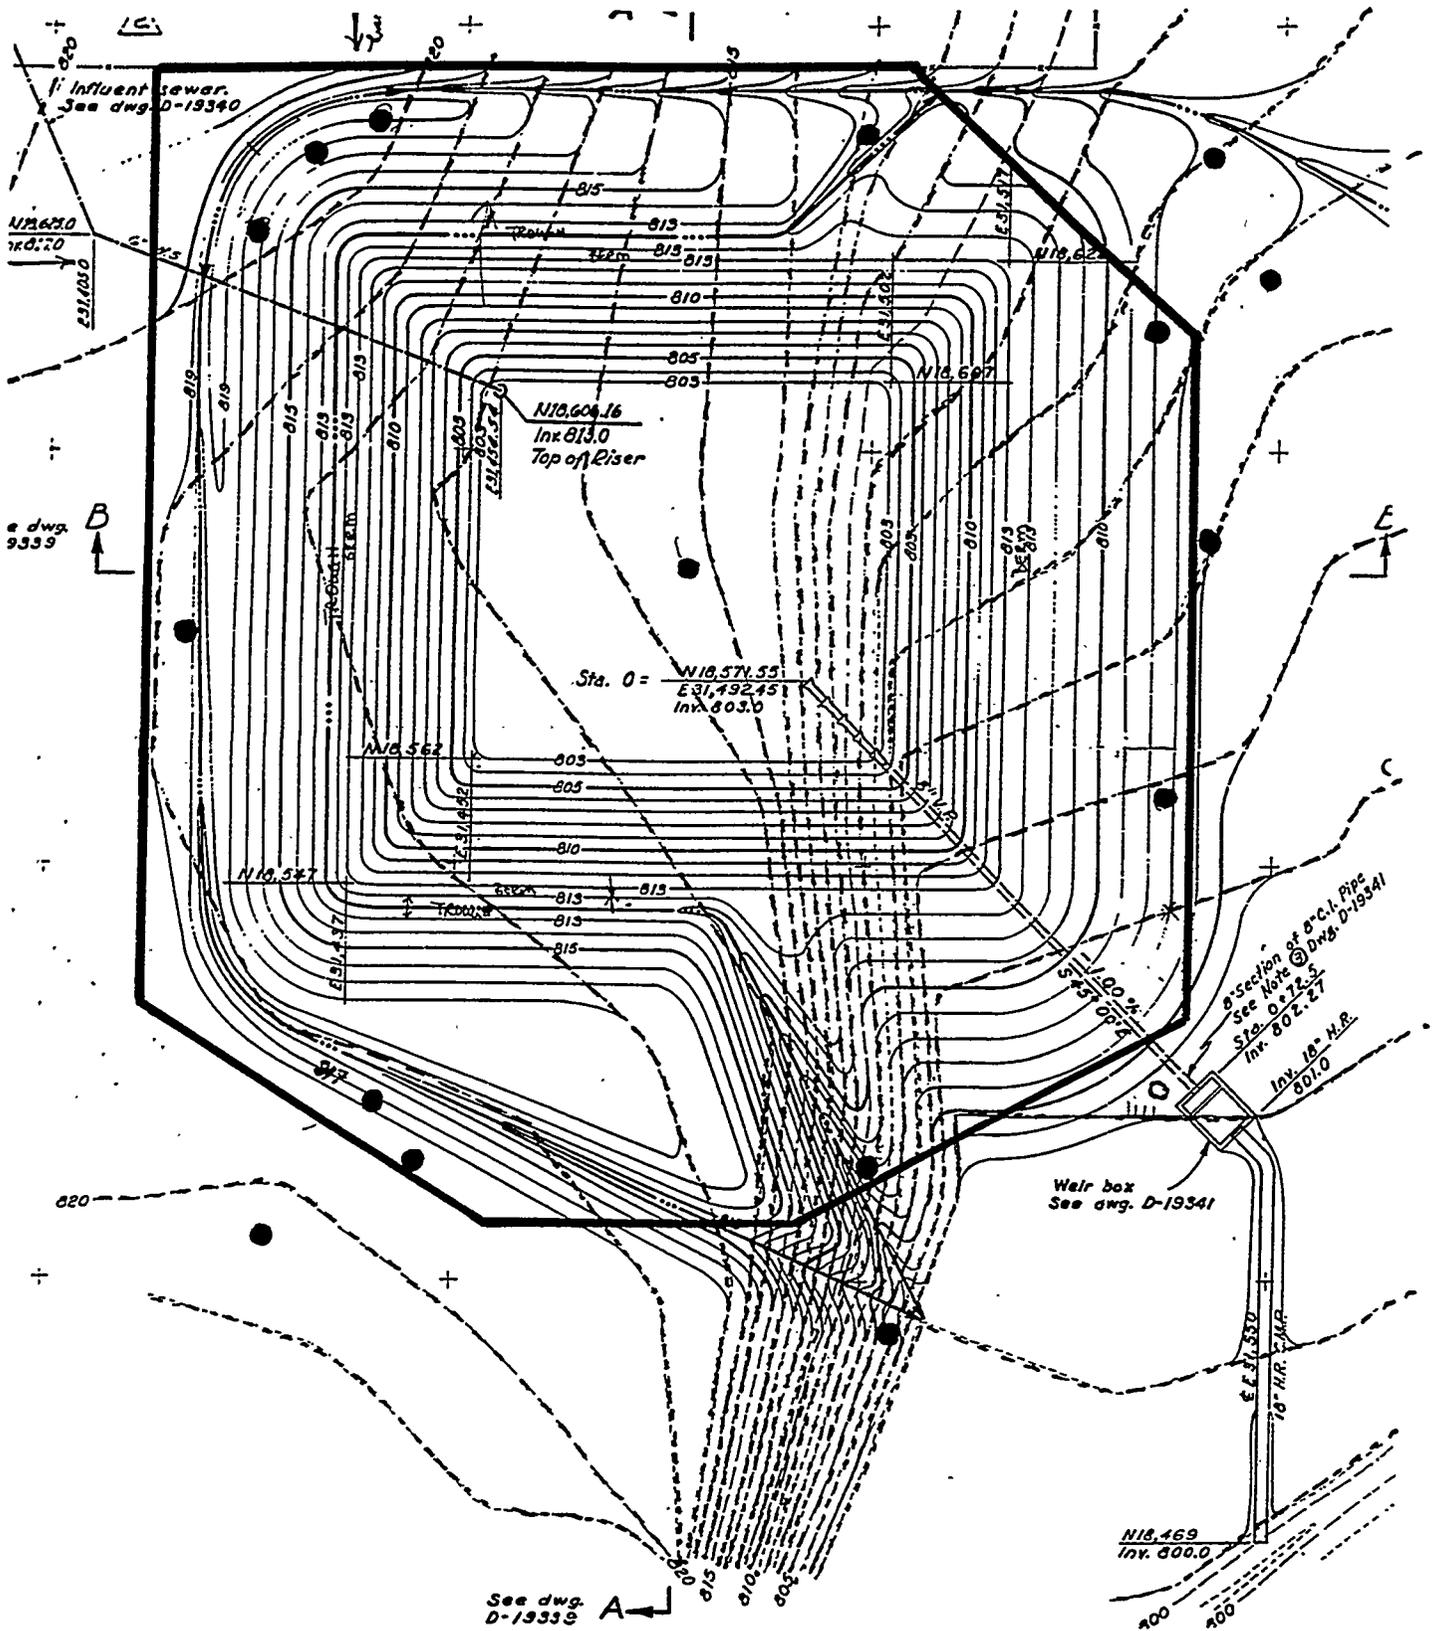
Figure 2. Engineering design for the HRE impoundment Dashed contours represent the original land surface before excavation. The boundary of the asphalt cap and well and standpipe locations have been added to the drawing. Note the location of the influent sewer line in the NW corner and the drainage pipeline in the SE corner. The original berm is located at 813' elevation.

While in operation from 1957-1962, the impoundment was used as a settling basin for low-level radioactive waste in the form of condensate from an evaporator in the process liquid waste system and shield water exposed to the reactor circuits. Contaminant settling was accelerated by the application of flocculants including ferric flocculants, trisodium phosphate, and diatomaceous earth. Figure 2 is an engineering drawing detailing the construction design for the impoundment, including the location of influent and effluent pipelines. Because these are not As-Built diagrams, it is not known how closely the actual construction matched the specifications shown in this drawing.

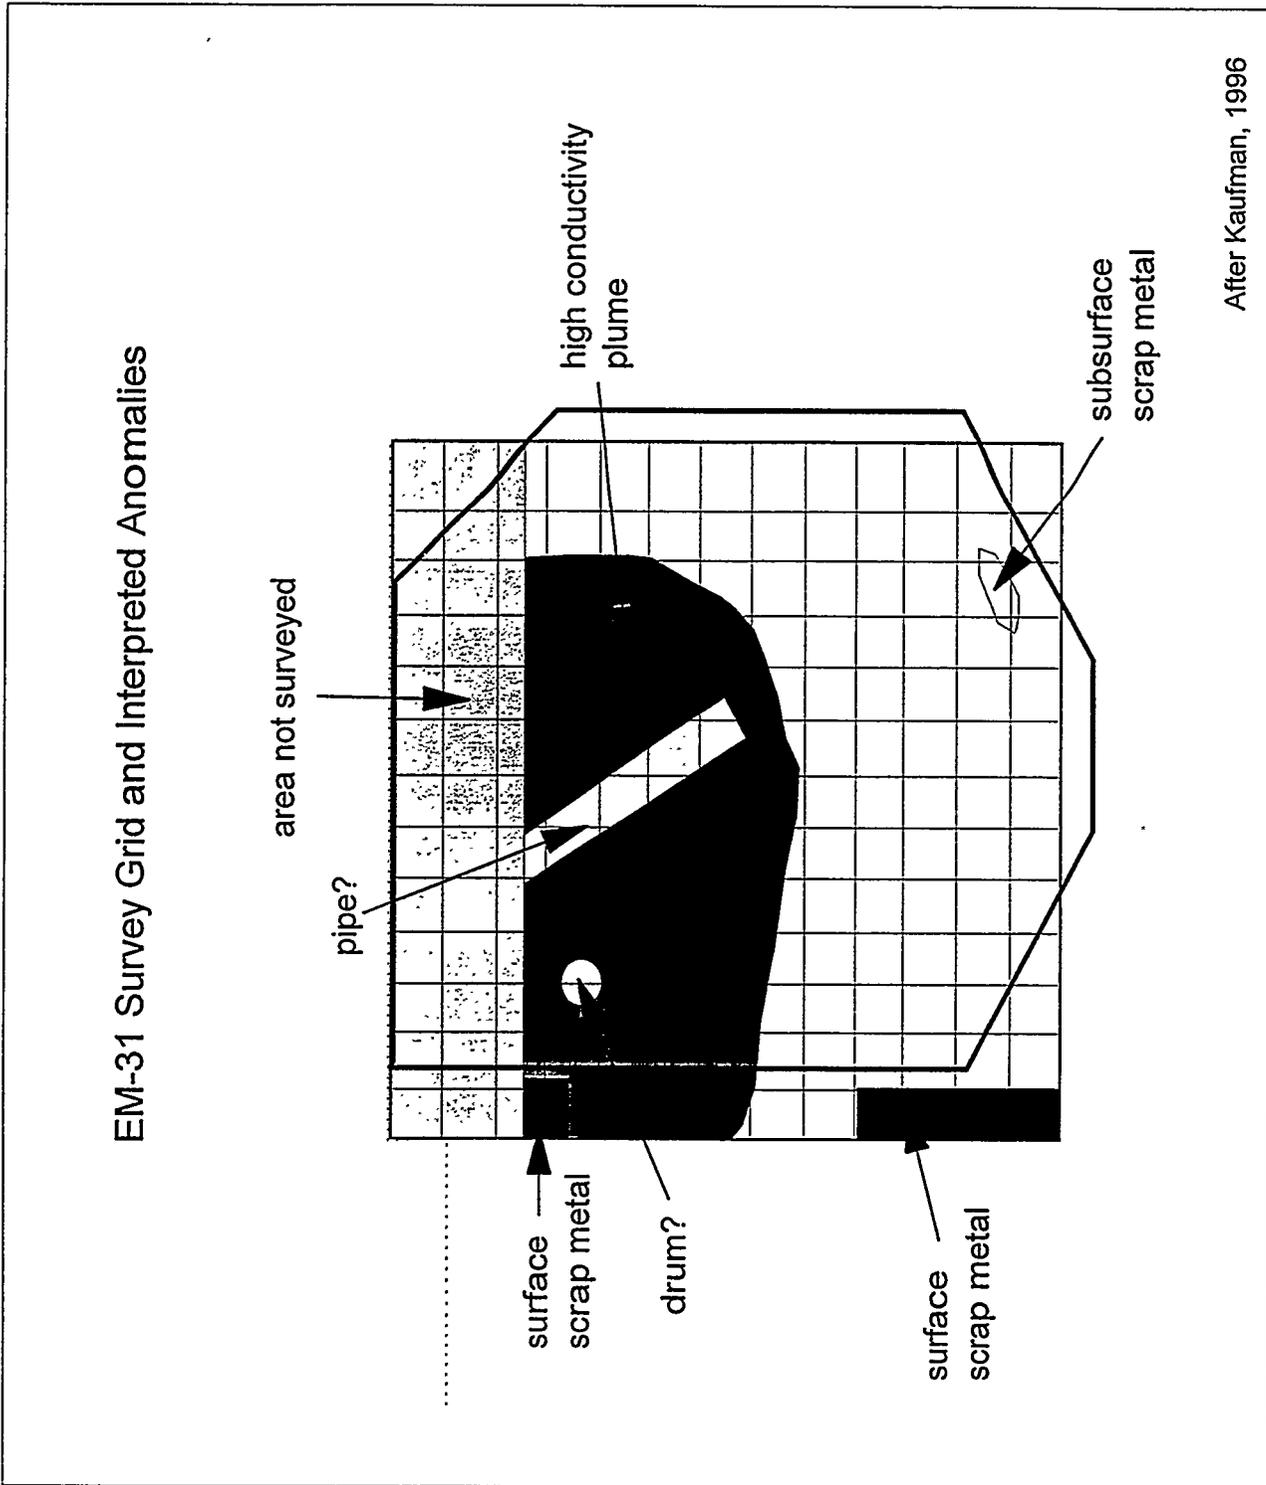
Figure 12. Results of an electromagnetic survey showing high conductivity regions and probable interpretations. The outline of the asphalt cap is shown.

In FY96 an electromagnetic conductivity survey of the HRE-Pond area was conducted to identify areas potentially containing buried drums, metallic pipes, and other metallic debris [Kaufmann, 1996]. The survey identified areas of high- and low-conductivity anomalies (Figure 12). One striking anomaly is the low-conductivity linear feature at the north end of the grid, extending through the north wall of the former impoundment and consistent with a subsurface pipe. Two other anomalies were interpreted as possible buried scrap metal in the NW and SE corners of the impoundment.

The in-phase components of the data are more sensitive to buried metallic objects, and the quadrature components are more related to the electrical conductivity of the ground which is controlled by clay content, moisture content, and groundwater conductivity [Kaufmann, 1996]. The quadrature data show generally much higher conductivity of the soils on the northern portion of the grid, identified as the high conductivity plume in Figure 12.

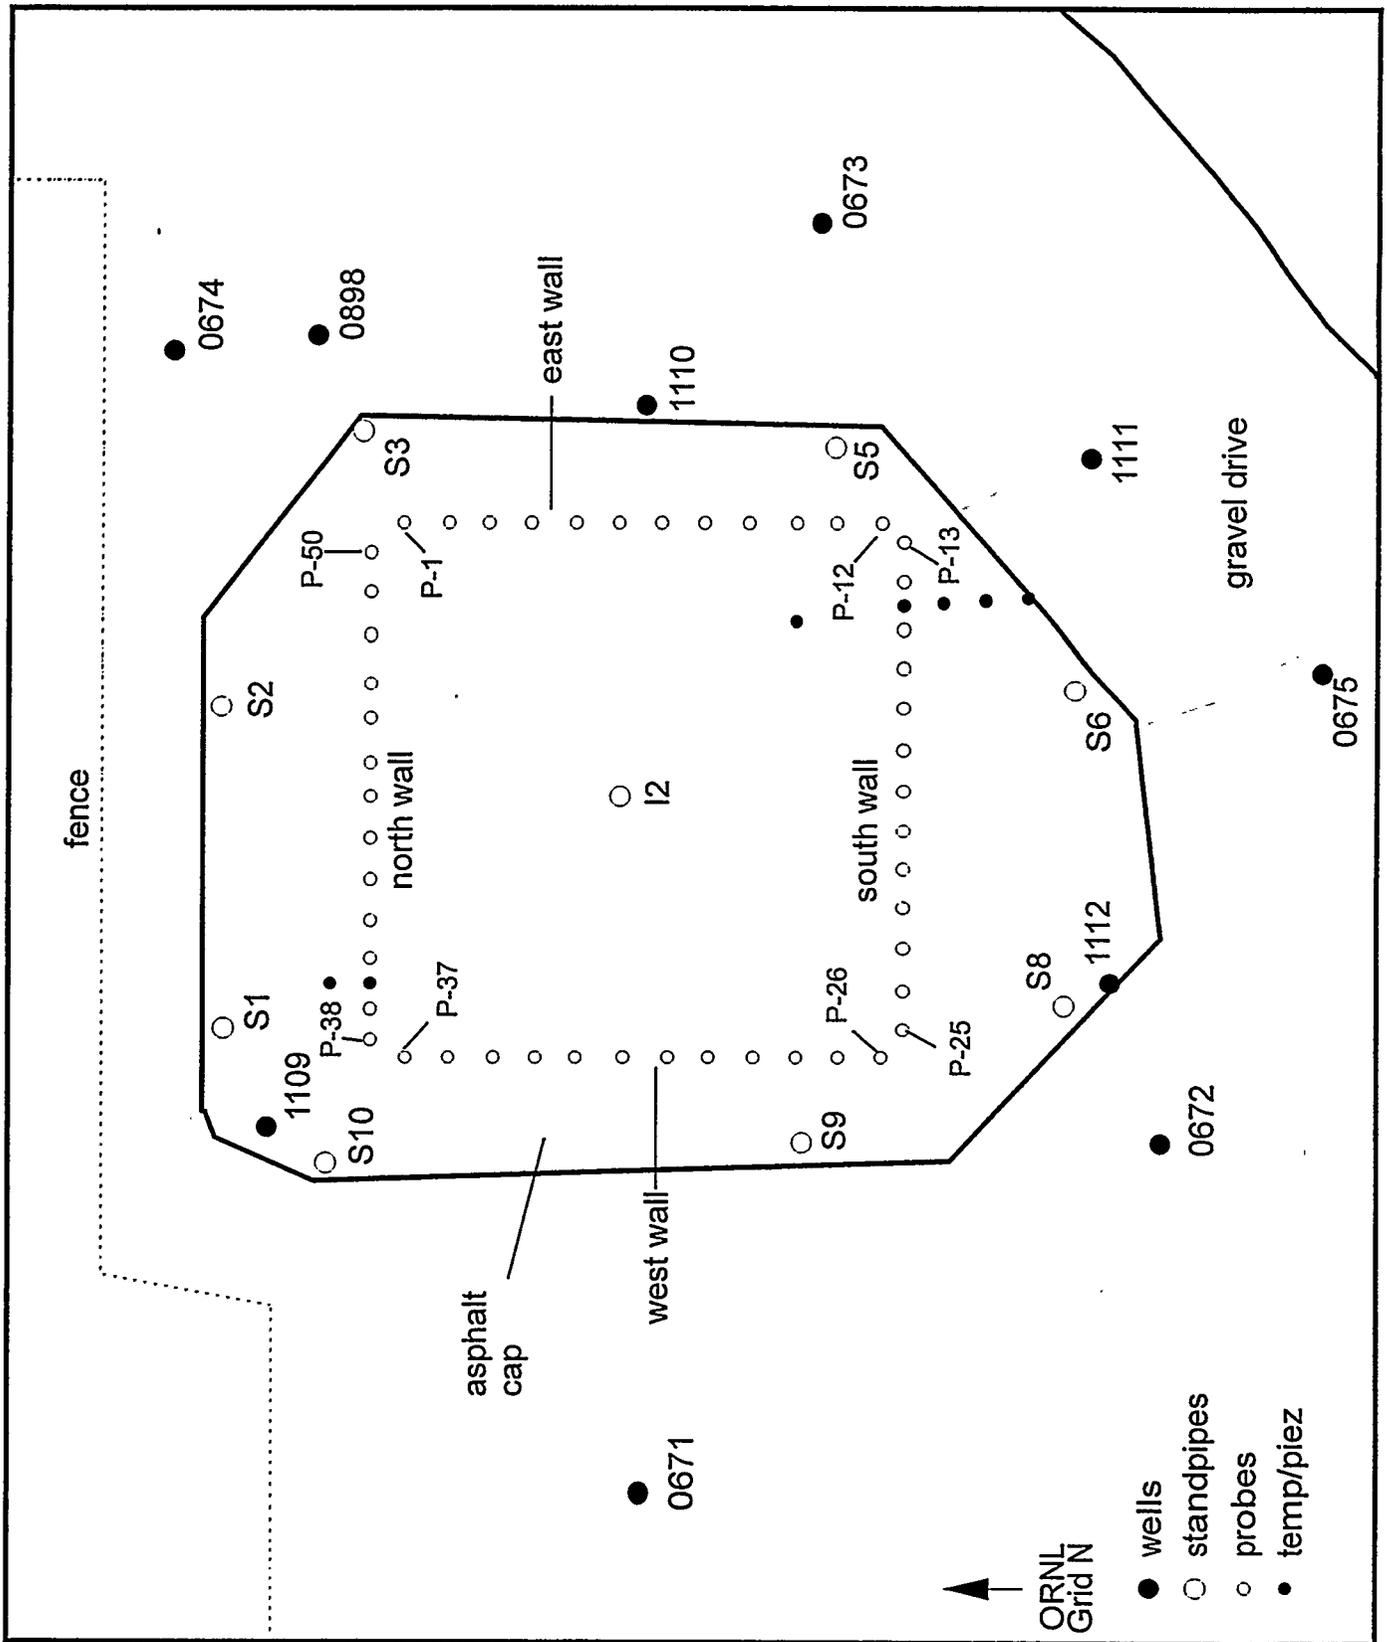
Figure 13. HRE-Pond site configuration.

Due to budgetary constraints, the pre-barrier hydrologic investigations required the use of preexisting site instrumentation (Figure 13). The only access to the interior of the impoundment beneath the asphalt cap is through a single standpipe that penetrates the cap at the center of the impoundment (I2, Fig. 13). Shallow groundwater monitoring at the water table interval was conducted by means of a network of standpipes (labeled S1 through S10 in Figure 13) that penetrate the asphalt cap but are immediately outside of the impoundment itself. All standpipes are three-inch diameter steel pipes with one-inch diameter holes drilled along the subsurface length at one-foot spacings. This construction affords sufficient connection with the surrounding groundwater to allow rapid response during transient events, as evidenced by the continuous water level data, but flow through the well is likely to be more limited than that of a screened well. Shallow groundwater below the water table interval is accessible through a network of screened monitoring wells, also shown on Figure 13. Well and standpipe construction information is summarized in Table 1.

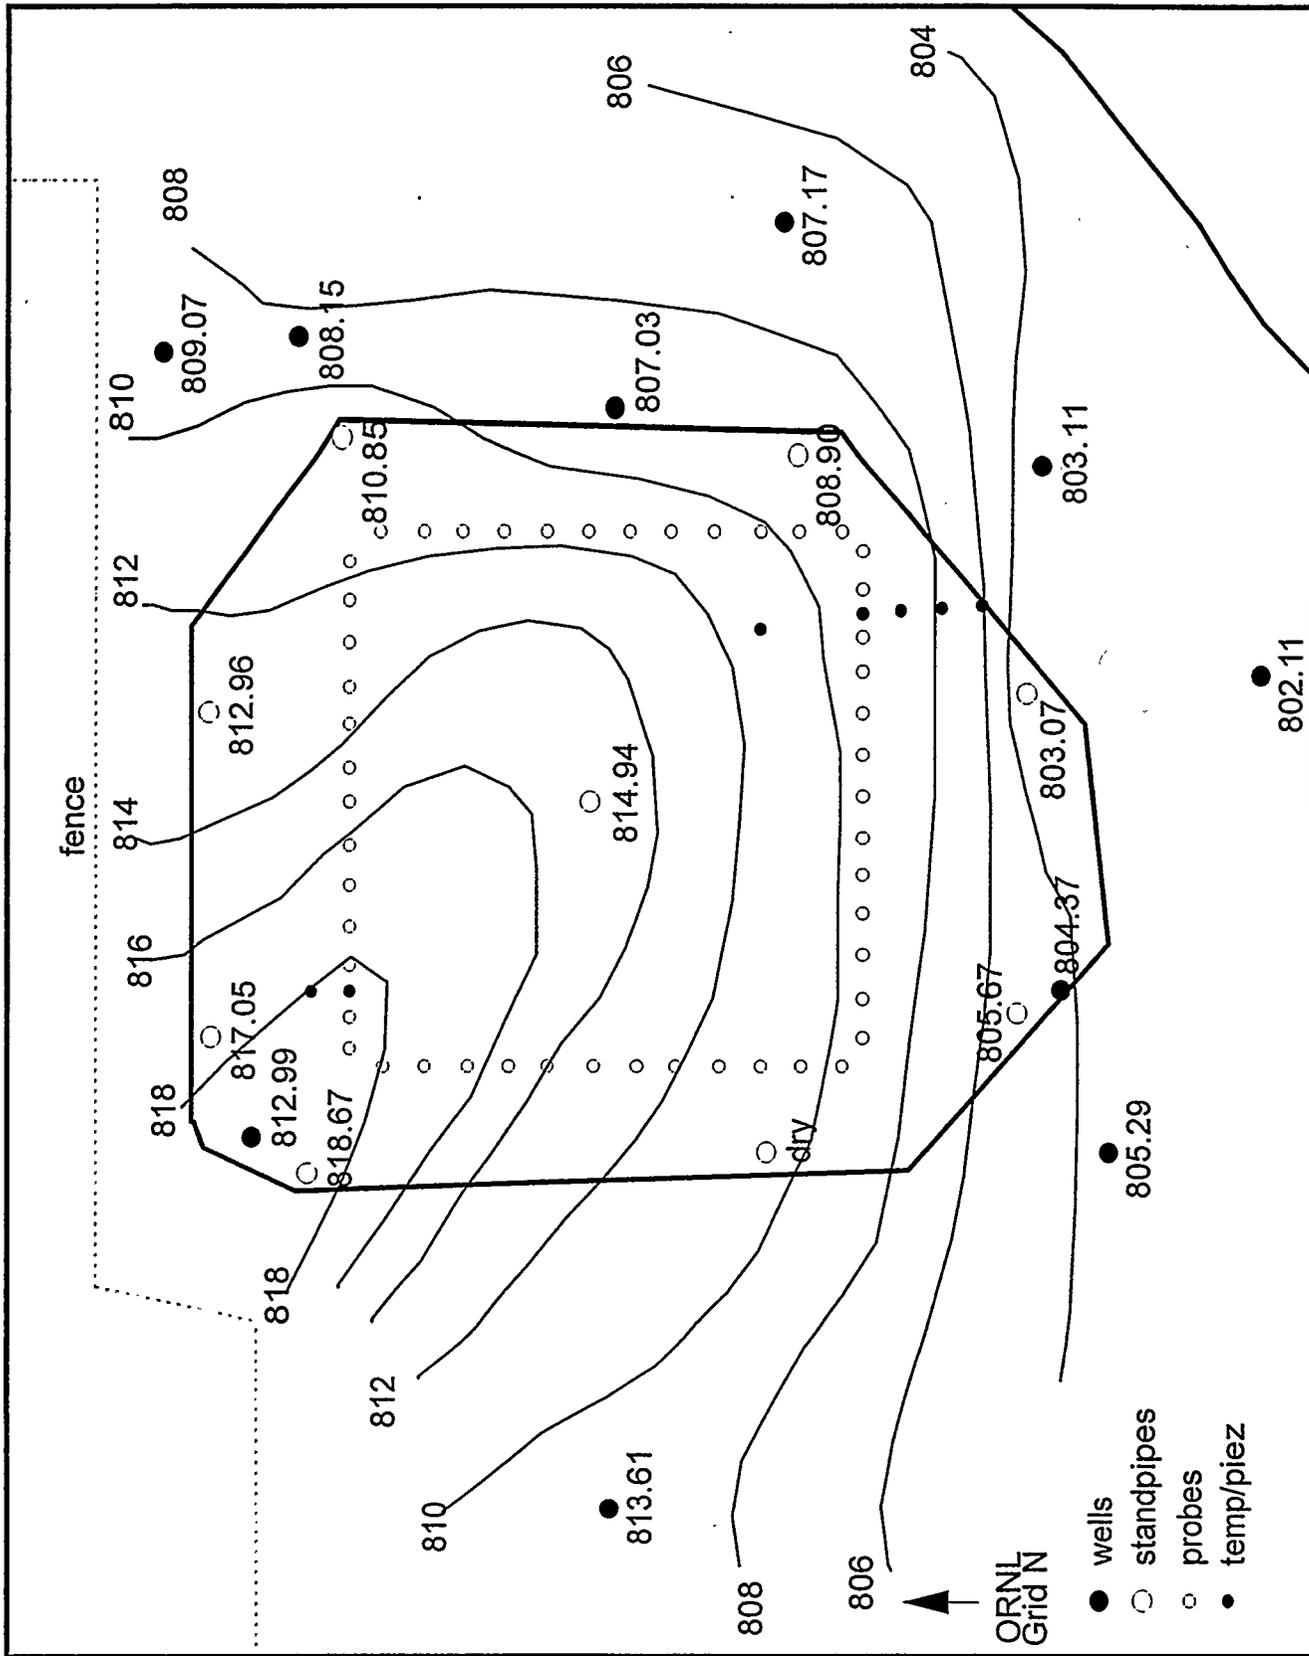
Figure 14. Dry season water table elevation on 7/8/96 (ft above msl).

Figure 14 shows a dry season water table map and measured hydraulic heads for July 8, 1996. In an isotropic porous medium, groundwater flow would be perpendicular to the hydraulic head contours. This may be a reasonable gross representation for flow through the fill materials within and overlying the impoundment, where any structure that might have been present in the original material would have been destroyed. However, flow through the undisturbed shale bedrock and overlying saprolite surrounding the impoundment will be heavily influenced by a fracture

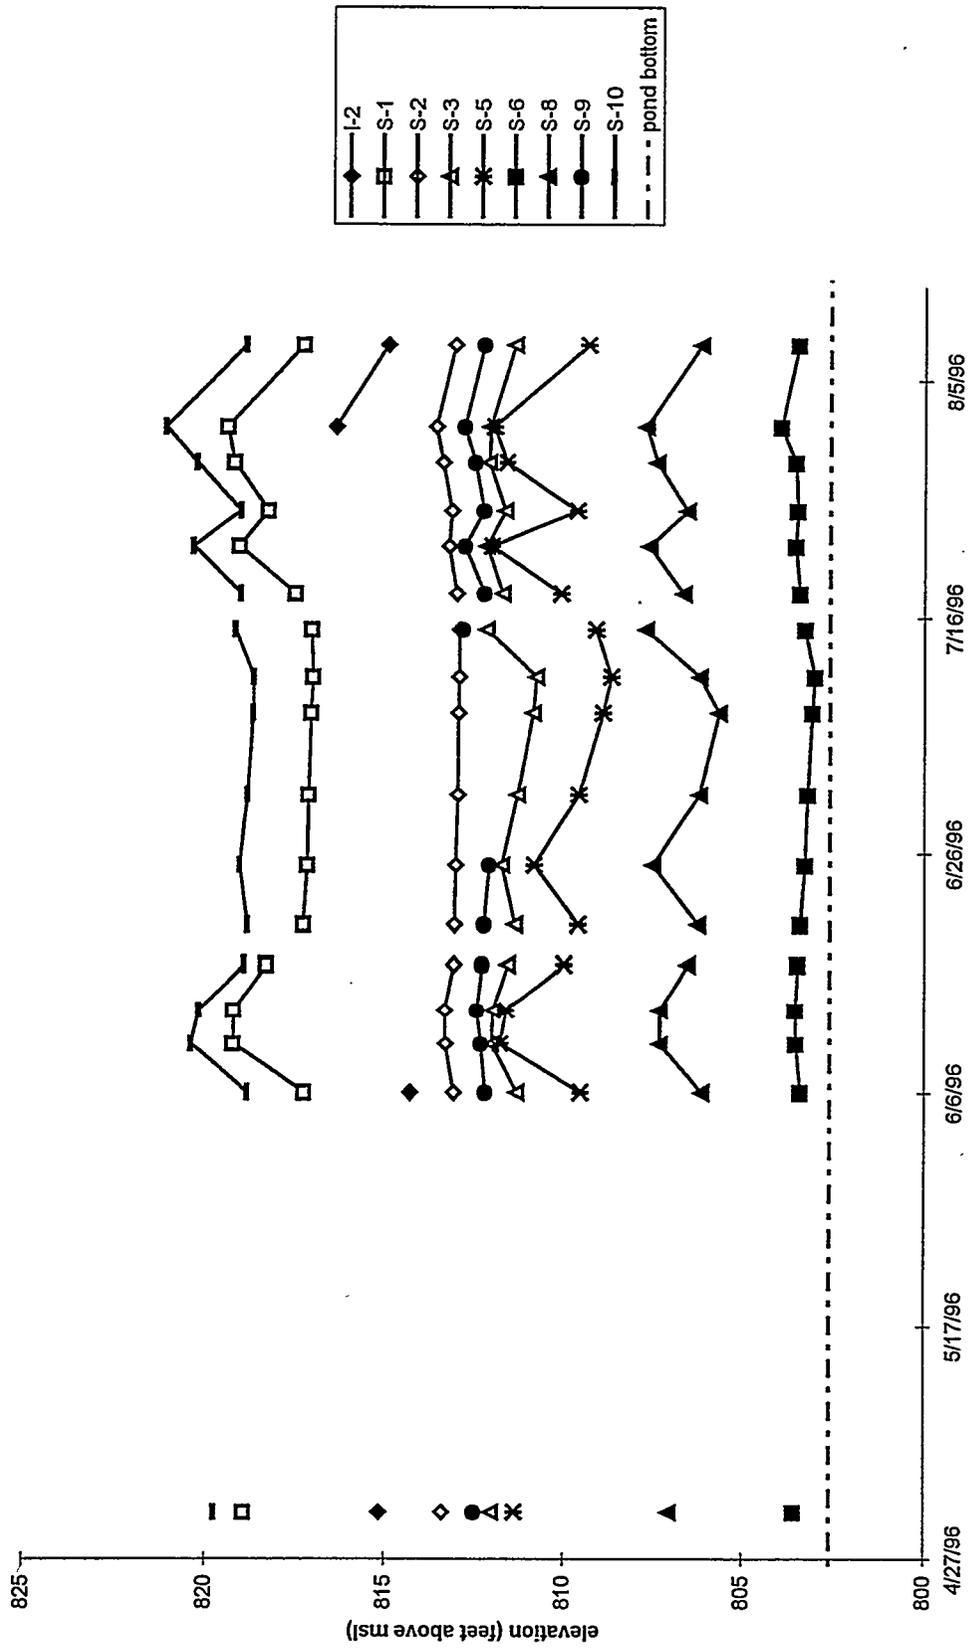
Hydraulic Heads: Stand pipes

Figure 15. Water levels in HRE-Pond stand pipes. Note that all levels exceed the bottom of the impoundment.

Composite hydrographs for the standpipes and wells derived from manual water level measurements are shown in Figures 15 and 16, respectively. These data indicate downward gradients along all margins of the cap, and upward gradients east of the impoundment close to the tributary. For example, well 0673 is flowing during much of the winter wet season. These downward gradients surrounding the impoundment indicate that any contaminants that may leak from the impoundment would be likely to be carried downward through the shallow groundwater system to some extent before being discharged to nearby tributaries. On average, water levels were only slightly higher in the winter months of 1996-97, and the pattern of hydraulic heads does not change significantly. However, direct comparison of continuous and manual water level measurements is difficult at best, and the continuous water level measurements for the summer of 1997 represent conditions that were disturbed by drilling and installation of the cryogenic barrier probes.

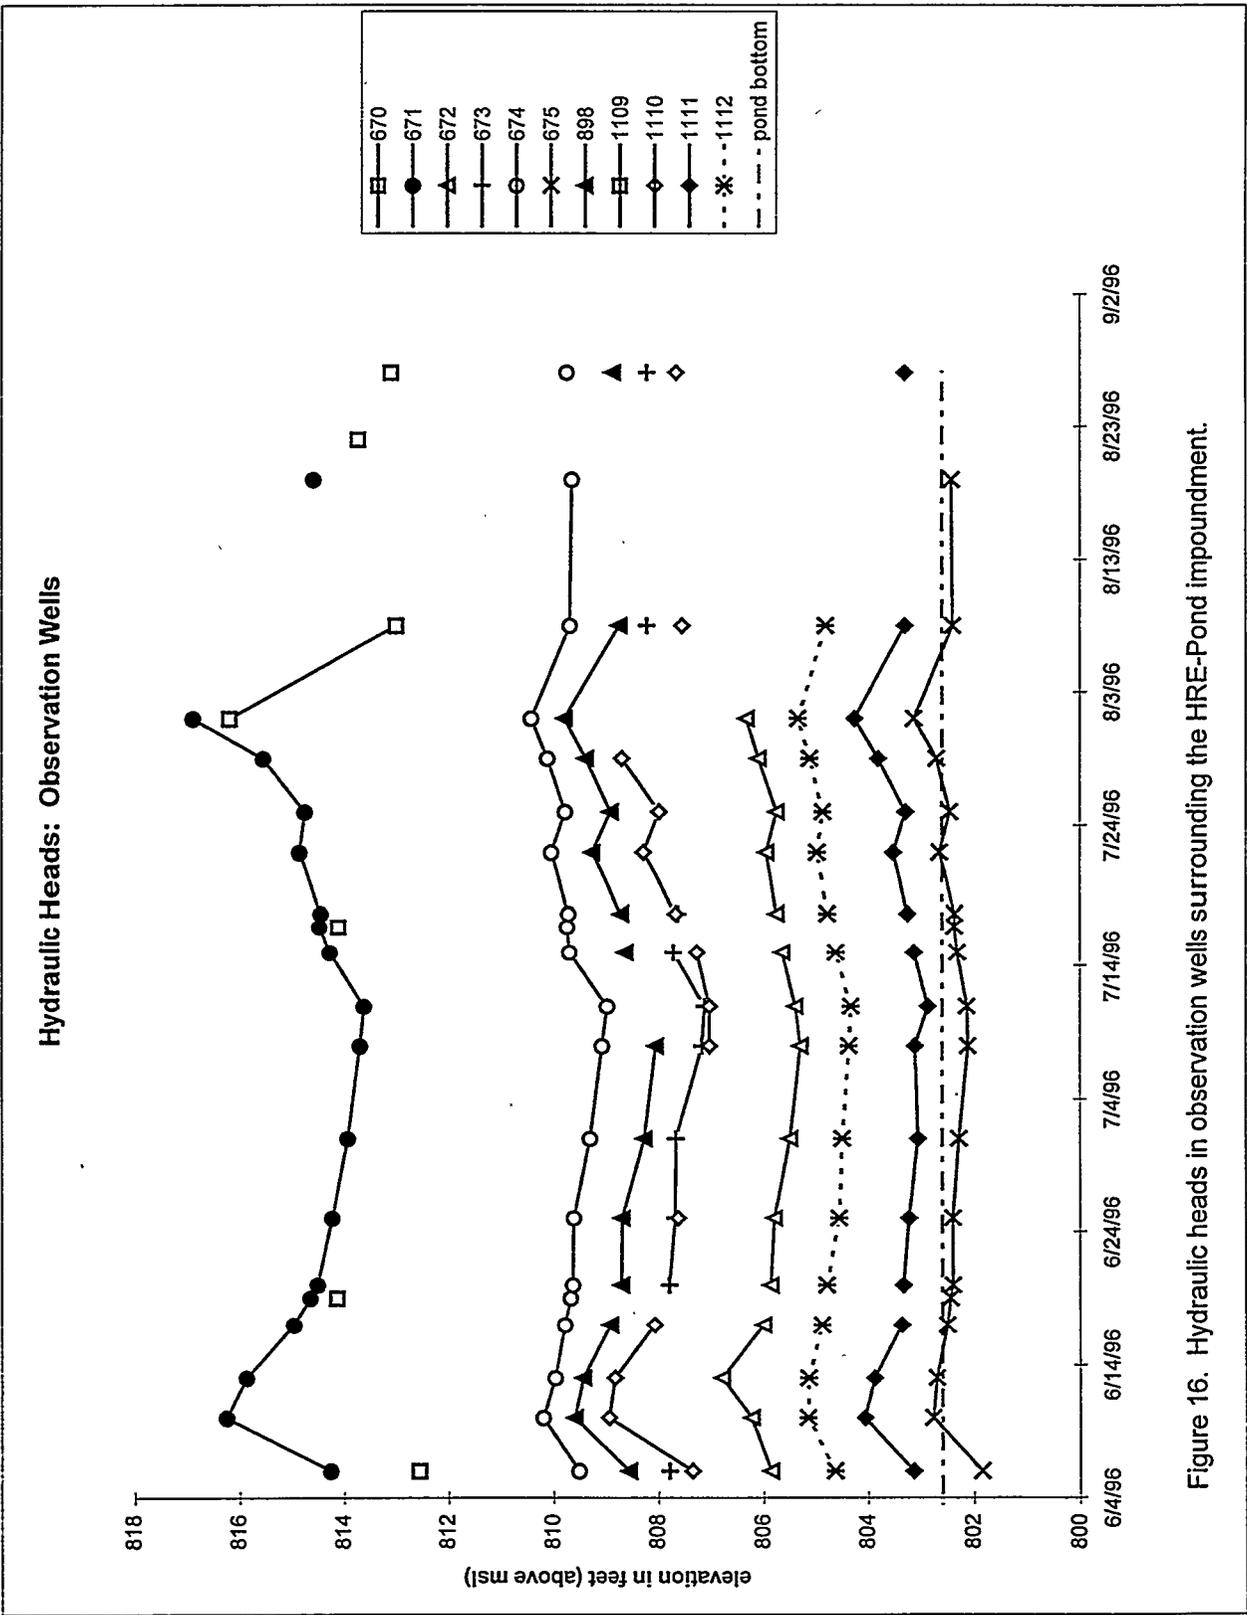
Figure 16. Hydraulic heads in observation wells surrounding the HRE-Pond impoundment.

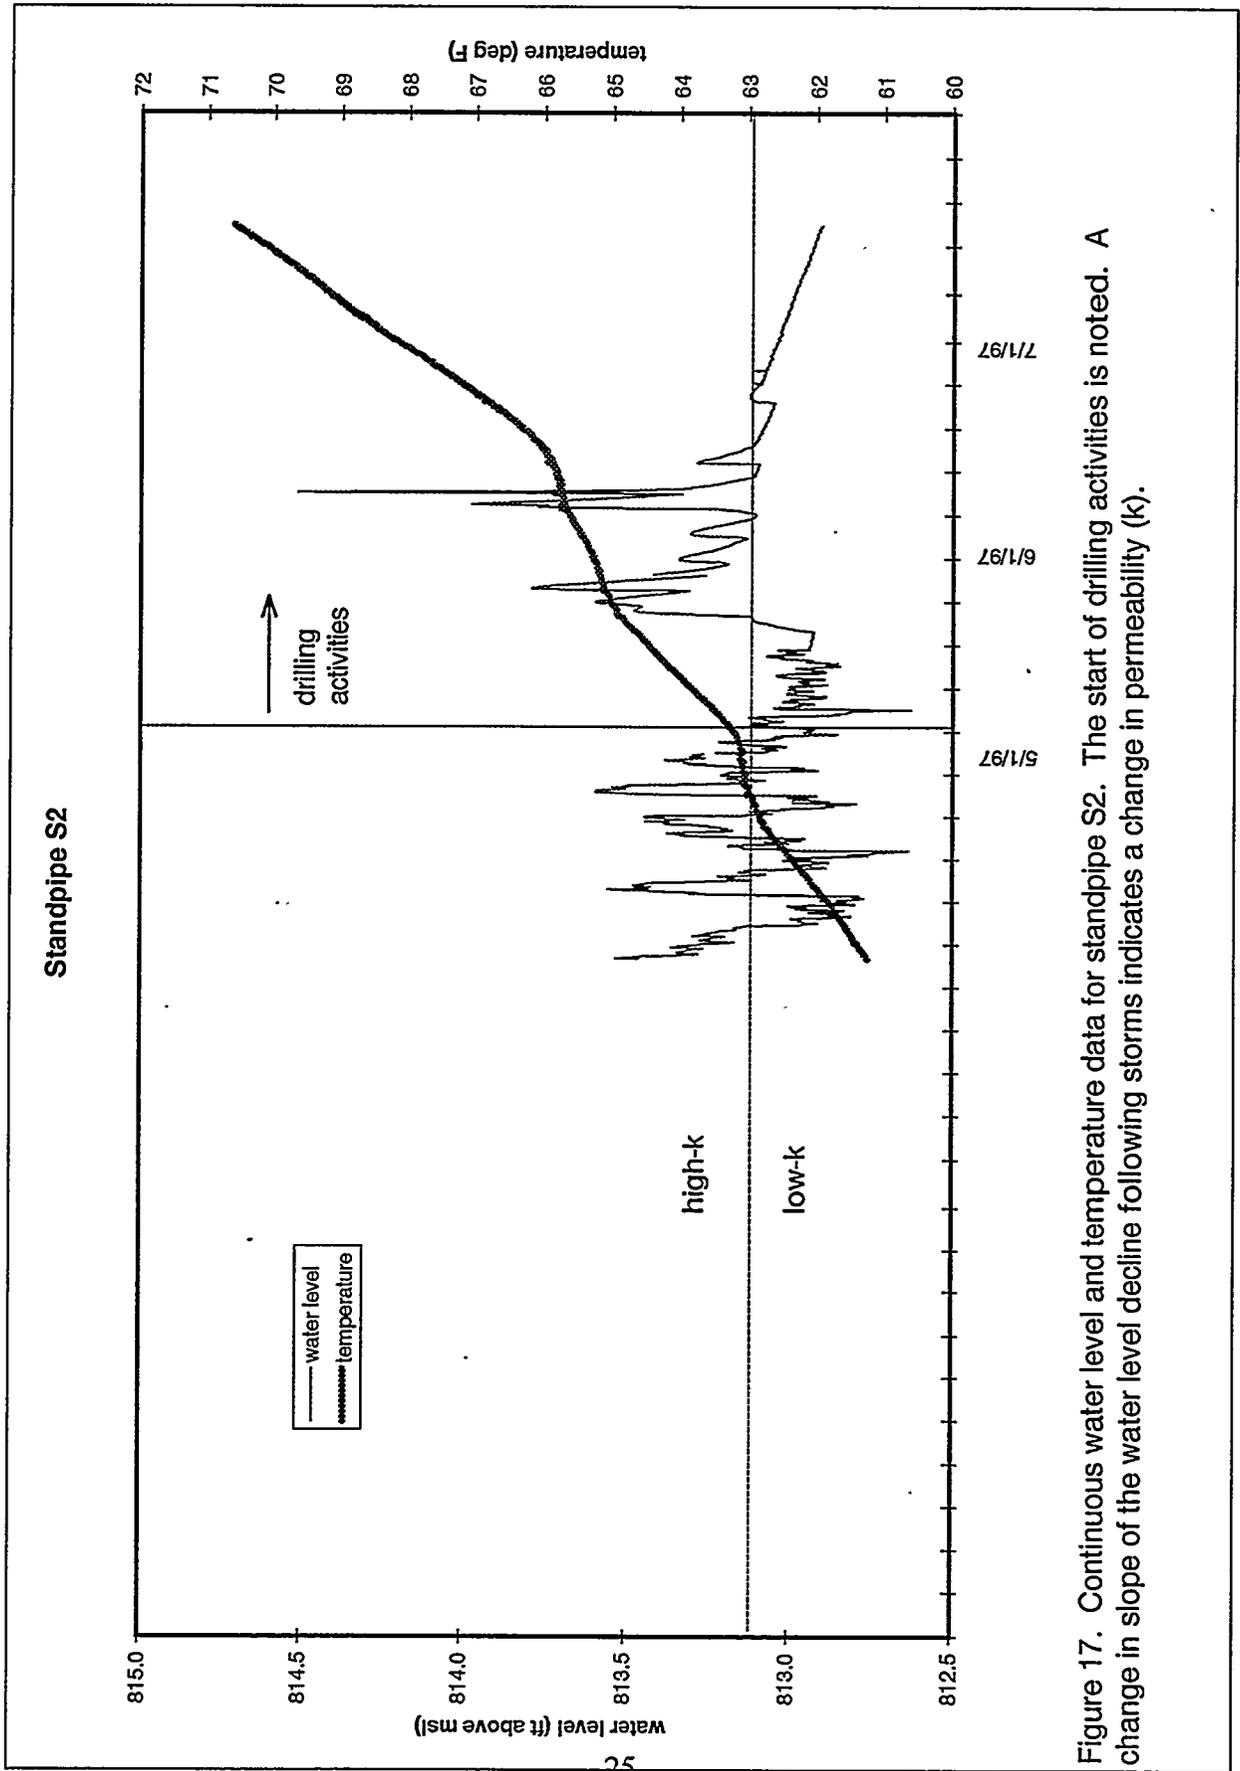
Figure 17. Continuous water level and temperature data for standpipe S2. The start of drilling activities is noted. A change in slope of the water level decline following storms indicates a change in permeability (k).

The majority of the hydrographs exhibit definite breakpoints in the slope of the recession curves following storm events. Several of the hydrographs demonstrate the consistency of the storm recession slopes and breakpoint elevation over a series of storm events. Where noted, these breakpoints are indicated on the hydrographs by a dashed line. Breakpoints and recession slopes can provide an indication of the relative hydraulic conductivity of various regions in and around the impoundment because the rate at which the water added to the system during a storm drains is a function of the local hydraulic conductivity and storativity. For example, Shevenell et al. [1996] used breakpoints in the storm recession curves from a number of wells to determine the transmissivities of multiple pore regions in a karst terrain (e.g., conduits, fractures, and matrix pores). Similarly, the HRE-Pond well hydrographs also reflect drainage from multiple pore regions, although in this case the pore regions are more likely to be associated with changes in subsurface materials rather than changes in pore types within the same material, as is the case with the deeper karst wells. The elevation at which a breakpoint occurs indicates the elevation at which a permeability change occurs for water table wells where changes in water level can be attributed to actual dewatering in an unconfined system. This conclusion is supported by comparing the hydrographs with the geologic logs and the pond construction information.

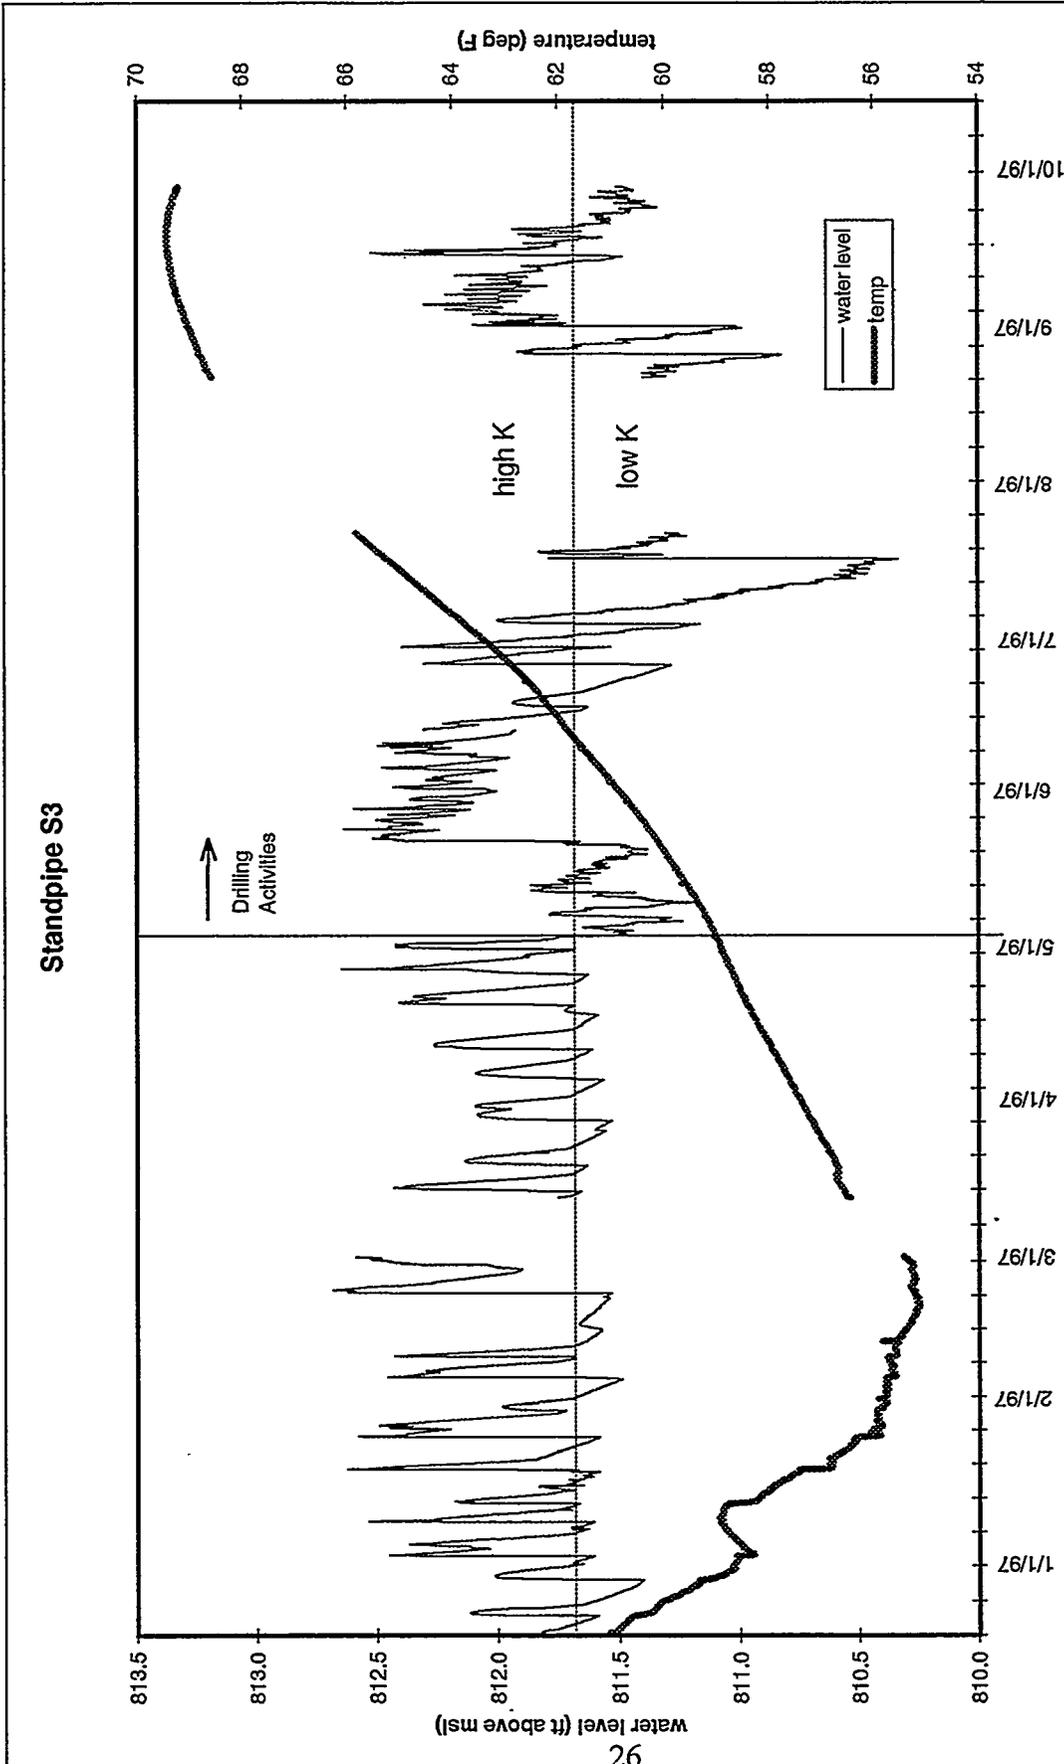
Figure 18. Continuous water level and temperature data for standpipe S3. The start of drilling activities is noted. A change in slope of the water level decline following storms indicates a change in permeability (k).

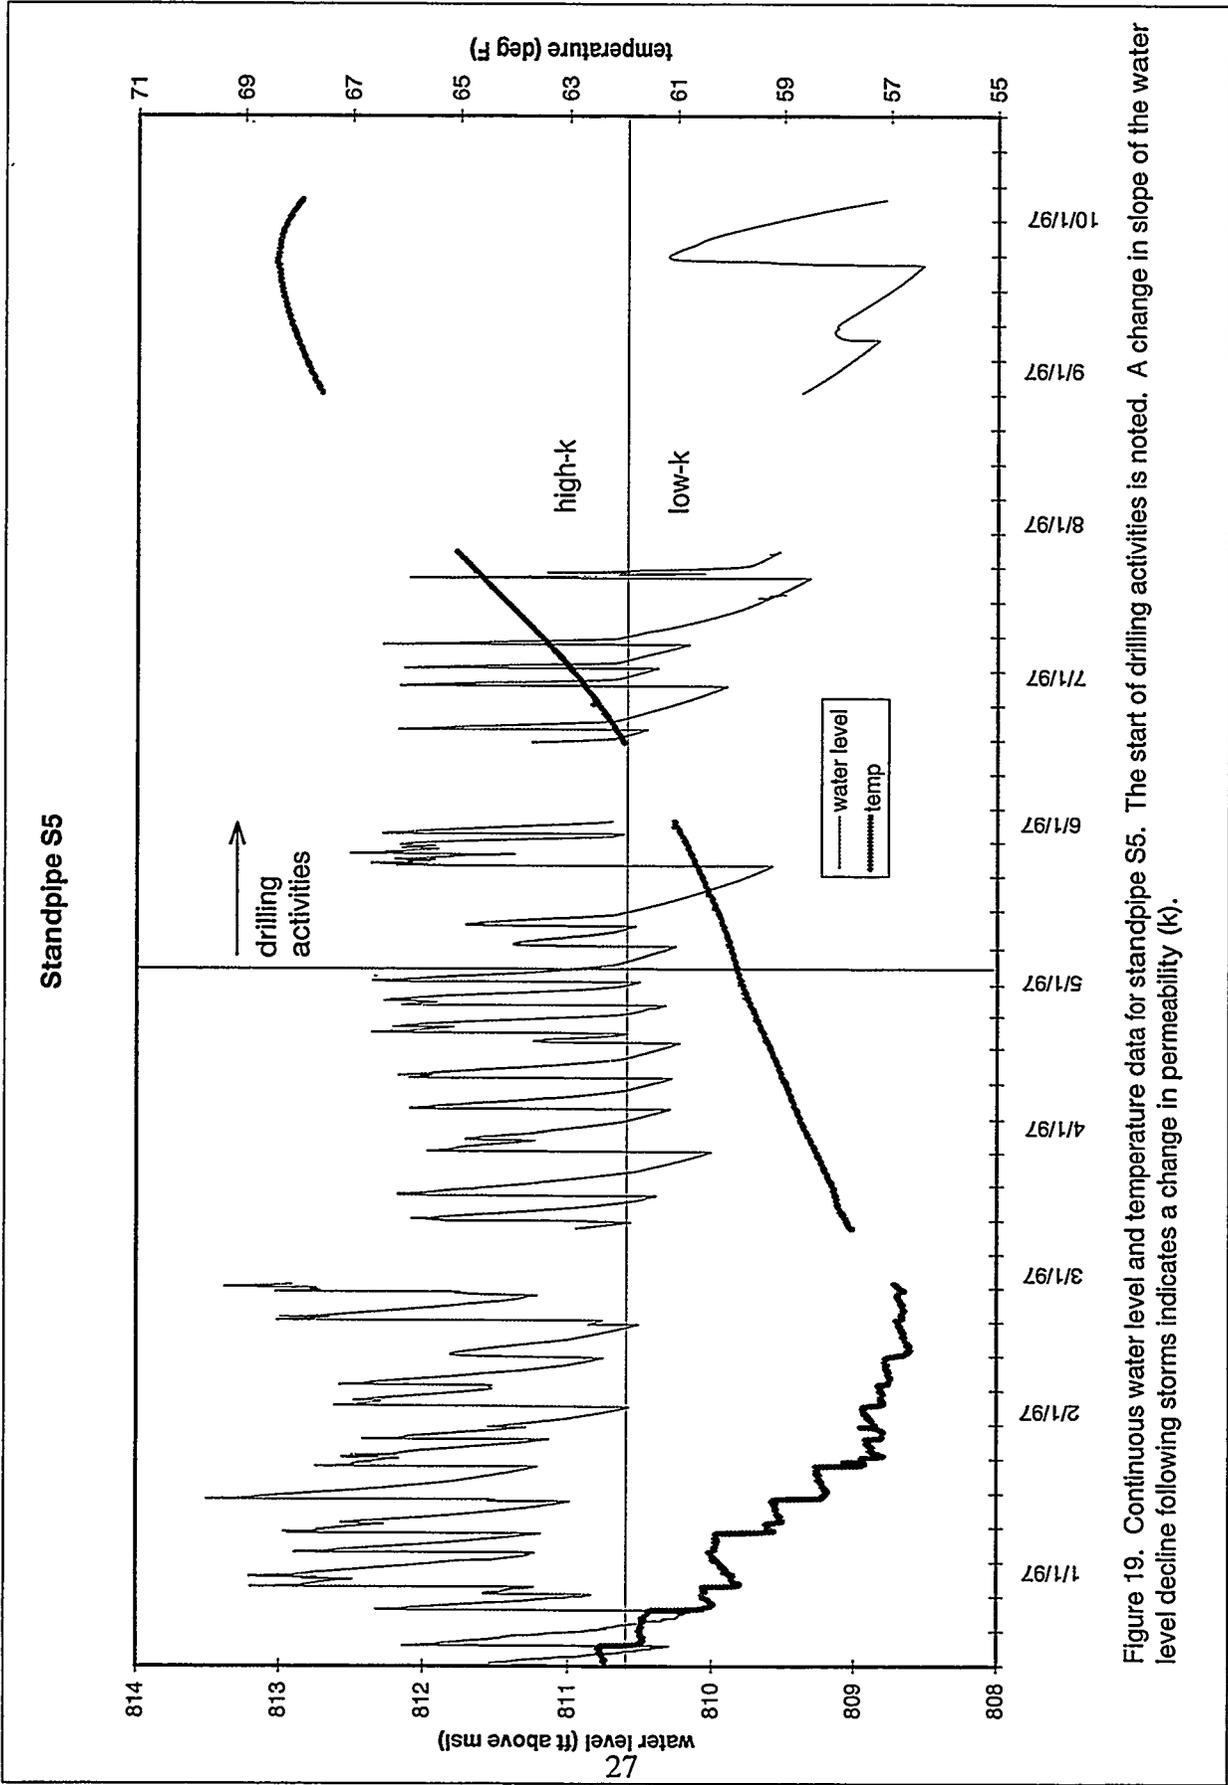
Figure 19. Continuous water level and temperature data for standpipe S5. The start of drilling activities is noted. A change in slope of the water level decline following storms indicates a change in permeability (k).

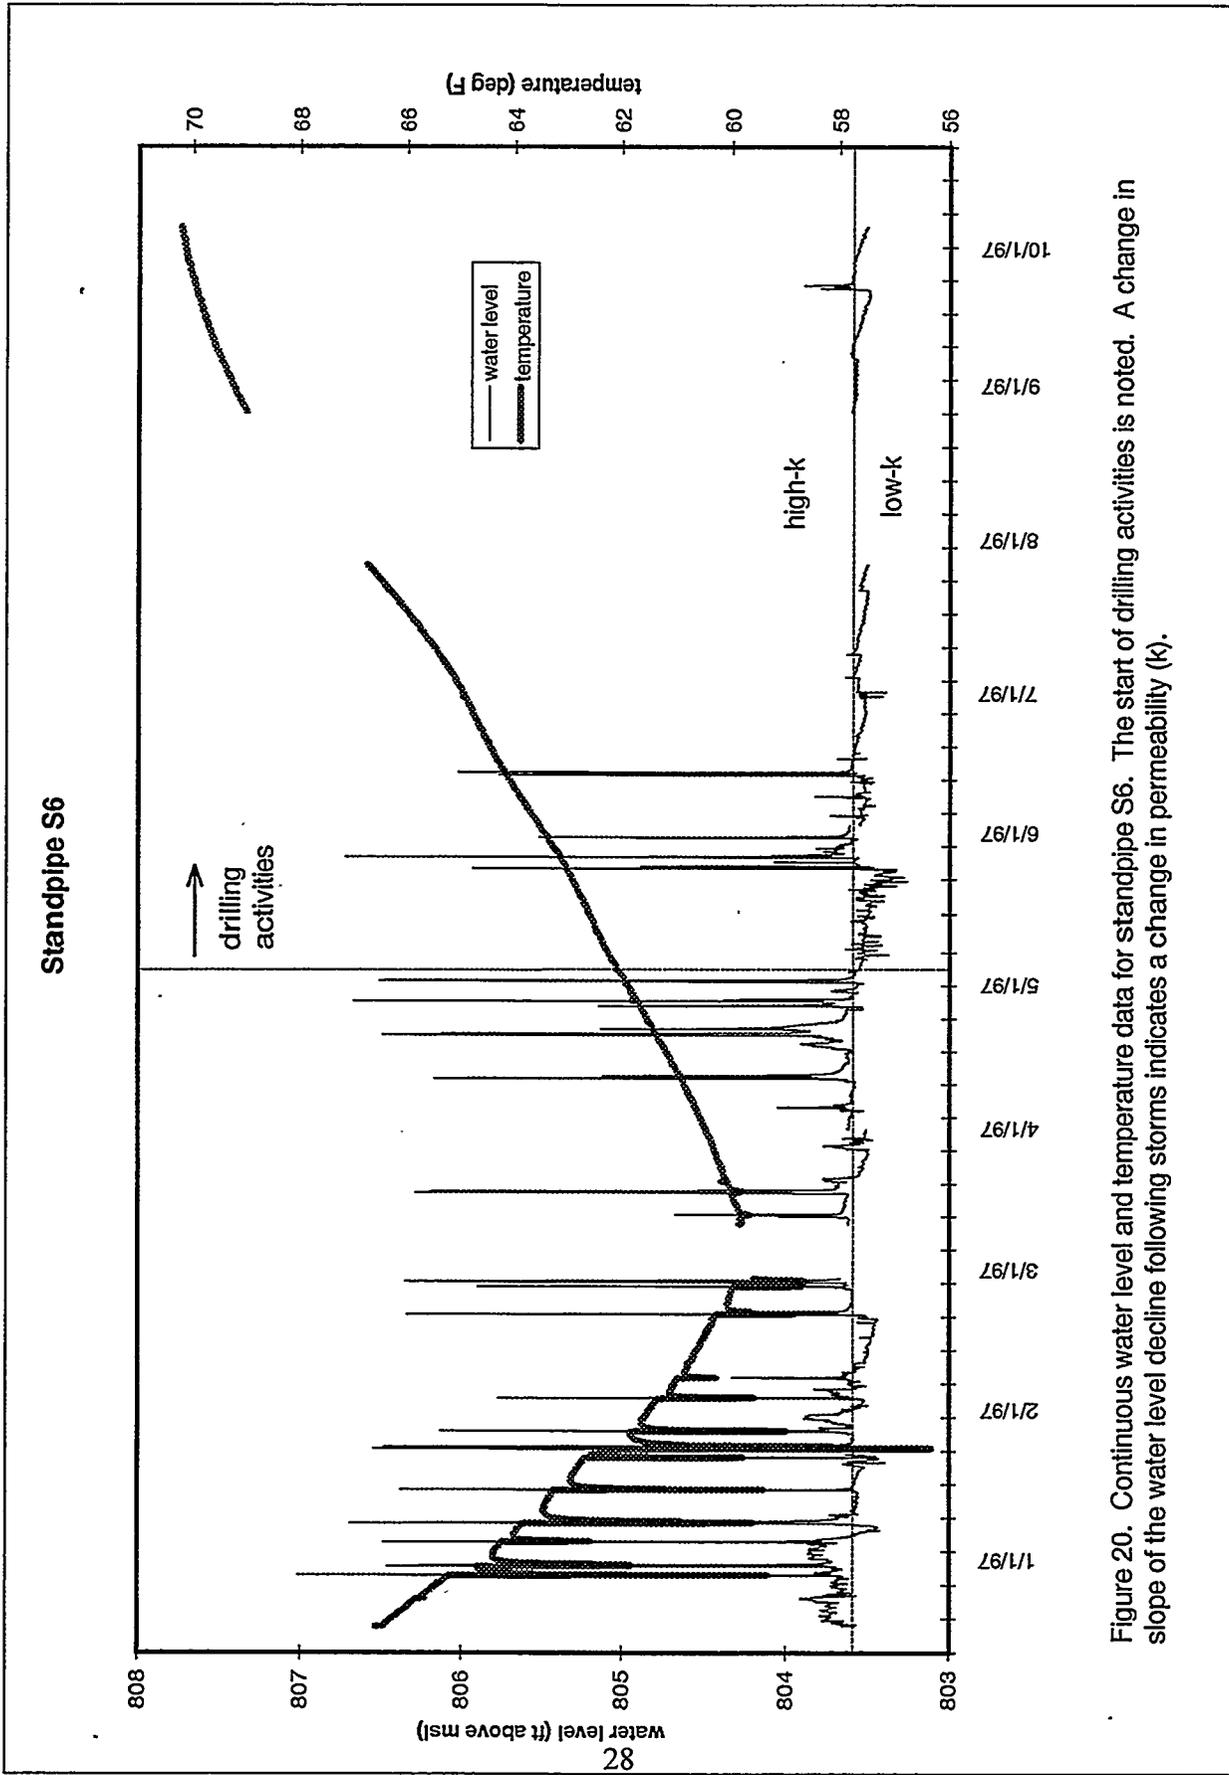
Figure 20. Continuous water level and temperature data for standpipe S6. The start of drilling activities is noted. A change in slope of the water level decline following storms indicates a change in permeability (k).
