ORNL/TM-13566

**Homogeneous Reactor
Experiment (HRE) Pond
Cryogenic Barrier Technology
Demonstration: Pre-Barrier
Subsurface Hydrology and
Contaminant Transport
Investigation**

March, 1998

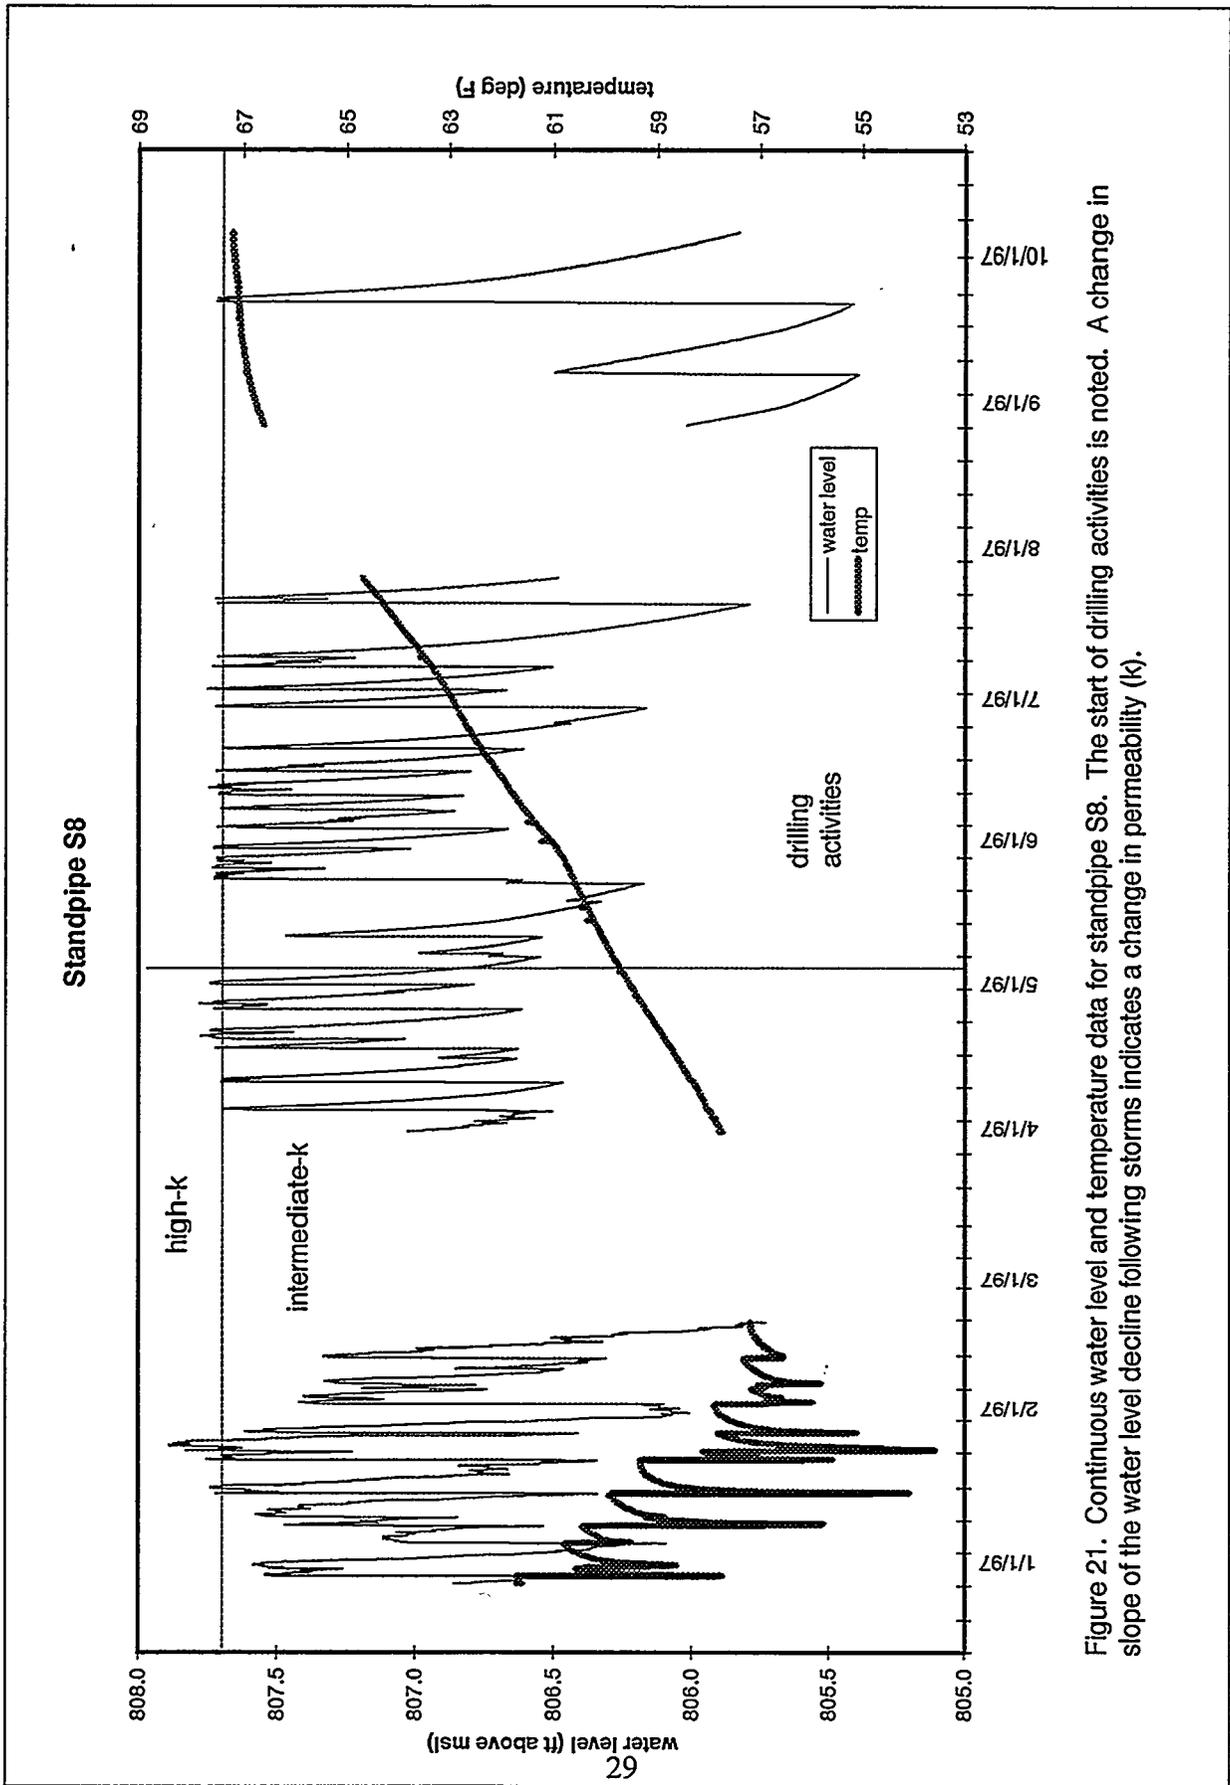
Figure 21. Continuous water level and temperature data for standpipe S8. The start of drilling activities is noted. A change in slope of the water level decline following storms indicates a change in permeability (k).

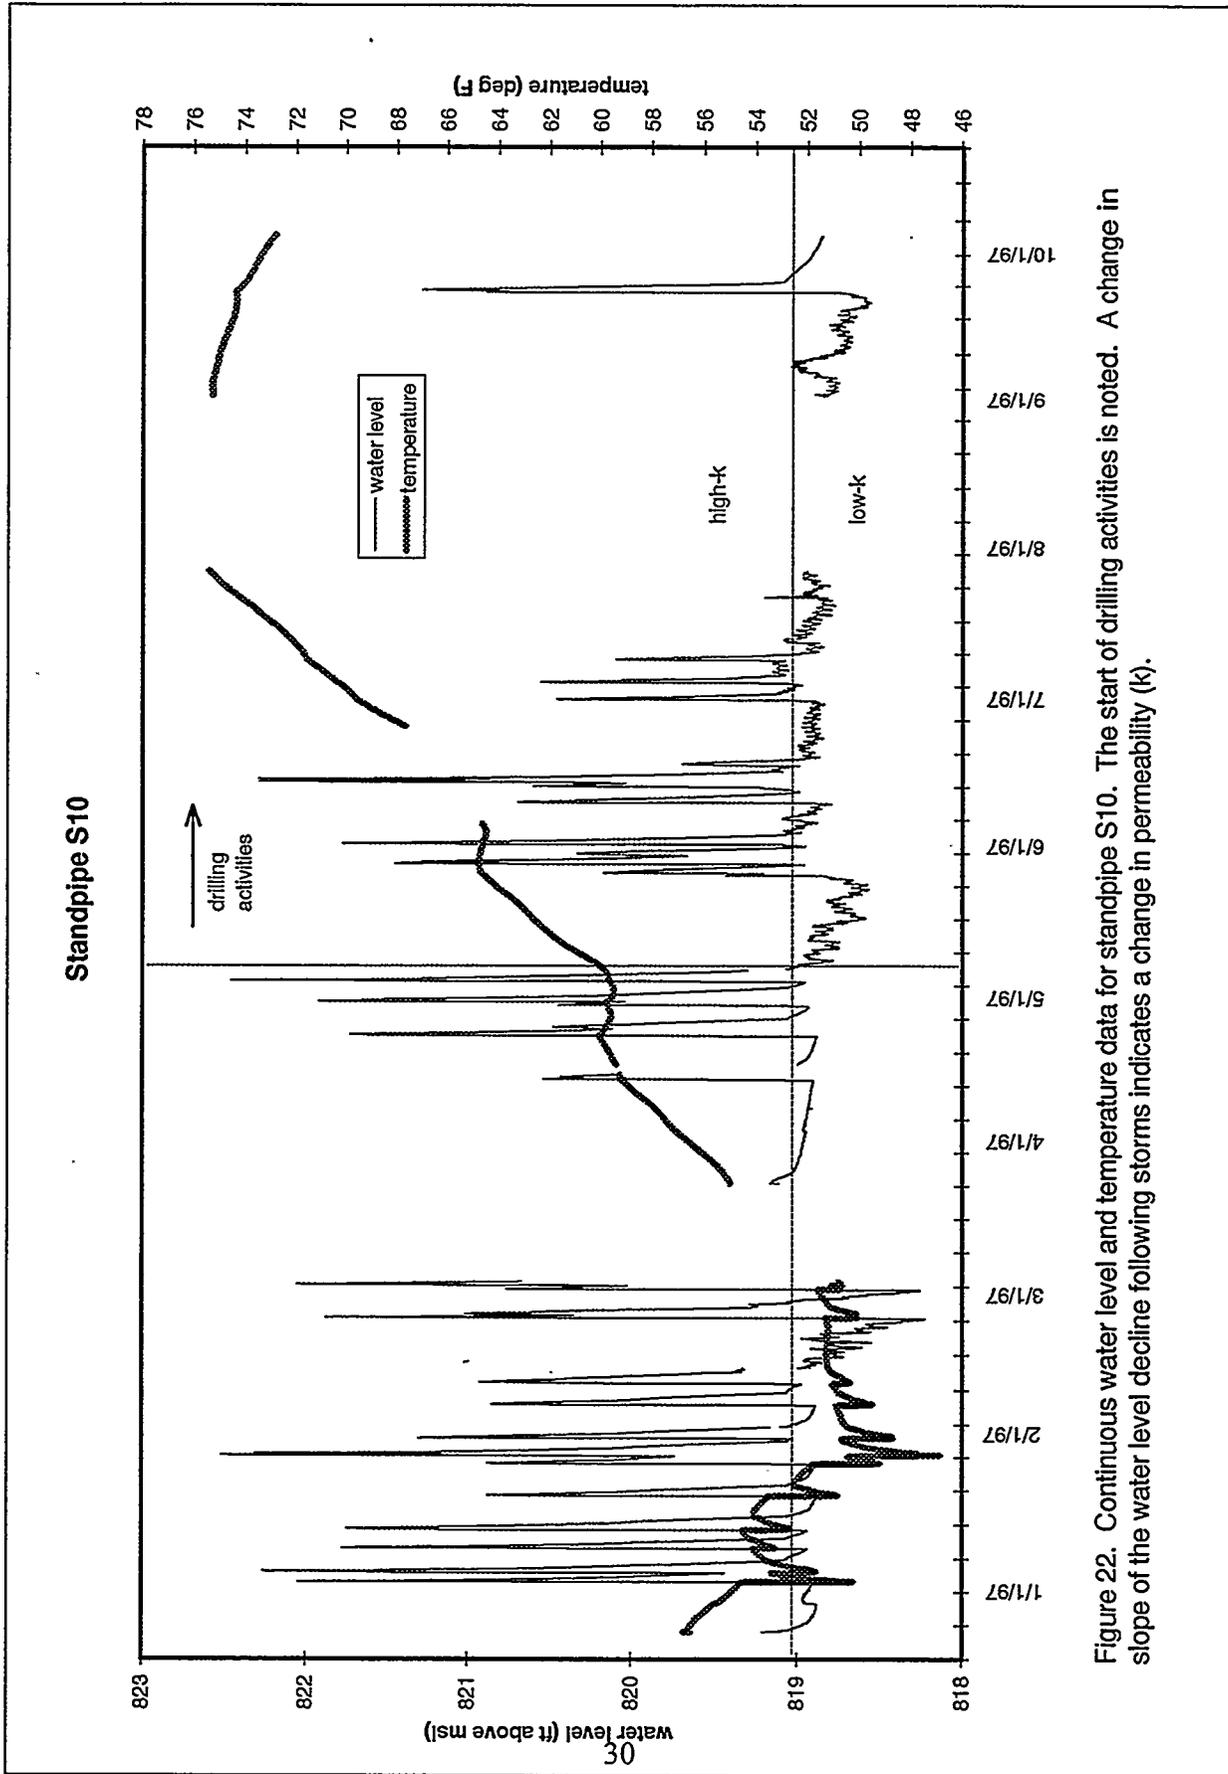
Figure 22. Continuous water level and temperature data for standpipe S10. The start of drilling activities is noted. A change in slope of the water level decline following storms indicates a change in permeability (k).

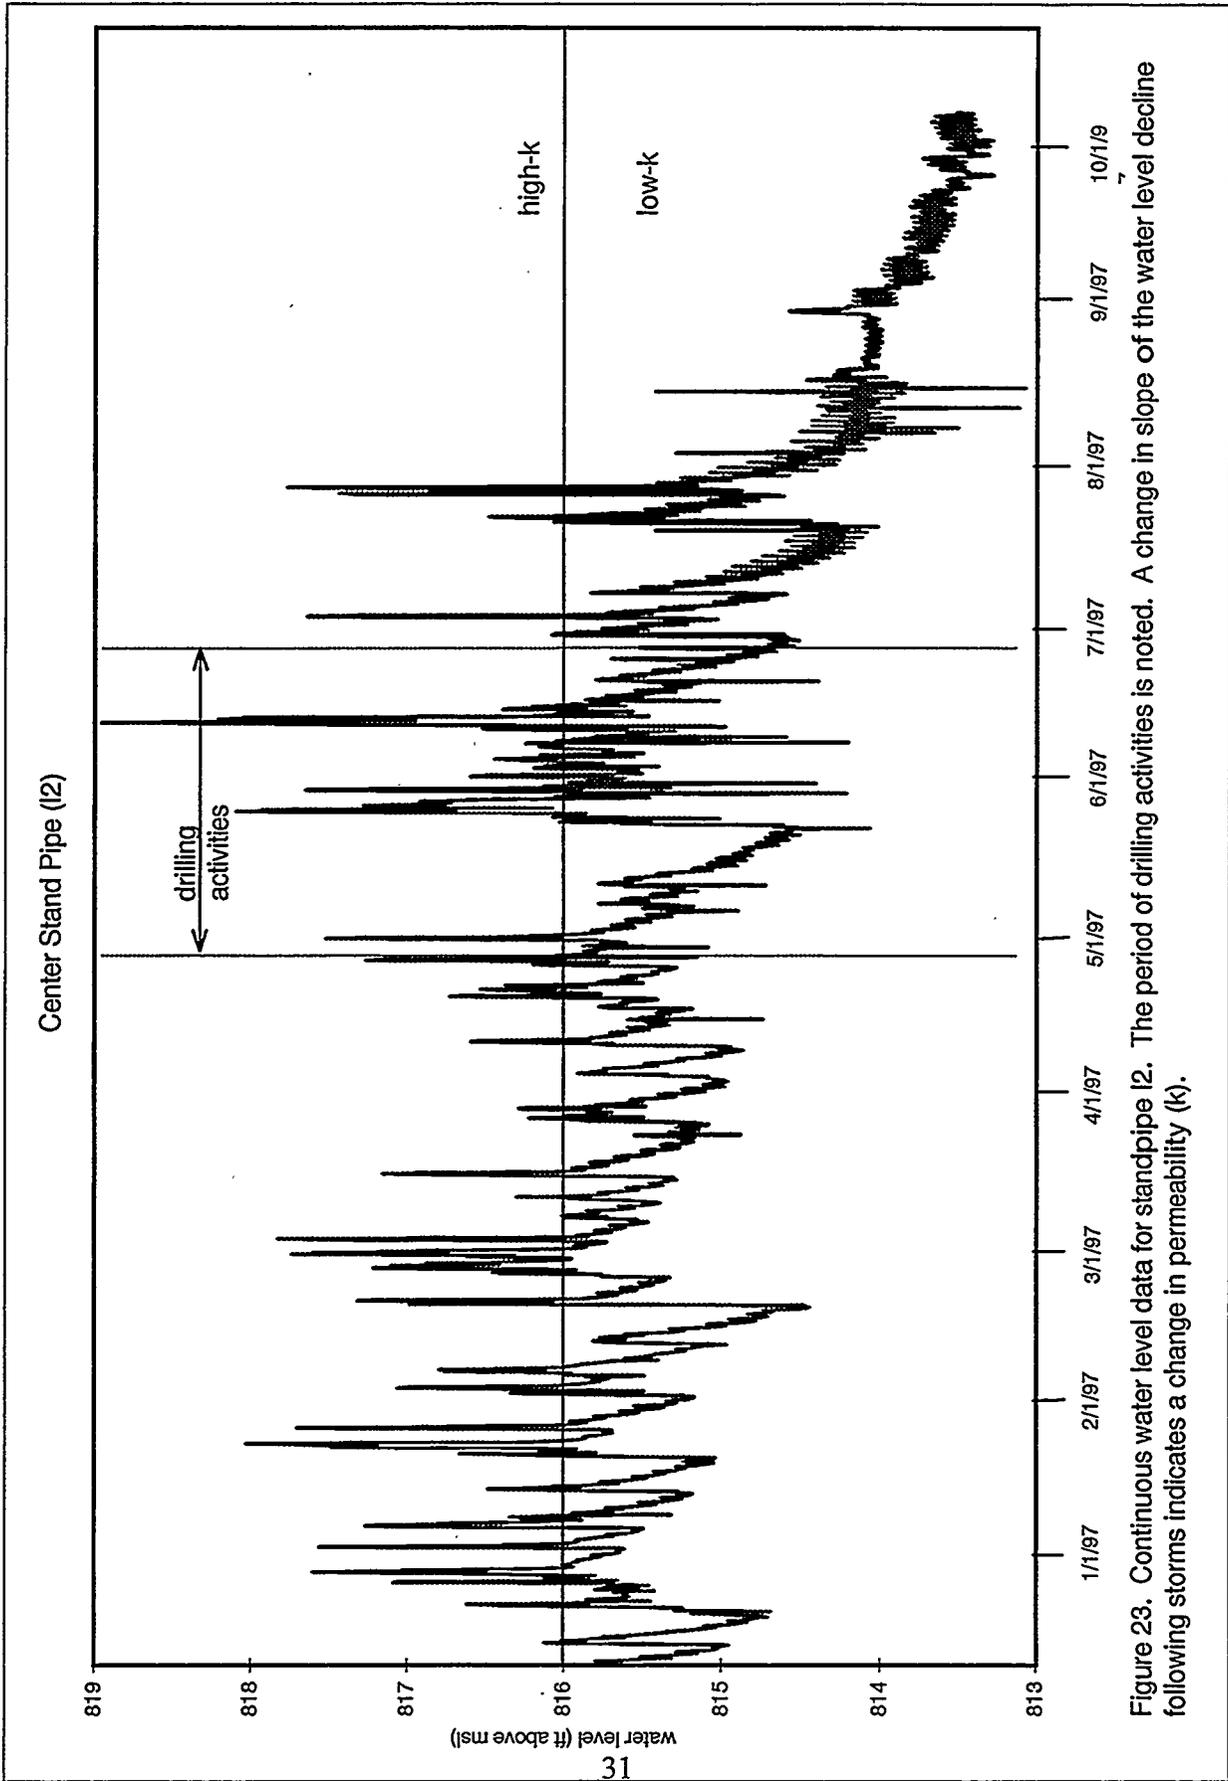
Figure 23. Continuous water level data for standpipe I2. The period of drilling activities is noted. A change in slope of the water level decline following storms indicates a change in permeability (k).

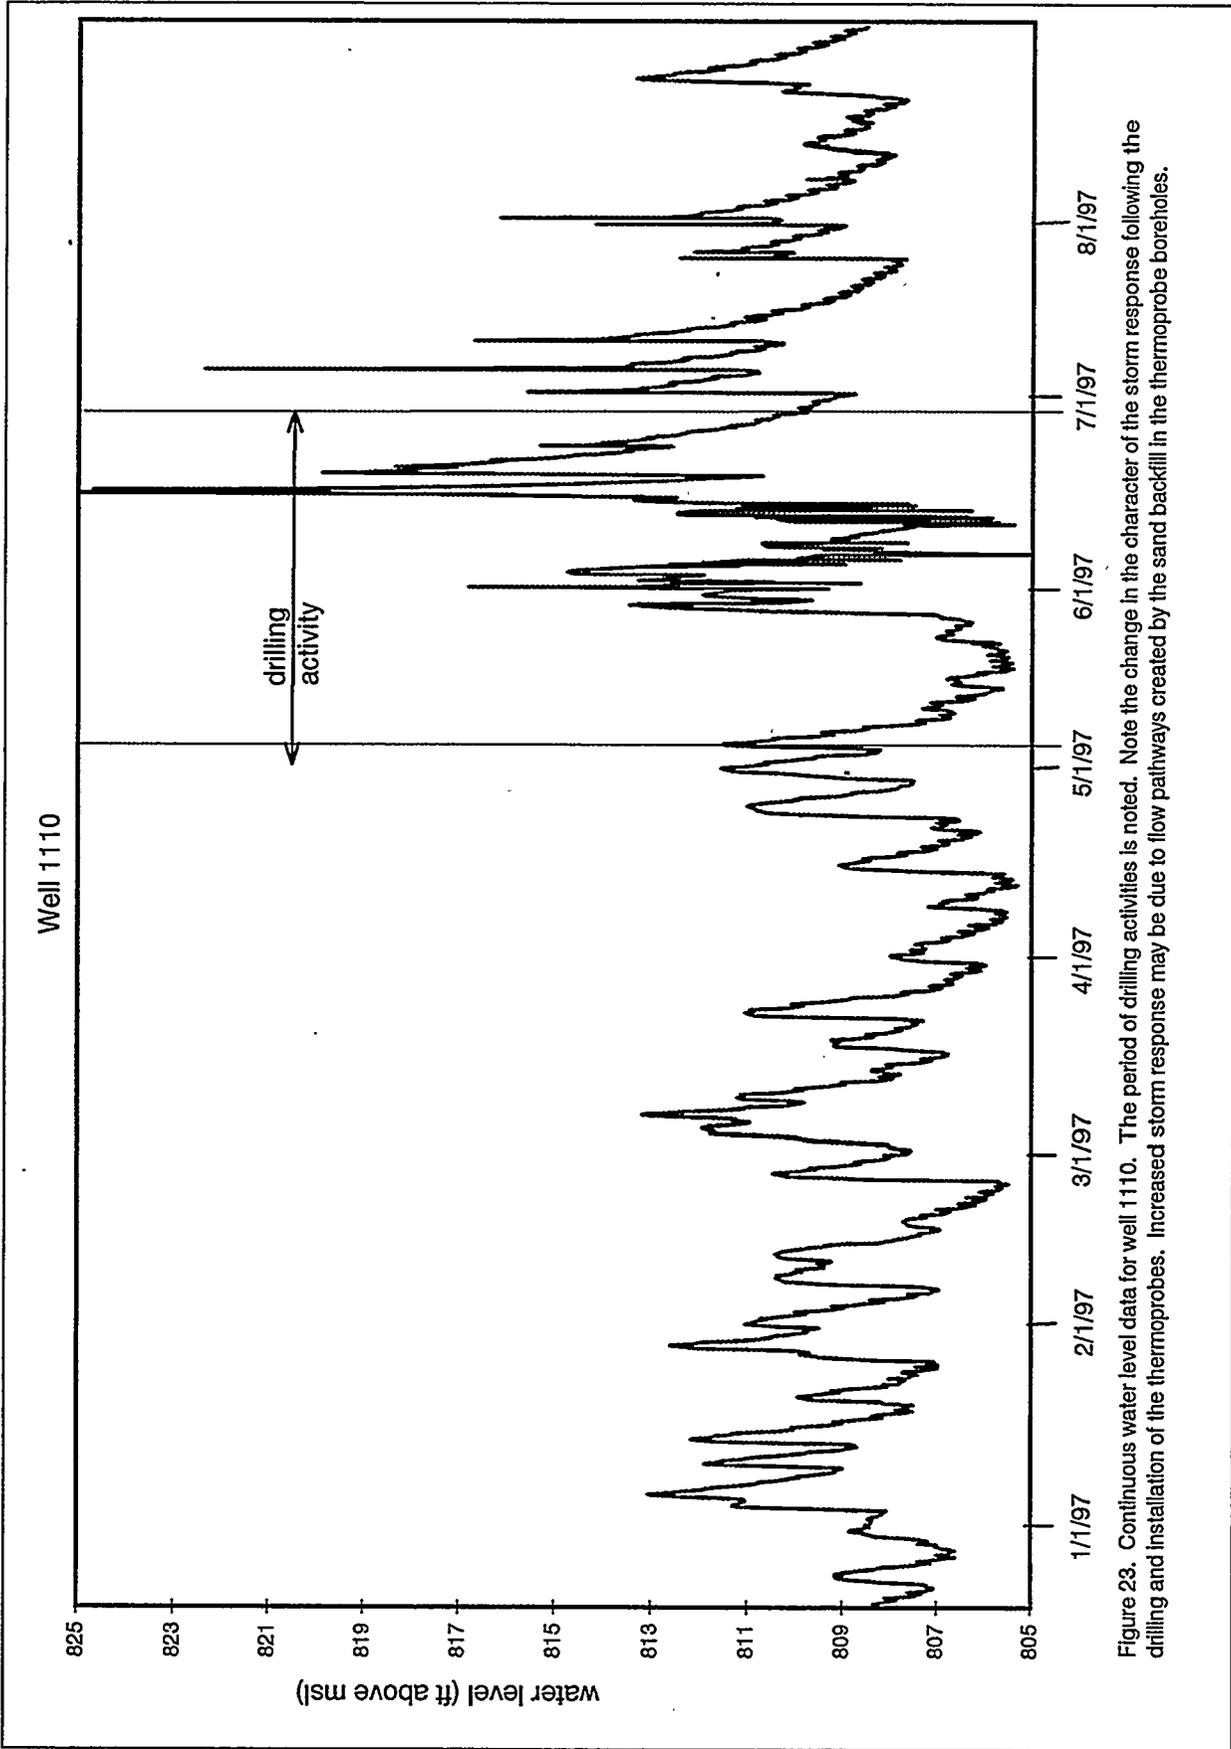
Figure 23. Continuous water level data for well 1110. The period of drilling activities is noted. Note the change in the character of the storm response following the drilling and installation of the thermoprobes. Increased storm response may be due to flow pathways created by the sand backfill in the thermoprobe boreholes.

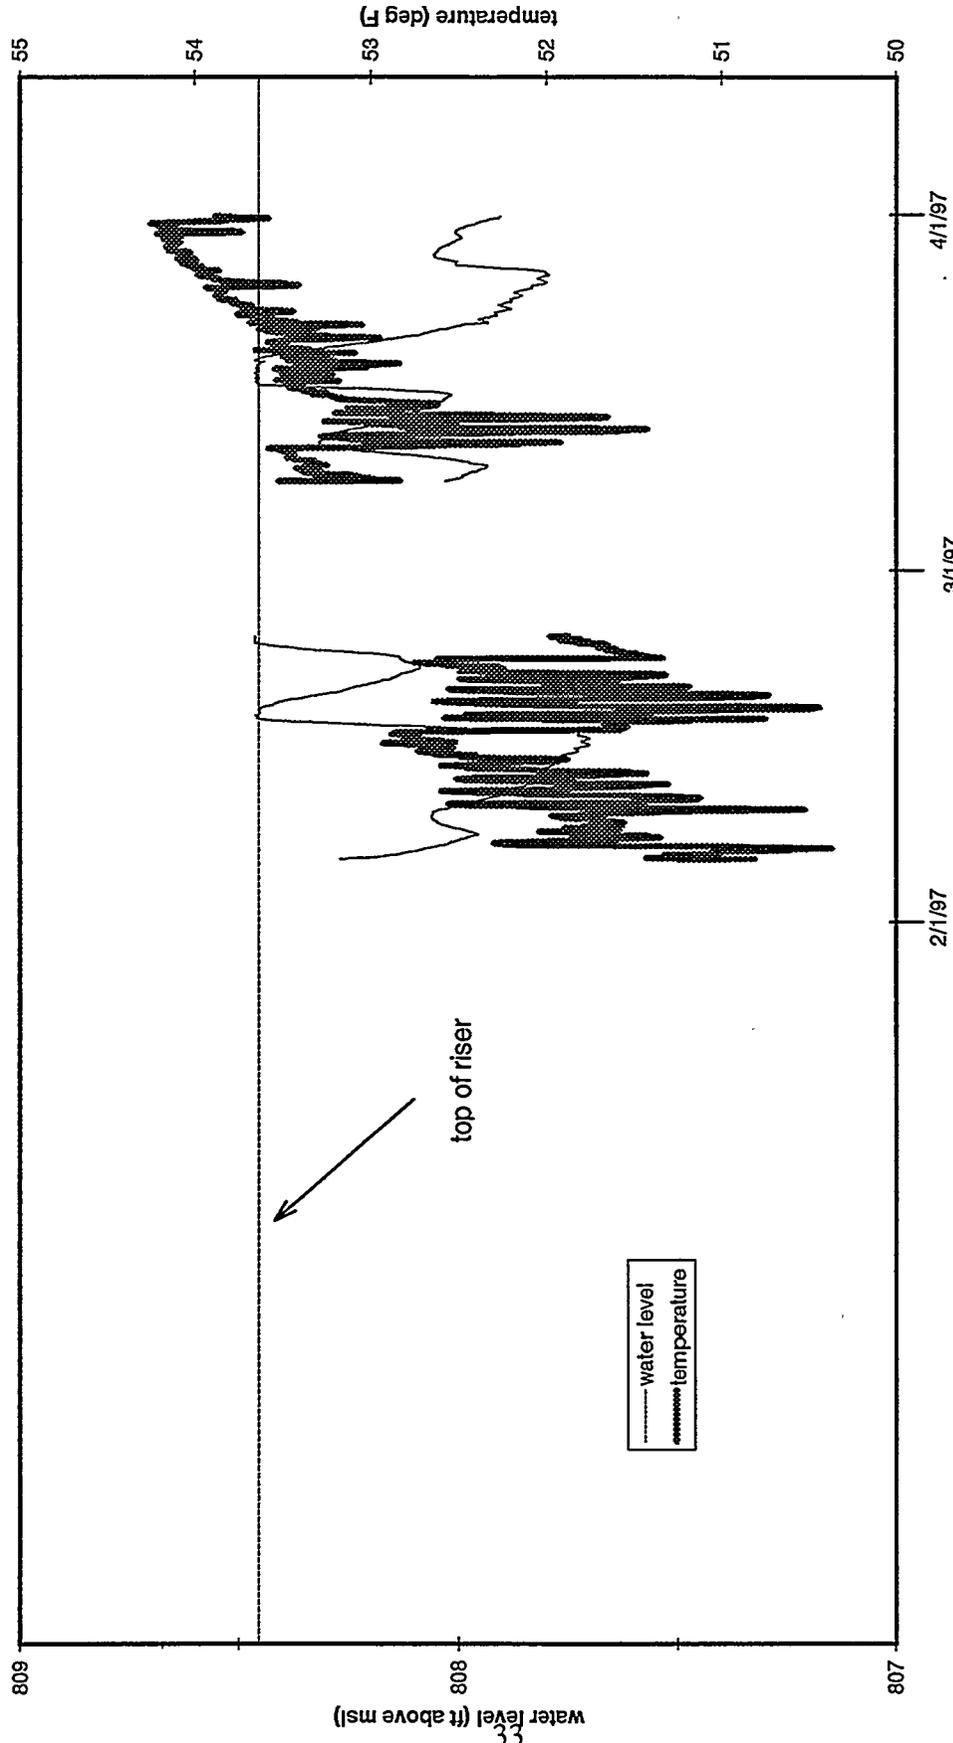
Well 0673

Figure 25. Continuous water level and temperature data for well 0673. The line indicates the elevation of the top of the riser. Above that level, the well was flowing.

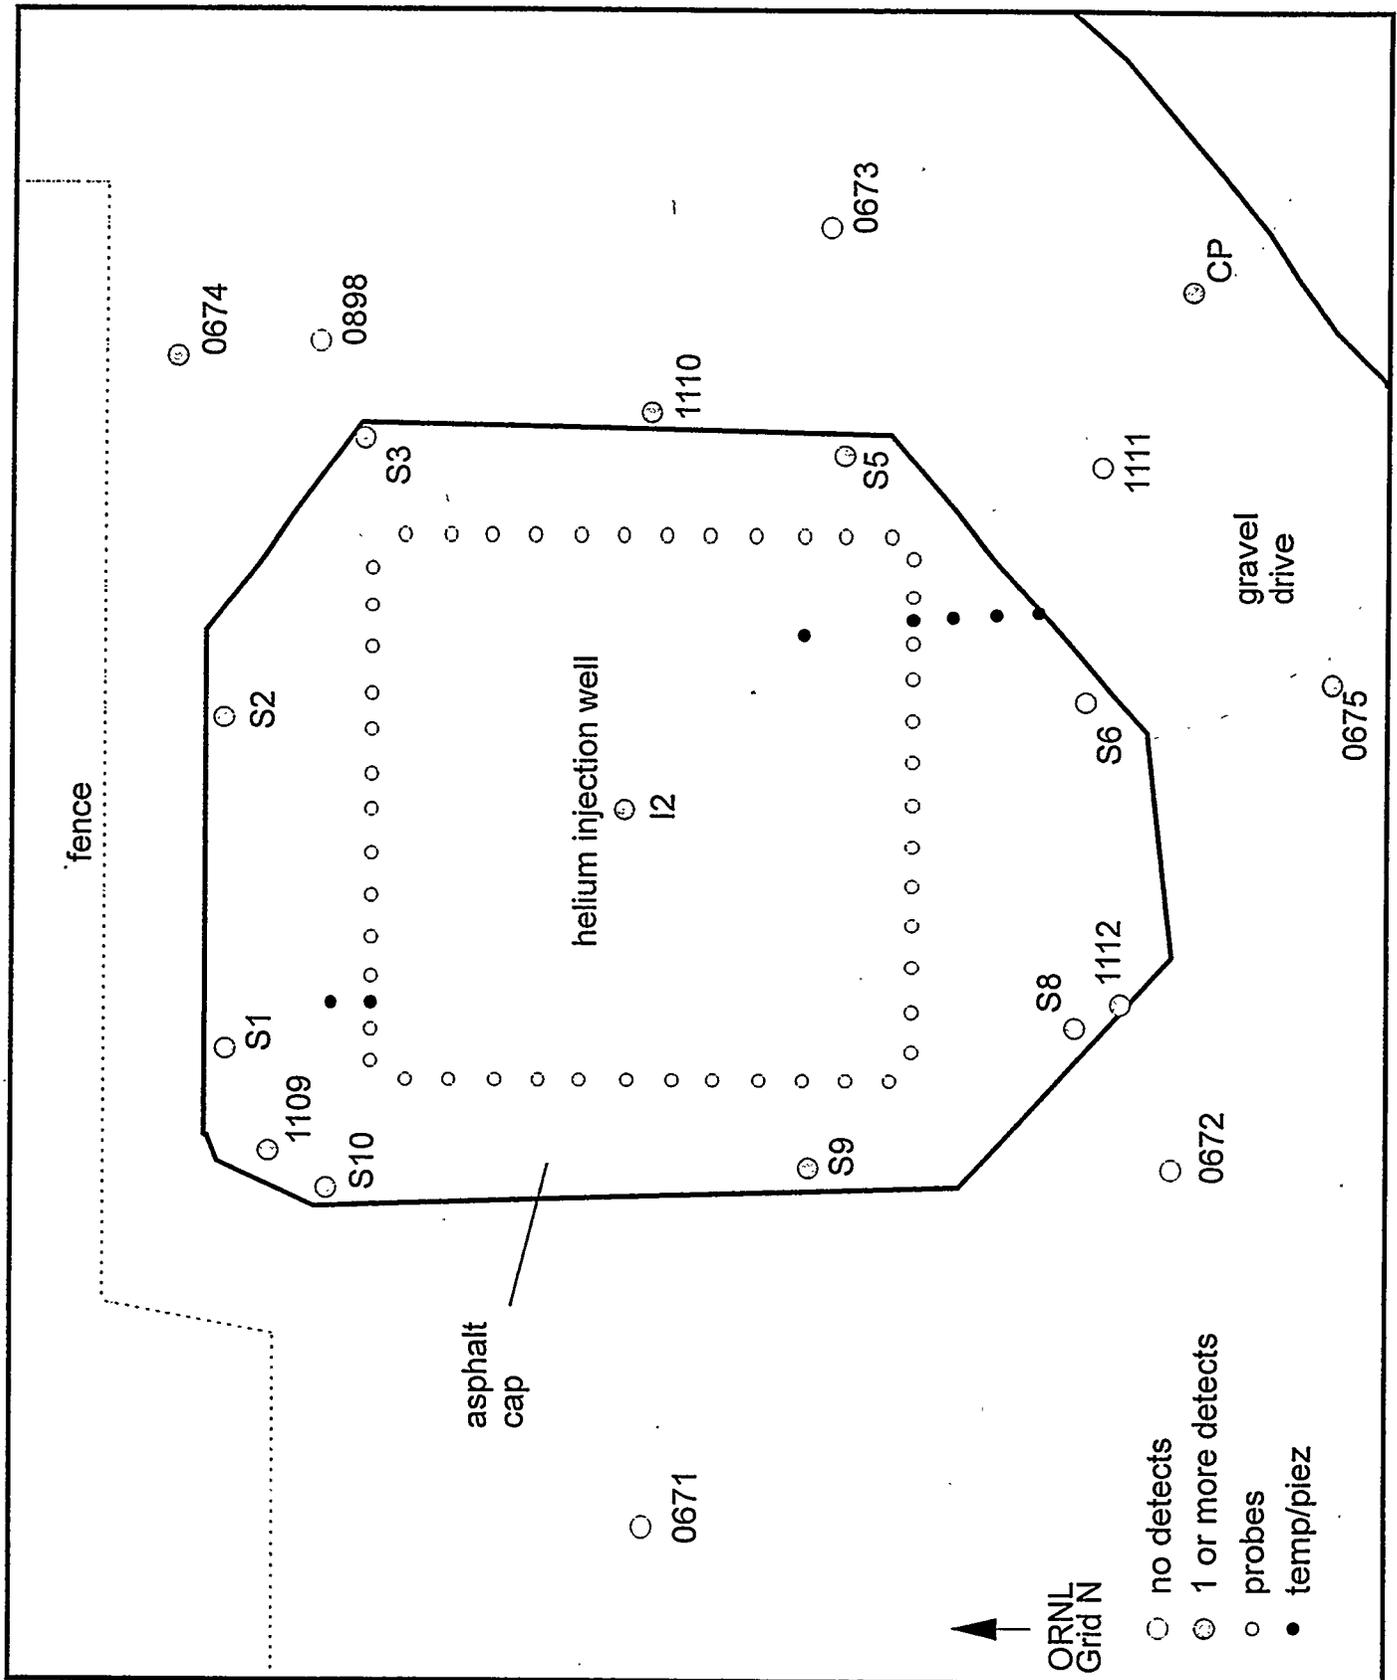
Figure 27. Locations where helium was detected during the tracer injections.

Table 3. Frequency of helium detections at the HRE-Pond monitoring locations following the 2nd tracer injection. Data are qualitative only due to changes in the design of the gas sampling device to rectify leakage problems. Locations are shown on Figure 27.

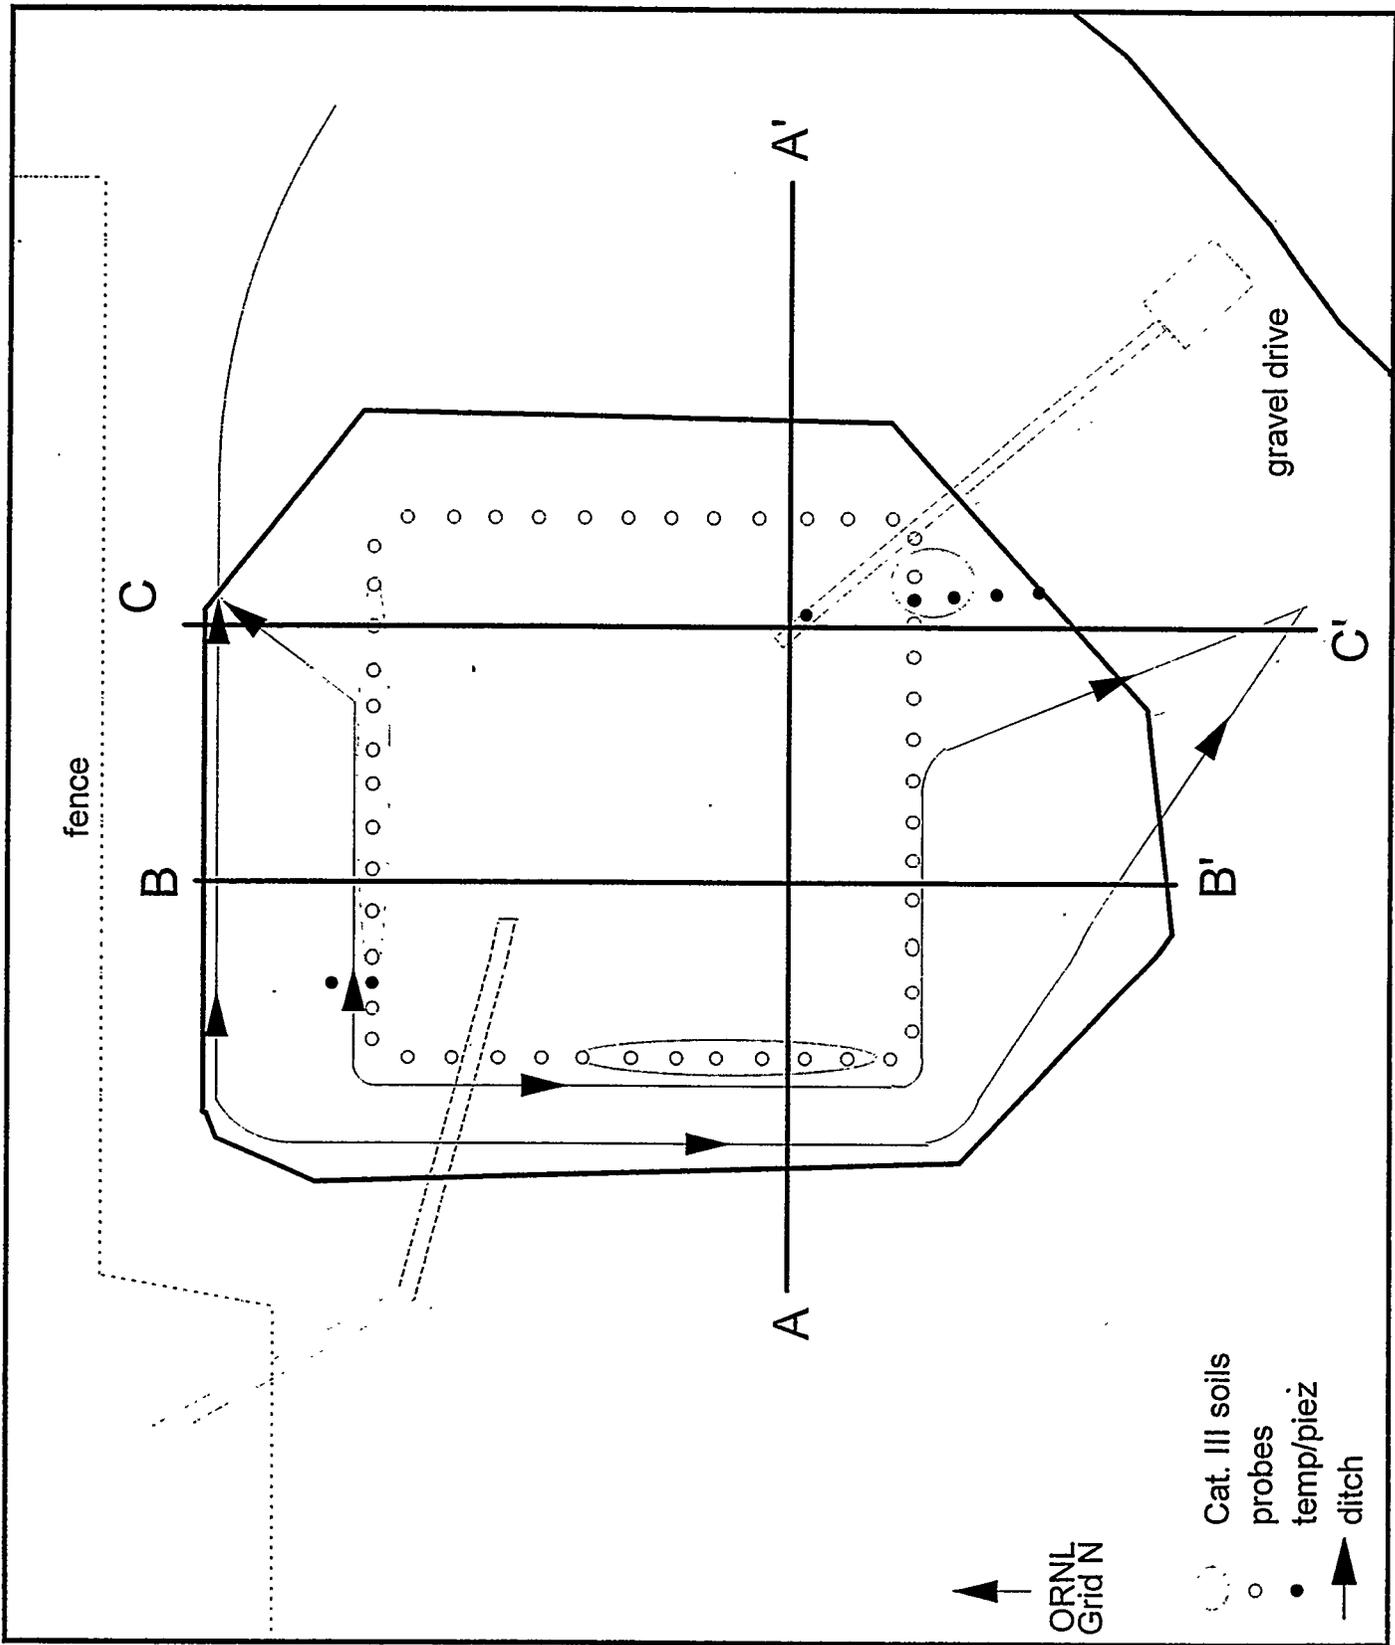
Figure 28. Original impoundment drainage configuration. Cross section locations for fig. 29 are identified.

Figure 28 shows the aerial distribution of Category III soils, location of the probe and piezometer boreholes, and key features of the original pond construction. Additional details can be observed in the cross sections identified in Figure 28 and shown in Figure 29. The pond construction information was obtained using the pre-construction engineering drawing [D-19938, R-2, 1955], and therefore the locations of the ditches, berms, and drainage pipes may not reflect the As-Built locations exactly. For example, the actual location of the influent and effluent pipelines may be indicated by the location of conductivity anomalies observed during the electromagnetic survey [Kaufmann, 1996], as shown in Figure 12. These locations are coincident with very high soil radionuclide contamination levels that extend well below the elevation of the berm, lending validity to these locations as regions where the impoundment was penetrated. Later drawings [e.g., Stansfield and Francis, 1986] also indicate that the base of the pond is consistent with the engineering drawing, but that the surface expression of the pond extended beyond the engineering projection at the north and south ends.

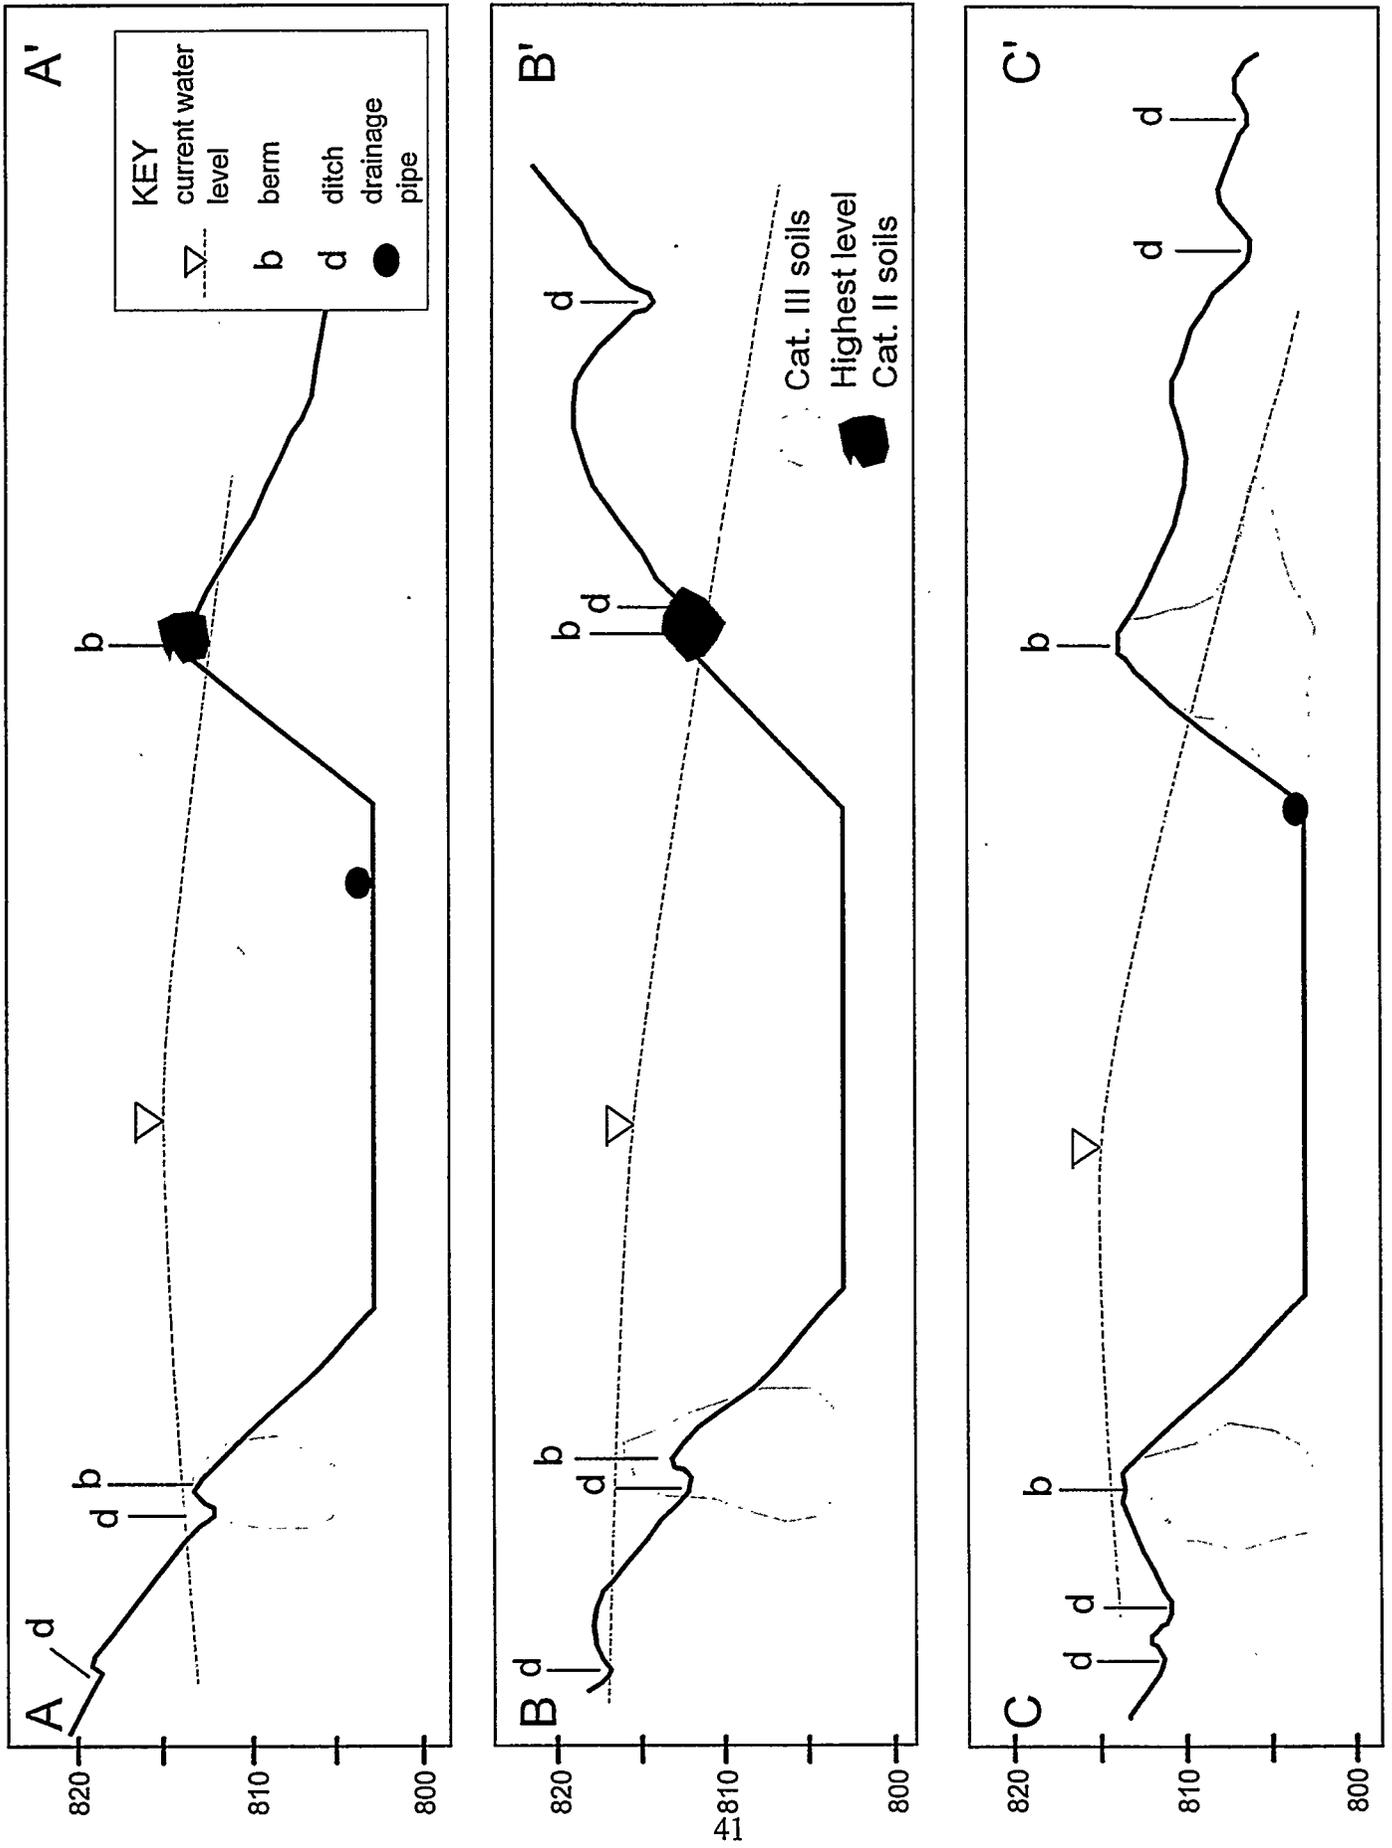
Figure 29. Cross sections of the original impoundment configuration with contaminated soil locations identified.

The soil contamination patterns indicate two primary locations where the contaminated soils are concentrated: a shallow pathway at or near the elevation of the berm, and deeper pathways that are in all likelihood associated with the location of pipelines into or out of the impoundment. The former could be a result of either overflow of the pond and concentration of contaminants in the soils of the surrounding drainage ditches prior to capping, or subsurface transport through the more permeable fill material above the impoundment walls due the rise in the water table following cap installation. According to Stansfield and Francis [1986], the water table rose several feet higher than when the pond was in operation and higher than was projected in response to cap installation. The deeper contaminant concentrations could have been due to either leakage through the pipes themselves or transport along the soils surrounding the pipes. The existence of higher permeability associated with the contaminant concentrations is supported by the water level data, as discussed in the previous section, as well as the geologic cross sections. The following paragraphs discuss the geologic cross sections and associated

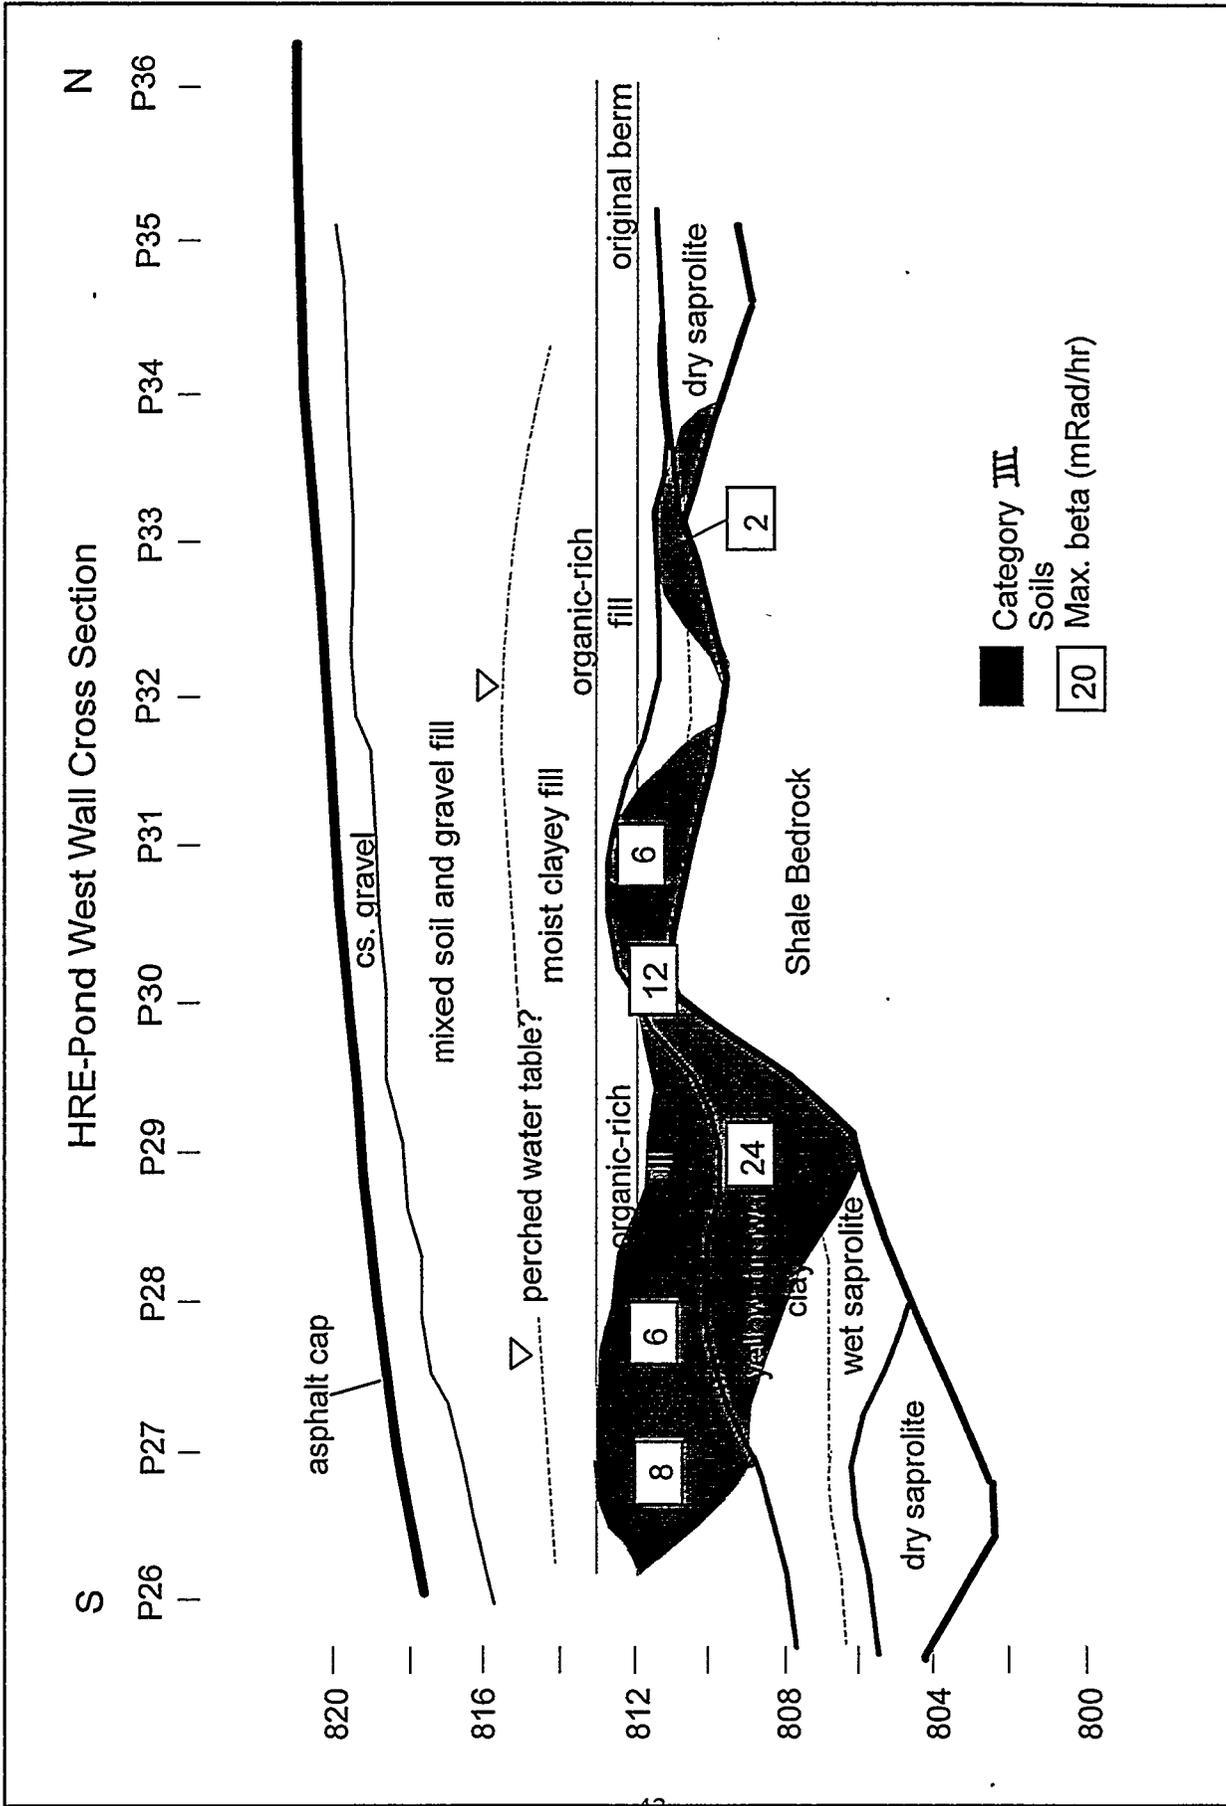
Figure 30. Cross section of the west wall of the impoundment showing gross soil descriptions and approximate location of contaminated soil.

Coarse gravel was encountered immediately beneath the asphalt cover at every borehole location. This layer extends at least a foot in thickness, and is underlain by a mix of dry soil and gravel fill that becomes increasingly moist and clay-rich. The presence of pieces of decaying wood and subangular pebbles at depth provides further indication that the material is backfill covering the original pond construction. The berm surrounding the original containment pond extends to an elevation of 813' per construction diagrams. At a depth approximately coincident with the elevation of the berm, sticky to wet yellow-brown clay was encountered, which grades to wet soupy saprolite in all but the northern and southern ends, where the clay is underlain by dry saprolite. Depth to bedrock is variable, ranging from 15' at the grid south end to 9.5' at the north end, and is probably controlled by bedrock composition and structure (dip).

Category II soils were encountered in all boreholes, with Category III soils encountered in most. At the southern end, these Cat. III soils are underlain by Cat. II soils, indicating that the highest contamination is concentrated in a relatively narrow interval, coincident with the former berm and/or the top of bedrock. This could have been a result of spillover of the berm when the containment pond was active, or due to preferential flow through the transition zone and in the relatively more permeable fill material above the clay. The clay itself provides significant surface area for sorption of cesium and strontium, and the small pore size could result in retention of contaminant-laden groundwater.

The presence of dry saprolite beneath the clay layer suggests that a perched water table exists at the east side of the impoundment. The water table is located at the approximate depth indicated in Figure 30 based on interpolation between the center stand pipe and other standpipes on the eastern side of the cap as well as the approximate depth to moist sediments logged during drilling.
