ORNL/TM-13566

**Homogeneous Reactor
Experiment (HRE) Pond
Cryogenic Barrier Technology
Demonstration: Pre-Barrier
Subsurface Hydrology and
Contaminant Transport
Investigation**

March, 1998

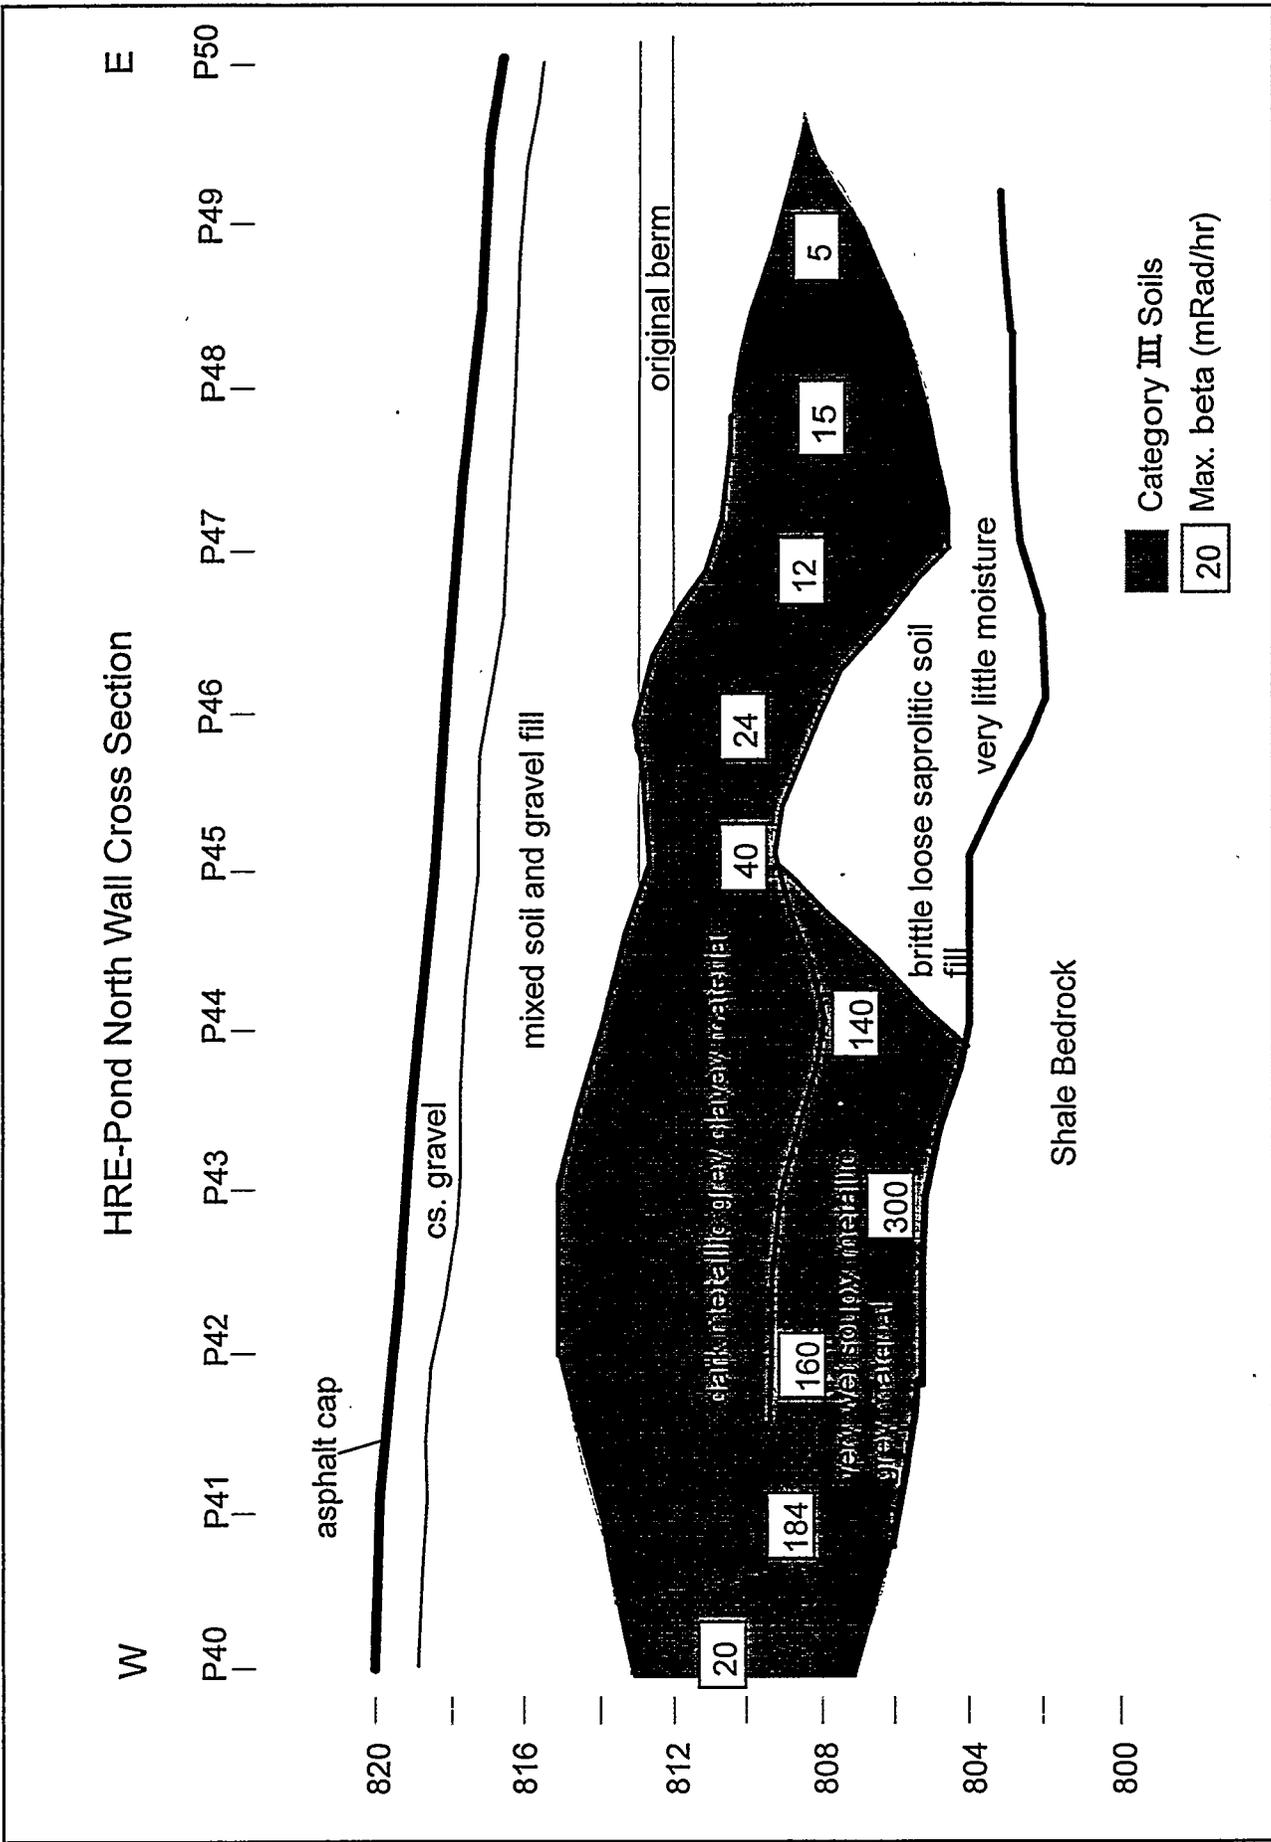
North Wall (Figure 31)

Figure 31. Cross section of the north wall of the impoundment showing gross soil descriptions and approximate location of contaminated soil.

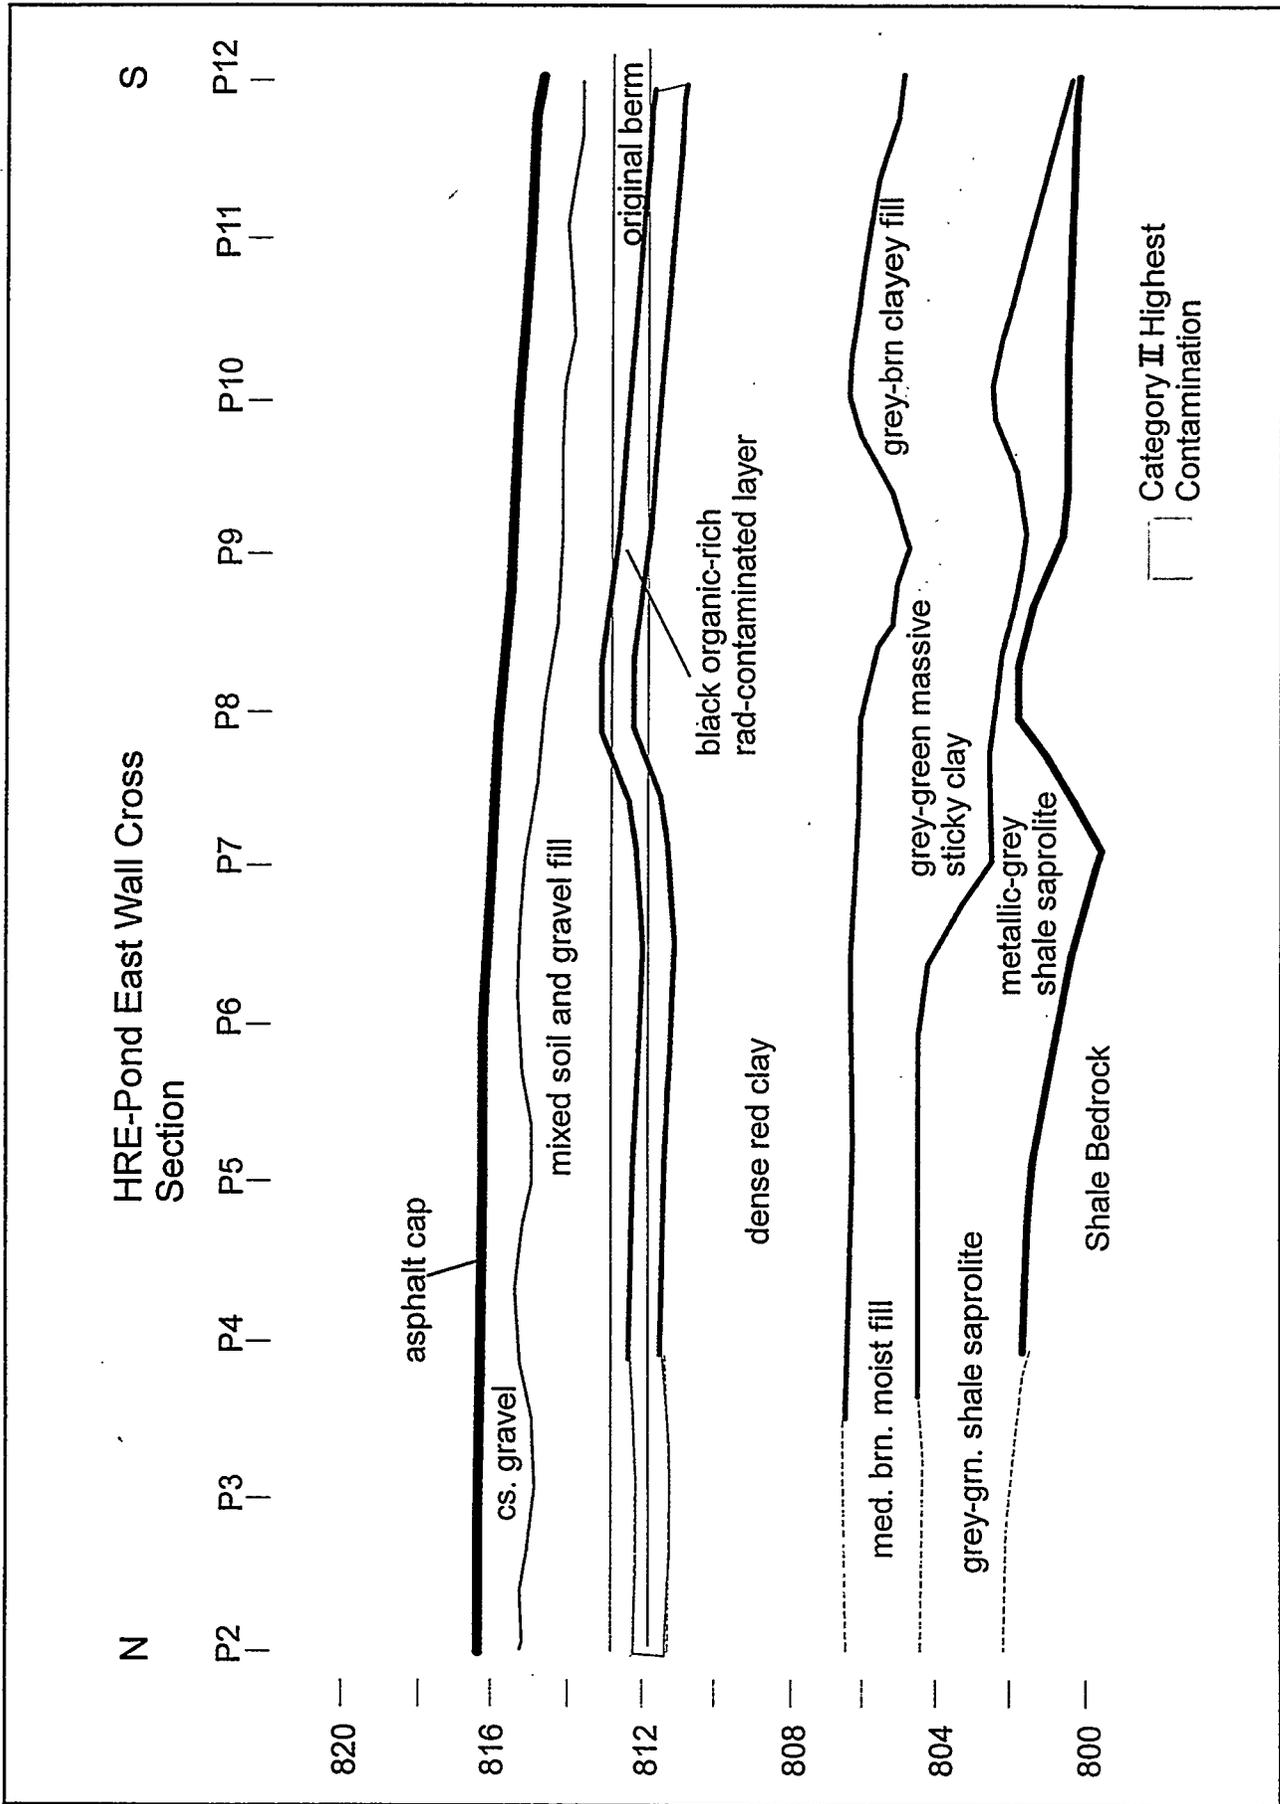
Figure 32. Cross section of the east wall of the impoundment showing gross soil descriptions and approximate location of contaminated soil.

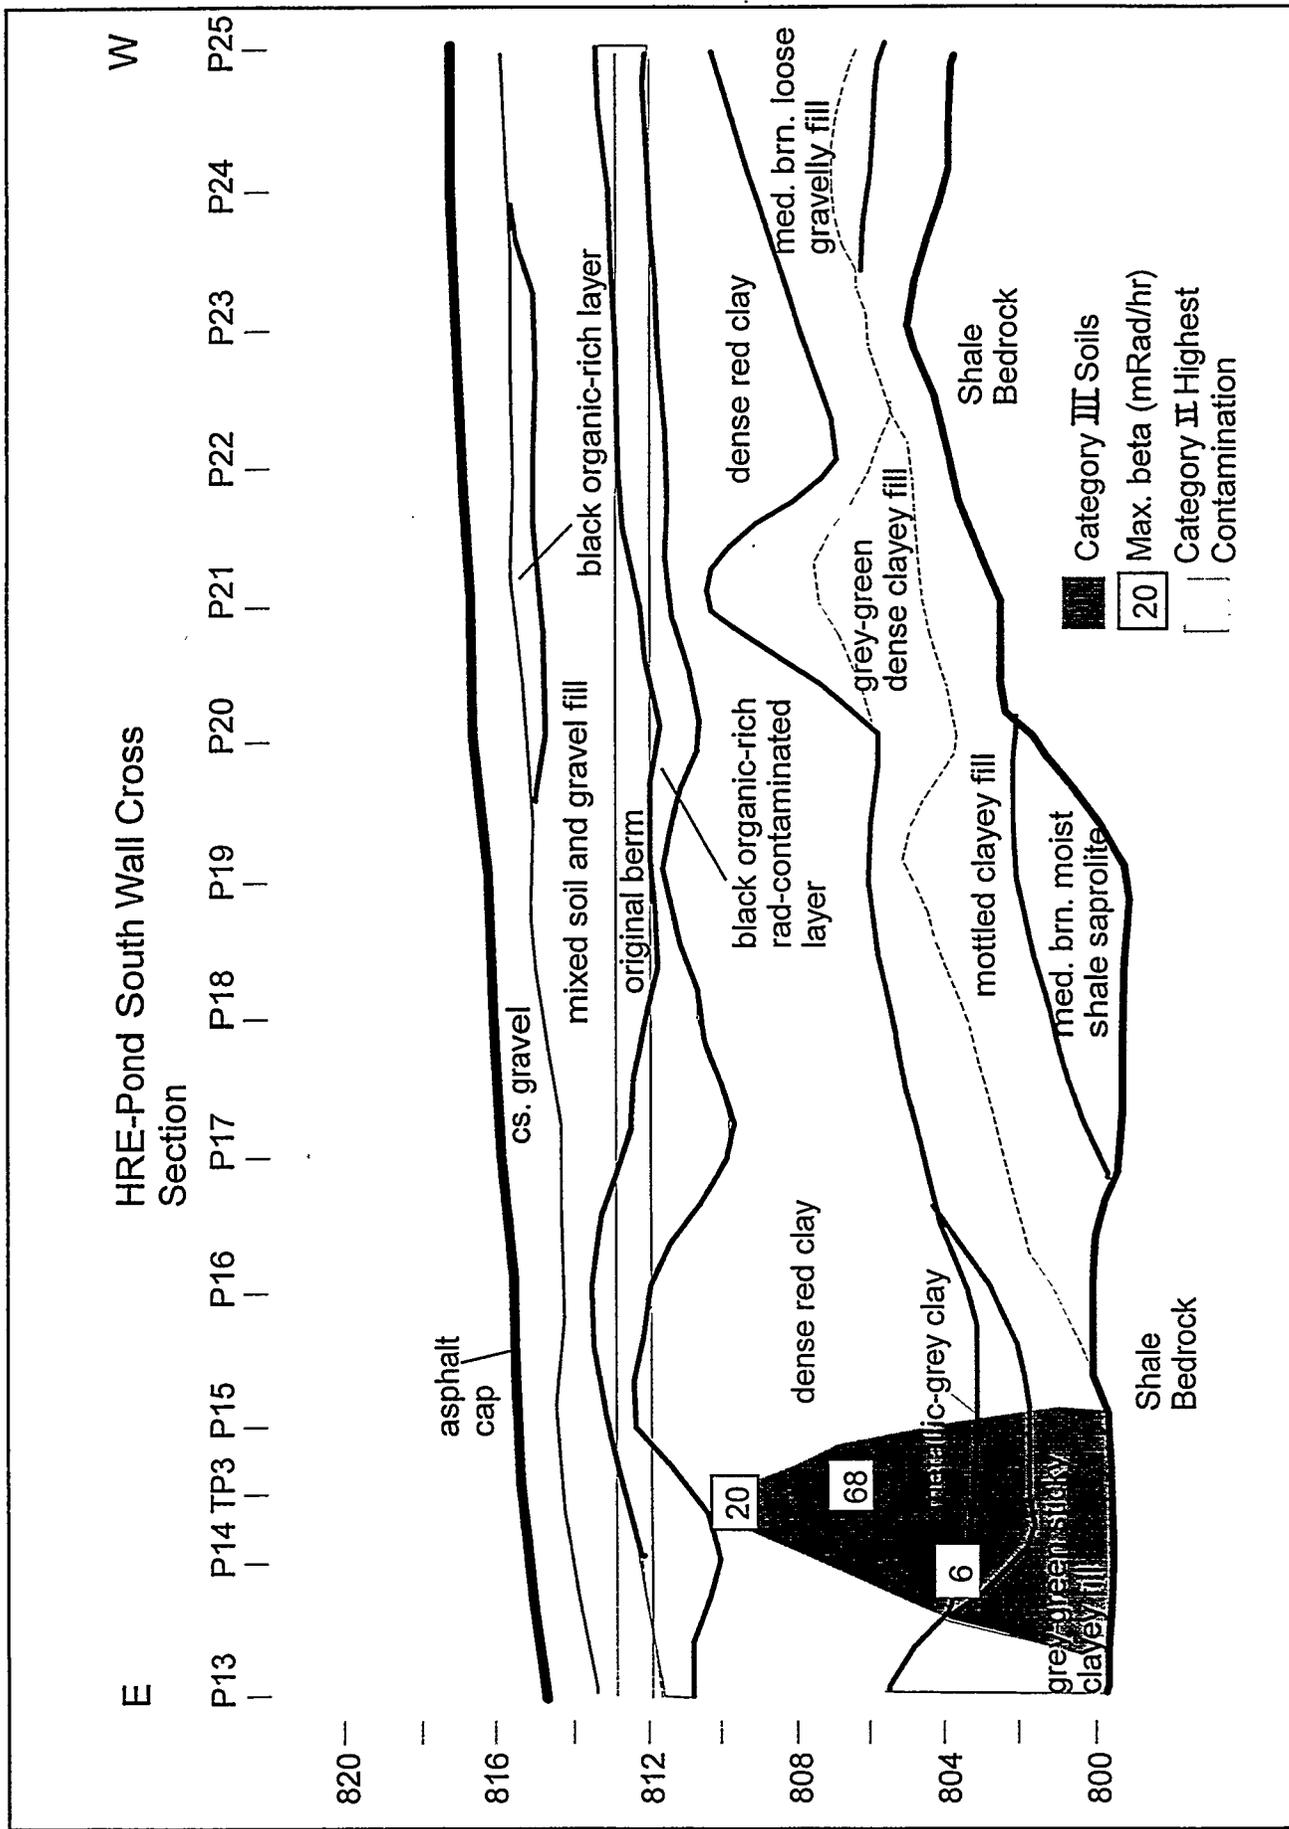
Figure 33. Cross section of the south wall of the impoundment showing gross soil descriptions and approximate location of contaminated soil.

Multiple exit pathways are indicated by the distribution of contaminated soil along the south wall, especially near the SE corner. Category III soils with higher gamma/beta ratio were identified within a narrow band at a location near the planned installation of a drainage pipe in the SE corner of the impoundment and an elevation consistent with base of the pond. The higher contamination is also located near an EM anomaly that was speculated to be buried scrap metal [Kaufman, 1996]. The elevated gamma/beta ratio indicates a higher concentration of ^{137}Cs , which was confirmed to be the major source of gamma radiation [S.Y. Lee, personal comm.]. A N-S cross section along the line of temperature probes (Figure 34) shows that this contamination extends out from the pond to the south as might be expected if the exit pathway were a high-permeability channel such as might have been created by the backfill around the drainage pipe. The water level data from S-6 confirm the presence of conduit-type flow in that vicinity, with very fast flow above the elevation of the bottom of the impoundment.

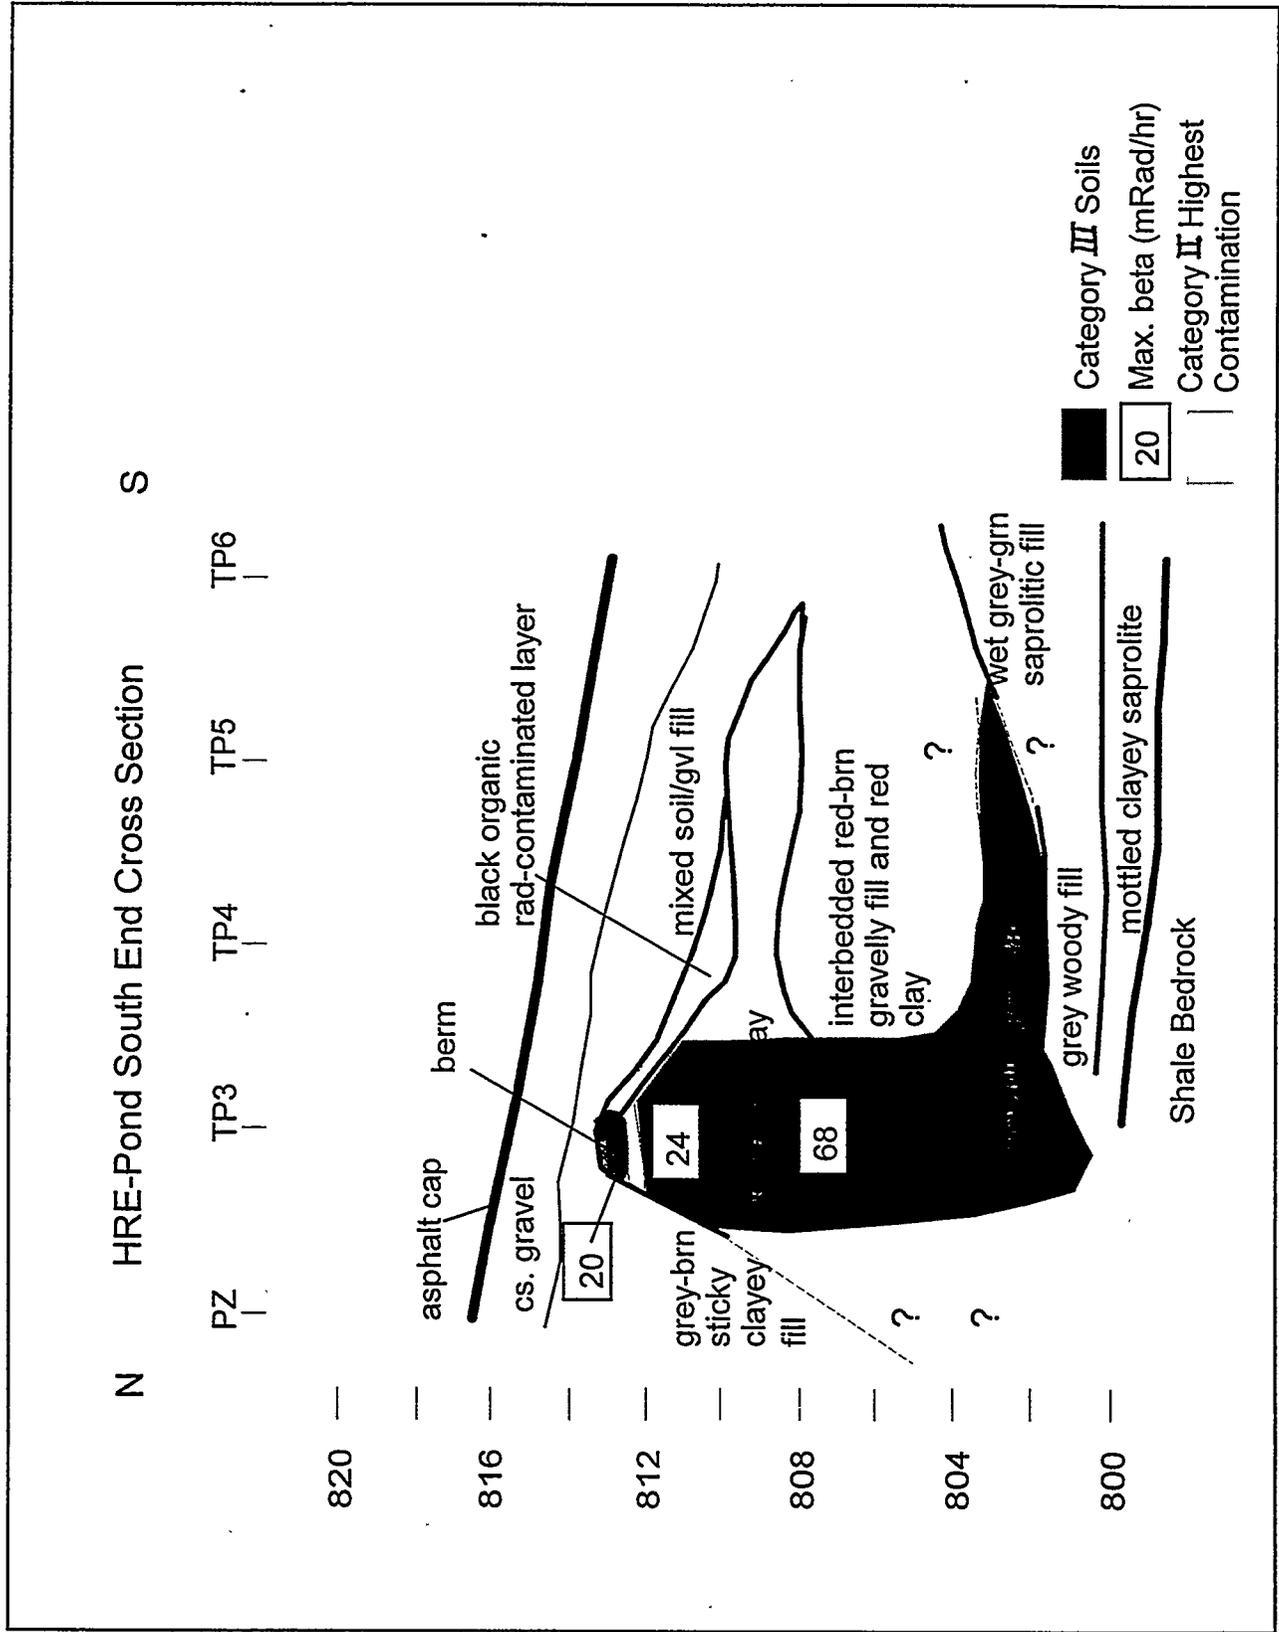
Figure 34. Cross section through the south end of the impoundment showing gross soil descriptions and approximate location of contaminated soil.
