ORNL/TM-7421

Shale Fracturing Injections at Oak Ridge National Laboratory—1977–1979 Series

Date Published: September 1980

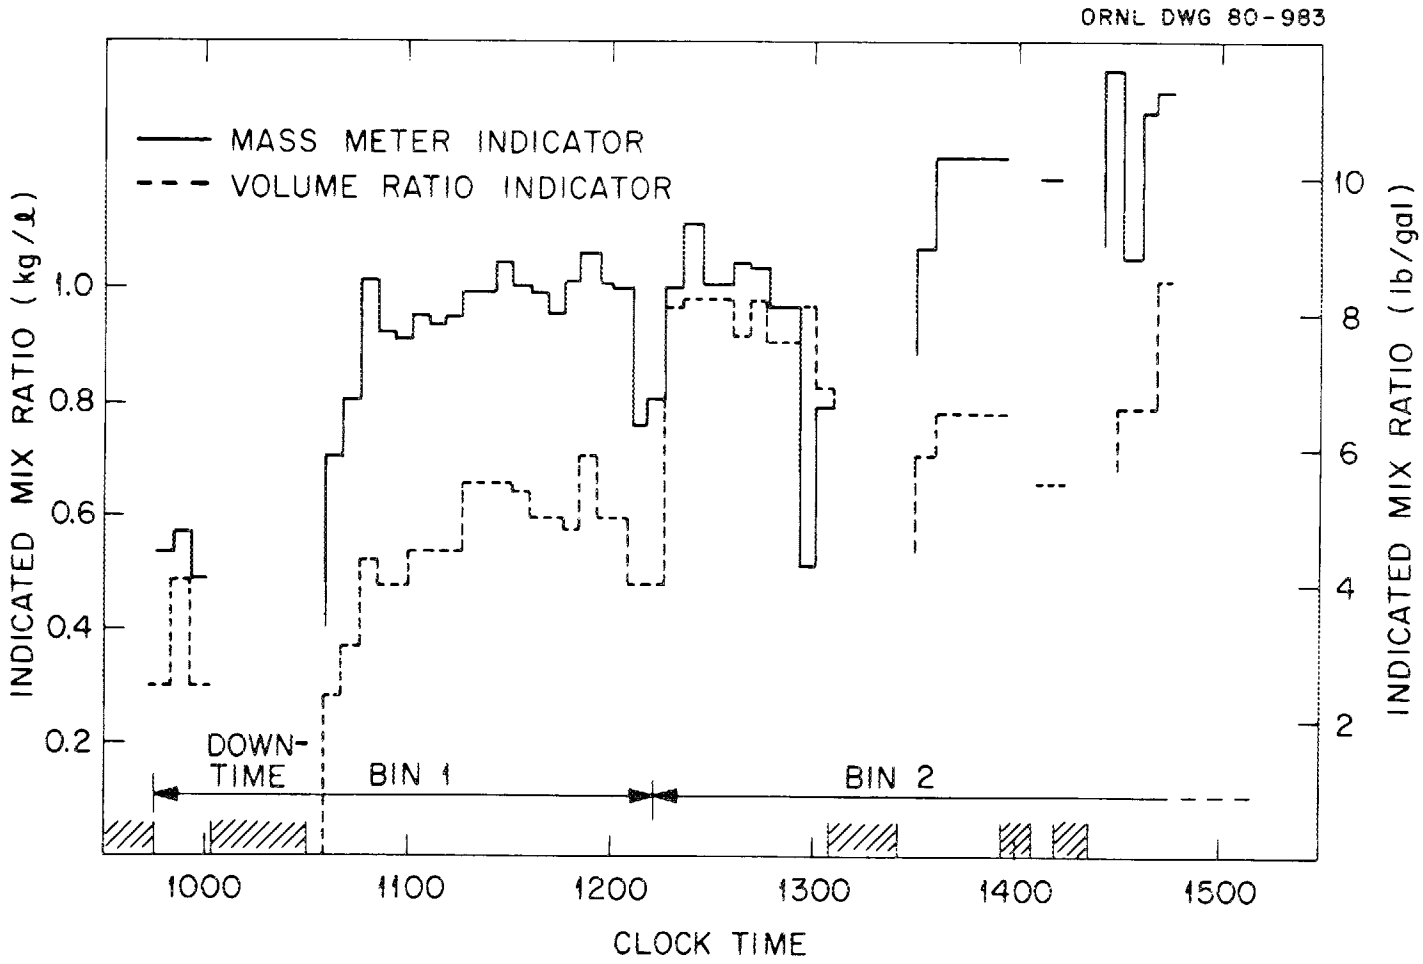
At 1445, the injection was halted because the waste pits were observed to be almost full of waste grout. It was found that one or more of the valves on the valve rack between the high-pressure system and the drain to the waste pit had eroded and would no longer hold pressure. The master valves on the wellhead were closed; the well cell was entered, and the discharge line from the injection pump was connected directly to the wellhead (bypassing the valve rack). The contents of the waste pit, followed by 5700 ℓ (1500 gal) of water, were then pumped down the tubing string and the tubing master valve was closed. The well cell was entered again, and the discharge line from the injection pump was

Fig. 5. Indicated mix ratios for Injection ILW-15, June 30, 1977.

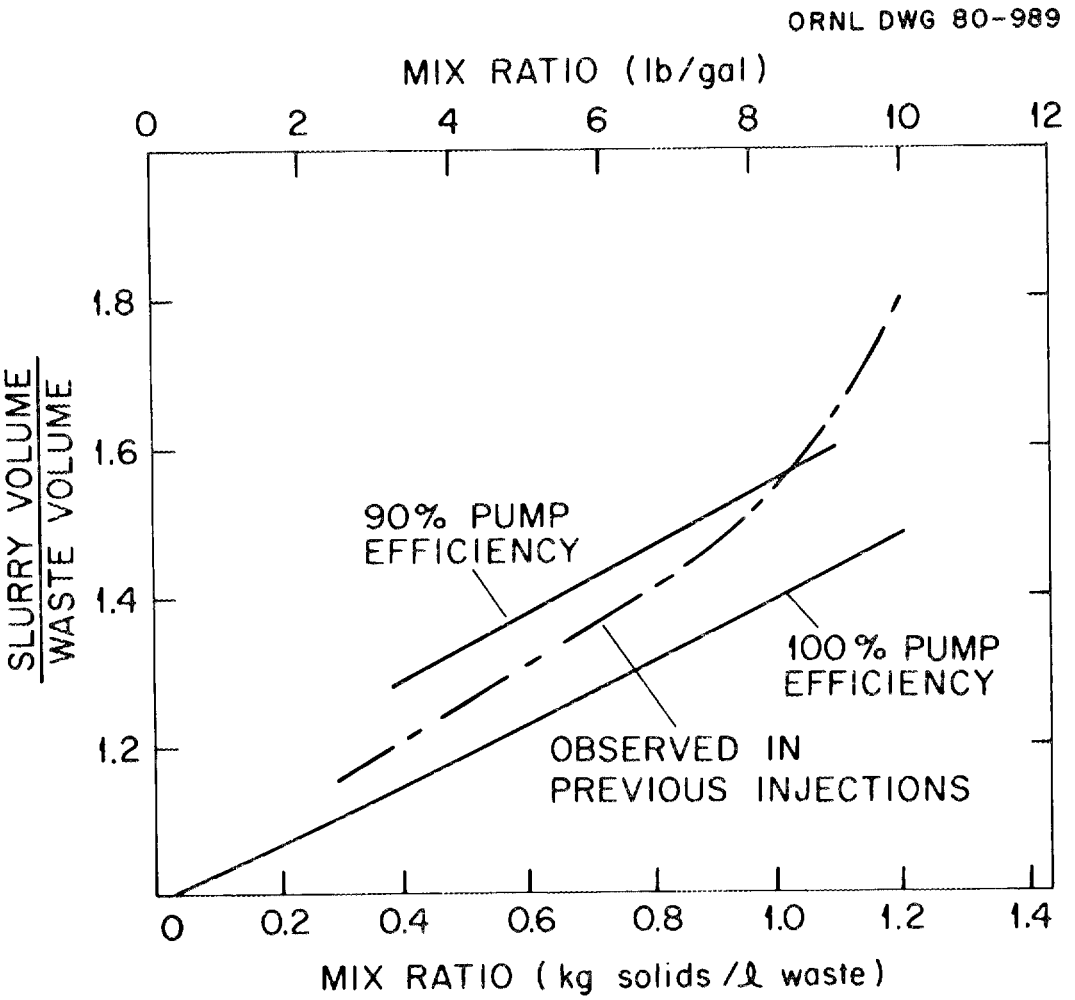
The results in Table 6 indicate that the mass-meter readings were high. The solids consumption computed from the volume ratio is also high, but the error is smaller and more consistent than that in the mass-meter indications. The source of this error is probably a bias in the curve used to relate the volume ratio to the mix ratio; a similar bias of approximately the same magnitude was noted in Injection ILW-14.

Fig. 13. Corelation between mix ratio and volume ratio.

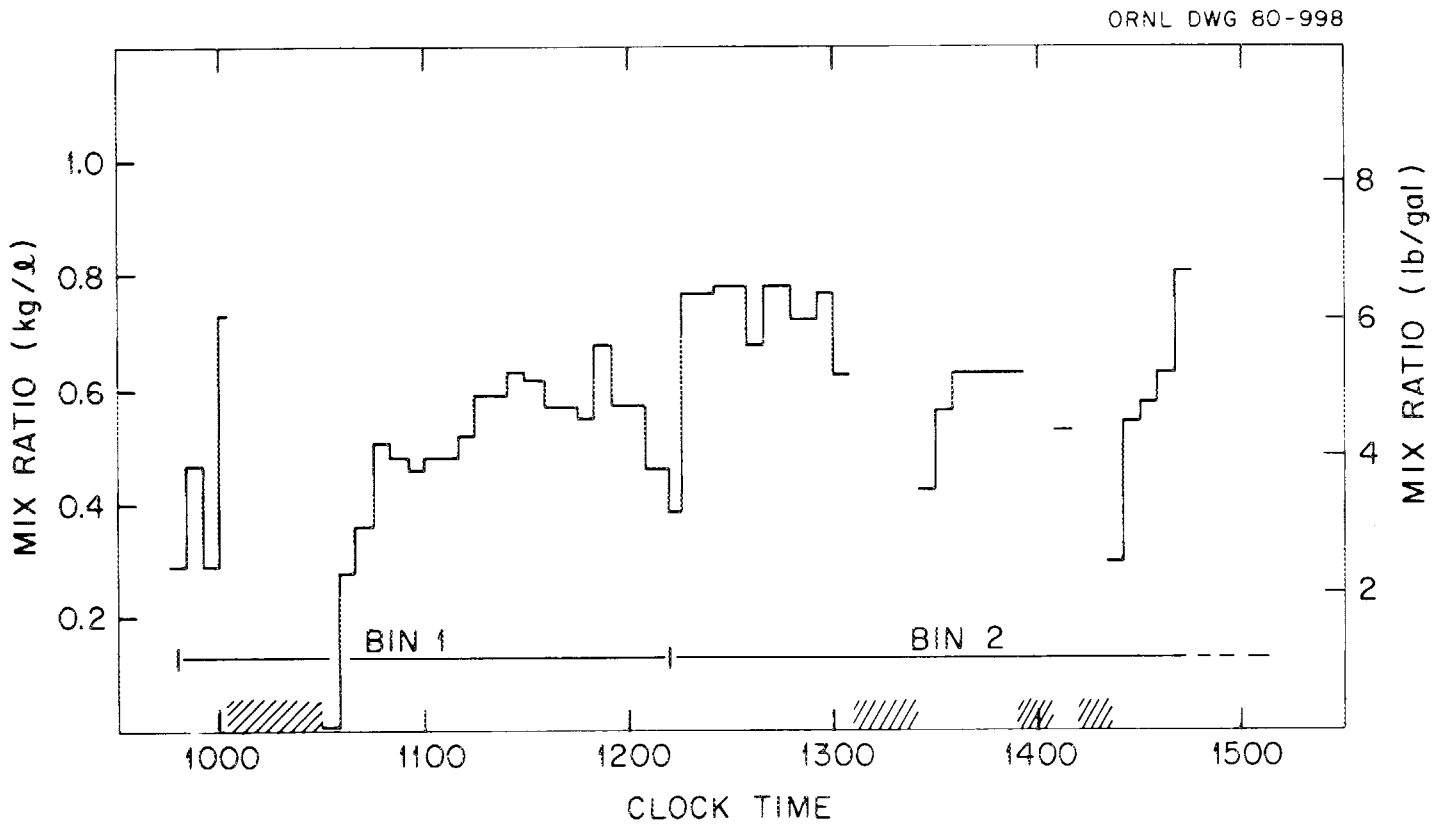
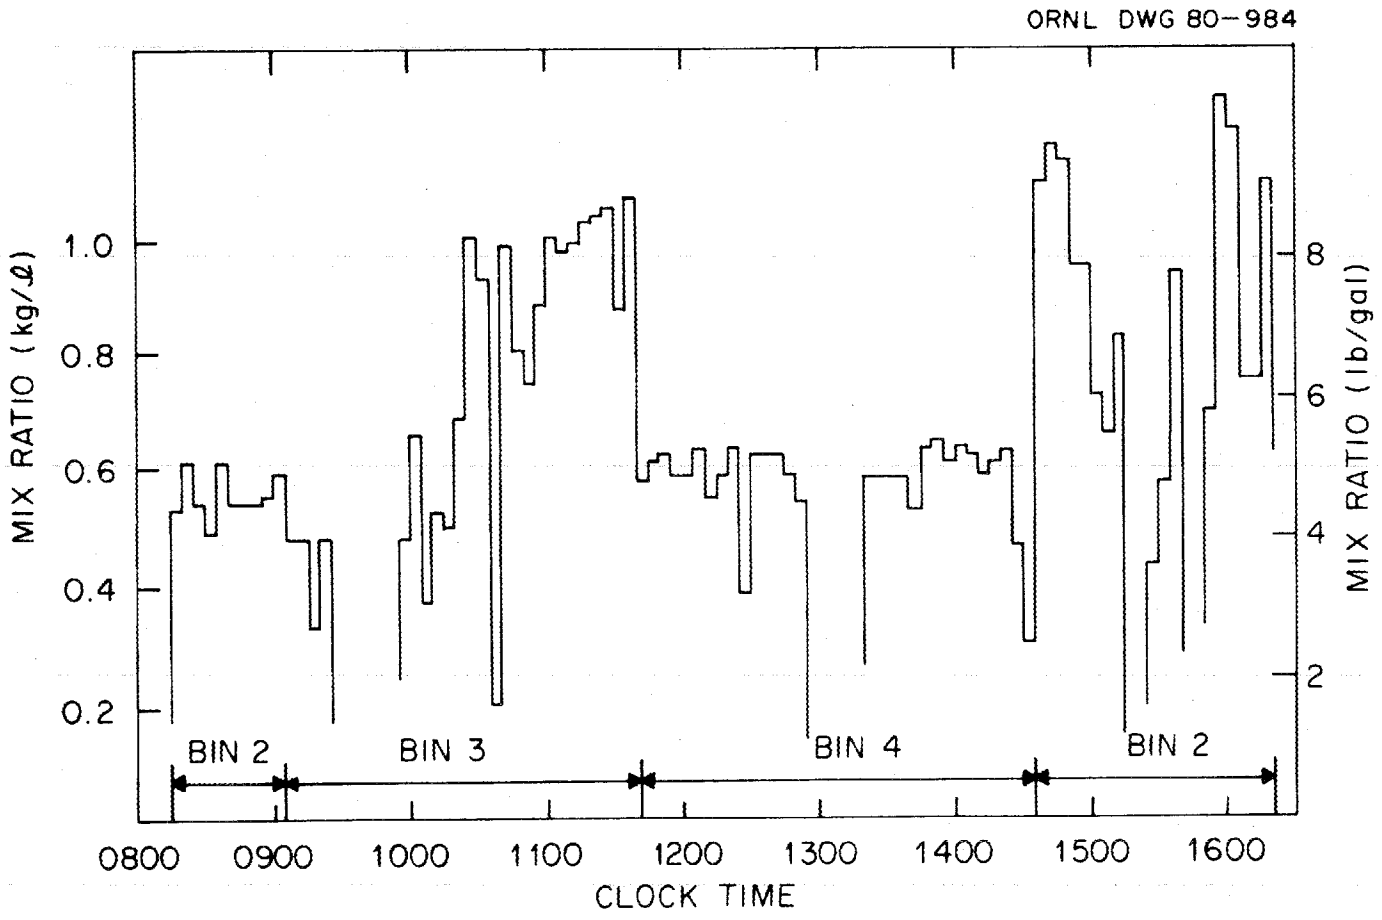
Values for the calculated mix ratio during Injection ILW-15 are given in Figs. 14 and 15. This ratio, which is based on the volume ratio, has been normalized so that the total quantity of solids injected would correspond to the quantity consumed.

Fig. 14. Corrected mix ratio for Injection ILW-15, June 30, 1977.

Fig. 15. Corrected mix ratio for Injection ILW-15, July 2, 1977.

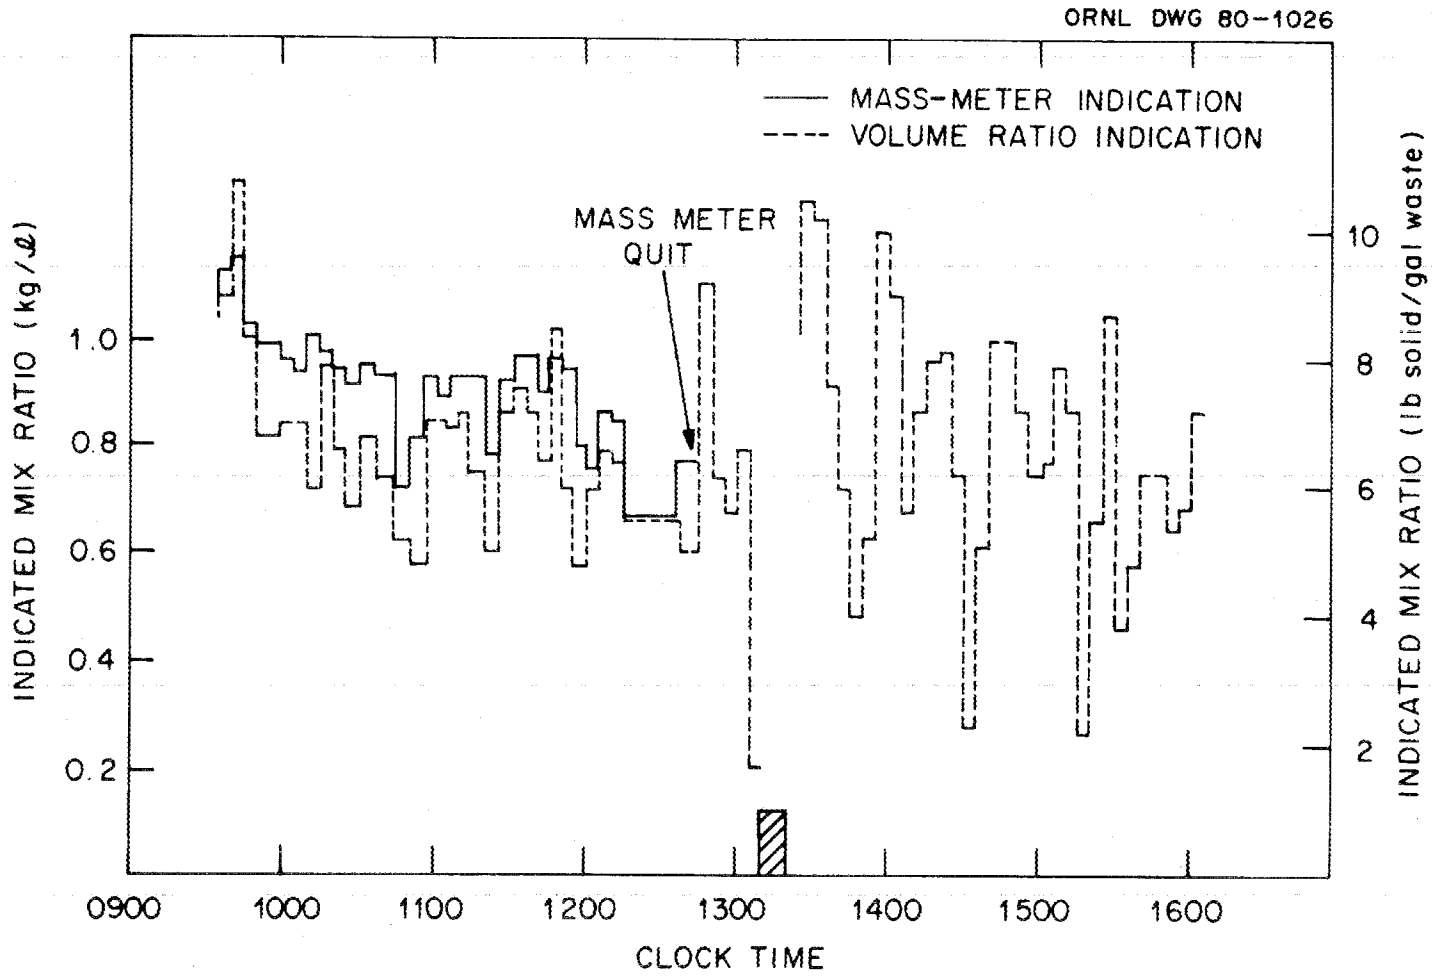
At 1245, the mass meter stopped functioning. From this time until the end of the injection, the only available measurement of the mix ratio was that derived from the volume ratio. Because this measurement was an "after-the-fact" measurement, it gave an average value of what the mix ratio had been; it did not give an instantaneous value of the mix ratio at a particular moment. (The experimental ratio indicator that could have given such an instantaneous value had developed a considerable bias and could not be trusted.) Estimation of the mix ratio from visual observation of grout in the mix tub was found to be unreliable. Only very thick (>1.2 kg/ℓ (10 lb/gal) or very thin [<0.24 kg/ℓ (2 lb/gal)] grouts could be recognized; all concentrations between these extremes appeared to be essentially the same. The method of mix control that was

Fig. 19. Indicated mix ratios for Injection ILW-16.

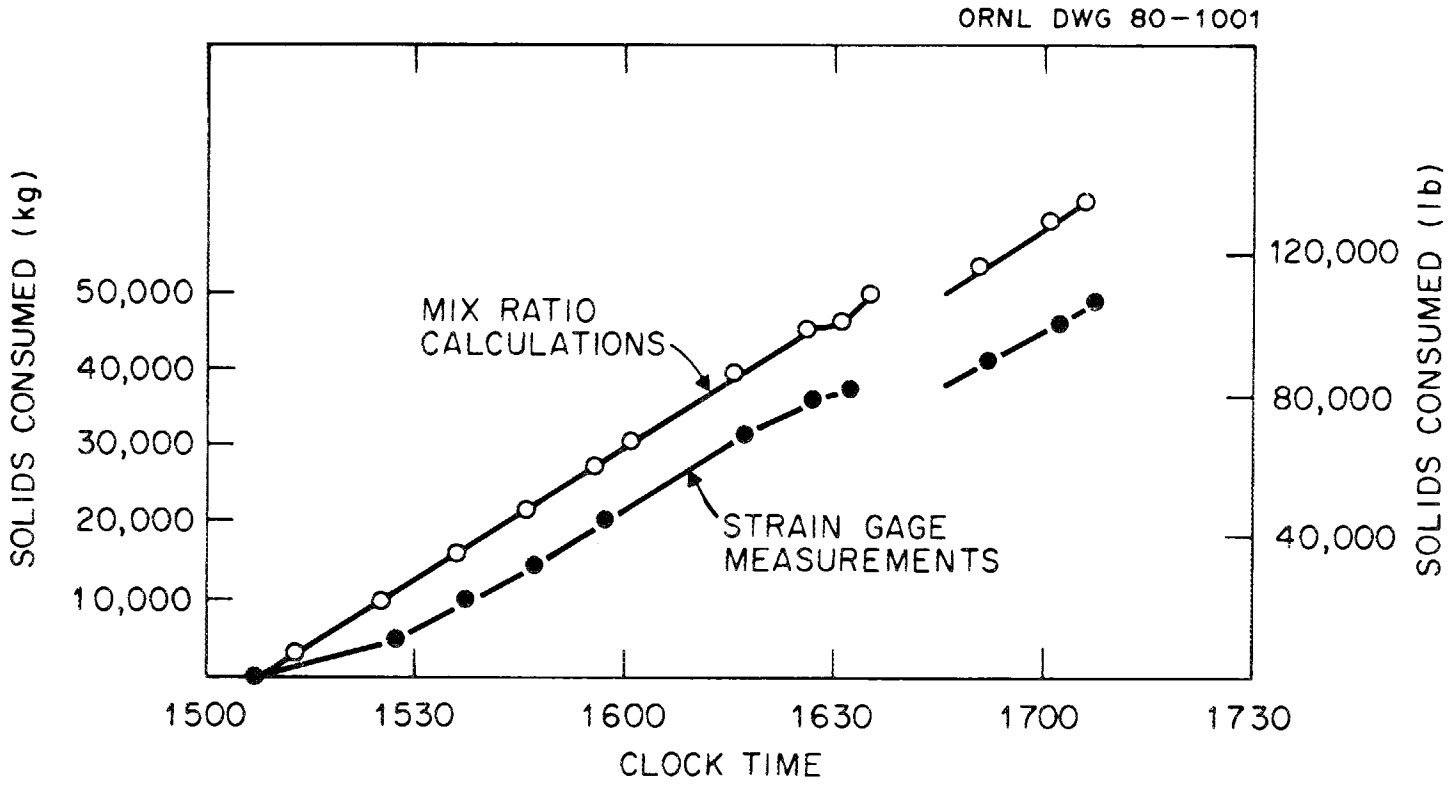
The readings obtained with the strain gage on bin 3 were not credible since they indicated that the amount of solids withdrawn was 26% of the amount determined via the mix ratio calculations. The strain gages on bins 1 and 4 indicated that the amount of solids withdrawn was between 77 and 92% of that suggested by the mix ratio calculations. The latter numbers are not unreasonable since the mix ratio calculations indicated that more solids were being consumed than were originally stored in the bins. The strain gage measurements generally showed a uniform withdrawal rate of solids; Fig. 26 shows the calculated amount of solids withdrawn from bin 4 based on strain gage measurements and on mix ratio calculations.

Fig. 26. Two measurements of solids withdrawn from bin 4 during Injection ILW-17.
