Proceedings of
2003 ASME Turbo Expo: Power for Land, Sea & Air
June16-19, Atlanta, Georgia, USA

GT2003-38919

DYNAMIC FATIGUE OF CVD-MULLITE COATED SN88 SILICON NITRIDE

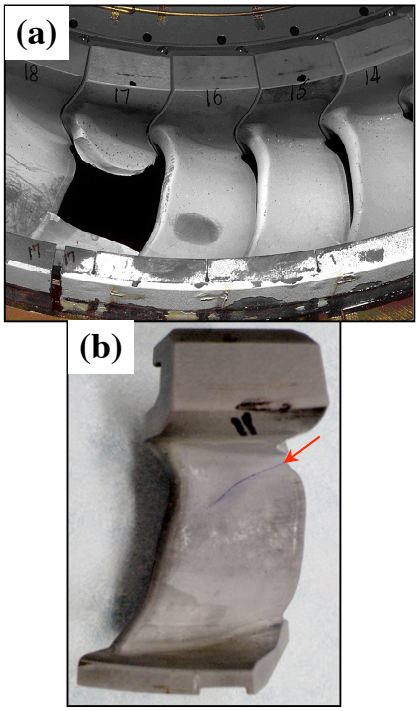
The cracking, which was observed on the airfoil surface of SN88 silicon nitride nozzles, initiated at the region near airfoil/platform transition region, as shown in Fig. 1. Finite-element-analysis of temperature distribution at steady state (~ 1120°C) during engine operation indicated that the temperature in the airfoil/platform transition region ranged from 800 to 900°C [9]. Therefore, the failure of SN88 silicon nitride nozzles, which resulted from crack generation in the

airfoil/platform transition region, would lead one to surmise that the SN88 silicon nitride might exhibit a mechanical instability at intermediate temperatures in an oxidizing environment. Recently studies carried out by Haynes et al. have shown that thin CVD mullite coatings (~ 2 μm) can effectively suppress the rapid oxidation of SiC/SiC CFCC with CVD SiC seal coats in high-temperature, high-pressure steam environments [10]. Thus, it is hypothesized that the dense CVD-mullite coatings could also provide effective protection from oxidation and subsequent phase change of SN88 silicon nitride components during engine operation. The long-term mechanical reliability and lifetime performance of SN88 silicon nitride can then be retained.

Figure 1. Photos of (a) SN88 silicon nitride nozzle sections after 68 h engine test and (b) nozzle show crack initiated at the air foil/platform transition region.

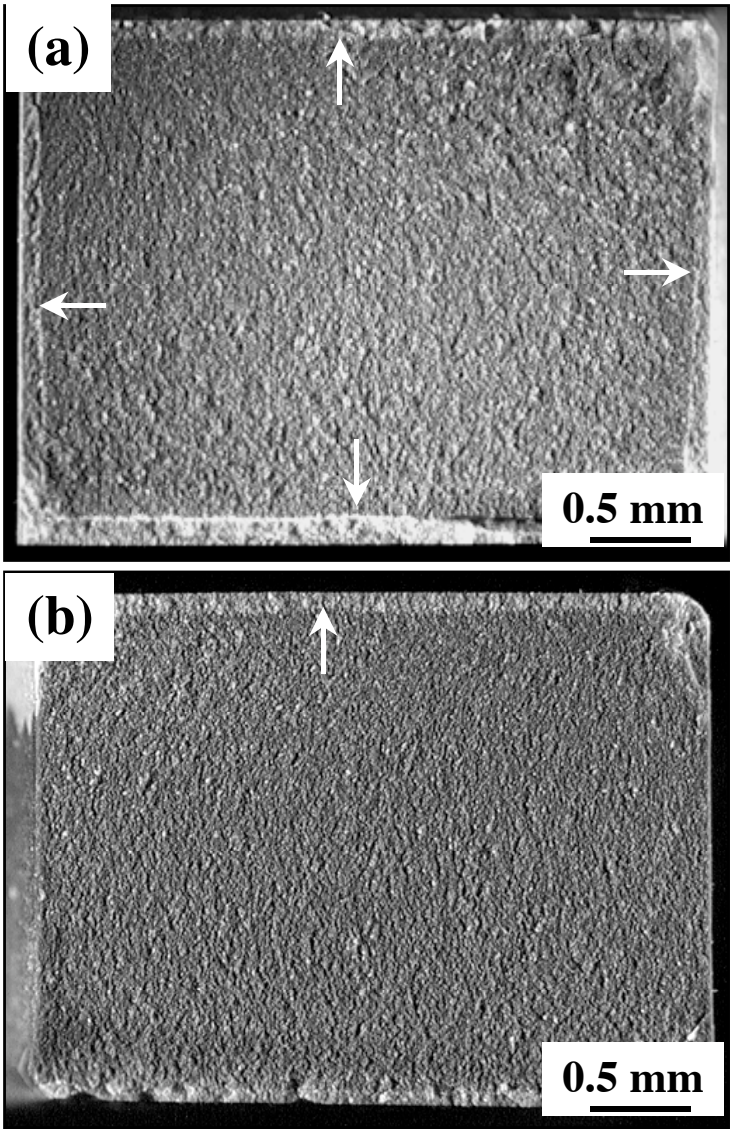
Analysis of optical fractography for uncoated SN88 samples tested at 0.003 MPa/s over the temperature range employed or under stress rupture tests at 850°C revealed a light-colored layer on all surfaces of the bend bars (as shown in Fig. 4a), indicating the presence of an environmentally-affected zone (EAZ). The light-colored layer was only observed on the tensile surface region of coated samples (as shown in Fig. 4b) where dominant cracks initiated. In addition, the depth of the EAZ developed in both coated and uncoated SN88 samples after stress rupture tests increased with an increase in lifetime. Note that a similar light-colored EAZ was also observed in the crack region of the SN88 nozzle that failed after the 68 h engine test [14]. SEM examinations of the fracture surfaces of coated and uncoated samples tested at 0.003 MPa/s at 850°C indicated a change in the secondary phase microstructure, i.e., presence of pores, inside the EAZ (Fig. 5). The change in secondary phase microstructure was not observed in material outside the EAZ. Therefore, these SEM observations suggested that the EAZ developed in SN88 silicon nitride was a thermally-activated, time-dependent process.

Figure 4. Optical fractography of (a) uncoated and (b) CVD-mullite coated SN88 tested at 850°C and 0.003 MPa/s in air.

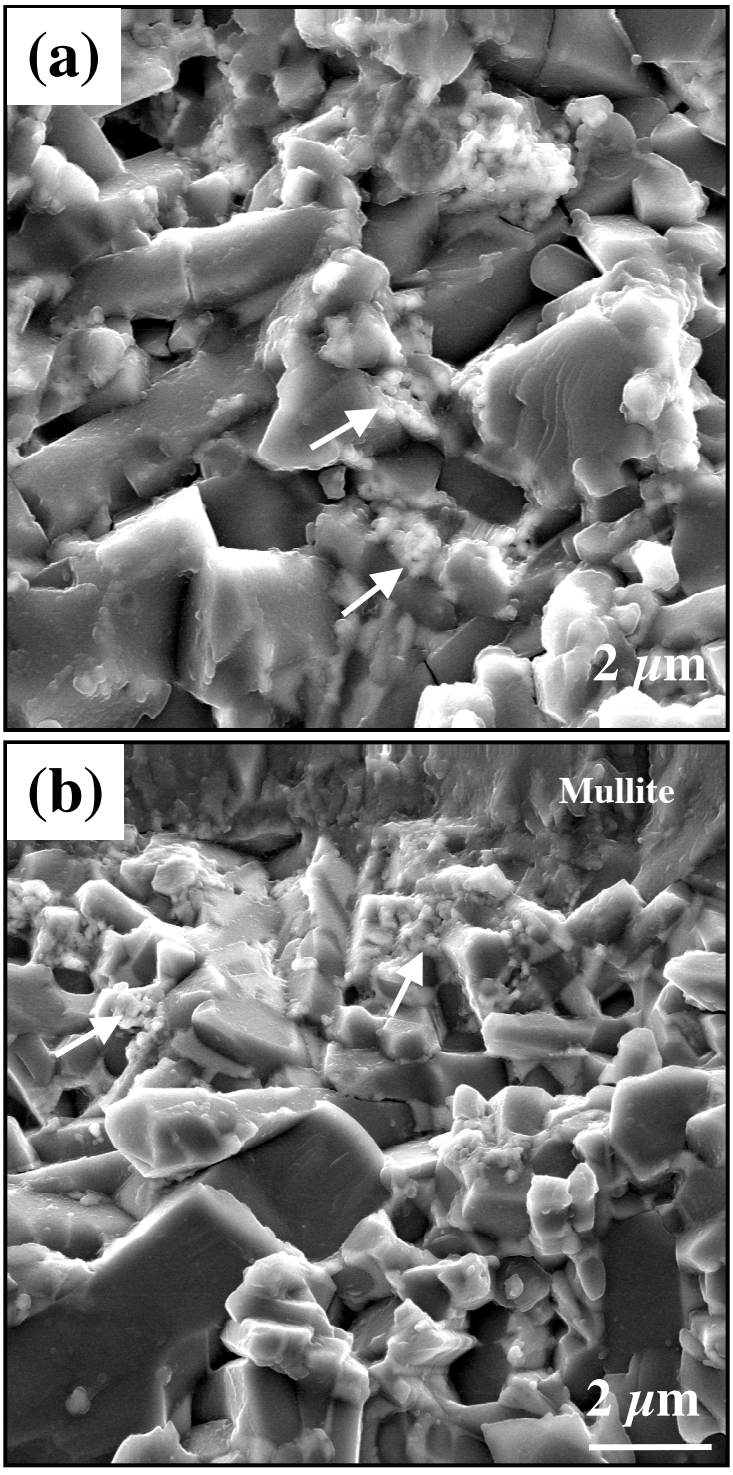
Figure 5. SEM of fracture surface for (a) uncoated and (b) CVD-mullite coated SN88 silicon nitride tested at 850°C and at 0.003 MPa/s. Arrows denote pores in secondary phase.

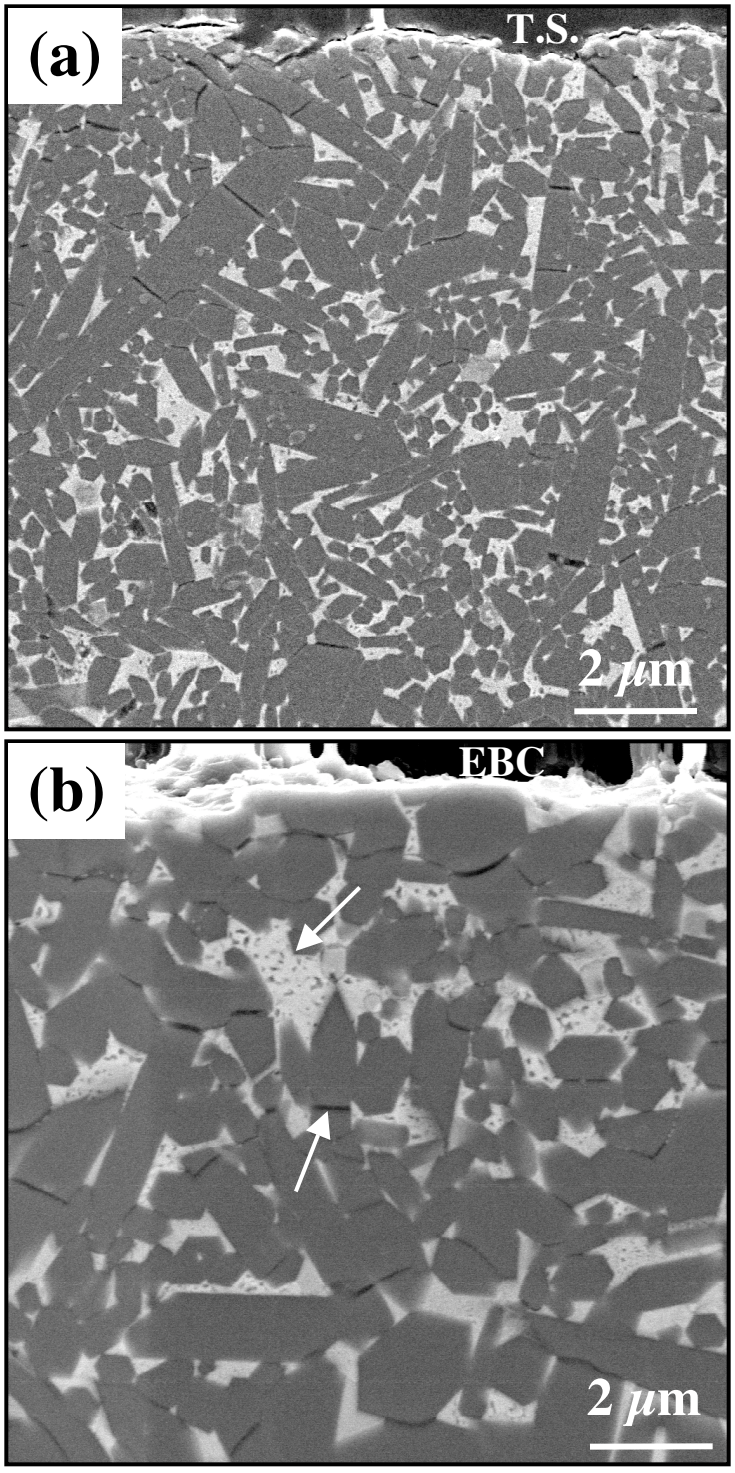
The light-colored EAZ became more evident on polished cross sections of 0.003 MPa/s test samples for both coated and uncoated SN88. SEM observations showed a ~ 30 μm damage zone consisting of multiple cracks and pores in the secondary phase (Fig. 6). The formation of an EAZ was observed in all four surfaces of the uncoated SN88, suggesting that the development of the EAZ was not a stress-promoted phenomenon, but solely oxidation-related. Results of X-ray diffraction analysis for 0.003 MPa/s test samples indicated a change in the secondary phase from J-phase ($Yb_4Si_2O_7N_2$) to $Yb_2Si_2O_7$ plus Yb_2SiO_5. Similar phase transformation of secondary phase was also observed in SN88 nozzles, which failed during engine test [14]. The phase transformation from J-phase to $Yb_2Si_2O_7$ plusYb_2SiO_5 will introduce a high residual tensile stress in the EAZ due to a ~71% decrease in material volume [15,16]. The development of a high tensile stress would then lead to fracture of elongated Si_3N_4 grains and generation of intergranular cracks in the surface region of the bend bars. The formation of these through-surface flaws would result in a substantial decrease in mechanical strength and reliability. Similar mechanical instability at intermediate temperatures due to phase changes was previously reported for Si_3N_4 materials sintered with Y_2O_3 additive [17-19].

Figure 6. SEM micrographs of polished cross section of (a) uncoated and (b) CVD-mullite coated SN88 silicon nitride tested at 850°C at 0.003 MPa/s. Arrows denote pores in secondary phase and fracture of silicon nitride grains and grain boundaries. Also, T.S. and EBC denote the tensile surface and CVD-mullite region, respectively.
