ICEF2004-875

Characterization of Erosion Mechanisms for Natural Gas Engine Spark Plugs

Oak Ridge National Laboratory

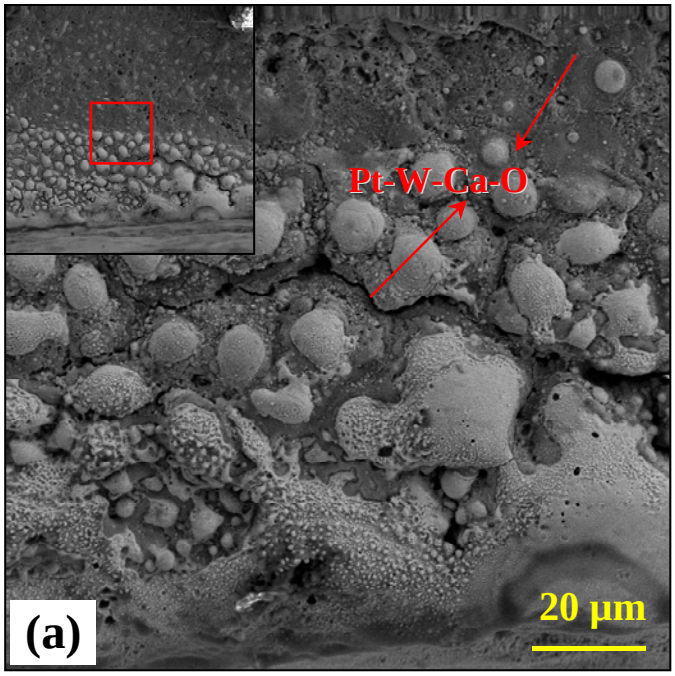
Pt-W-Ca-O
20 µm
(a)

The observation of Ca in the used plug emission spectrum was confirmed by SEM analysis of the electrode side surfaces (Ni alloy) and Ir/Pt-W tips of the 4,383 h used plug (Figs. 5 and 6). Although this observation is for plugs with 4,386 hours of use, the investigation of plugs involving 2,020 hours is in progress and initial observations on surfaces revealed similar features. The side surfaces of the Ni alloy ground electrode (Fig. 5a) were covered with a glassy Pt-W base oxide phase, with a significant quantity of Ca. The center electrode showed comparable features, with a Ir-Ni base oxide, again containing significant quantities of Ca (Mn, Cr, and Si were also detected in some regions) (Fig. 5b). Examination of the Pt-W tip showed evidence of extensive cracking and local melting (Fig. 6a and 6b), but no evidence of oxide-containing phase(s) formation. The absence of oxide formation at the Pt-W tip surface suggests its loss during the sparking process and

Figure 5. SEM micrographs show the side surface feature of Ni-based electrode on (a) Pt-W tip insert (anode) side and (b) Ir tip insert (cathode) side after field service. Note the inserts show the low magnification of both Pt-W and Ir tip insert. This plug had 4,386 hours of engine operation.

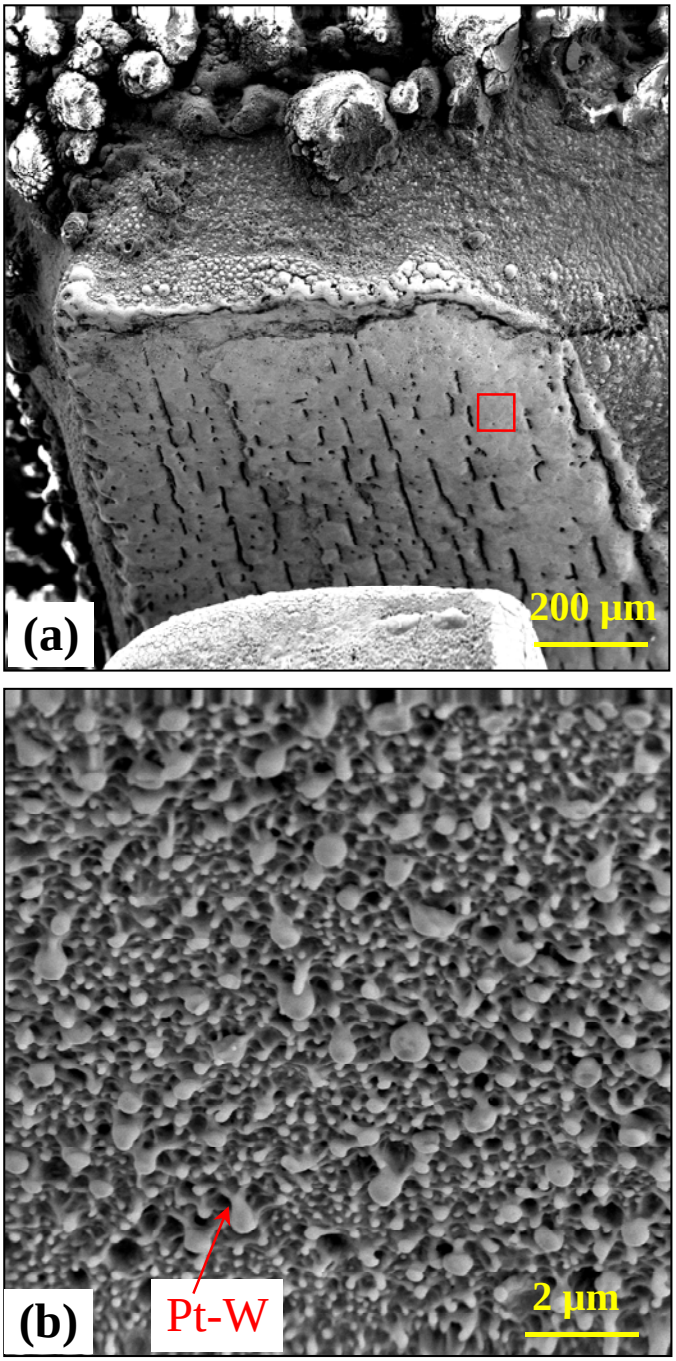
(a)
200 µm
(b)
Pt-W
2 µm

that significant material loss during sparking may be occurring at the Pt-W ground electrode tip insert. At the Ir tip (Fig. 6c), cracking was also observed, although there were no signs of local melting and the surface was fully covered by the Ir-Ni-Ca oxide phase (Fig. 6d). The source of the Ca is speculated to be the engine lubricant, as Ca-containing compounds are an additive in low ash lubricants required for NG engines [1]. The formation of such Ca-containing oxide glass(s) may lead to enhanced wear as Ca is known as a glass former and can readily decrease the melting point of oxides.

F**igure 6.** SEM micrographs show the top surface morphology of Pt-W (a, b) and Ir (c, d) tip insert after field service. Note that (b) and (d) are the high magnification of (a) and (c), respectively. This plug had 4,386 hours of engine operation.

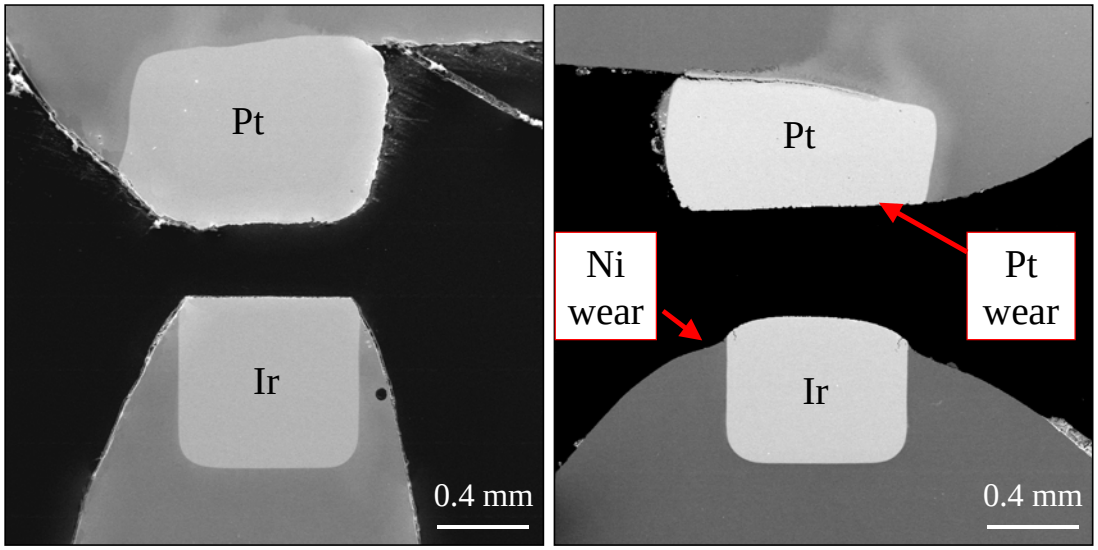
A polished SEM cross-section image of a new plug is shown in Fig. 7a. Preliminary analysis by EPMA suggested significant interdiffusion of the precious metal tips with the Ni electrode alloy in the new plugs, particularly with the Pt-W tip. The polished SEM cross-section image of the 4,383 h used plug is shown in Fig. 7b. Wear of Ni is evident at the corners of the center electrode Ni alloy/Ir tip, which is consistent with the spectroscopic finding of Ni emission from the new spark plug. Significant loss of the Pt-W alloy tip insert material is also evident in the ground electrode, which is consistent with the local melting and absence of oxide at this tip surface (Fig. 6a and 6b).

Figure 7. Micrograph showing the differences between a new and used spark plug (4,386 hours); of note is the erosion of both the nickel base and the platinum electrode.

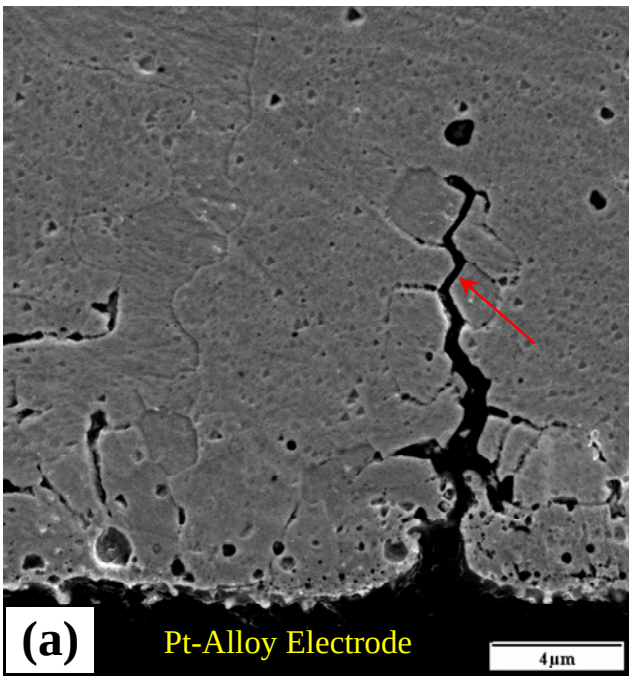
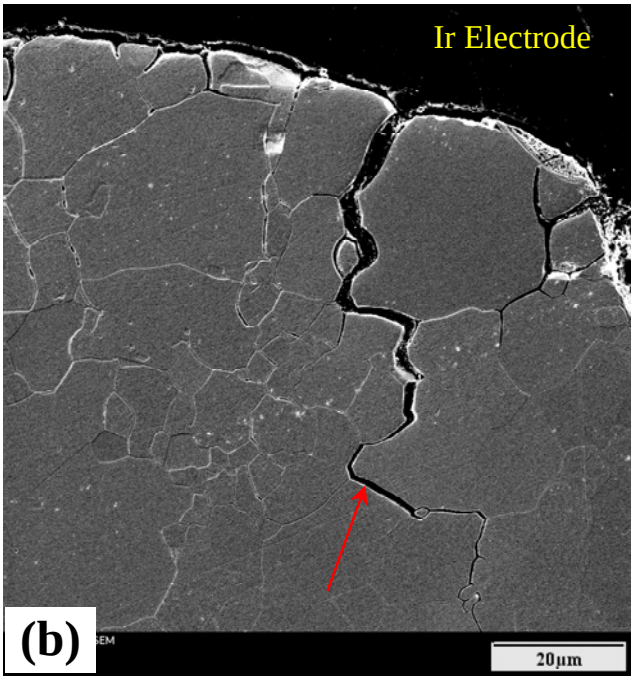
Figs. 8a and 8b show etched cross-sections of the outer surface of the Ir and Pt-W alloy tips. Intergranular cracking is evident in both Pt-W and Ir tip. In addition to the typical surface erosion processes/material loss phenomena resulting from sputtering, melting, ablation, particle erosion, and related effects during sparking [e.g. 2, 3], the generation, growth, and coalescence of intergranular cracks would also result in significant material loss and accelerated erosion during service. Characterization of shorter term NG tested partially worn spark plugs is planned in an attempt to determine the relative contribution of this intergranular cracking to the loss of electrode tip material.

The absence of significant Pt in the emission spectrum of the used plug is consistent with loss of Pt-W alloy by cracking rather than directly during sparking, however, again, the absence of these metals in the emission spectrum could be the result of clustering of atoms during sparking not registering with the spectroscopic techniques used. The cause of this cracking is not yet known, although Pt alloys have been reported to be susceptible to intergranular cracking when exposed to carbon at elevated temperatures [4].

Figure 8. SEM micrographs show extensive formation of intergranular cracks in both Pt-W (a) and Ir (b) tip insert after field service. This plug had 4,386 hours of engine operation.
