INTERGRANULAR CRACKING OF INOR-8 IN THE MSRE

H. E. McCoy

NOVEMBER 1972

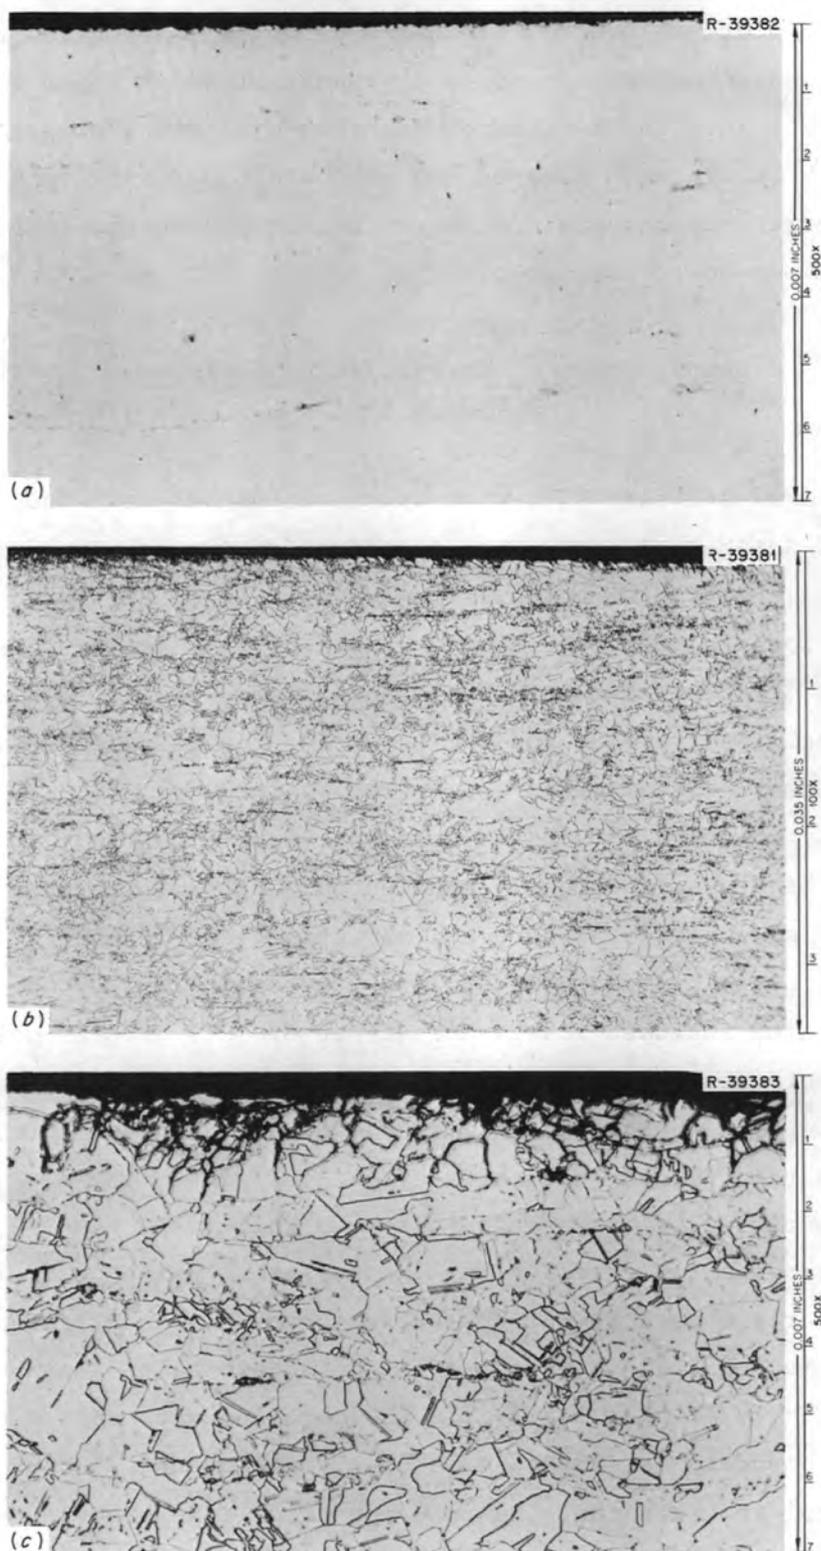
Visual inspection showed the core specimens to be very slightly discolored but otherwise apparently unaffected. Photomicrographs of specimens (unstrained) after exposure are shown in Figs. 13 and 14. (The unusually fine grain size is due to the fabrication history of the specimens, which included 100-hr anneals at 870°C.) The as-polished views of specimens of both heats show some evidence of grain boundary modifications to a depth of 1 to 2 mils, and both show some tendency to etch more readily near the surface.

Fig. 13. Photomicrographs of Zirconium-Modified INOR-8 (Heat 21554) Removed from the MSRE after 5554 hr above 500°C. Edge exposed to flowing salt. (a) As polished. 500 \times . (b) Etchant: aqua regia. 100 \times . (c) Etchant: aqua regia. 500 \times . Reduced 30%.

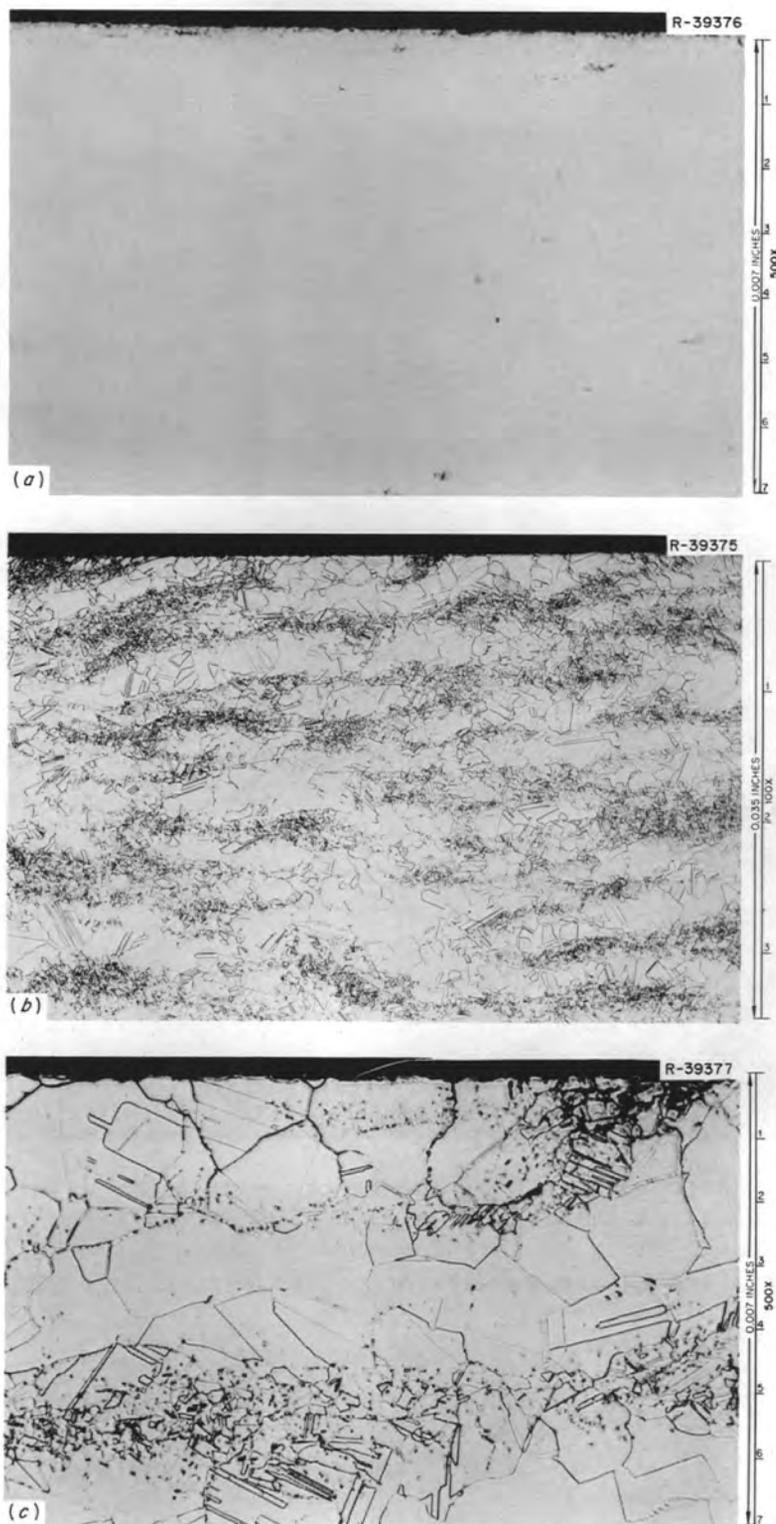
Fig. 14. Photomicrographs of Titanium-Modified INOR-8 (Heat 21545) Removed from the MSRE After 5554 hr above 500°C. Edge exposed to flowing salt. (a) As polished. 500x. (b) Etchant: aqua regia. 100x. (c) Etchant: aqua regia. 500x. Reduced 33%.

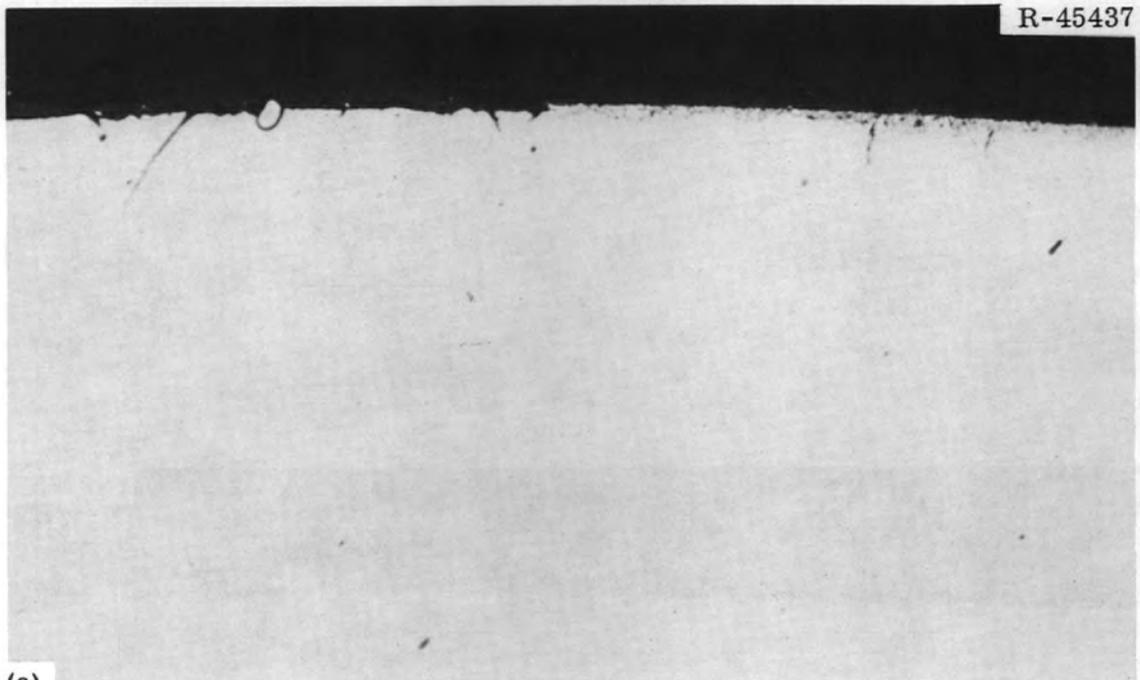
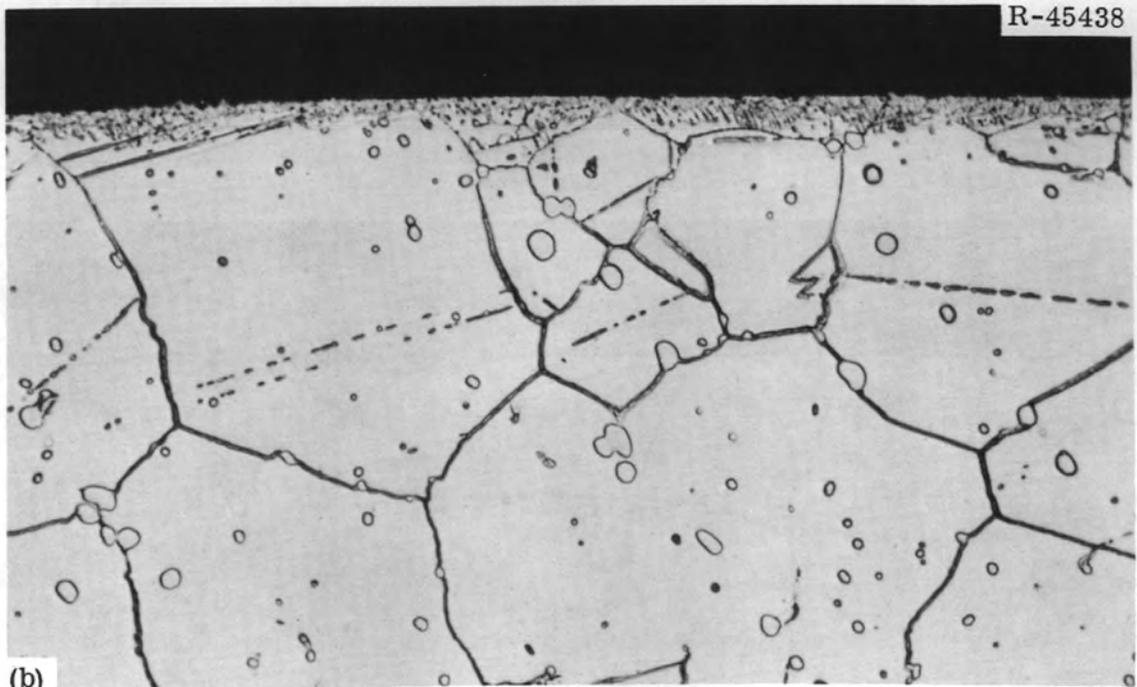
Stringers RR2, with the standard heats, had been exposed 2 to 4 times as long as the standard alloy specimens in the first group. (The factor depends upon which exposure index is used; see Table 3.) Effects of the longer exposure were evident in metallographic examinations of unstrained specimens. Figures 19 and 20 are of specimens of heats 5065 and 5085 exposed on stringer RR2 in the core. Some of the grain boundaries near the surface are visible in the as-polished condition, and a few appear to be opened as small cracks with a maximum visible depth of about 1 mil. The etched views show the large amounts of carbide precipitate that formed along the grain boundaries and the modified structure near the surface, which is thought to be due to working from machining. In samples of these heats exposed in the control facility, grain boundaries were not visible in as-polished samples. This is shown for heat 5065 in Fig. 21. As in the core specimens, however, etching brought out the carbide precipitate and the modified structure near the surface. The microstructure of control specimens of heat 5085 was quite similar.

Fig. 20. Photomicrographs of INOR-8 (Heat 5085) Surveillance Specimens Exposed to Fuel Salt for 11,933 hr above 500°C. 500x. Shallow reaction layer is seen near surface. (a) Unetched. (b) Etched (glyceria regia).

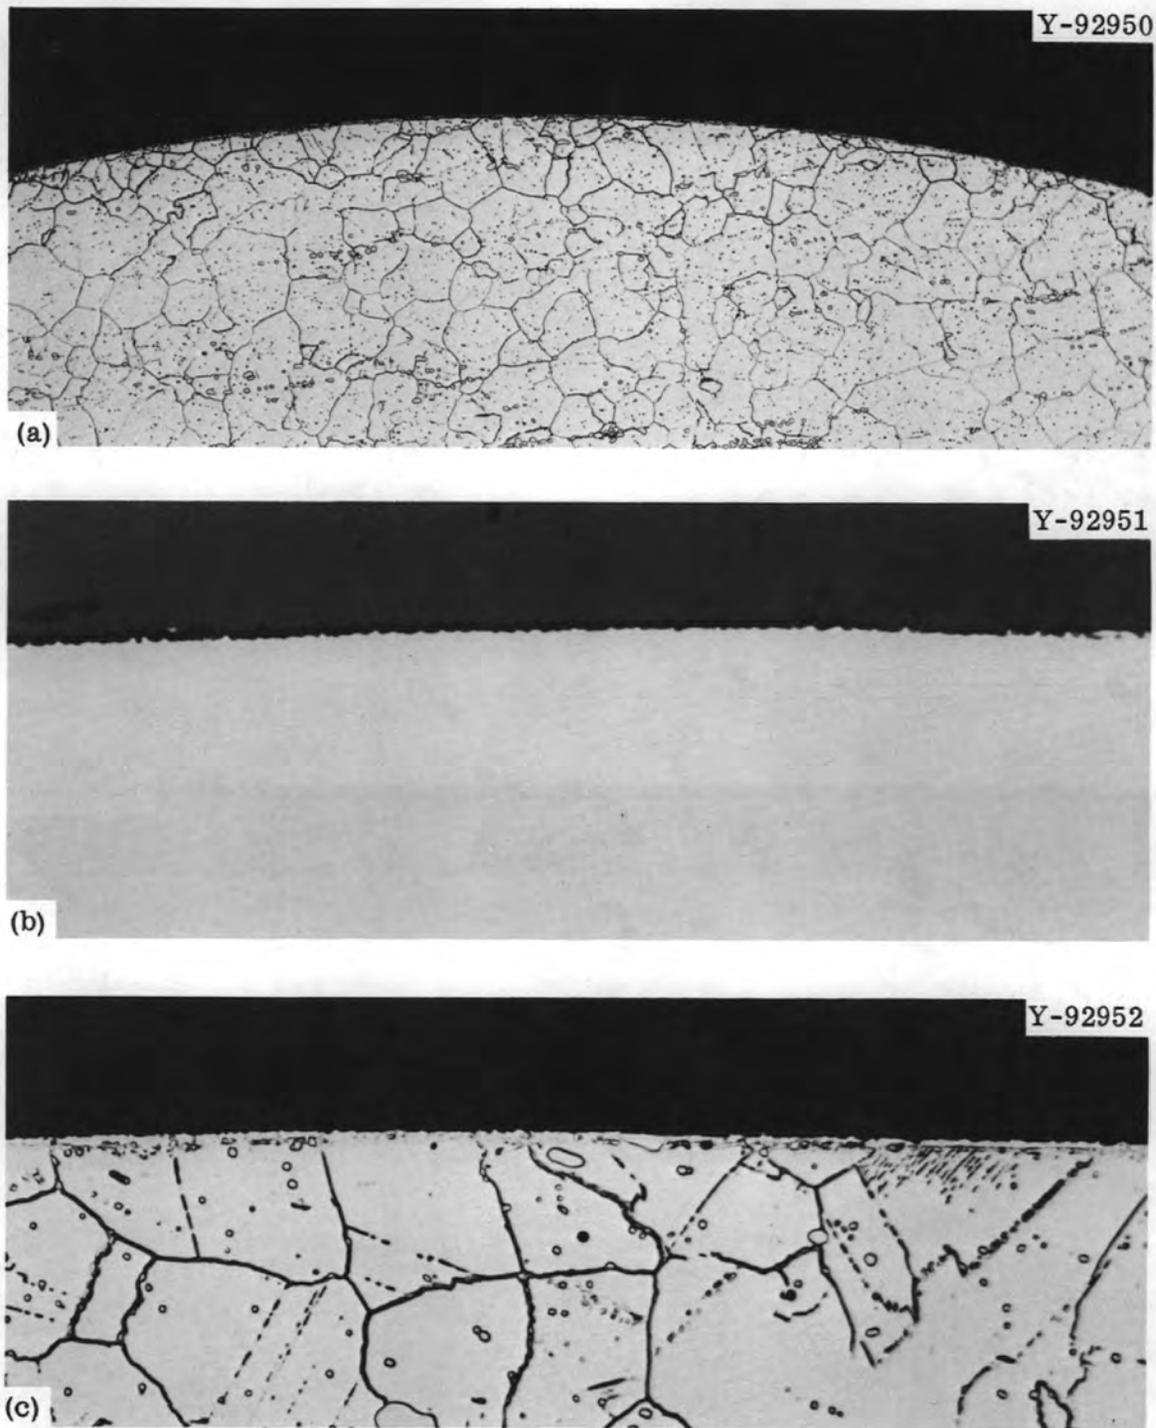
Fig. 21. Photomicrographs of INOR-8 (Heat 5065) Surveillance Control Specimens Exposed to Static Barren Fuel Salt for 11,933 hr above 900°C. Note the shallow reaction layer near the surface. (a) Etched. 100×. (b) As polished. 500×. (c) Etched. 500×. Etchant: glyceria regia.

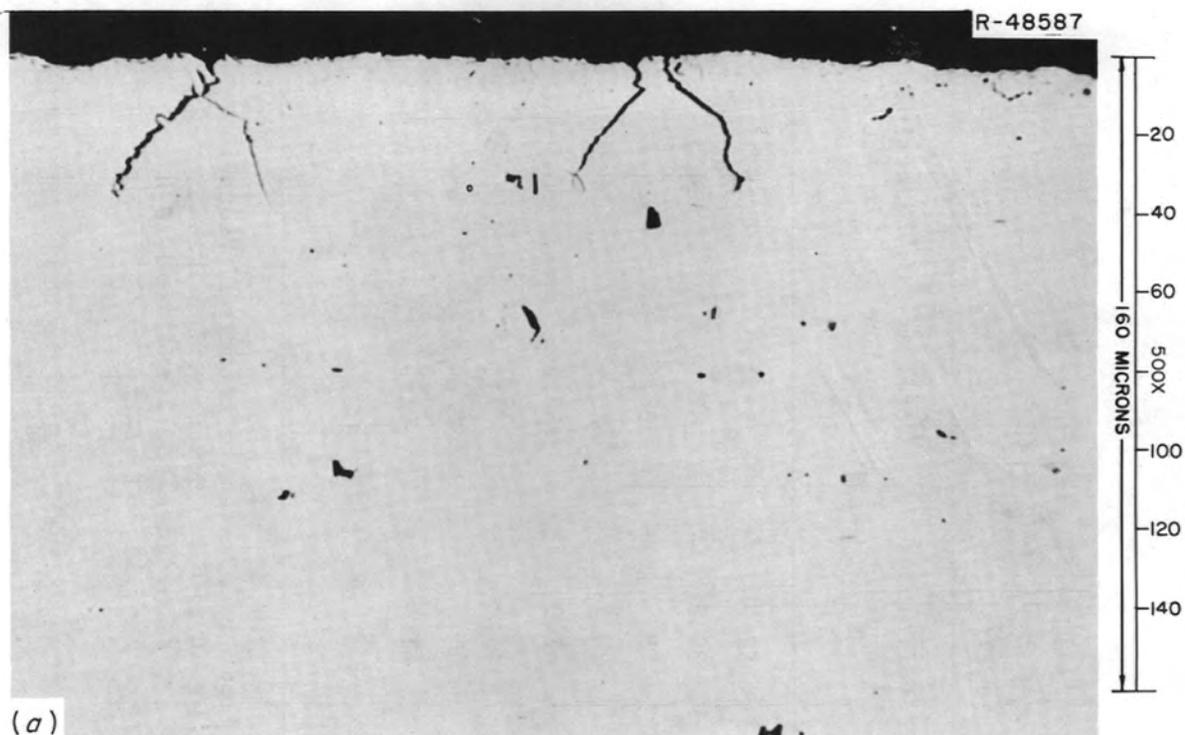
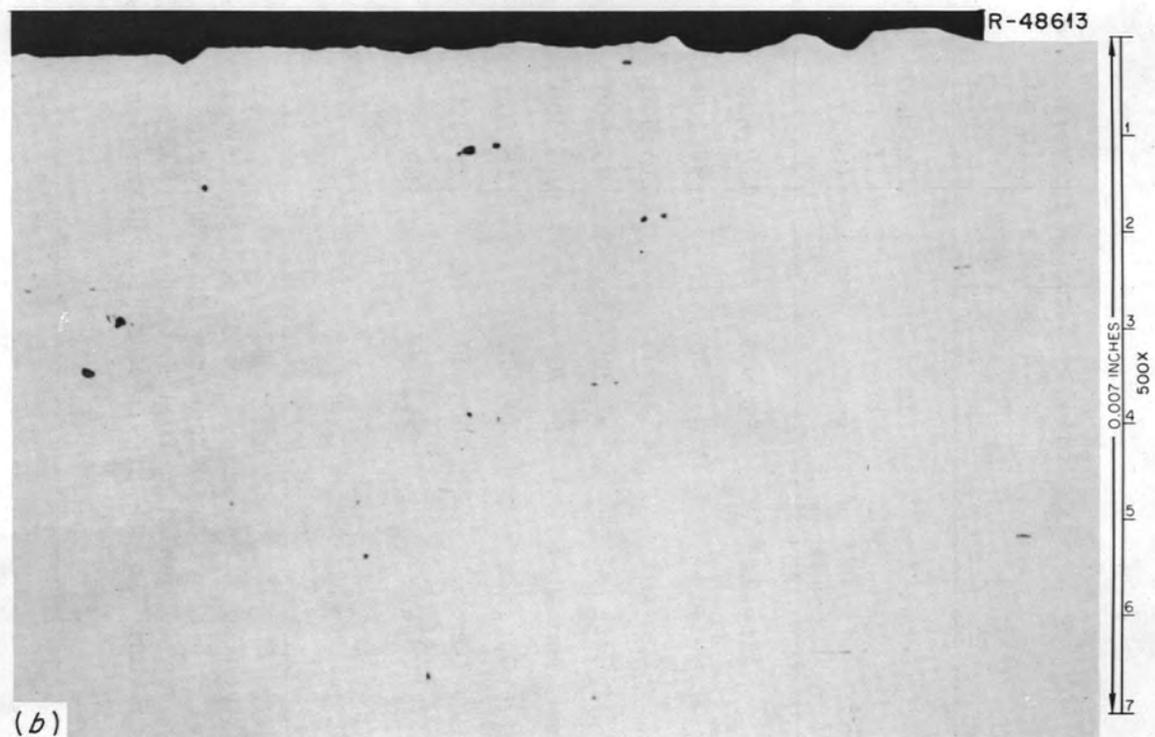
Cracking at the surface of unstrained material was even more evident in the examination of the straps that bound stringer RR2. These straps and those around the control stringer CR2 were of standard INOR-8 heat 5055. As shown in Fig. 22, the strap exposed in the core had cracks to a depth of about 1.5 mils. Cracks were distributed uniformly, both on surfaces exposed to flowing salt and those facing the graphite specimens. In contrast, the straps exposed in the control facility did not show any cracks. The straps after being formed, had been annealed for 1 hr at 1180°C and should not have been stressed thereafter since they expanded more at high temperature than did the graphite they enclosed.

Fig. 22. Photomicrographs of INOR-8 (Heat 5055) after Exposure to (a) the MSRE Core and (b) the MSRE Control Facility for 11,933 hr above 500°C. This material was used for straps for the surveillance assembly. As polished. 500x.

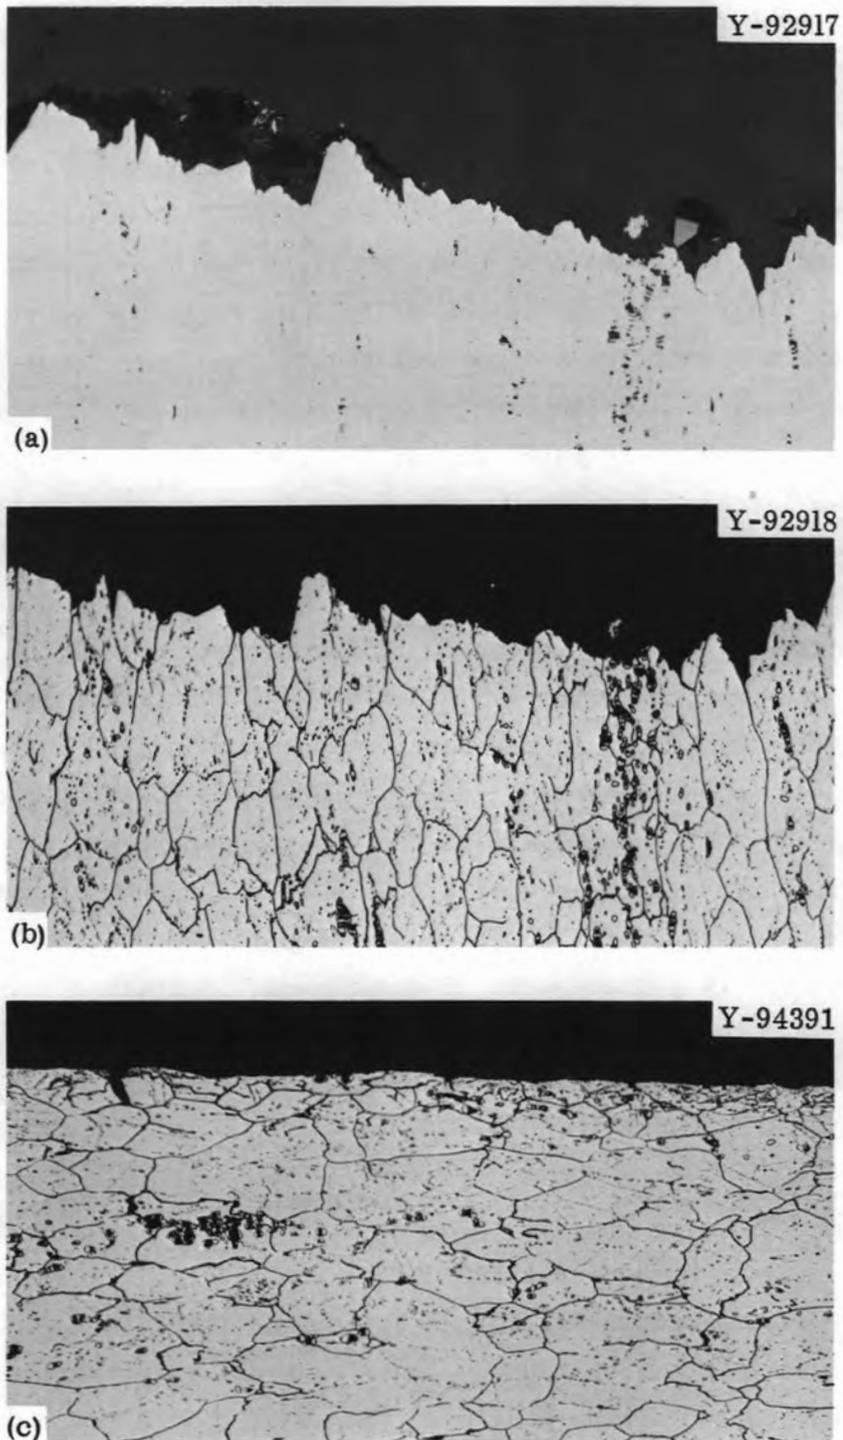
Microstructures of stressed samples of heat 5065 from the control facility and from the core are shown in Figs. 23 and 24, respectively. Numerous intergranular edge cracks are found in the sample from the core (Fig. 24) and very few in the sample from the control facility (Fig. 23). The fractures of both of these samples are largely intergranular at all locations and not just near the edge, which is further evidence that the reduction in fracture strain (Table 5) is due to carbide precipitation along the grain boundaries and not related to the intergranular cracking near the surface. Tested samples of heat 5085 from the control facility and the core are shown in Figs. 25 and 26, respectively. The as-polished views in the latter figure show some of the large carbide particles that fractured during testing.

Fig. 23. Photomicrographs of a INOR-8 (Heat 5065) Sample Exposed to Static Barren Fuel Salt for 11,933 hr above 500°C and Then Tested at 25°C and a Strain Rate of 0.05/min. 100×. (a) Fracture, as polished. (b) Fracture, etched. (c) Edge of stressed portion, etched. Etchant: glyceric acid.

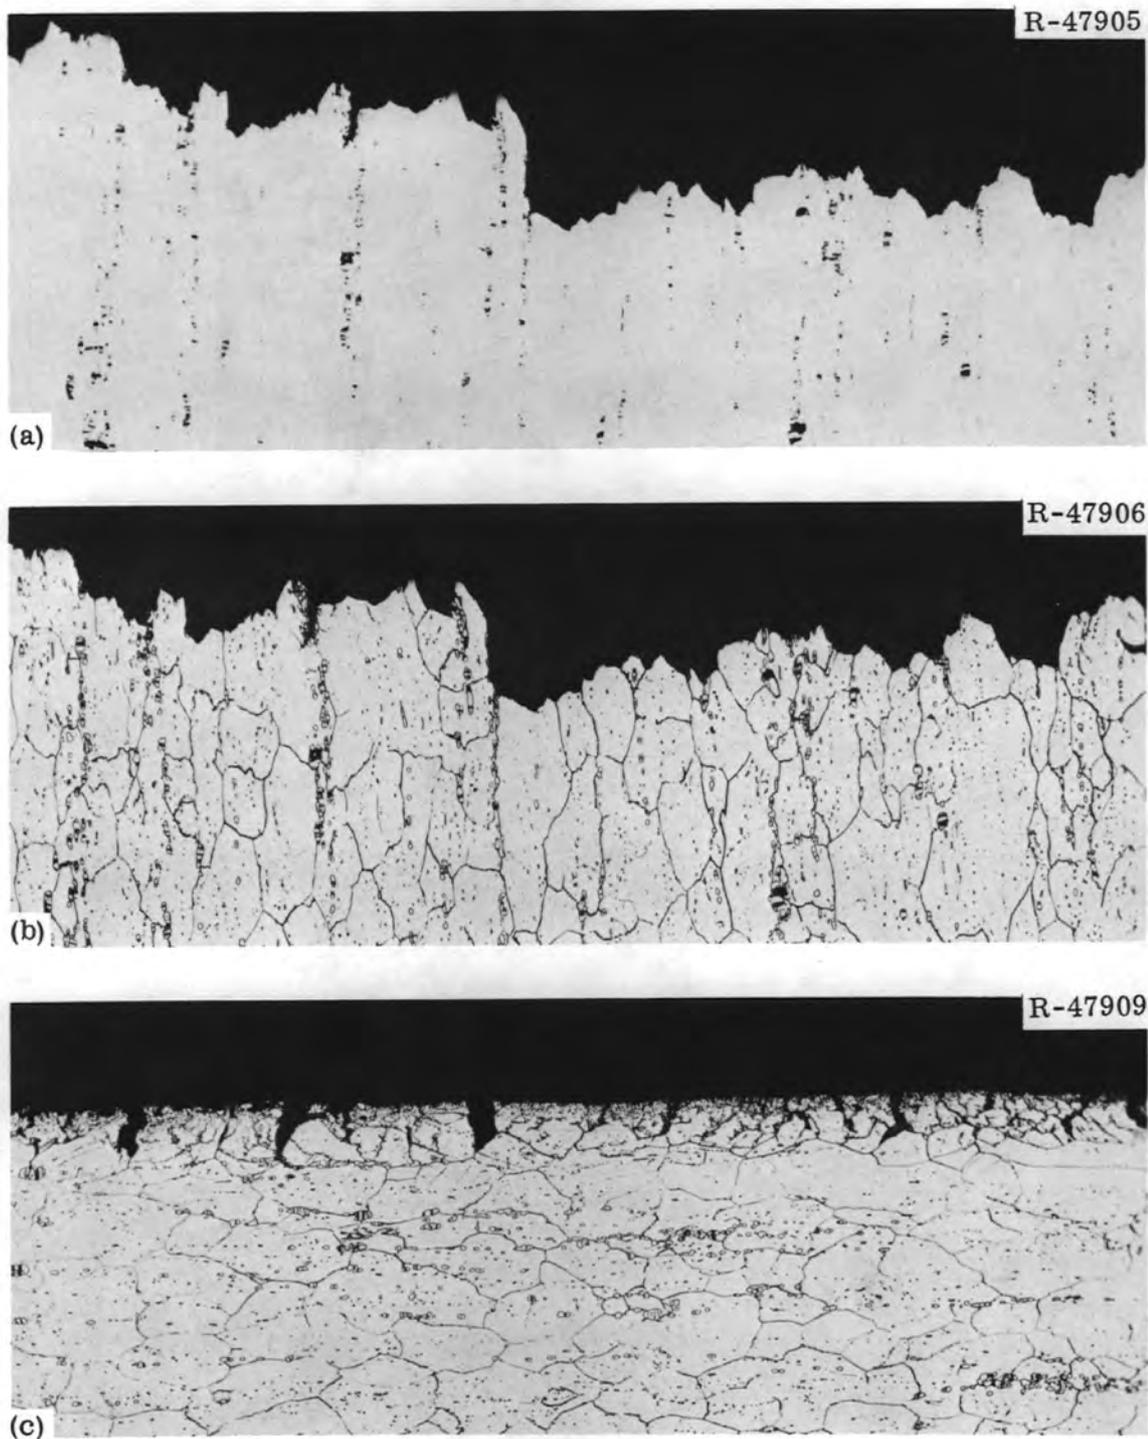
Fig. 24. Photomicrographs of INOR-8 (Heat 5065) Sample Exposed to Fluoride Salt in the MSRE for 11,933 hr above 500°C and Then Tested at 25°C and a Strain Rate of 0.05/min. Thermal fluence was 9.4×10^{20} neutrons/cm². 100x. (a) Fracture, as polished. (b) Fracture, etched. (c) Edge of stressed portion. Etchant: aqua regia.

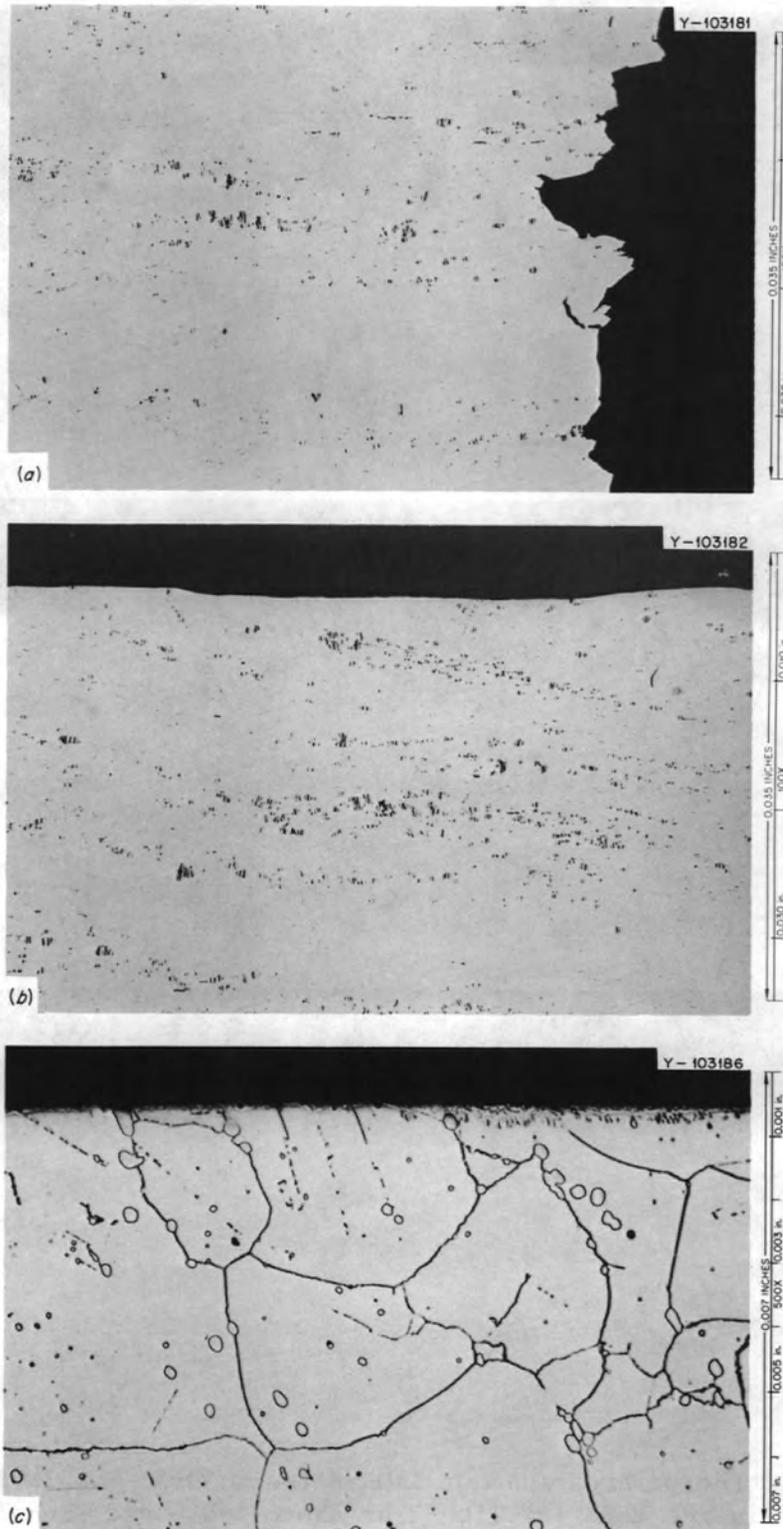
Fig. 25. Photomicrographs of INOR-8 (Heat 5085) Specimen Exposed to Depleted Static Fuel Salt for 11,933 hr at 650° and Strained at 25°C. (a) Fracture, as polished, (b) typical edge of gage section, as polished, (c) typical unstressed edge, etched with glyceria regia.

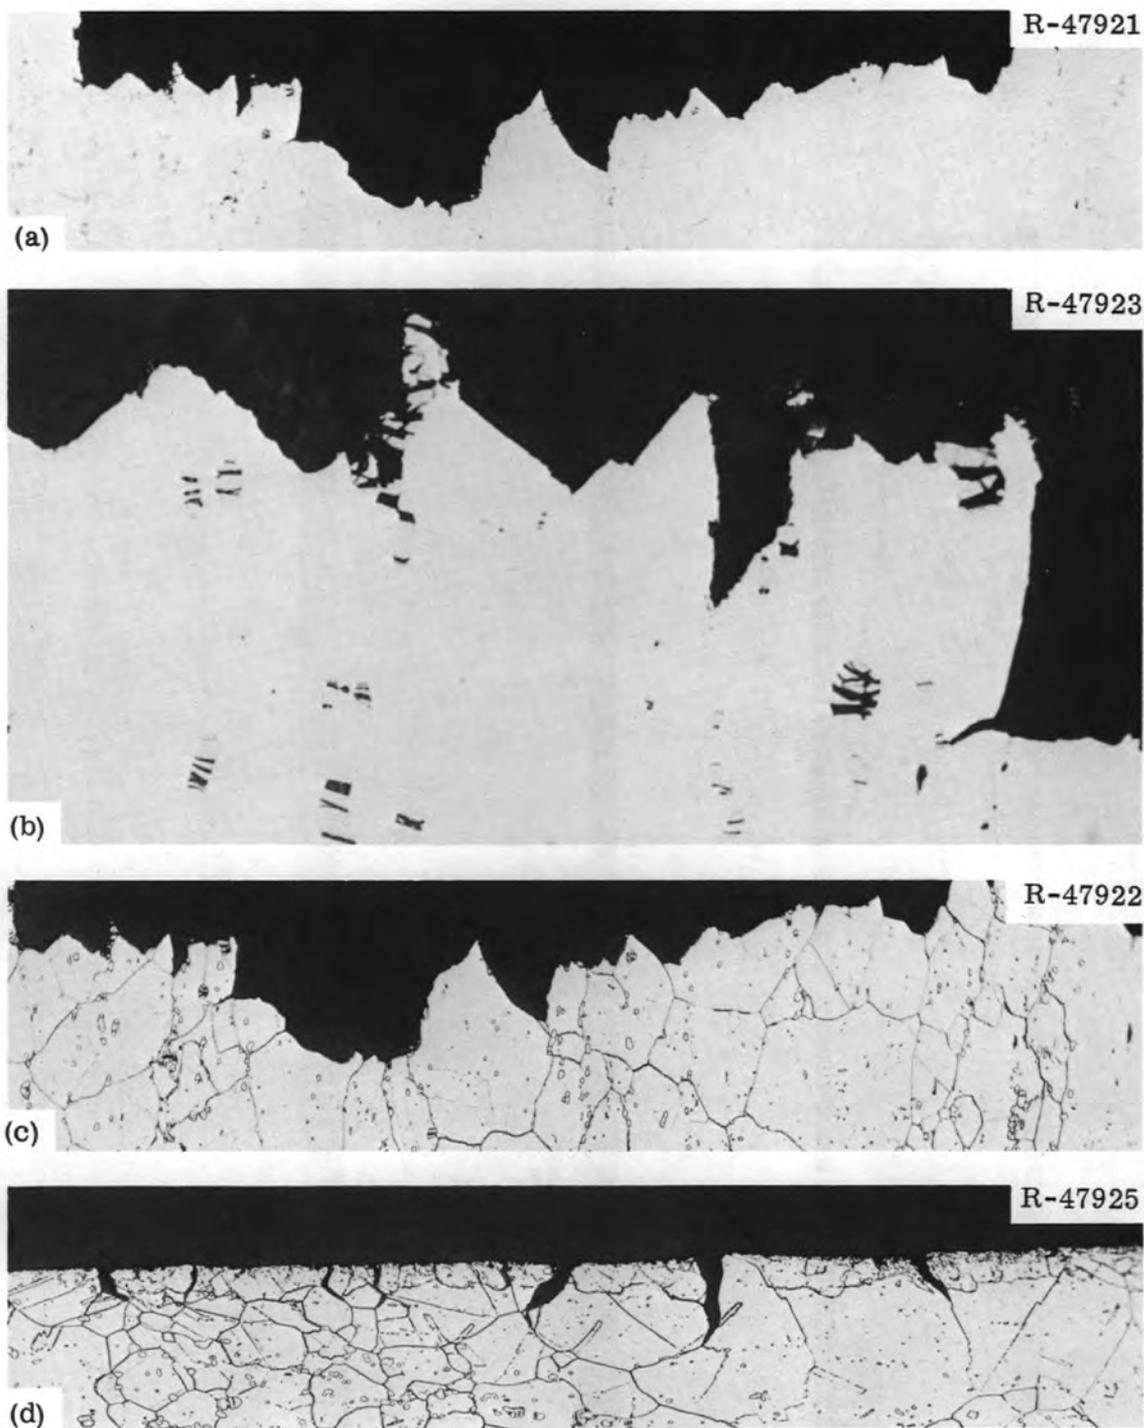
Fig. 26. Photomicrographs of INOR-8 (Heat 5085) Sample Exposed to Fluoride Salt in the MSRE for 11,933 hr above 500°C and then Tested at 25°C. Thermal fluence was 9.4×10^{20} neutrons/cm². (a) Fracture, as polished. 100x. (b) Fracture, as polished. 500x. (c) Fracture, etched. 100x. (d) Edge of stressed portion, etched. 100x. Etchant: aqua regia.

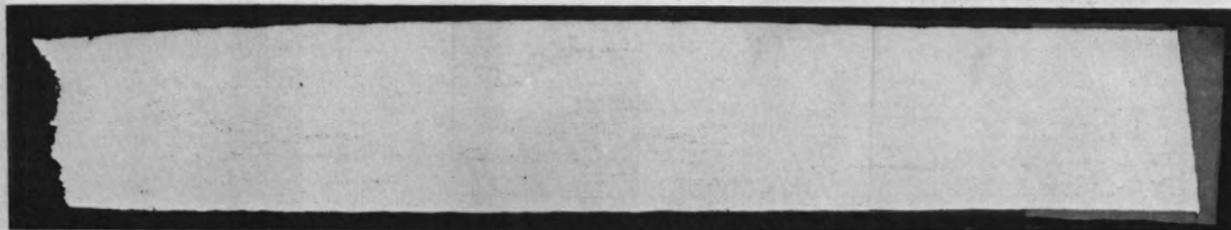
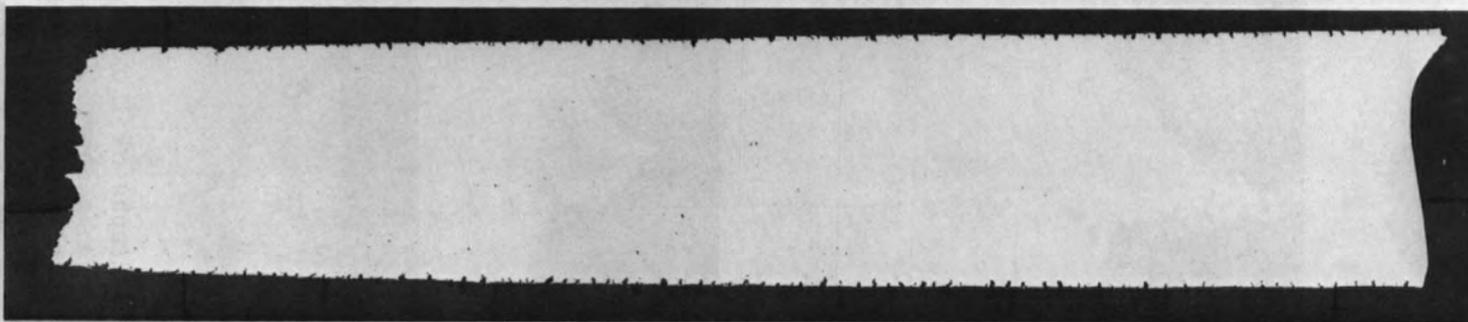
PHOTO 2695-71

The samples that were fractured at 25°C were repolished at a later date, one-half of each fractured sample was photographed. The composite microstructures for heat 5065 are shown in Fig. 27. There are obviously more intergranular cracks in the sample exposed to the core than in the sample exposed in the control facility. There were 3 cracks per inch with an average depth of 1.0 mil in the control sample and 230 cracks per inch with an average depth of 1.8 mils in the sample from the core. A composite photograph of the tested portions of the heat 5085 sample is shown in Fig. 28. There were 134 cracks per inch along the edge of the sample from the core with an average depth of 1.9 mils. None were visible along the edge of the control specimen.

Fig. 27. Sections of Heat 5065 Tested at 25°C After Exposure to Fuel Salt for 11,933 hr above 500°C. Diameters of specimens are about 0.1 in. The fractures are on the left end.

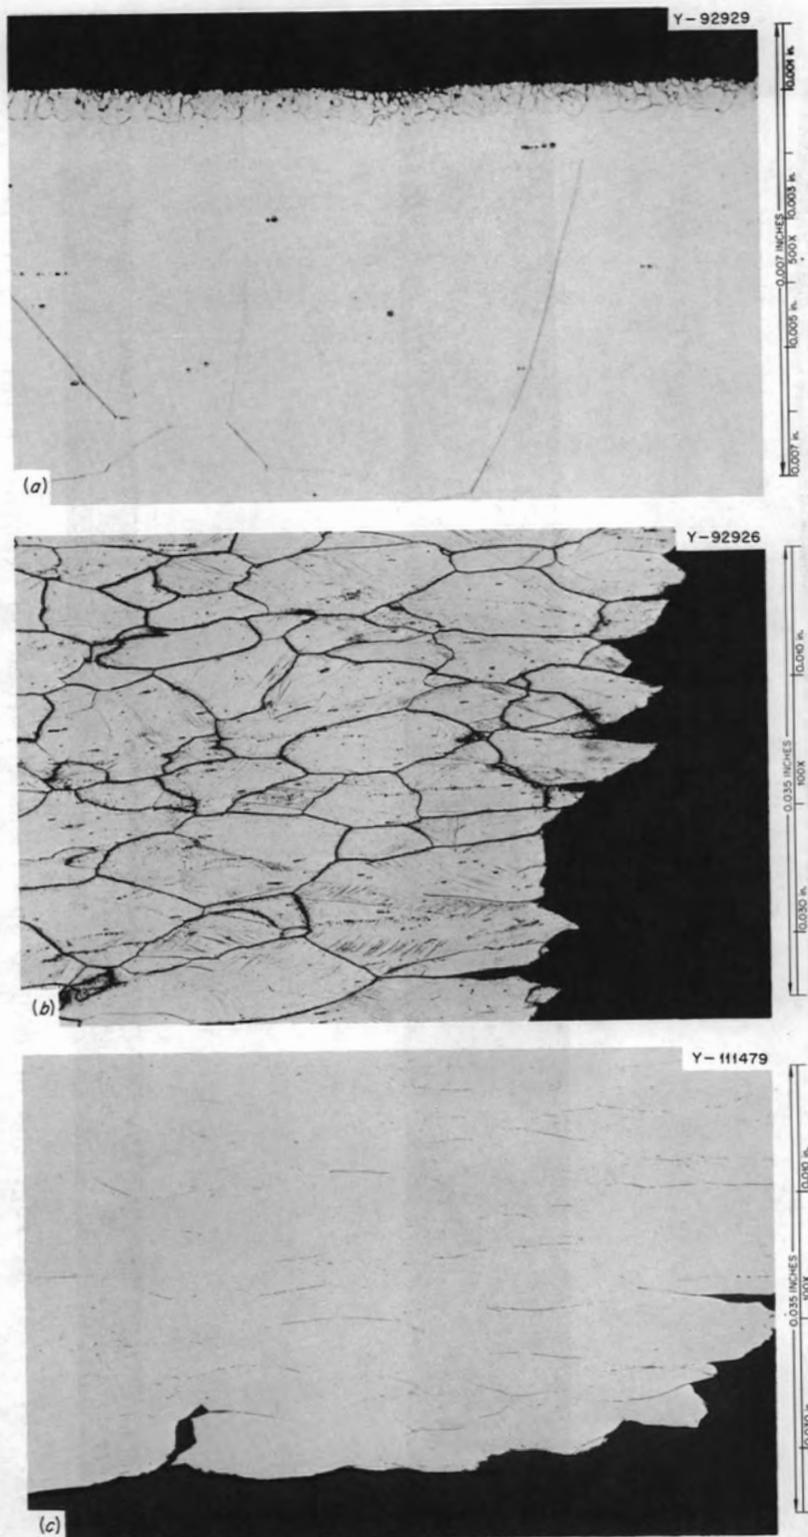
Figures 29 and 30 are photomicrographs of strained specimens of heat 67-502 (modified with 0.49% Ti and 2.15% W and containing 0.04% Fe). The specimen exposed in the control facility (Fig. 29) has its edges

Fig. 29. Photomicrographs of Alloy 67-502 (see Table 1) Exposed to Depleted Fuel Salt for 6379 hr Above 500°C and Tested at 25°C. (a) Edge of unstressed portion, (b) Fracture, (c) Edge of stressed portion. Figs (a) and (c) etched lightly. Fig. (b) etched more heavily with glyceria regia.

coated with small crystals of almost pure iron. (The control facility was constructed of material containing 4 to 5% Fe, so the transfer of Fe to an alloy that contained only 0.04% Fe is quite reasonable.) The sample strained 55% before fracture, and the fracture was mixed transgranular and intergranular. The edge was uneven from the large deformation, but there were very few intergranular separations. The sample from the core (Fig. 30) deformed almost as much (52%) before fracturing. In contrast to the control specimen, edge cracking occurred at almost every grain boundary. The cracks generally extended to a depth of about 5 mils, with the maximum depth being about 7 mils. However, as shown in the view of the fracture, this material tended to crack intergranularly and these internal cracks may have in some cases linked together with the surface cracks to make them extend deeper.

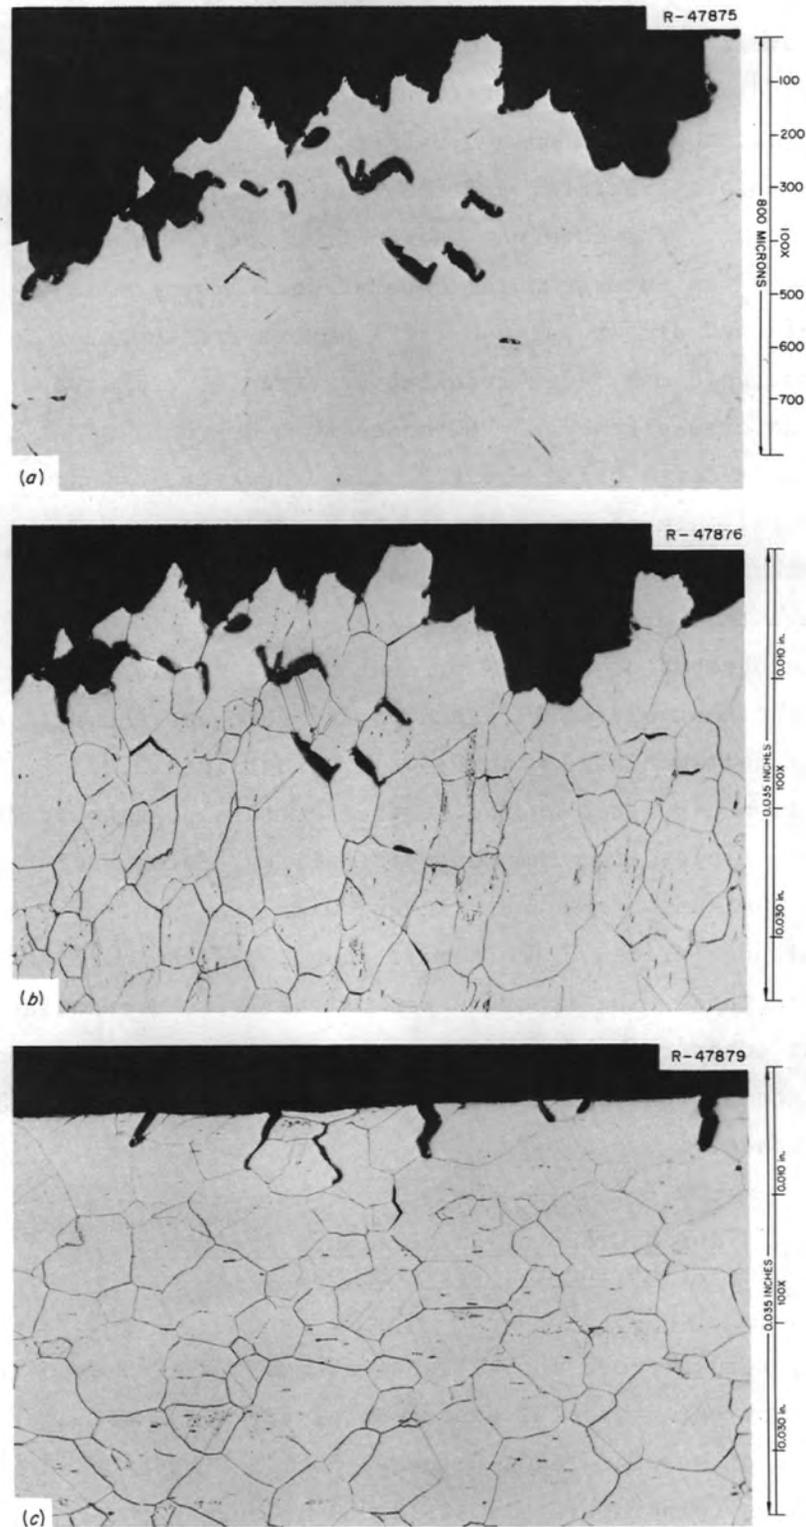
Fig. 30. Photomicrographs of Alloy 67-502 Sample Exposed to Fluoride Salt in the MSRE for 6379 hr Above 500°C and then Tested at 25°C. 100X. (a) Fracture, as polished. (b) Fracture, etched. (c) Edge of stressed portion, etched. Etchant: aqua regia. Reduced 33%.

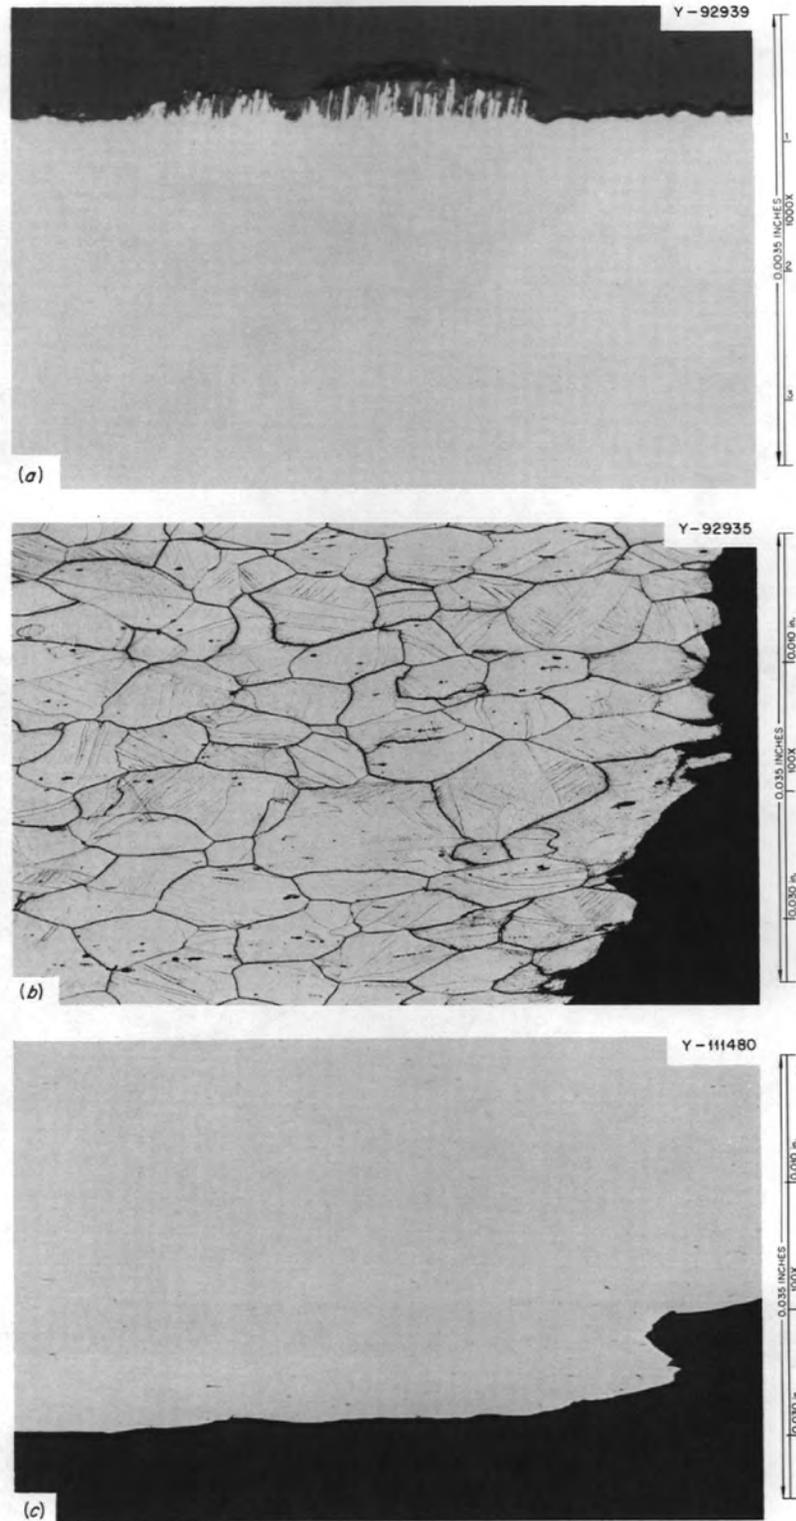
Photomicrographs of samples of heat 67-504 tested at 25°C after exposure in the control facility and in the core are shown in Figs. 31 and 32. This heat modified with 0.50% Hf, contained 0.07% Fe. As shown in Fig. 31, iron deposited on the surface of this heat as it did on 67-502. This sample, from the control facility, deformed 55% before failing with a mixed inter- and transgranular fracture. There were no intergranular edge cracks. The sample exposed in the core deformed 52% before fracture. The fracture was primarily transgranular but there were frequent edge cracks (Fig. 32). Most boundaries were cracked, but the cracks extended only to a depth of about 2 mils in the fields that were photographed.

Fig. 31. Photomicrographs of Alloy 67-504 (see Table 1) Exposed to Depleted Fuel Salt for 6379 hr Above 500°C and Tested at 25°C. (a) Edge of unstressed portion, (b) Fracture, (c) Edge of stressed portion. Figs (a) and (c) as-polished and Fig. (b) etched with glyceria regia. Reduced 33.5%.

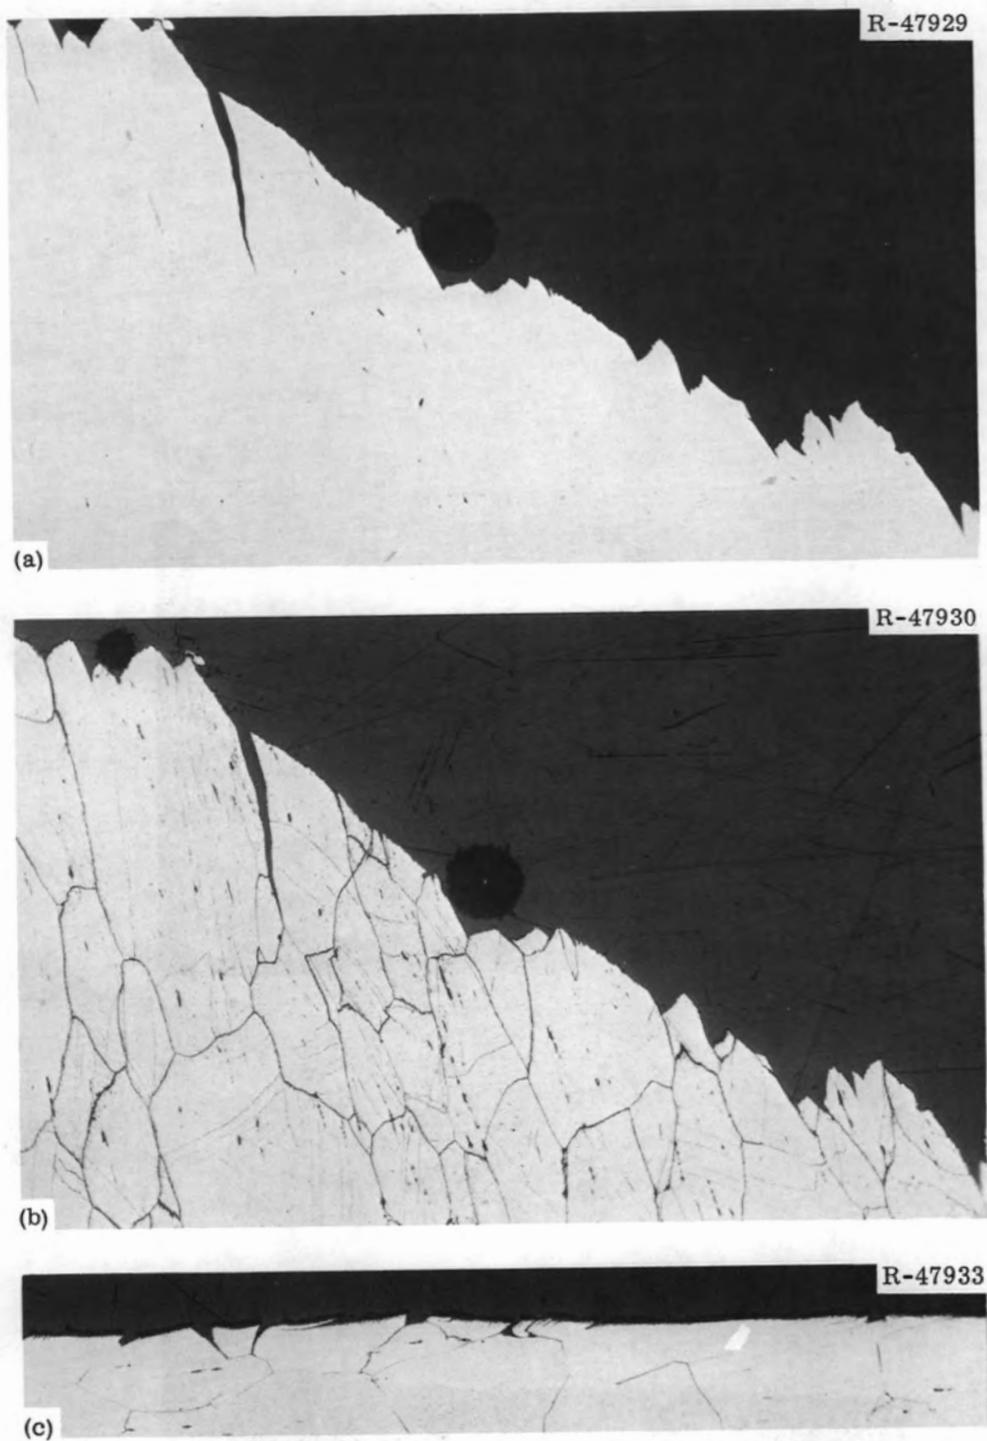
Fig. 32. Photomicrographs of INOR-8 (Heat 67-504) Sample Exposed to Fluoride Salt in the MSRE for 6379 hr Above 500°C and Tested at 25°C. 100x. (a) Fracture, as polished. (b) Fracture, etched. (c) Edge of Stressed portion, etched. Etchant: aqua regia. Reduced 14%.
