INTERGRANULAR CRACKING OF INOR-8 IN THE MSRE

H. E. McCoy

NOVEMBER 1972

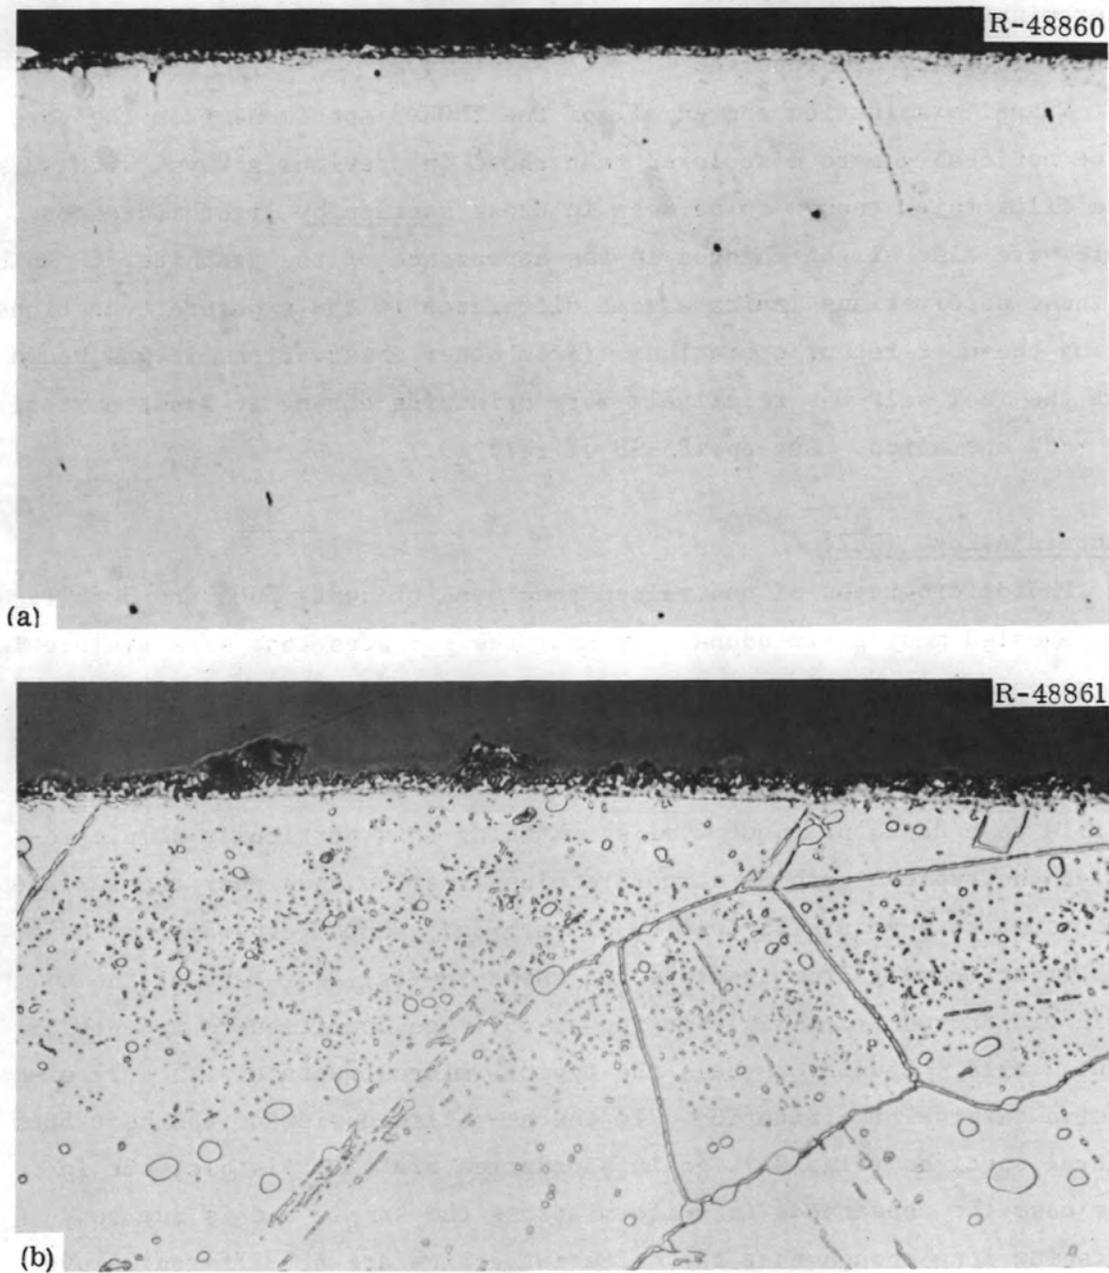
Photomicrographs of unstrained specimens of heats 5065 and 5085 from RL2 revealed many grain boundaries near the surfaces that were visible in the as-polished condition. The view of a specimen of heat 5065 in the as-polished condition, (Fig. 33) shows a thin surface layer (believed to be the cause of the visible discoloration) and some grain boundaries visible to a depth of about 2 mils. Etching this particular sample revealed the typical carbide structure plus a narrow band near the surface that seems to have a high density of carbide. Photomicrographs of heat 5085 after removal from the core are shown in Fig. 34. Many of the grain boundaries are visible in the as-polished condition to a depth of about 2 mils. Etching reveals the typical microstructure with very extensive carbide precipitation. In the as-polished view of the heat 5065 control specimen (Fig. 35), grain boundaries are also visible, but in this case the appearance is uniform across the sample and is due to polishing long enough that the different grains are at different elevations. Etching reveals the shallow surface modification and the typical carbide structure. The heat 5085 specimen from the control facility, shown in Fig. 36, was also slightly overpolished so that the grains are visible in the as-polished condition. Etching revealed the typical microstructure and the shallow surface modification.

Fig. 33. Typical Photomicrographs of INOR-8 (Heat 5065) Exposed to the MSRE Core for 19,136 hr Above 500°C. (a) As polished. (b) Etchant: aqua regia. 500x.

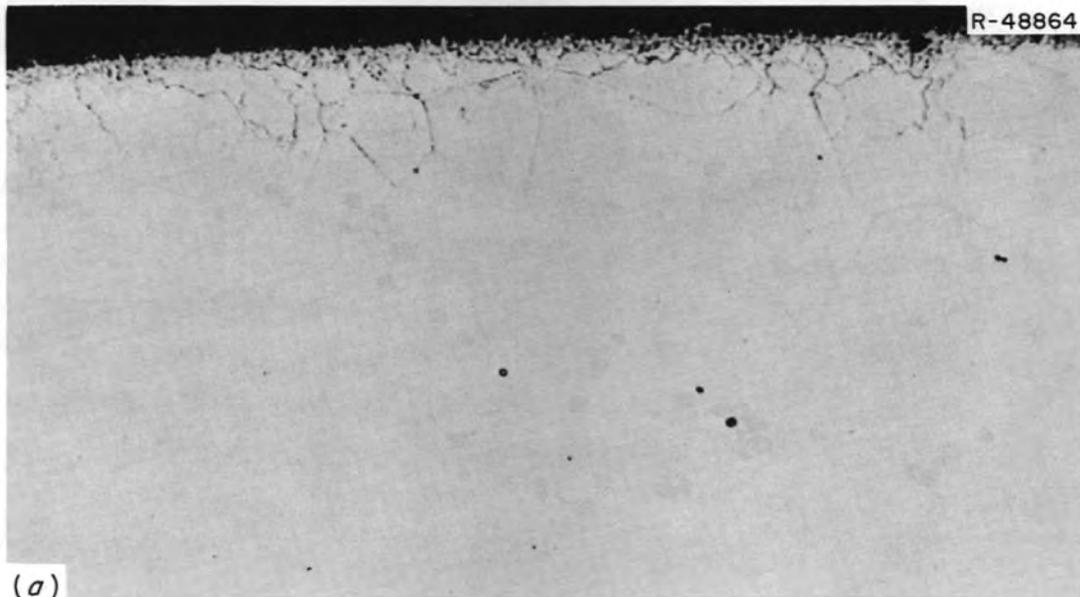
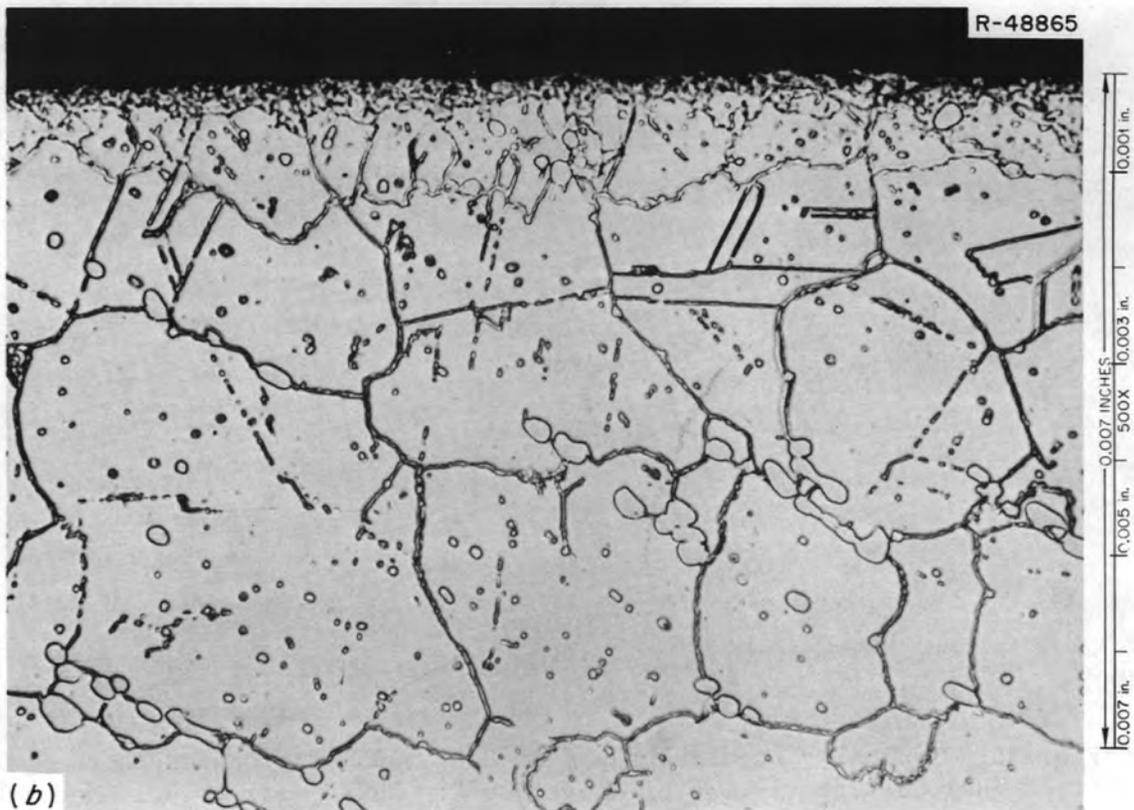
Fig. 34. Typical Photomicrographs of INOR-8 (Heat 5085) Exposed to the MSRE Core for 19,136 hr Above 500°C. (a) As polished. (b) Etchant: glyceria regia. 500x.

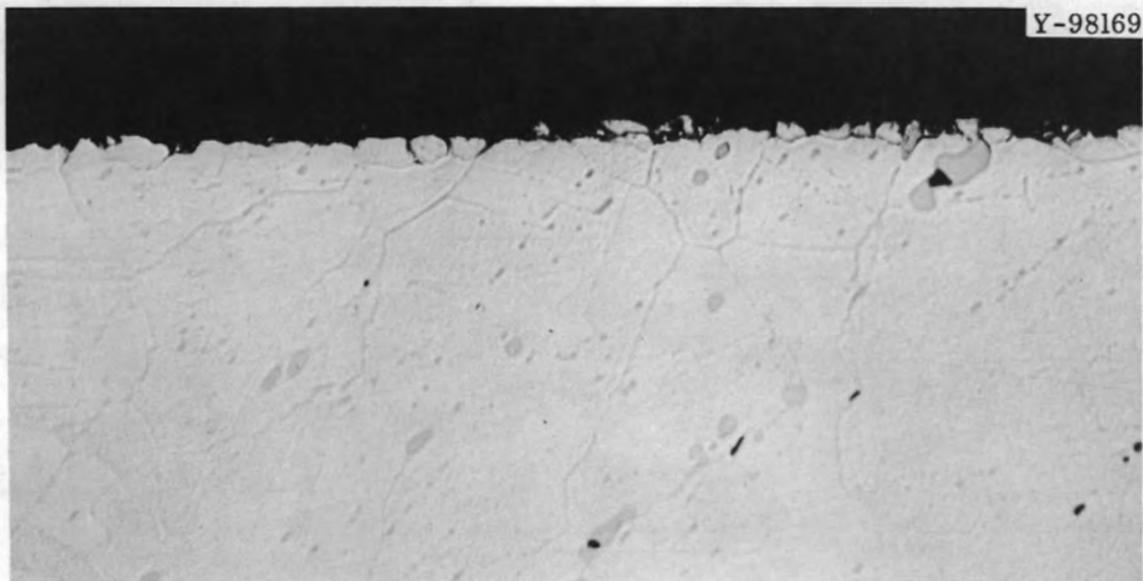
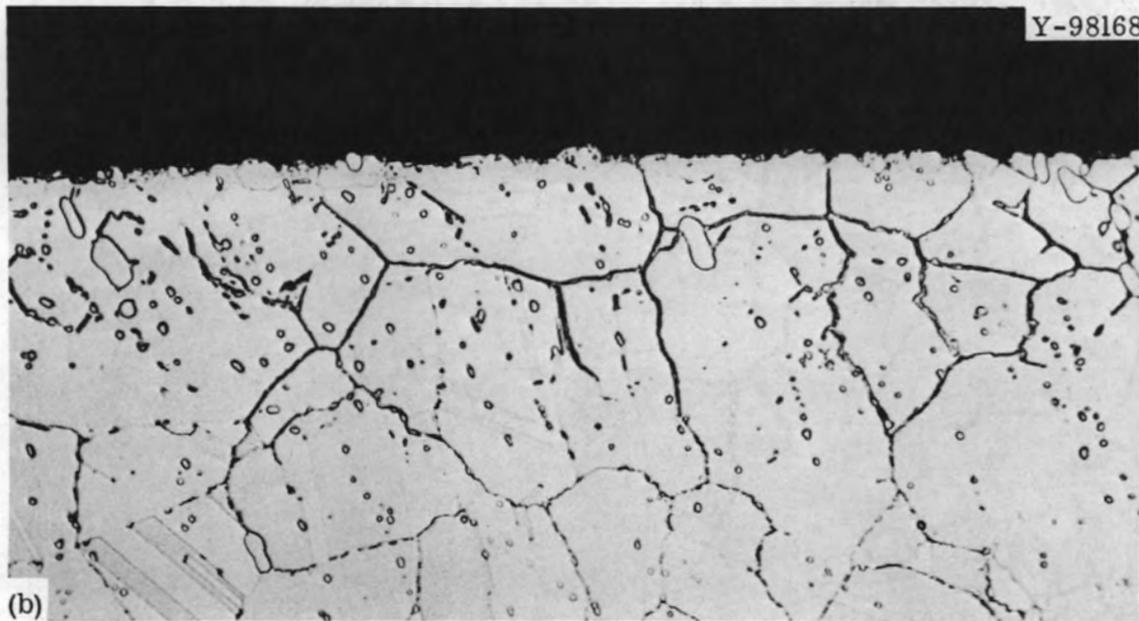
Fig. 35. Typical Photomicrographs of Heat 5065 After Exposure to Static Unenriched Fuel Salt for 19,136 hr Above 500°C. 500x. (a) As polished. (b) Etchant: glyceria regia.

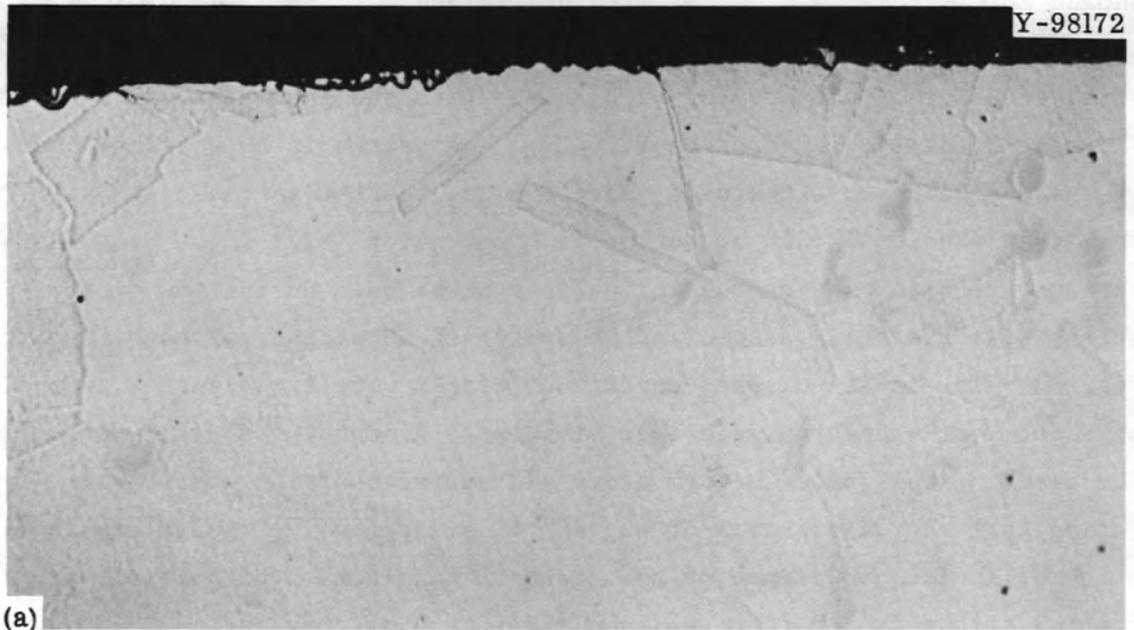
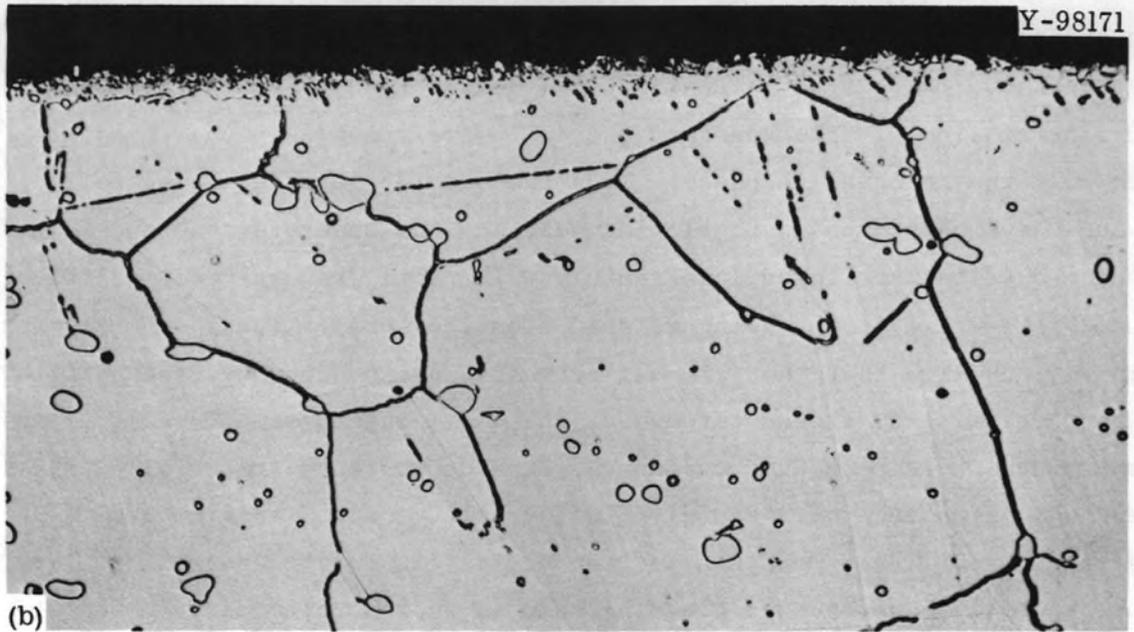
Fig. 36. Typical Photomicrographs of Heat 5085 After Exposure to Static Unenriched Fuel Salt for 19,136 hr above 500°C. 500x. (a) As polished. (b) Etchant: glyceria regia.

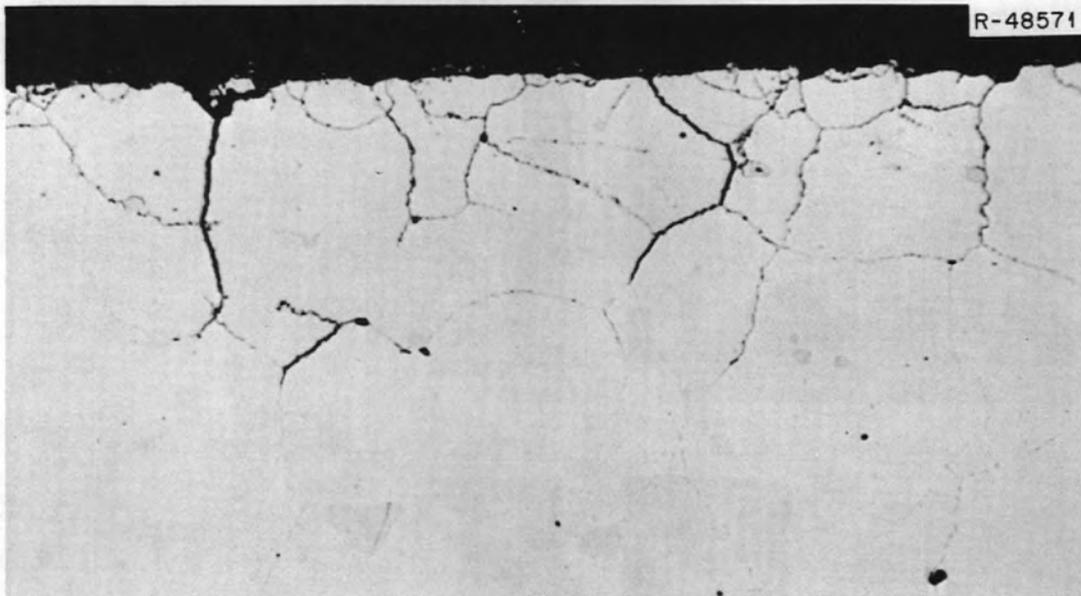
As in the previous set of core specimens, the straps of heat 5055 showed more cracks in the nominally unstrained condition than did the tensile specimens on the same stringer. A section of a strap from stringer RL2 that had been exposed, along with the specimens shown in Figures 33 and 34, is shown in Fig. 37. The cracks in this as-polished view are visible to a depth of about 3 mils, about twice as deep as in the strap exposed 12,000 hr during ^{235}U operation (Fig. 22). Heat 5055 straps were also used on the stringers exposed only during the ^{233}U operation (7200 hr). A specimen of one of these straps is shown in Fig. 38. In the as-polished condition, cracks were visible to a depth of about 1 mil; etching made them visible to a depth of about 3 mils. The cracking was quite uniform along all surfaces of the straps, indicating that the deformation of the 20-mil straps during removal was not a factor in the appearance of the cracks. Examination of unirradiated control straps failed to reveal a similar type of cracking.

Fig. 37. Typical Microstructure of INOR-8 (Heat 5055) After Exposure to the MSRE Core for 19,136 hr Above 500°C. This material was used for straps for the surveillance assembly. As polished. 500x.

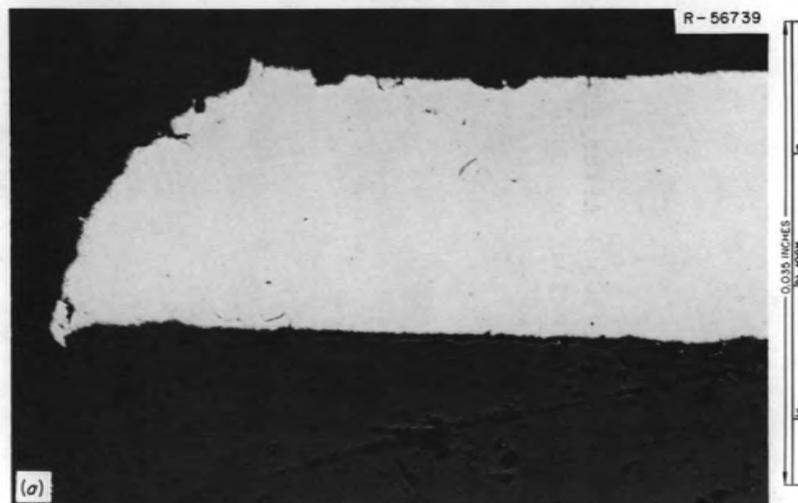
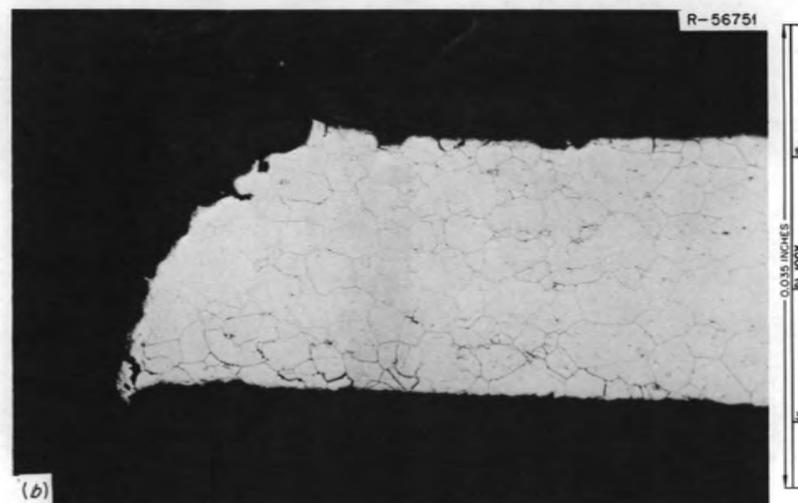
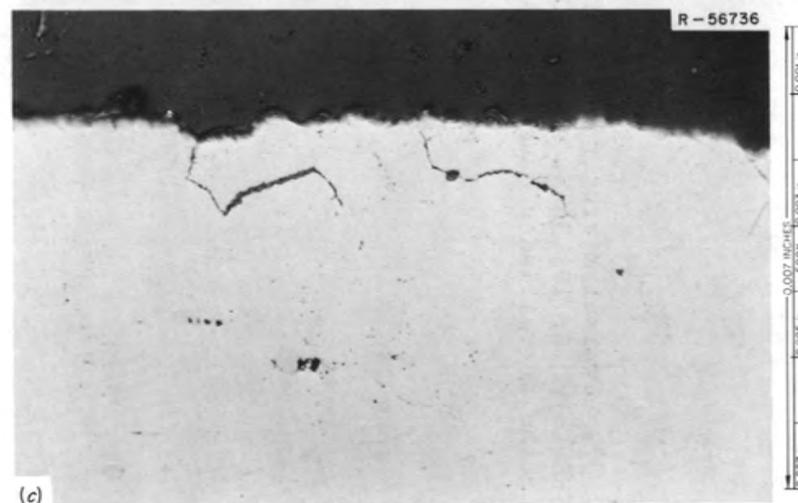
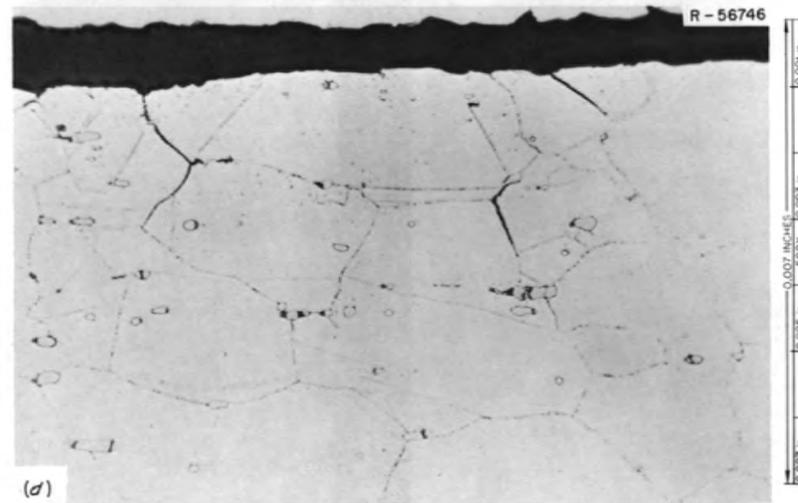
One other interesting specimen that showed extensive cracking was a piece of thin INOR-8 sheet (heat 5075) that had been attached to the strap shown in Fig. 38. The sheet had been rolled to 4 mils and annealed 0.5 hr at 1180°C. The edges of the foil were wrapped around the strap to hold the material in place. Thus the outside surface of the foil would have been exposed to flowing salt and the underside and the folded ends to salt that flowed less rapidly. The foil was extremely brittle and broke while it was being removed from the strap. The photomicrographs in Fig. 39 show that the foil had extensive grain boundary cracks, with many appearing to extend throughout the 4 mil thickness. In some areas the cracks were more numerous on the outside where the material was curved and was in contact with rapidly flowing salt. Photomicrographs of a strap and foil that were exposed to static salt in the control facility are shown in Figs. 40 and 41. The samples showed no evidence of intergranular cracking.

Fig. 38. Photomicrographs of INOR-8 (Heat 5055) Strap Exposed to the MSRE Core 7203 hr above 500°C. (a) As-polished view near cut (b) Etched view near cut (c) As polished view of outside edge (d) Etched view of outside edge. Etchant: Lactic acid, HNO₃, HCl. Reduced 32%.

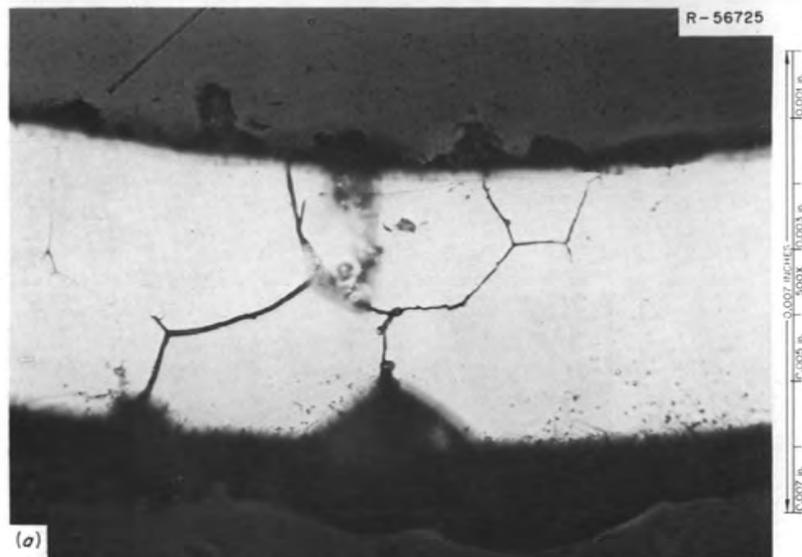
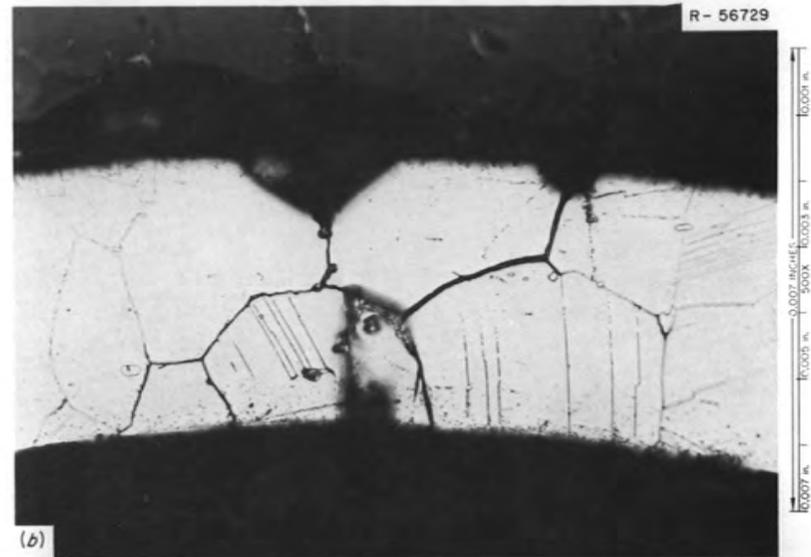
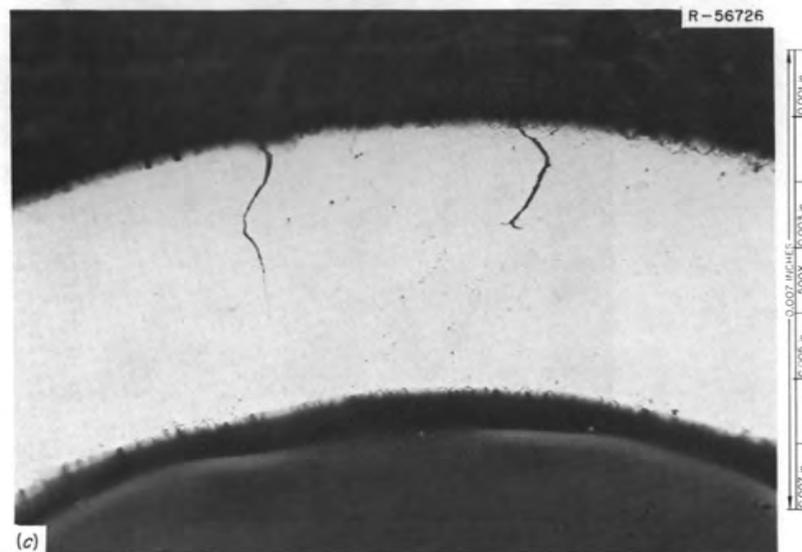
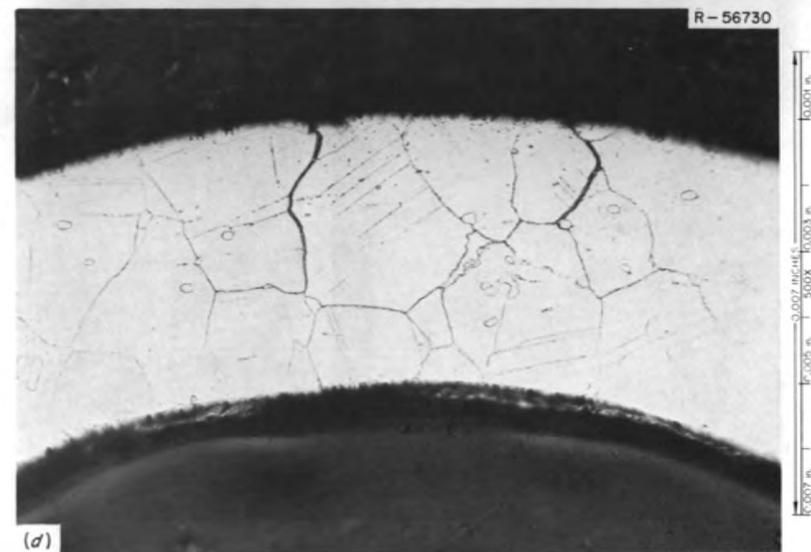
Fig. 39. Photomicrographs of Two Specimens From a Thin INOR-8 (Heat 5075) Foil that was Attached to the Strap Shown in the Previous Figure. The curvature was caused by forming before being inserted into the MSRE. (a) As polished (b) Etched (c) As polished (d) Etched. Etchant: Lactic acid, HNO_3 , HCl . Reduced 32%.

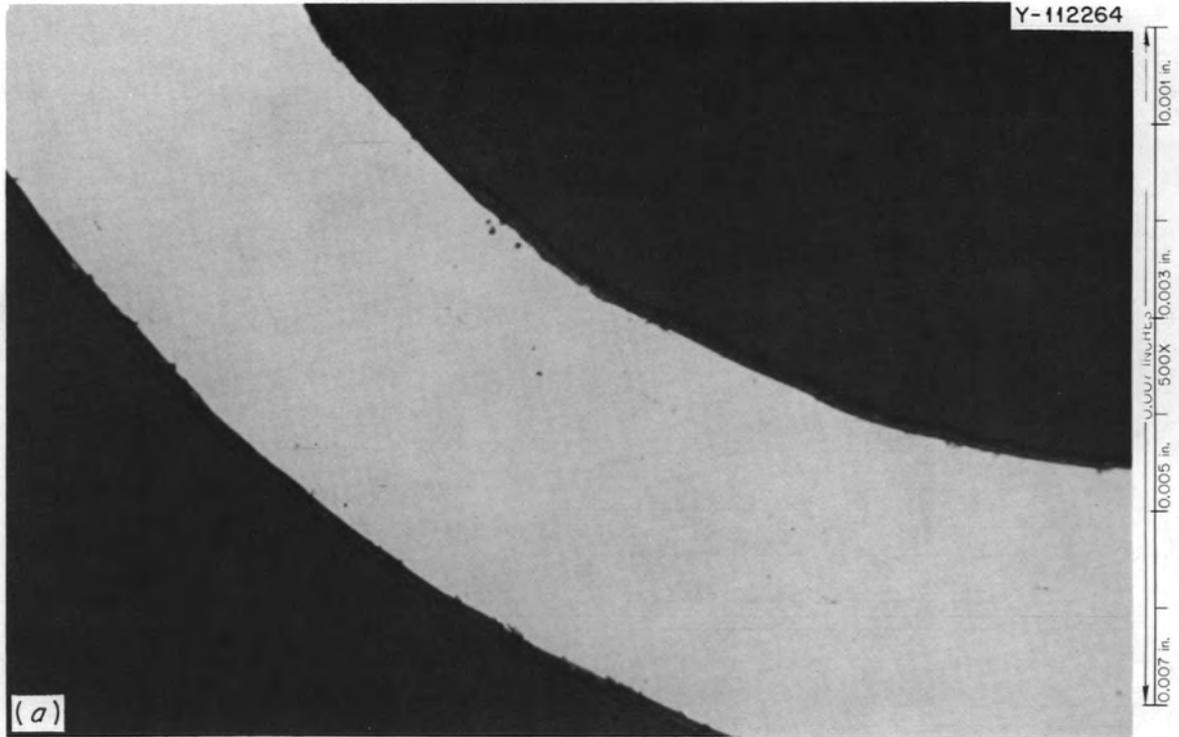
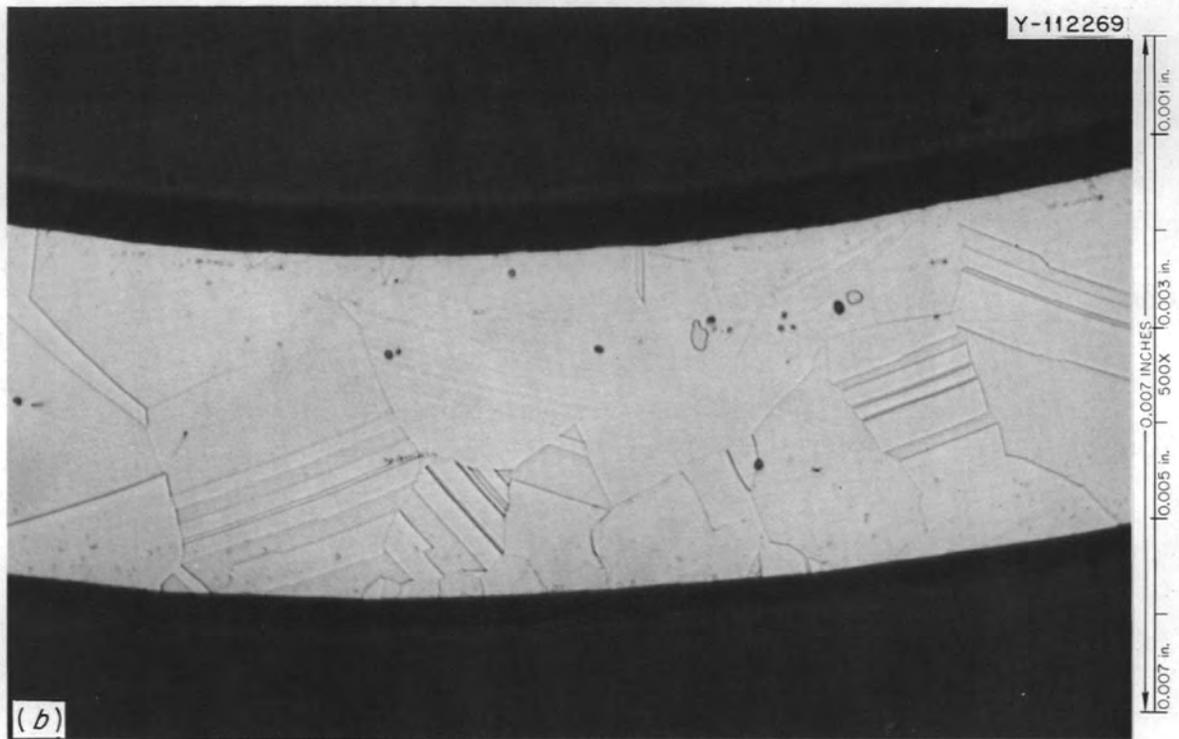
Fig. 41. Photomicrographs of a Thin INOR-8 (Heat 5075) Foil that was attached to the strap shown in the Previous Figure. (a) As Polished, (b) Etched with glyceria regia. 500x.

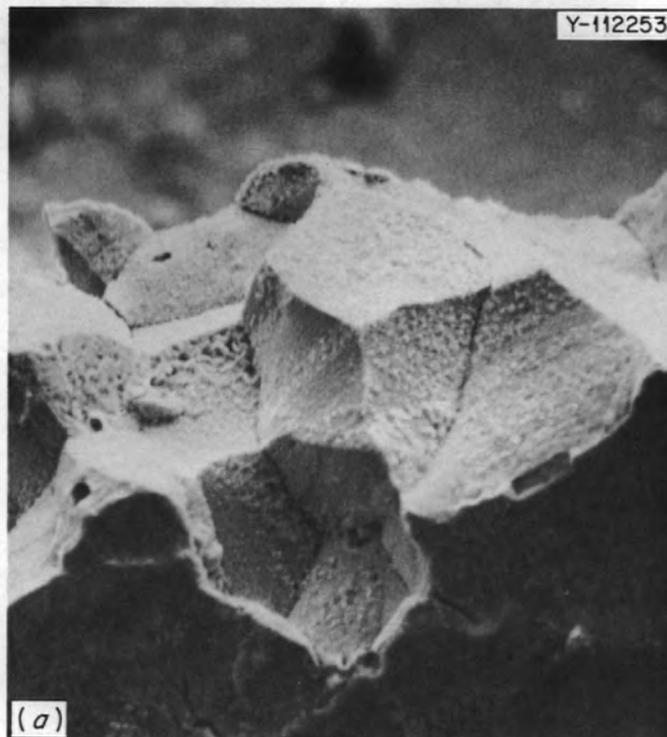
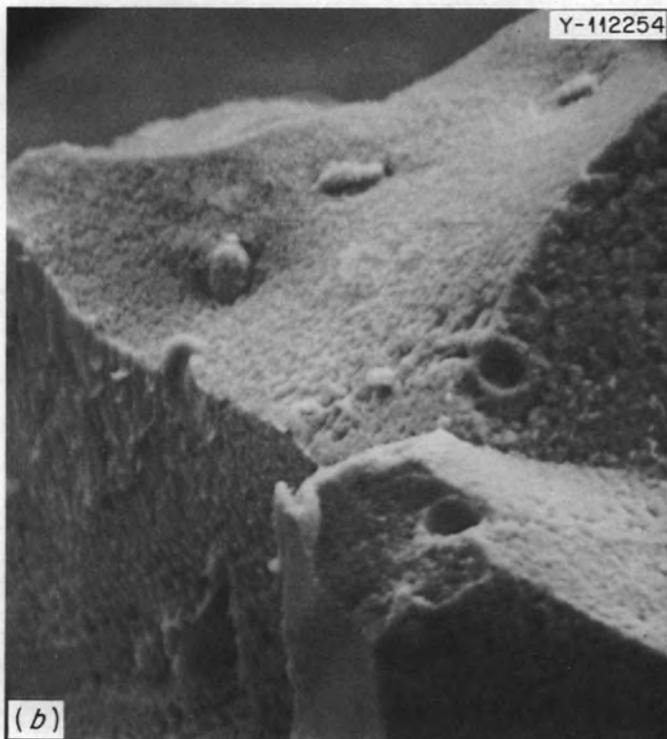
A fracture surface of the foil from the MSRE was examined by the scanning electron microscope (SEM) and Auger spectroscopy. The fracture is shown in Fig. 42 and is intergranular. The SEM with a dispersive x-ray analytical system indicated the presence only of the elements normally

Fig. 42. Scanning Electron Micrograph of INOR-8 (Heat 5075) Foil Exposed to the MSRE Core for 7203 hr Above 500°C. (a) Topographical view of fracture showing the surfaces of the fractured grain boundaries. 500x. (b) 1000x.

found in INOR-8. Auger electron spectroscopy indicated that Te, S, and Mo were concentrated in the boundaries. Definite confirmation of the presence of these elements was difficult because many of the spectra overlapped.

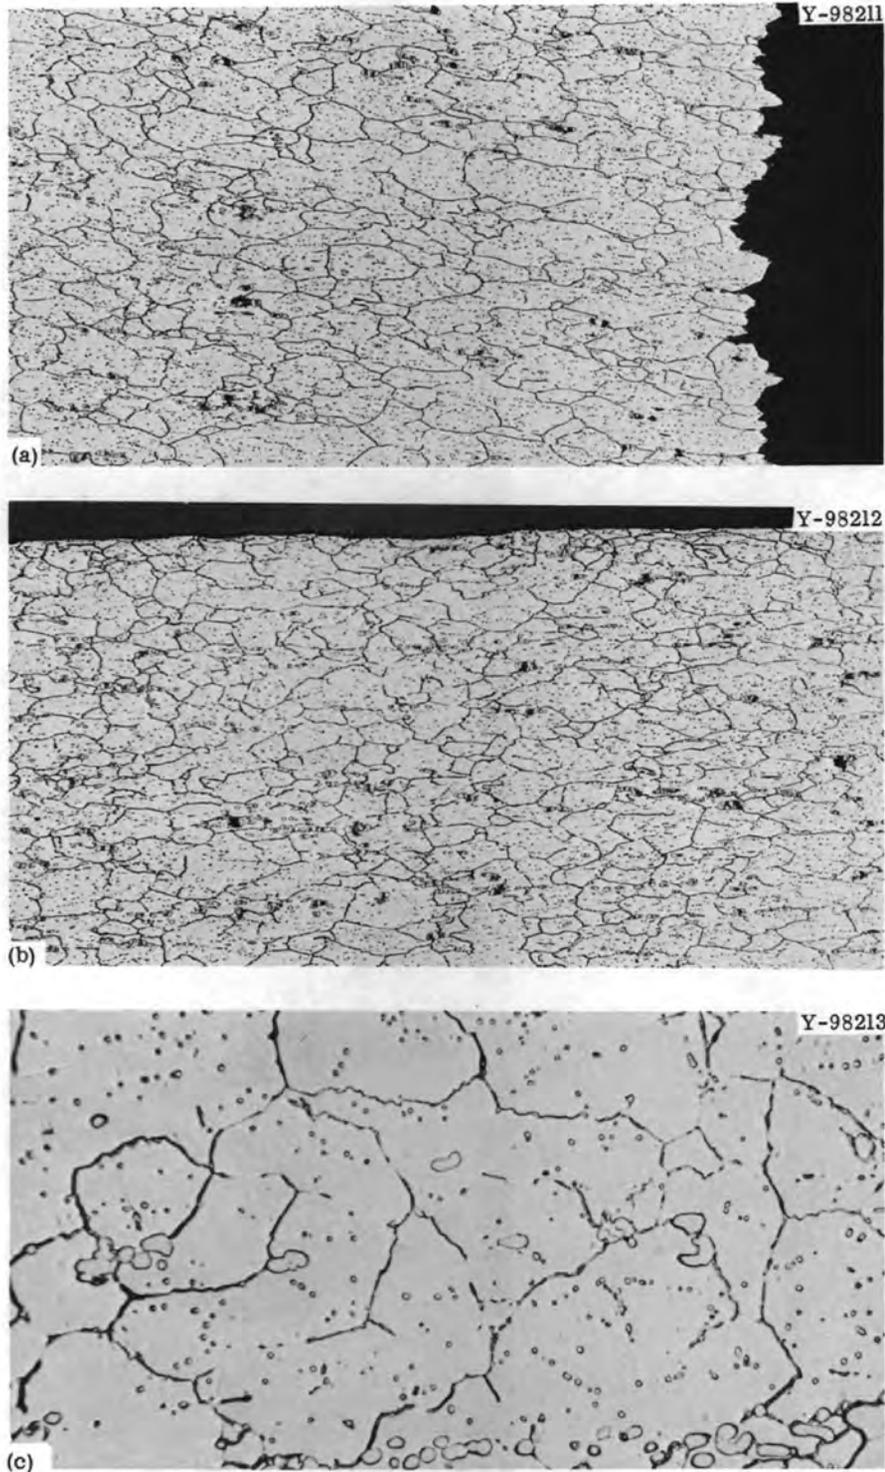
The control sample of heat 5065, whose microstructure is shown in Fig. 43, deformed 50% before fracture. The fracture is mixed intergranular and transgranular and no cracks formed along the edge away from the immediate vicinity of the fracture. The microstructure of a heat 5065 sample from the core is shown in Fig. 44. This sample deformed 43% and had a mixed fracture. Numerous intergranular cracks to a depth of about 5 mils formed along the gage length. Samples of heat 5085 from the control facility and the core are shown in Figures 45 and 46. The control sample failed after 41% strain with a mixed fracture. No intergranular cracks were visible in the field shown in Fig. 45. The sample of heat 5085 from the core that was tested at 25°C failed after much less strain (22%). As shown in Fig. 46, the fracture is mixed, and numerous intergranular cracks formed along the surfaces to a depth of 5 mils.

Fig. 43. Typical Photomicrographs of INOR-8 (Heat 5065) Sample Tested at 25°C After Being Exposed to Static Unenriched Fuel Salt for 19,136 hr above 500°C. Etchant: glyceria regia. (a) Fracture. 100×. (b) Edge near fracture. 100×. (c) Representative unstressed structure. 500×. Reduced 22%.

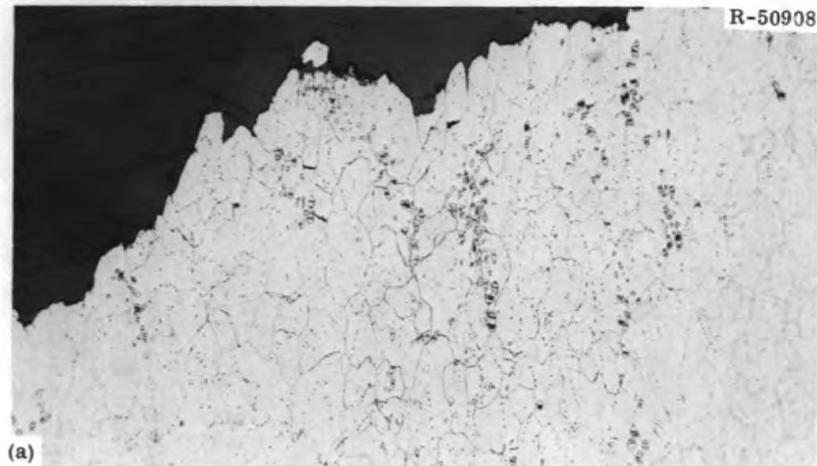
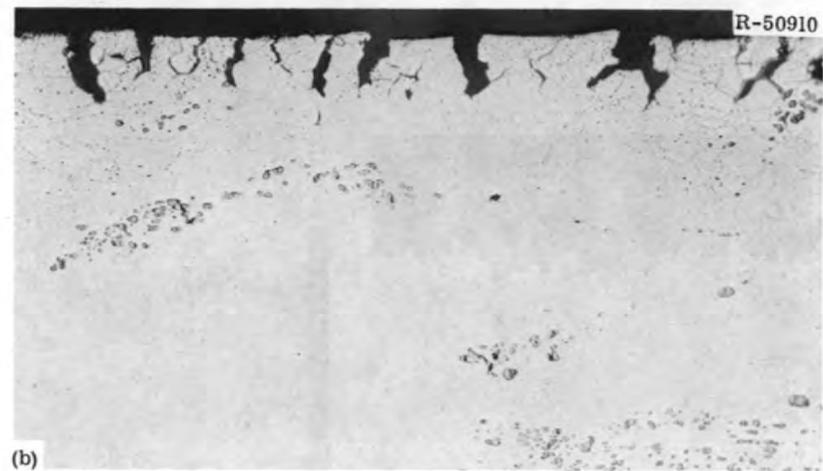
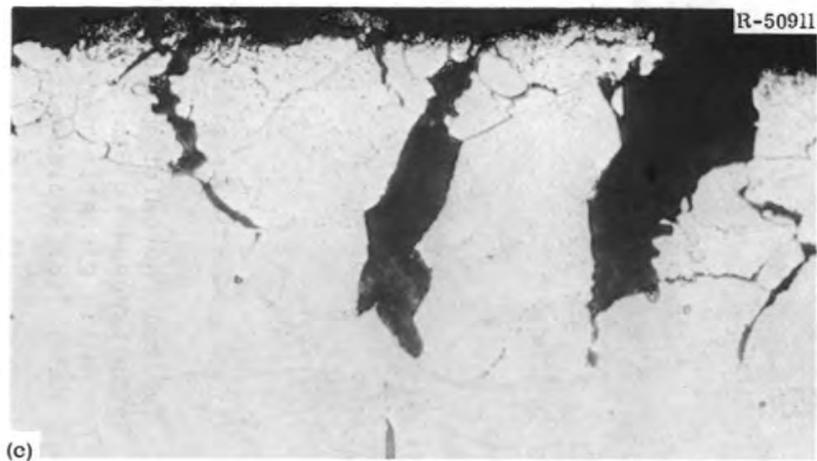
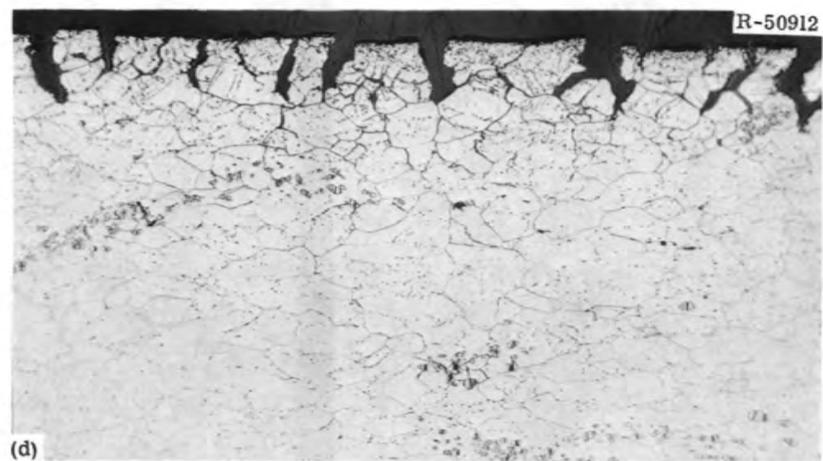
Fig. 44. Photomicrographs of INOR-8 (Heat 5065) Sample Tested at 25°C After Being Exposed to the MSRE Core for 19,136 hr Above 500°C and Irradiated to a Thermal Fluence of 1.5×10^{21} neutrons/cm². (a) Fracture, etched. 100x. (b) Edge, as polished. 100x. (c) Edge, as polished. 500x. (d) Edge, etched. 100x. Etchant: glyceria regia. Reduced 26%.

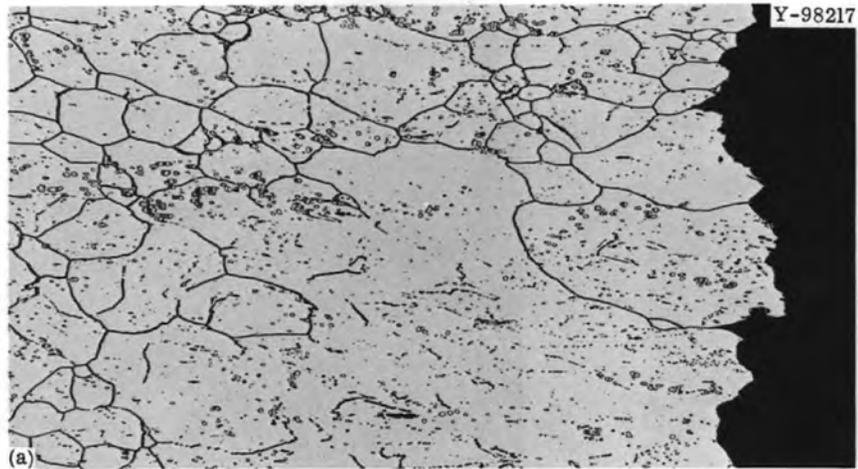
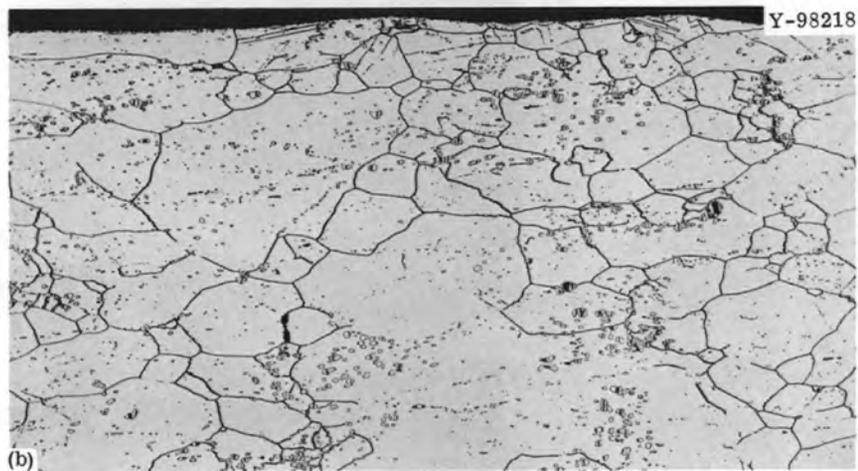
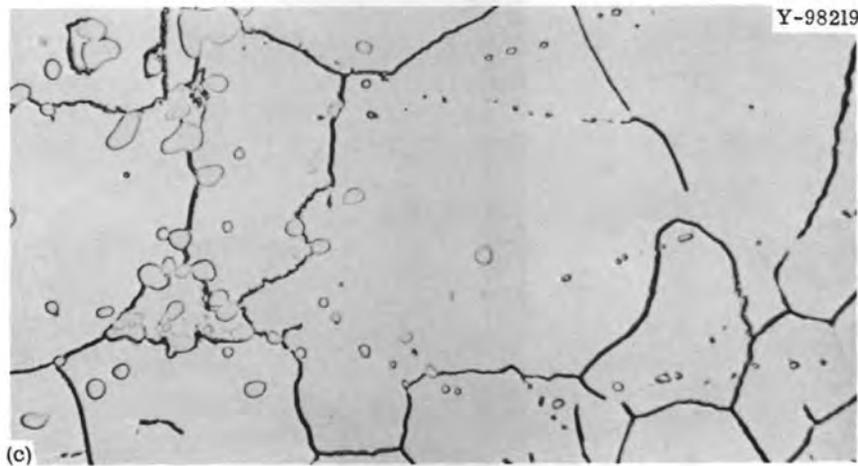
Fig. 45. Typical Photomicrographs of INOR 8 (Heat 5085) Sample Tested at 25°C After Being Exposed to Static Unenriched Fuel Salt for 19,136 hr Above 500°C. (a) Fracture, etched. 100×. (b) Edge near fracture, etched. 100×. (c) Representative unstressed structure, etched. 500×. Etchant: glyceria regia. Reduced 24.5%.

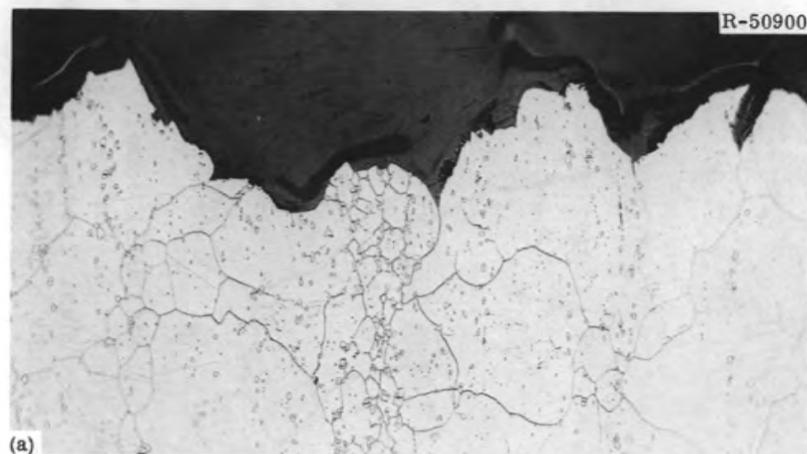
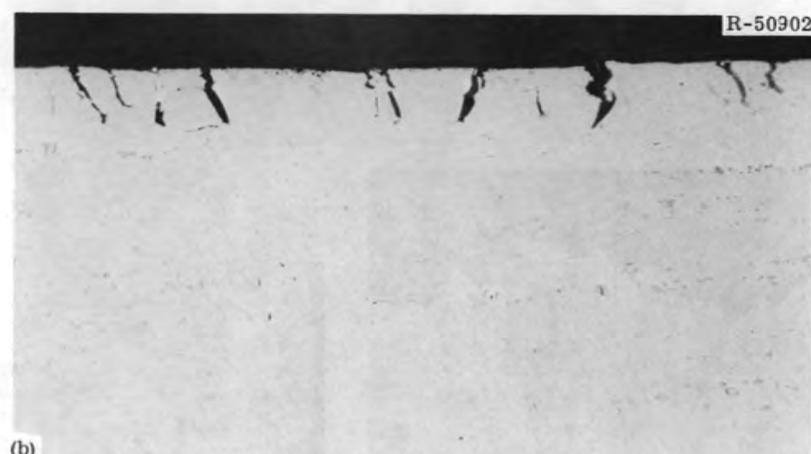
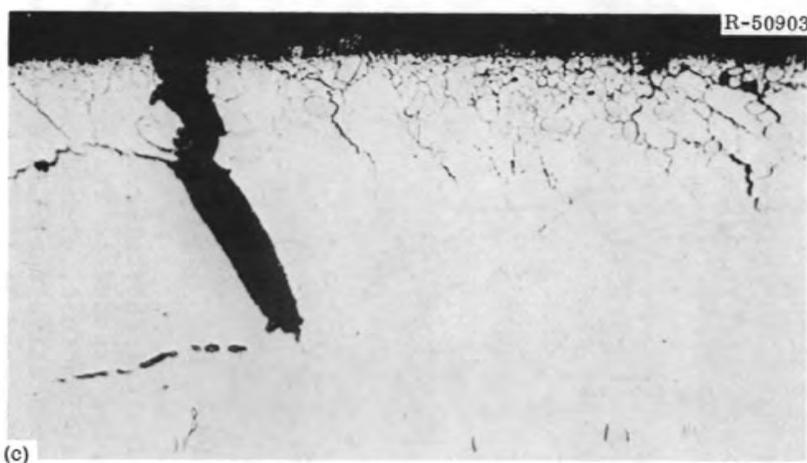
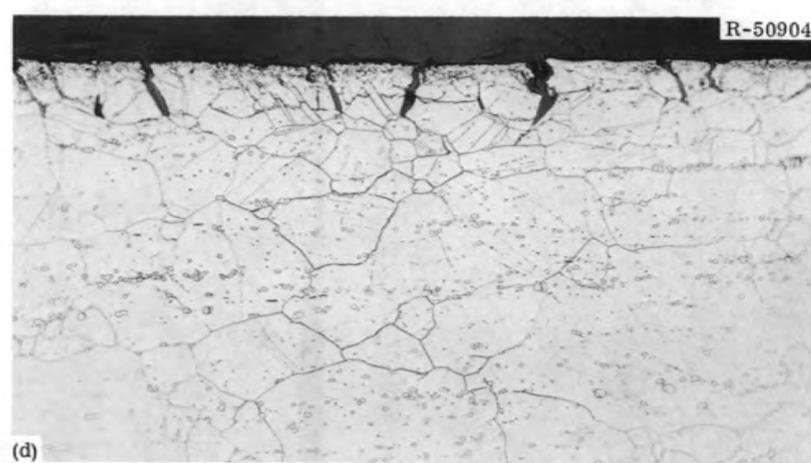
Fig. 46. Photomicrographs of INOR-8 (Heat 5085) Sample Tested at 25°C After Being Exposed to the MSRE Core for 19,136 hr Above 500°C and Irradiated to a Thermal Fluence of 1.5×10^{21} neutrons/cm². (a) Fracture, etched. 100x. (b) Edge, as polished. 100x. (c) Edge, as polished. 500x. (d) Edge, etched. 100x. Etchant: glyceria regia. Reduced 27%.

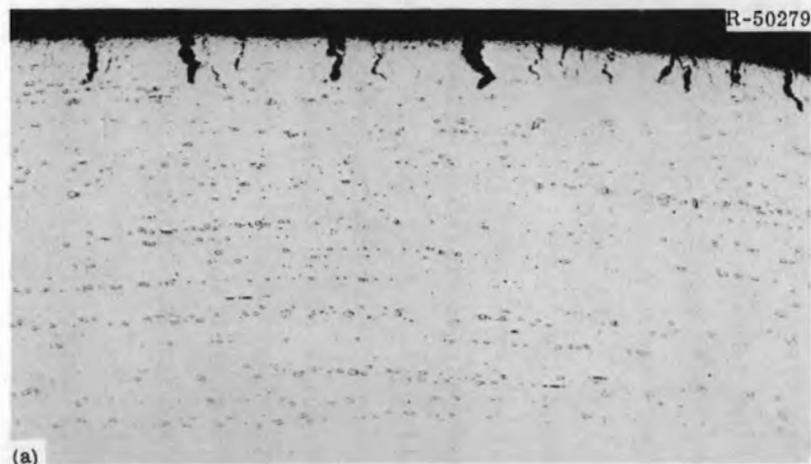
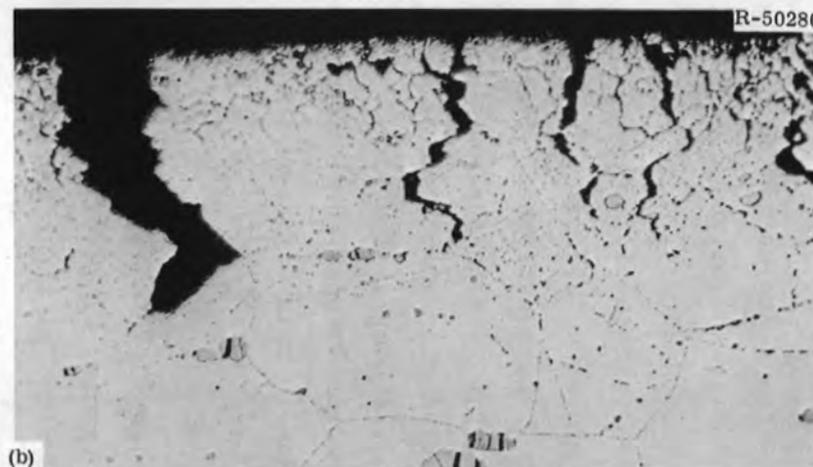
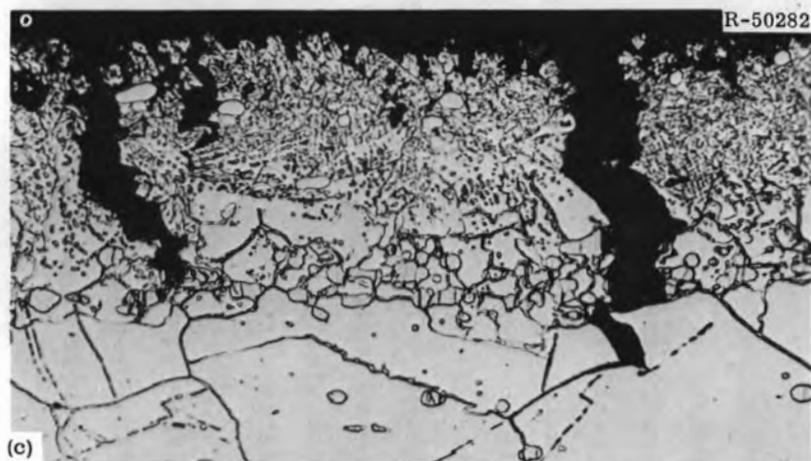
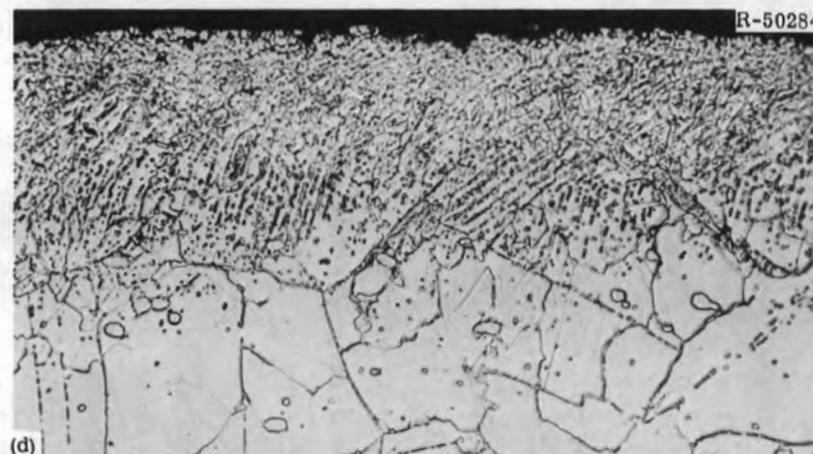
An additional experiment was made with a core sample of heat 5085 that had been cut too short for mechanical property testing. The remaining segment was bent about 30° in a vise, then was sectioned and examined metallographically. The resulting photomicrographs are shown in Fig. 49. The tension side had intergranular cracks to a depth of about 4 mils, but no cracks were evident on the compression side. Both the tension and compression sides etched abnormally near the surface because of the modification thought to be due to cold working.

Fig. 49. Typical Photomicrographs of INOR-8 (Heat 5085) Sample Exposed to the MSRE Core for 19,136 hr Above 500°C. The sample was bent in a vise. (a) As polished, tension side. 100x. (b) As polished, tension side. 500x. (c) Etched, tension side. 500x. (d) Etched, compression side. 500x. Etchant: aqua regia. Reduced 27%.
