INTERGRANULAR CRACKING OF INOR-8 IN THE MSRE

H. E. McCoy

NOVEMBER 1972

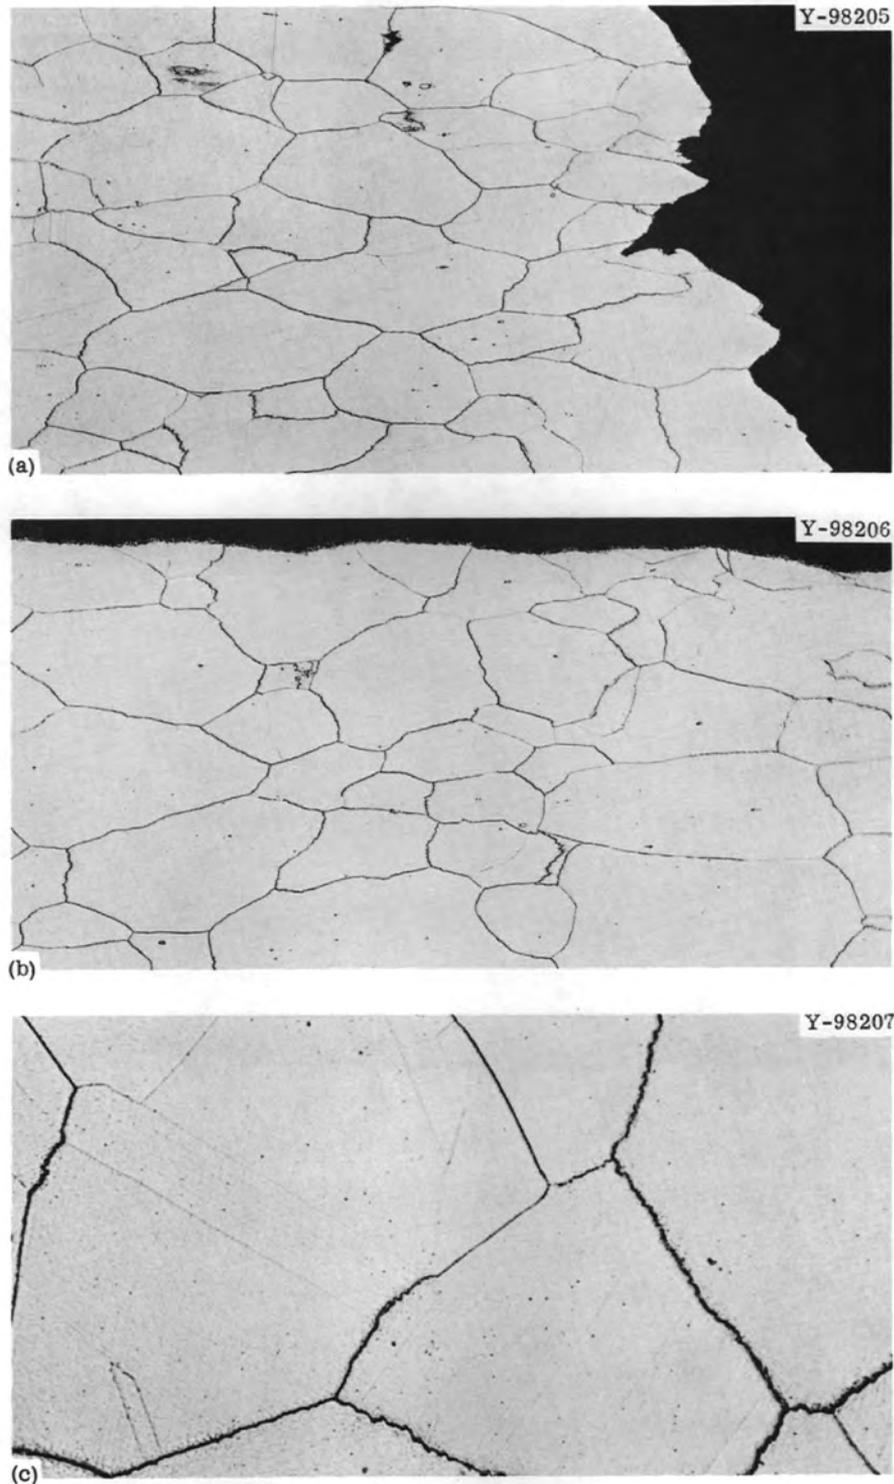
Fig. 50. Photomicrographs of a Modified INOR-8 (Heat 7320) Sample Tested at 25°C After Being Exposed to Static Unenriched Fuel Salt for 7203 hr Above 500°C. (a) Fracture. 100×. (b) Edge. 100×. (c) Typical unstressed microstructure. 500×. Etchant: glyceria regia. Reduced 22.5%.

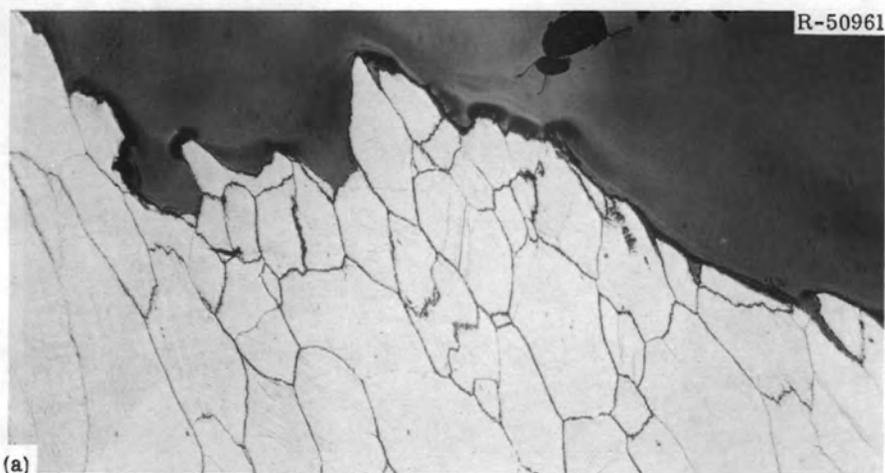
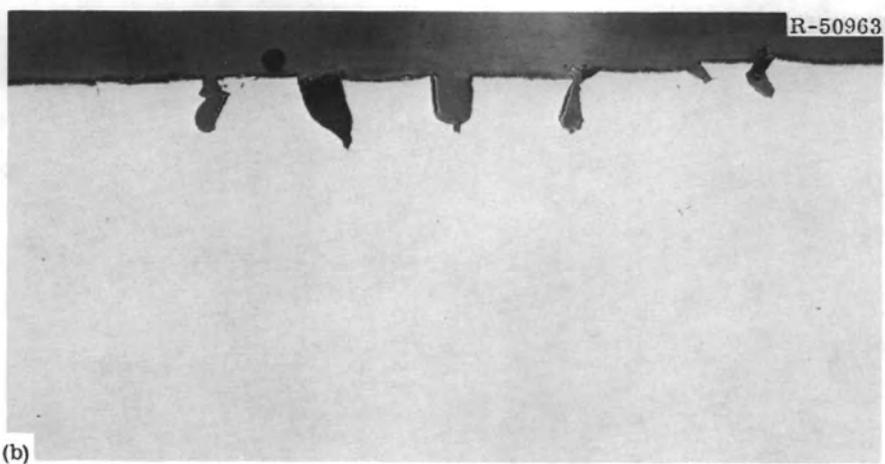
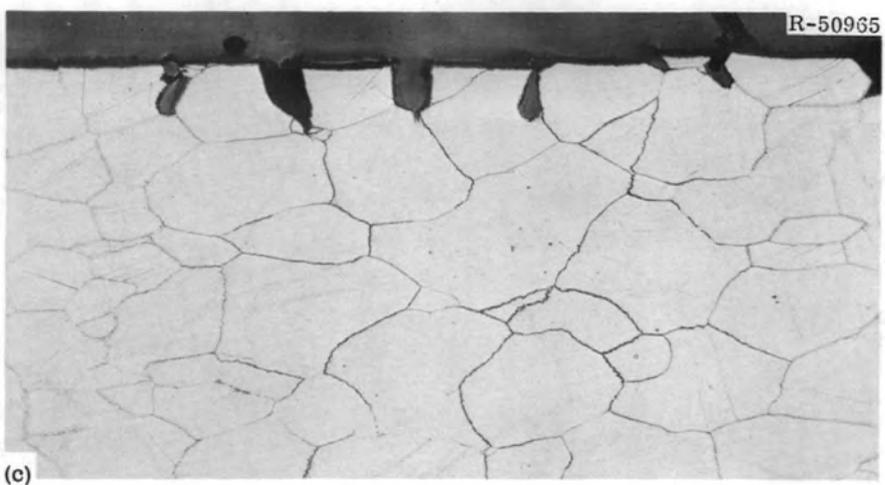
Fig. 51. Photomicrographs of a Modified INOR-8 (Heat 7320) Sample . Tested at 25°C After Being Exposed to the MSRE Core for 7203 hr Above 500°C and Irradiated to a Fluence of 5.1×10^{20} neutrons/cm². (a) Fracture, etched, 100x. (b) Edge, as polished. 100x. (c) Edge, Etched. 100x. Etchant: glyceria regia. Reduced 22%.

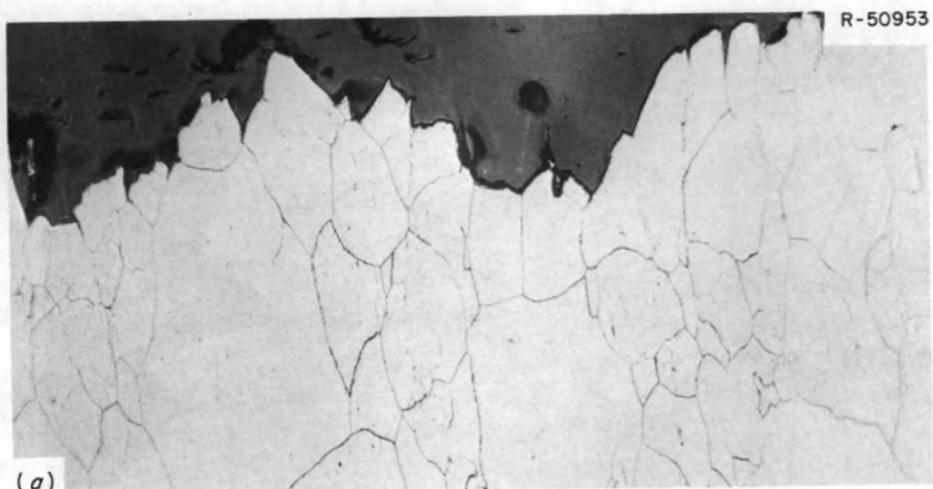
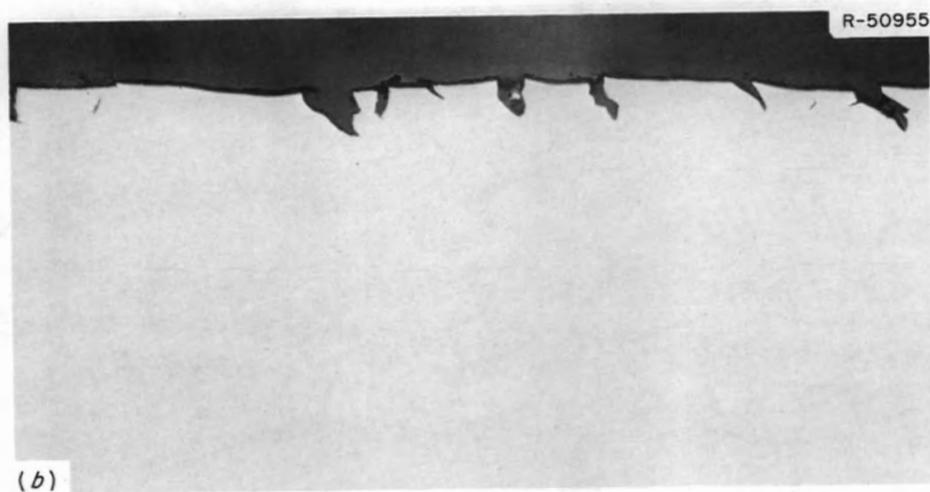
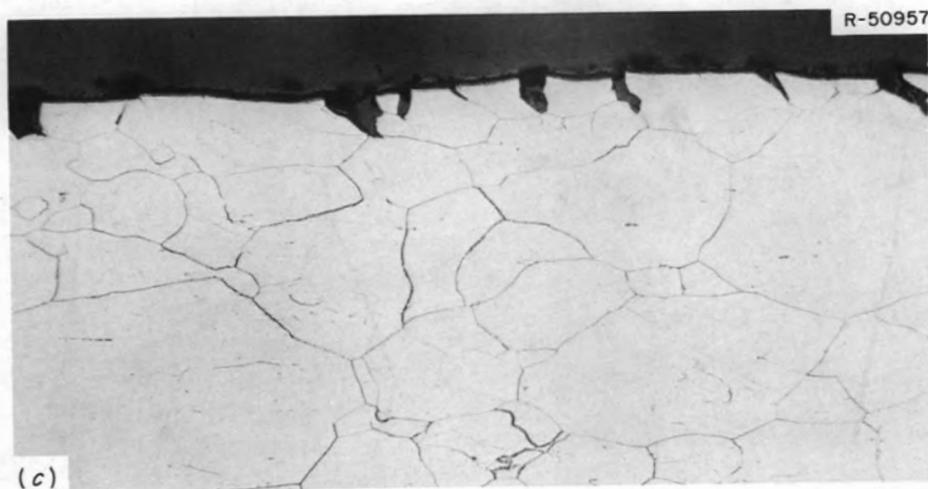
The specimens on stringers RR3 and RS4 were of two different heats of titanium-modified alloy: heat 7320, containing 0.65% Ti, and heat 67-551, containing 1.1% Ti. The 7200-hr exposure of these specimens had been entirely during the ^{233}U operation, in which the initial oxidation state was relatively high. The specimens were discolored and had much the same appearance as the standard heats. The samples were subjected to various mechanical property tests and some were examined metallographically. The microstructure of heat 7320 after exposure in the control facility and testing at 25°C is shown in Fig. 50. The sample deformed 50% before fracturing in a mixed mode. No edge cracks were visible. A similar sample that was exposed to the fuel salt is shown in Fig. 51. It failed after deforming 45%. Edge cracks were present along almost every grain boundary to a depth of 3 to 5 mils. Note that many of these cracks proceed to where the cracking grain boundary intersects another boundary. Note also that the crack tips are quite blunt indicating that they formed early during deformation and were simply spread by further deformation and did not propagate. Similar metallographic observations were made on heat 67-551. Control and core specimens deformed almost equal amounts before fracturing (52% and 51%). No edge cracks were observed in the sample from the control facility (Fig. 52), but numerous intergranular cracks were evident in the sample from the core (Fig. 53).

Fig. 53. Photomicrographs of a Modified INOR-8 (Heat 67-551) Sample Tested at 25°C After Being Exposed to the MSRE Core for 7203 hr Above 500°C and Irradiated to a Fluence of 5.1×10^{20} neutrons/cm². (a) Fracture, etched. 100x. (b) Edge, as polished. 100x. (c) Edge, etched. 100x. Etchant: Glyceria regia. Reduced 17%.

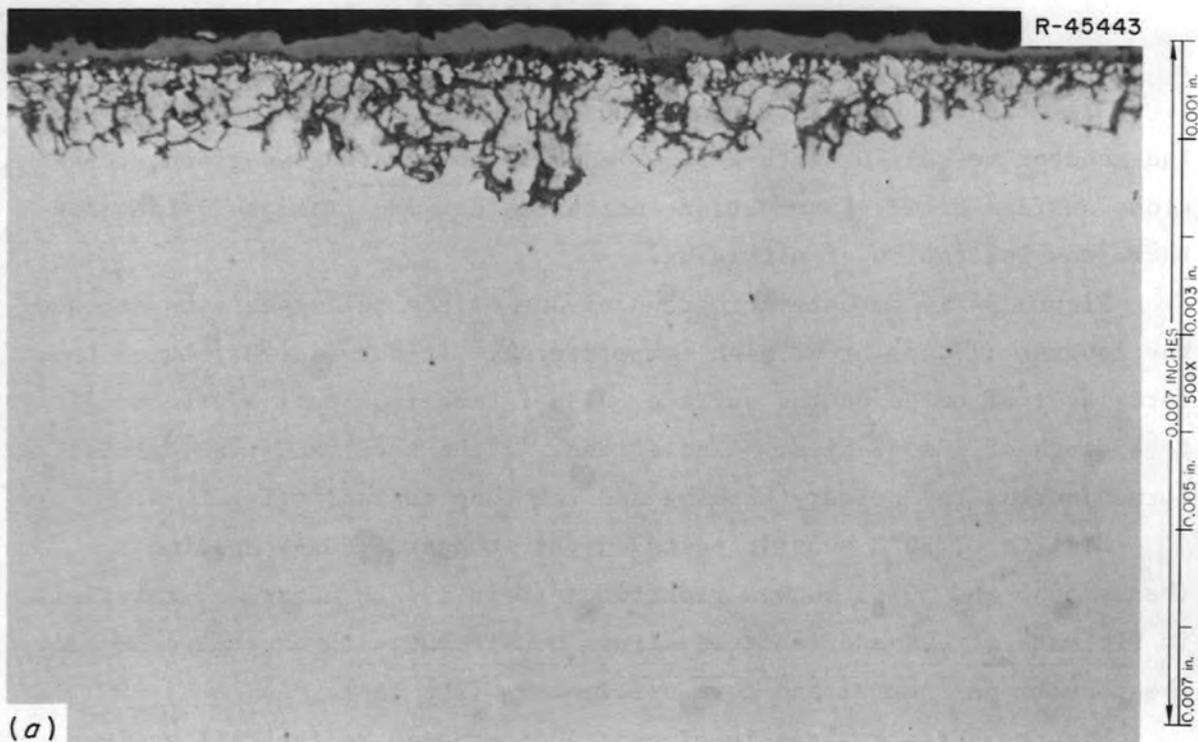
Figure 54 is a photomicrograph of one of the cell specimens exposed the longest (17,483 hr at high temperature). It shows a very thin, uniform layer of oxide on the surface, with internal oxidation extending to a depth of 1 to 2 mils. Also evident is the usual M_6C -type carbide formed during the primary working and the long thermal aging.

Fig. 54. Photomicrographs of Hastelloy N (Heat 5065) Surveillance Specimens Exposed to the Cell Environment of $N_2 + 2$ to 5% O_2 for 20,789 hr at $650^\circ C$. 500 \times . (a) Unetched showing surface oxidation (b) Etched (glyceria regia) showing shallow modification of microstructure due to reaction with cell environment.

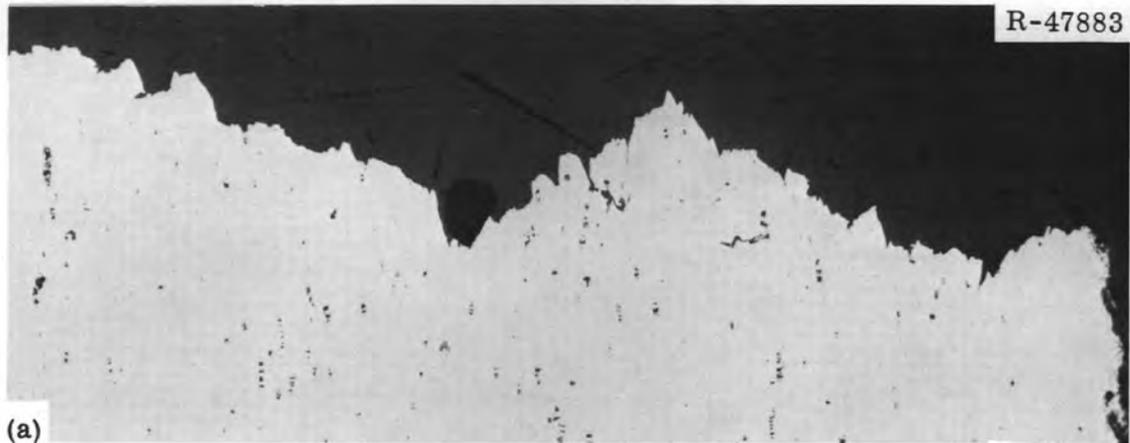
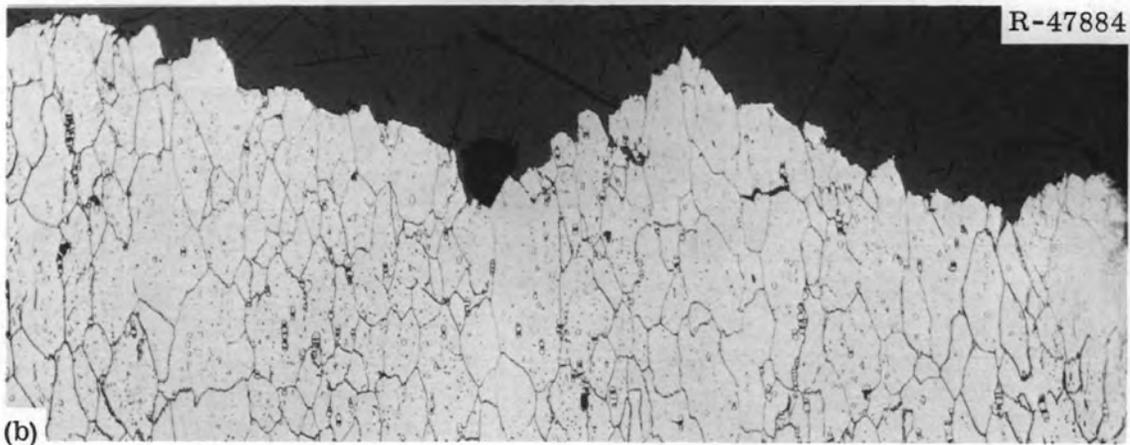
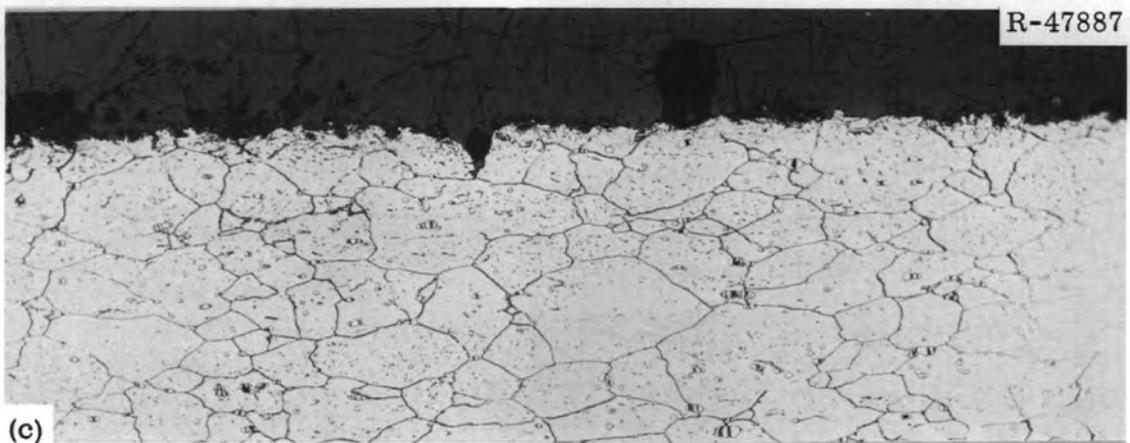
Figure 55 shows a sample of heat 5065 exposed to the cell environment and fractured at 25°C. The elongated grains attest to the large fracture strain (59%), and the fracture is mixed transgranular and intergranular. A heat 5085 specimen exposed the same length of time failed with only 33% fracture strain, in a primarily intergranular mode as shown in Fig. 56. Both specimens showed a few shallow surface cracks, but the oxide layer did not appear to affect the deformation of the specimens.

Fig. 55. Photomicrographs of INOR-8 (Heat 5065) Sample Tested at 25°C at a Strain Rate of 0.05/min. Sample had been irradiated to a thermal fluence of 2.6×10^{19} neutrons/cm² while being exposed to the cell environment above 500°C for 17,483 hr. 100×. (a) Fracture, as polished. (b) Fracture, etched. (c) Edge of stressed portion. Etchant: aqua regia.

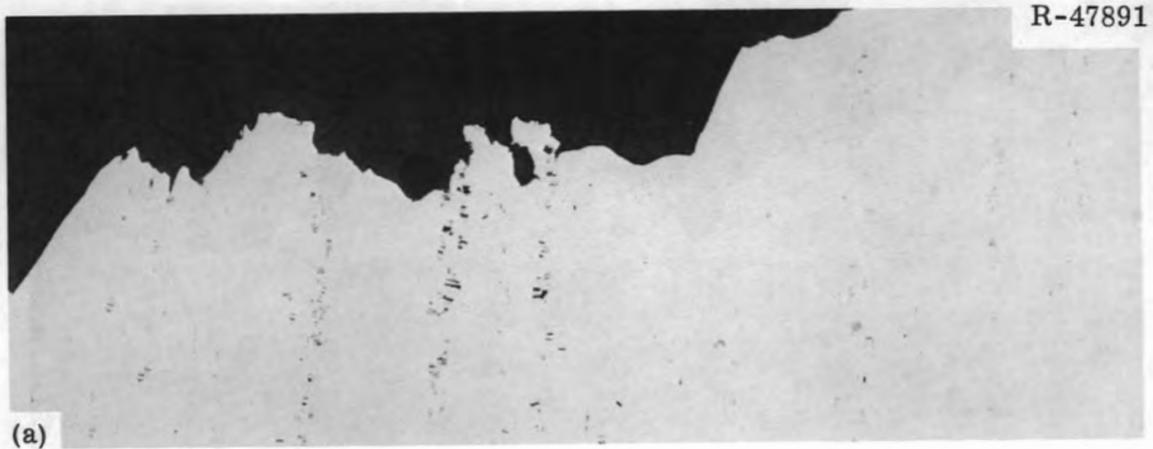
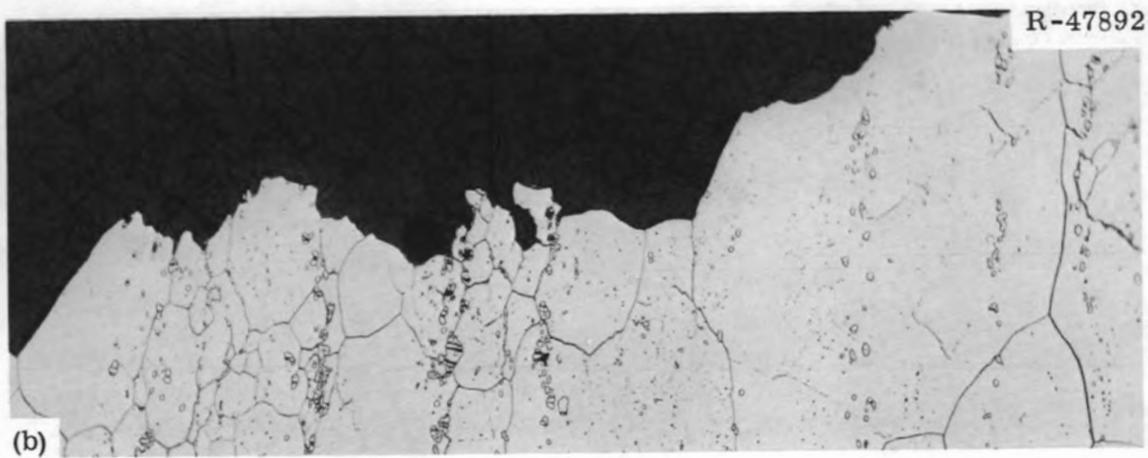
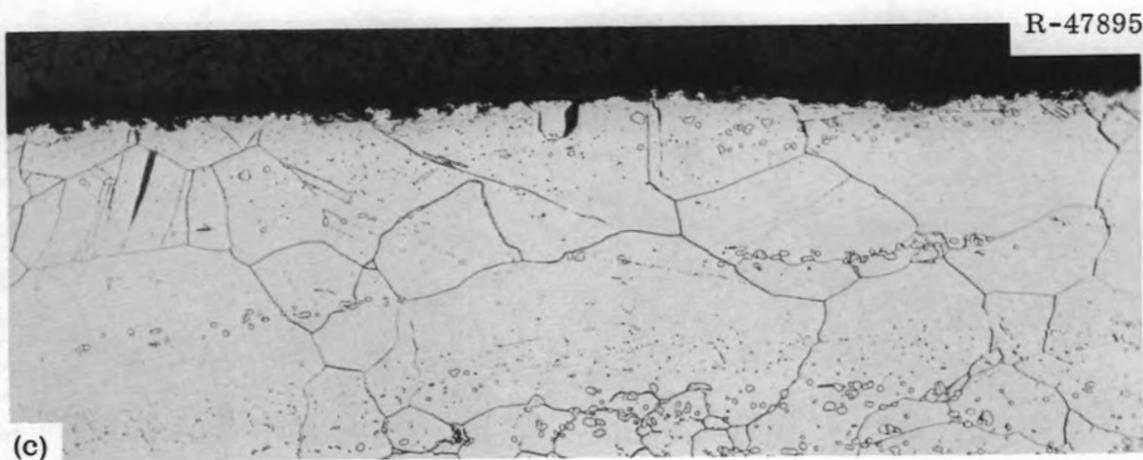
Fig. 56. Photomicrographs of INOR-8 (Heat 5085) Sample Tested at 25°C at Strain Rate of 0.05/min. Sample had been irradiated to a thermal fluence of 2.6×10^{19} neutrons/cm² while being exposed to the cell environment above 500°C for 17,483 hr. 100x. (a) Fracture, as polished. (b) Fracture, etched. (c) Edge of stressed portion. Etchant: aqua regia.

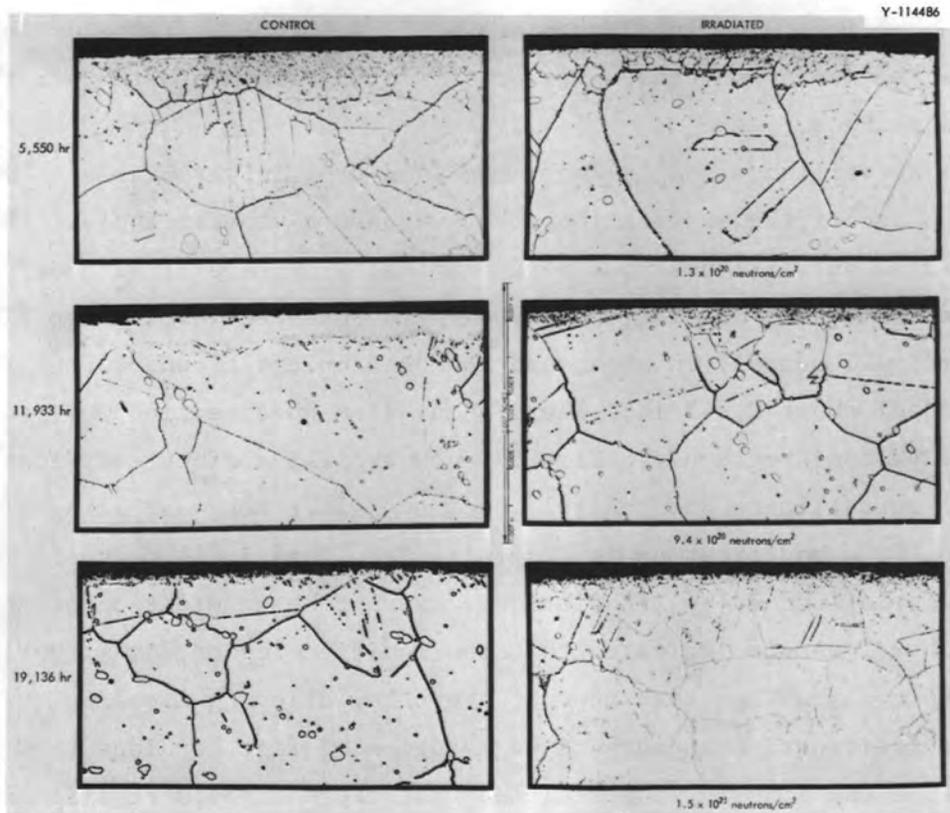
The photomicrographs in Fig. 57 show typical surface modifications noted on surveillance and control specimens after long annealing times at 650°C. The modification is generally less than 1 mil deep and is not detectably influenced by irradiation. Microprobe examination of the first control sample indicated that the modified region was slightly enriched in carbon and that none of the other alloying elements varied. Thus the modification appears to be a region of fine carbides that are dispersed along lines. We postulated that these lines were slip lines that resulted from the surface working during the final stages of fabrication. These slip lines would provide preferred sites for carbide precipitation when the alloy was held at 650°C.

Fig. 57. Photomicrographs of Unstressed INOR-8 (Heat 5085) Control and Irradiated Samples.

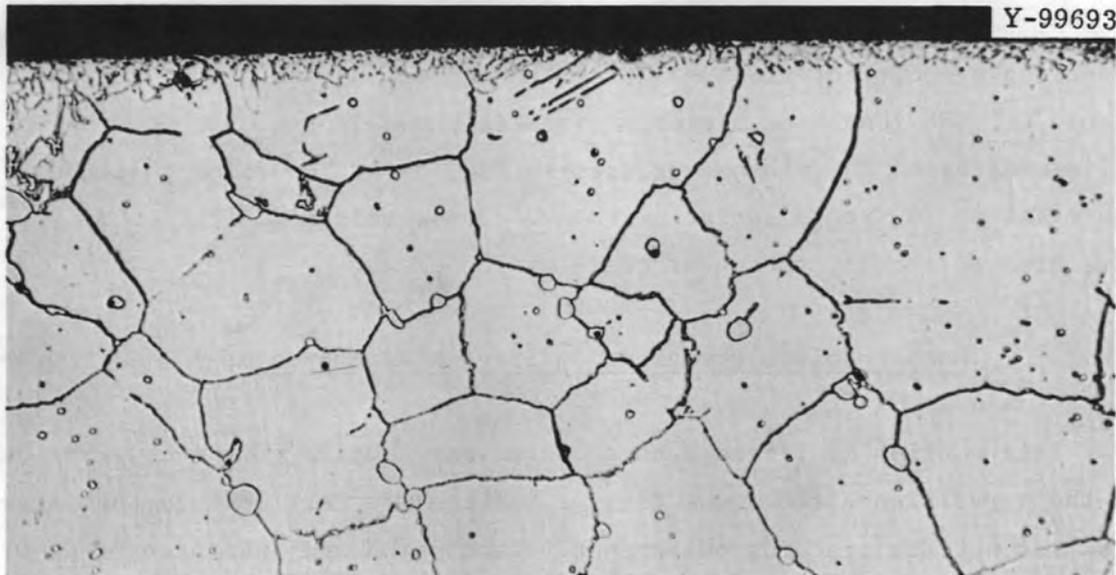
We were able to duplicate the surface modification by solution annealing a rod, centerless grinding, and annealing for a long period at 650°C. The resulting microstructure is shown in Fig. 58. It is quite similar to the microstructures in Fig. 57 and confirms that the modification is due to surface working. Thus, this modification is unrelated to the intergranular cracking phenomenon.

Fig. 58. Photomicrograph of INOR-8 (Heat 5085) Rod that was Annealed 1 hr at 1177°C, Centerless Ground 5.2 mils, and Annealed 4370 hr at 650°C in Argon. 500x. Etchant: glyceria regia.

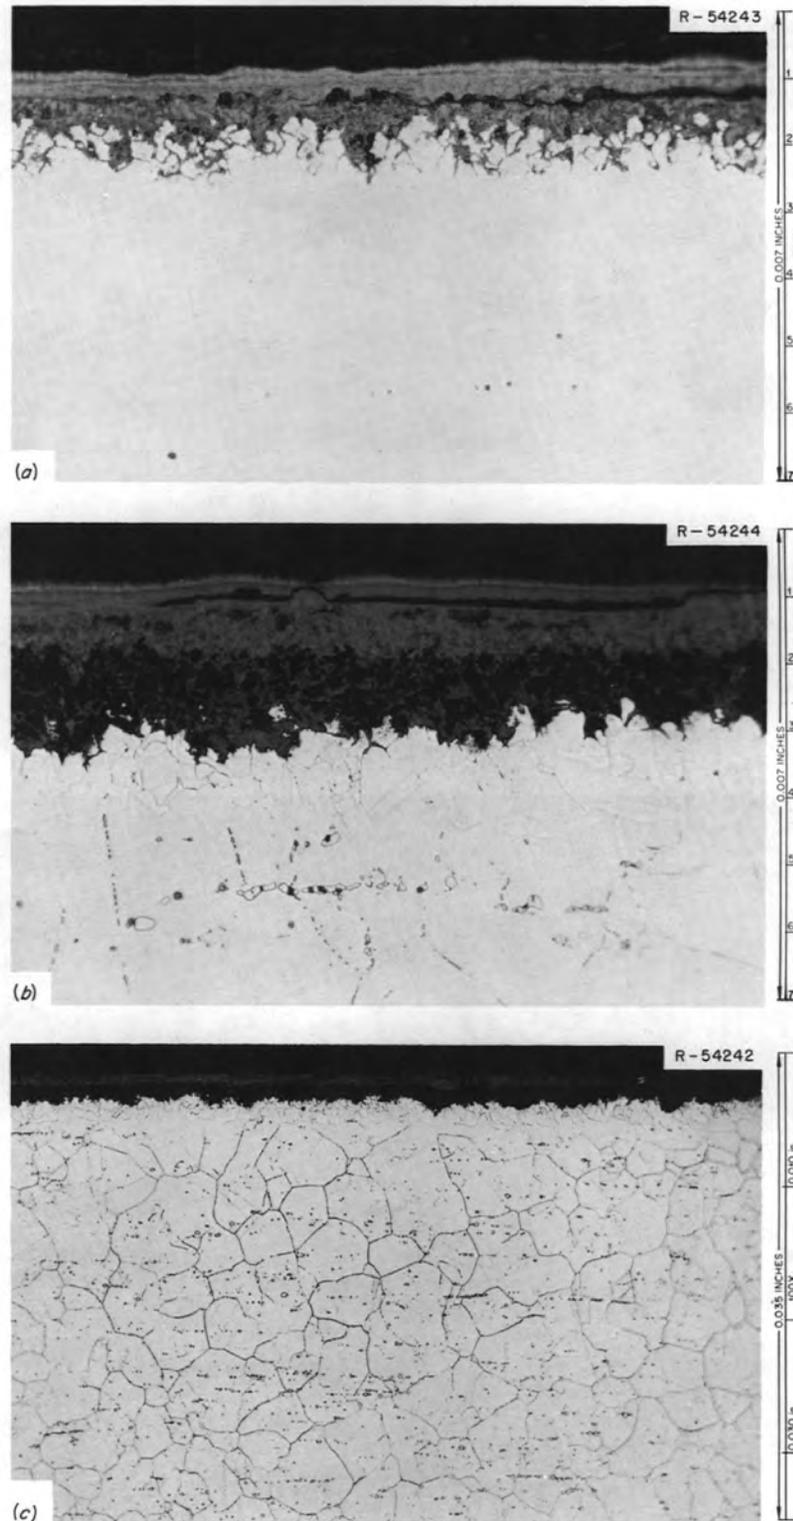
Samples of the control rod thimble and the spacer sleeve were cut and examined to determine their condition at the end of service. Typical photomicrographs of the inside of the thimble tube are shown in Fig. 61. This surface was oxidized to a depth of about 2 mils by the cell environment of nitrogen containing 2 to 5% O_2 . The oxidation process modified the microstructure to a depth of 4 mils, likely due to the selective removal of chromium.

Fig. 61. Photomicrographs of the Inner Surface of the Control Thimble in the As-removed Condition. This surface was exposed to cell environment of N_2 containing 2 to 5% O_2 . (a) As polished. (b) Etched. (c) Etched, typical microstructure. Etchant: Aqua regia. Reduced 30.5%.

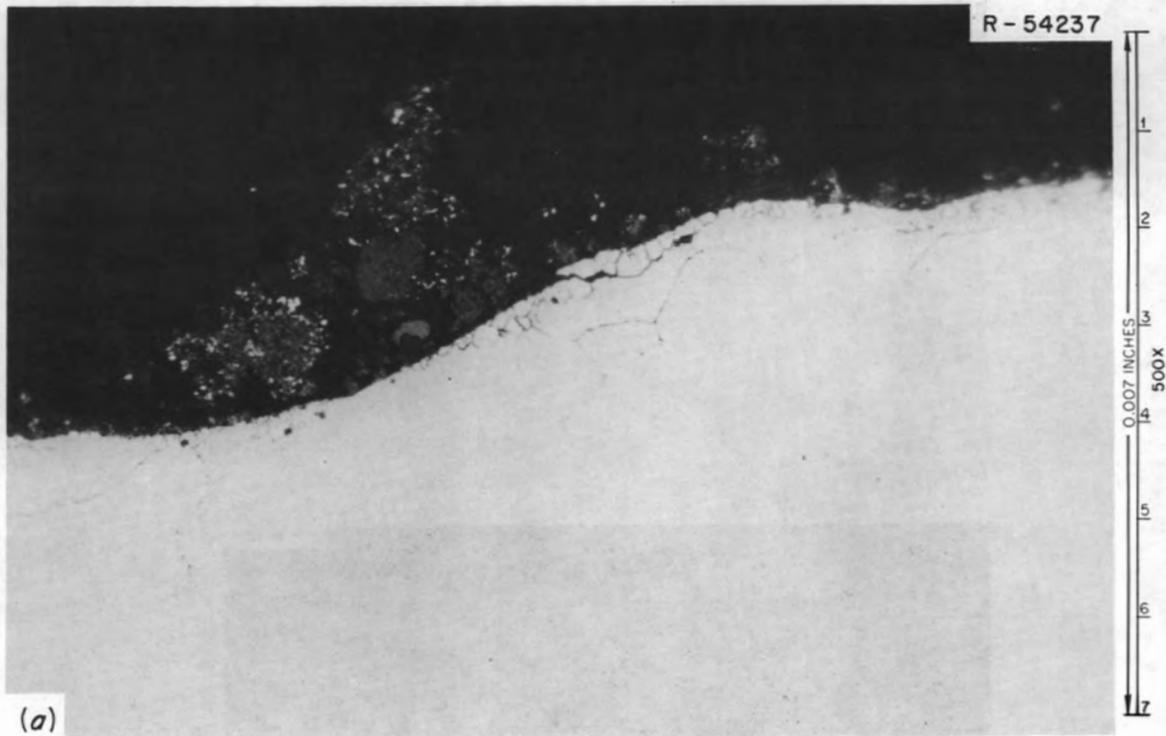
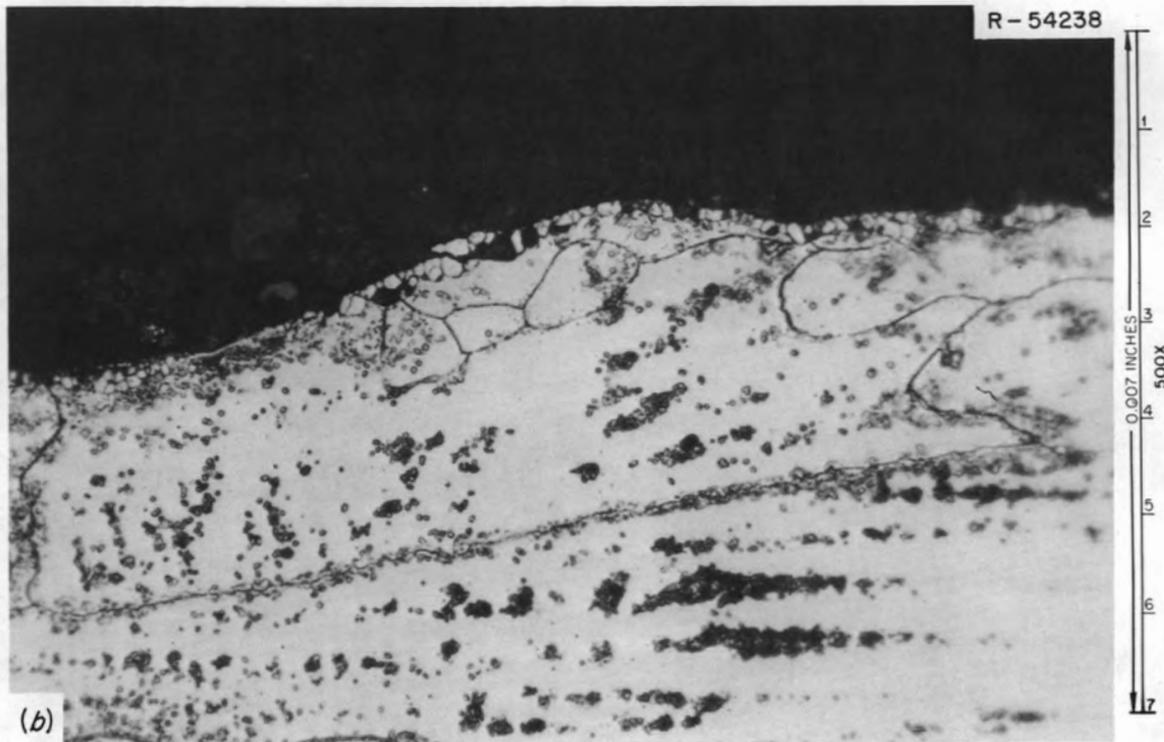
Photomicrographs of one of the weld beads are shown in Fig. 62. All of the surface shown was exposed to flowing fuel salt. Some dislodged grains are near the surface, and grain boundaries are visible in the as-polished condition to a depth of 1 to 1.5 mils.

Fig. 62. Photomicrographs of Outer Surface of Control Rod Thimble Showing the Weld Deposit Made to Hold the Spacer Sleeve. The weld surface was exposed to flowing salt. (a) As polished. (b) Etched: Aqua regia.

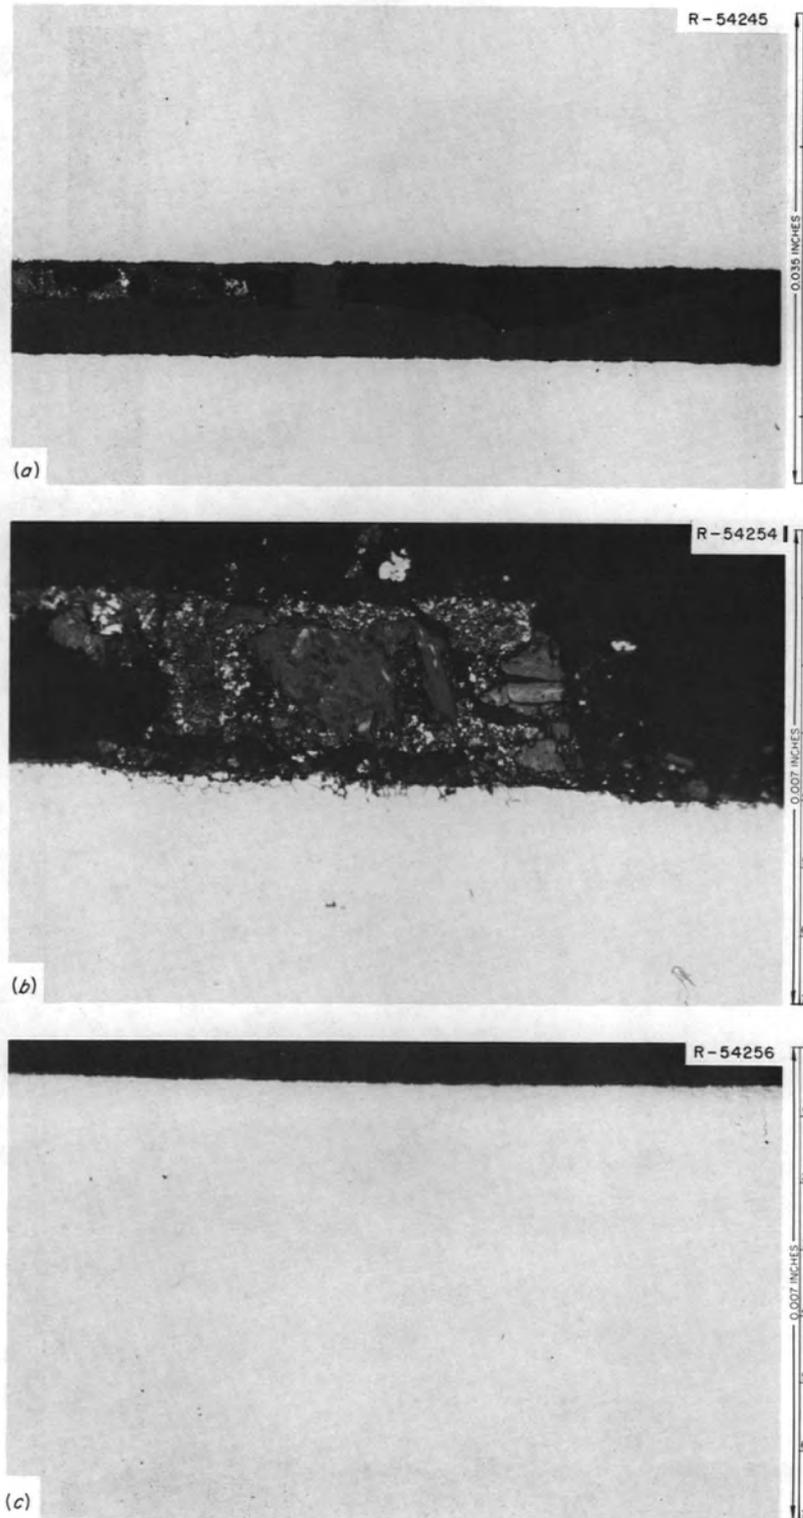
Photomicrographs involving the interface between the thimble and sleeve are shown in Fig. 63. Figure 63(a) shows the annular region with a separation of about 7 mils and some salt present. Few surface irregularities are visible at a magnification of 100 \times , indicating that they are considerably below 1 mil. Figure 63(b) is a 500 \times view of the thimble and shows some surface cracks to a depth of 0.3 mil. The outside of the sleeve is shown in Fig. 63(c); a few grain boundaries to a depth of about 1 mil are visible. Additional photomicrographs of the sleeve are shown in Fig. 64. The sleeve material does not appear to have received much working since the carbide is very inhomogeneously distributed. The grain size is larger than usual away from the stringers. The inner and outer surfaces both have modified structures. A higher magnification view of the inner surface [Fig. 64(b)] shows that much of the modification is a high density of primary carbide. The outer surface [Fig. 64(c)] has a shallow layer of small grains, likely due to a working operation.

Fig. 63. Photomicrographs of As-polished Surfaces of Control Rod Thimble and Sleeve. (a) Annulus between thimble and sleeve. Thimble surface is in upper part of picture. (b) Outside surface of control rod thimble, showing presence of some salt and shallow surface cracking. (c) Outside surface of sleeve. Surface exposed to flowing fuel salt.

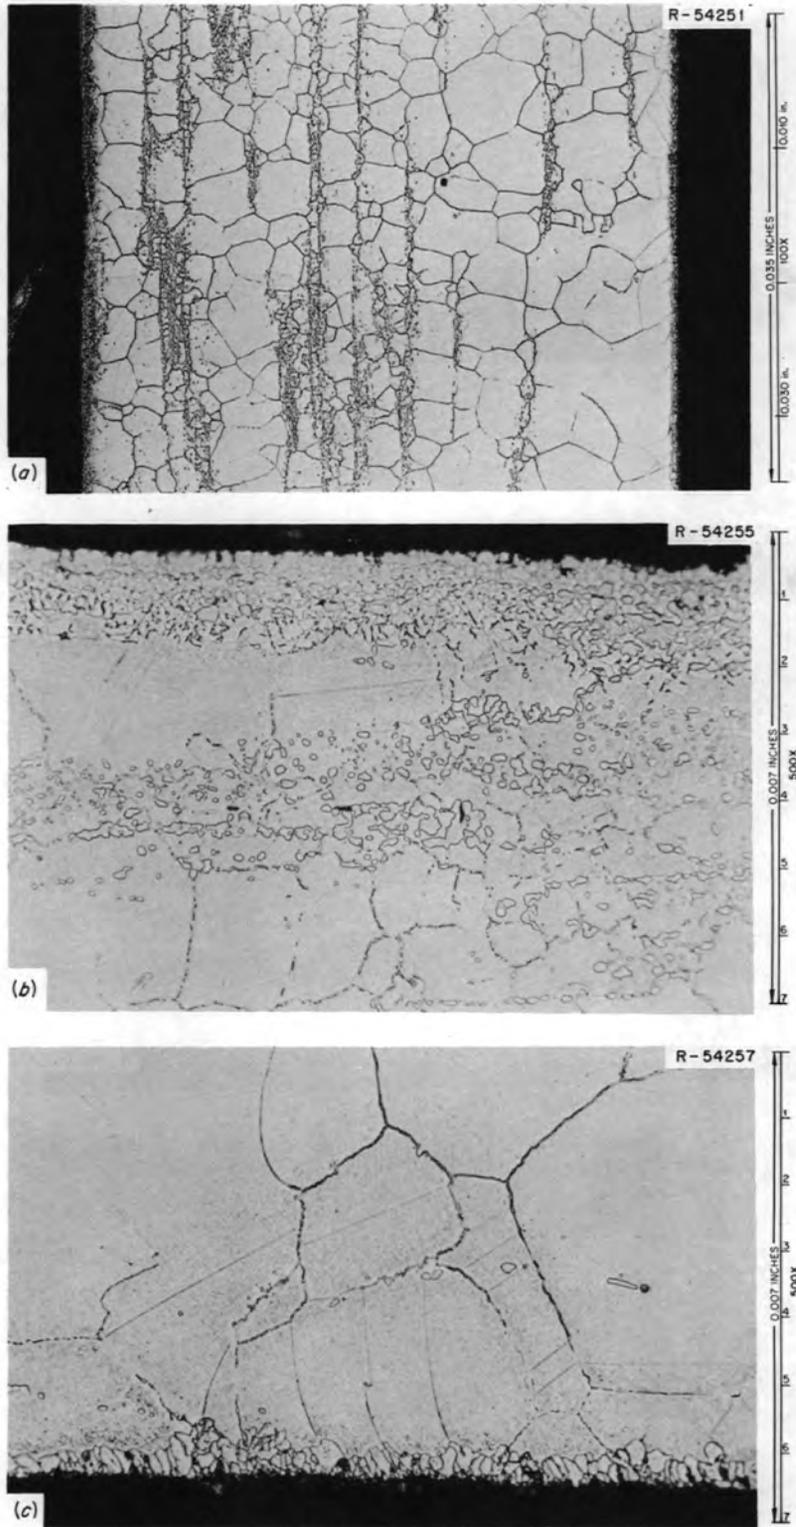
Fig. 64. Photomicrographs of Control Rod Sleeve. (a) Etched view showing general microstructure. Inner surface is on left and outer surface is on right. (b) Inner surface of sleeve. (c) Outer surface of sleeve. Etchant: Aqua regia. Reduced 30.5%

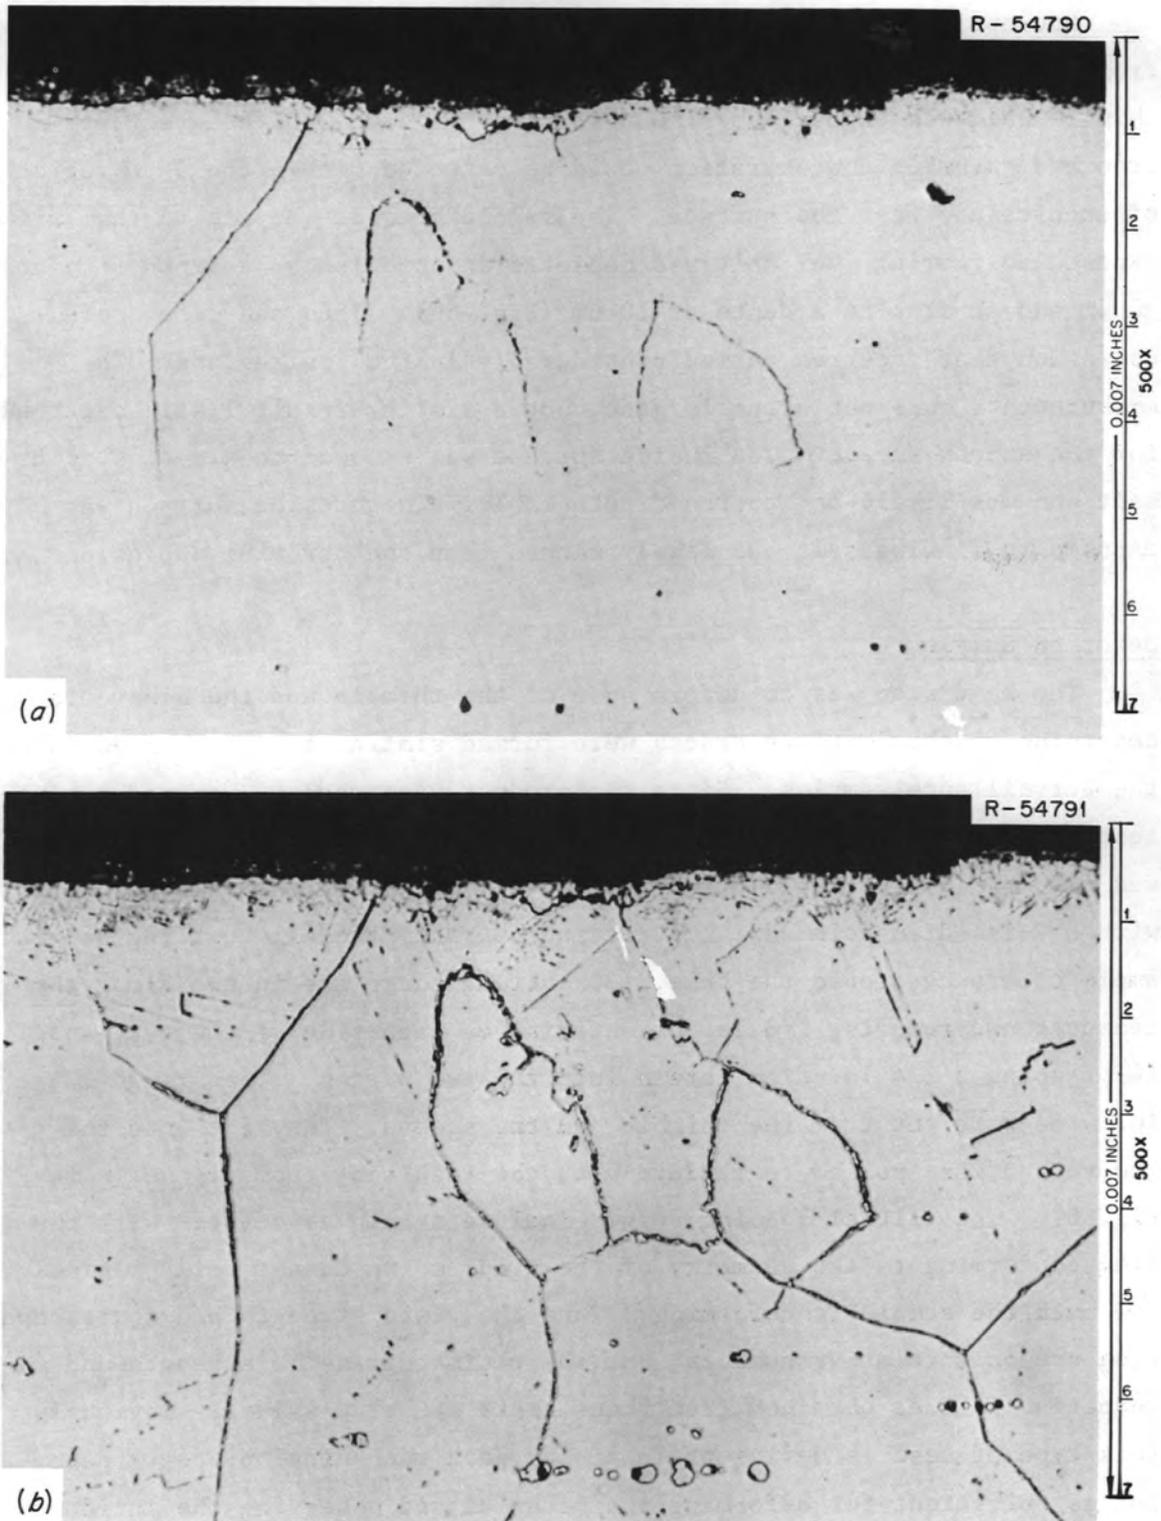
A second cut was made away from the sleeve, and typical photomicrographs are shown in Fig. 65. This part of the thimble was exposed to flowing salt. Some of the grain boundaries are visible in the as-polished condition to a depth of about 4 mils and there is some surface modification [Fig. 65(a)]. Etching [Fig. 65(b)] delineates more of the grain structure and shows the shallow surface modification.

Fig. 65. Photomicrographs of Control Rod Thimble where it was Exposed Directly to Flowing Salt. (a) As polished. (b) Etched: Aqua regia.

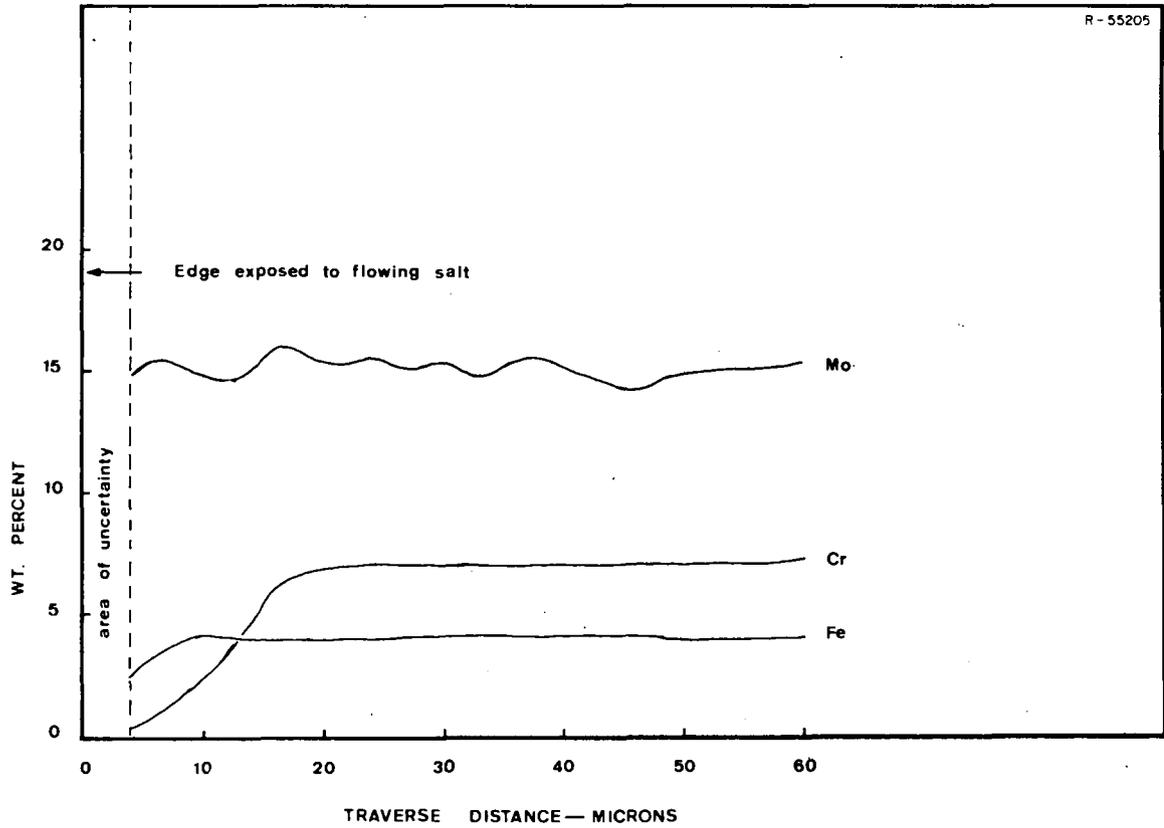
Microprobe scans were run on the thimble samples that were taken from under the sleeve and outside the sleeve. In the first case the thimble wall was exposed to almost static fuel salt, and no gradients in iron and chromium concentration could be detected within the 3- μm region of uncertainty near the surface. The sample outside the sleeve that was exposed to flowing fuel salt was depleted in chromium to a depth of almost 20 μm and in iron to a depth of 10 μm (Fig. 66). Thus the amount of corrosion that occurred varied considerably in the two regions. The measurements were not actually made, but a similar result likely occurred for the spacer sleeve. The inside surface was exposed to almost static salt and was likely not corroded detectably. The outside surface was exposed to flowing salt and likely showed iron and chromium depletion.

Fig. 66. Electron Microprobe Scan of Sample from Control Rod Thimble. The thimble had been exposed to the fuel salt for 21,040 hr and had been above 500°C for 30,807 hr.

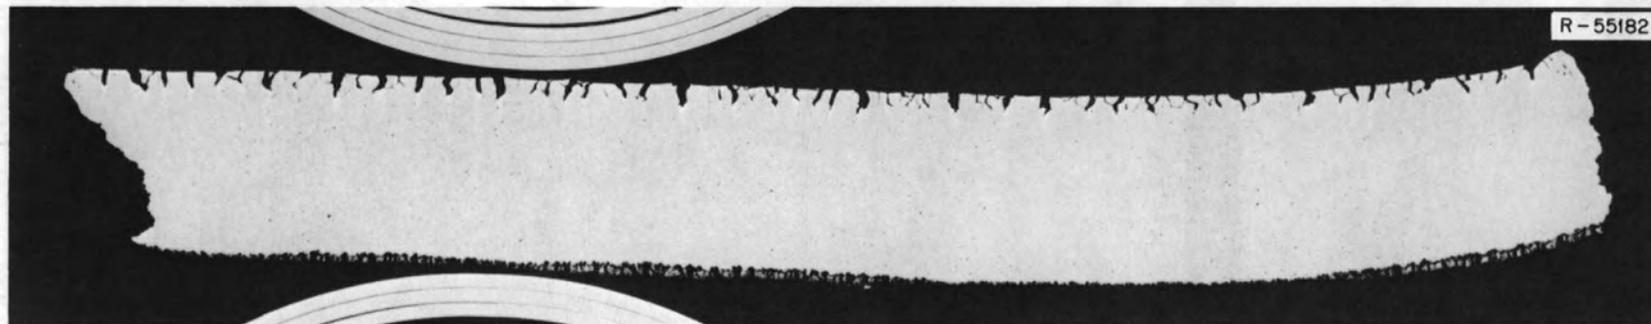
Several of the specimens that had been strained were examined metallographically to determine the extent of cracking during straining. Several photomicrographs of the control rod thimble that was exposed to flowing salt are shown in Fig. 68. The inside surface was oxidized, and the oxide cracked as the specimen was strained. The oxide should be brittle, but it is important that these cracks did not penetrate the metal. The side exposed to the salt exhibited profuse intergranular cracking. Almost every grain boundary cracked, and the cracks generally propagated to a depth of one grain, although there are several instances where the crack depth exceeded a depth of one grain. Several photomicrographs were combined and rephotographed to obtain Fig. 69. This sample had 192 cracks per inch with average and maximum depths of 5.0 and 8.0 mils, respectively. Many of the cracks shown in Fig. 68 and 69 have blunt tips, indicating that they did not propagate into the metal as the specimen was strained.

Fig. 69. Photomicrographs of a Deformed Section of the Control Rod Thimble. The fracture is on the left. The upper surface was in contact with flowing salt and the lower surface was exposed to the cell environment of N_2 plus 2 to 5% O_2 . The sample is about 0.06 in. thick.

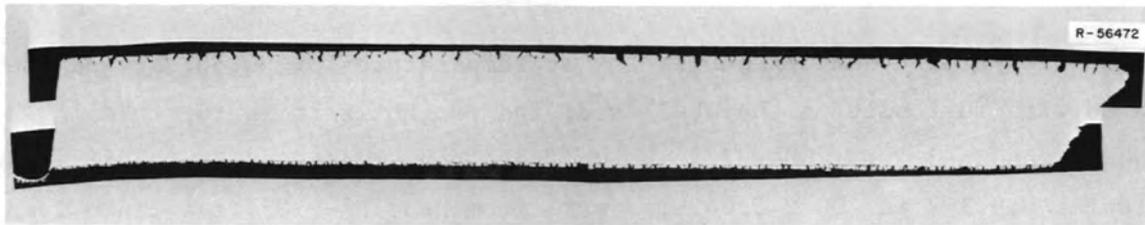
A similar sample was cut from the thimble under the sleeve, where the salt access was restricted. Photomicrographs of a specimen tested at 25°C are shown in Fig. 70. The cracks are quite similar to those in Fig. 68 for a sample that was exposed to flowing salt. The composite photograph in Fig. 71 is quite similar to Fig. 69 of the sample exposed to flowing salt. The sample in Fig. 71 had 257 cracks per inch, with average and maximum depths of 4.0 and 8.0 mils, respectively. The accuracy of our statistics and possible sampling inhomogeneities lead us to conclude that the severity of cracking is equivalent in the samples exposed to flowing and almost static salt. Thus flow rate over the range represented by these two sample locations does not appear to be an important variable.

Fig. 71. Composite Photograph Showing the Density of Cracking Along the Edge of a Portion of the Deformed Control Rod Thimble. 9.5 \times . The sample is 0.58 in. long. The fracture is on the left, the upper surface was exposed to fuel salt, and the lower surface was exposed to the cell environment of N_2 plus 2 to 5% O_2 .

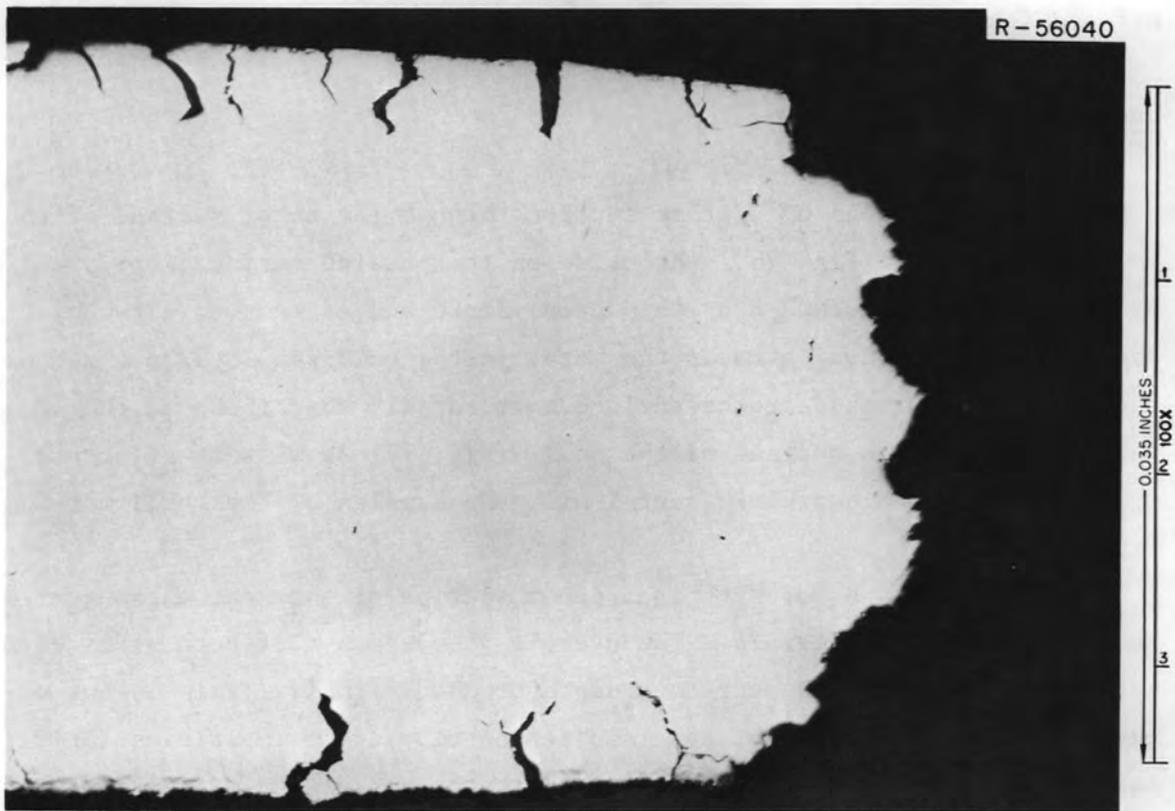
The spacer sleeve gave another opportunity to examine whether a relationship existed between salt velocity and cracking. The photomicrograph in Fig. 72 shows cracks on both sides, with more being present in the field photographed on the side where the salt was rapidly flowing. However, the composite photograph in Fig. 73 shows that the cracking is about equivalent on both sides. Cracking statistics on the side exposed to rapidly flowing salt revealed 178 cracks per inch with a maximum depth of 7.0 mils. The side exposed to restricted salt flow had 202 cracks per inch, with a maximum depth of 5.0 mils. The average depth was 3.0 mils on both sides. These observations again show that salt flow rate is not a significant factor in intergranular cracking.

Fig. 72. Photomicrograph of a Section of Spacer Sleeve Tested at 25°C. As polished. The upper surface was exposed to almost static fuel salt and the lower surface was exposed to rapidly flowing fuel salt.
