INTERGRANULAR CRACKING OF INOR-8 IN THE MSRE

H. E. McCoy

NOVEMBER 1972

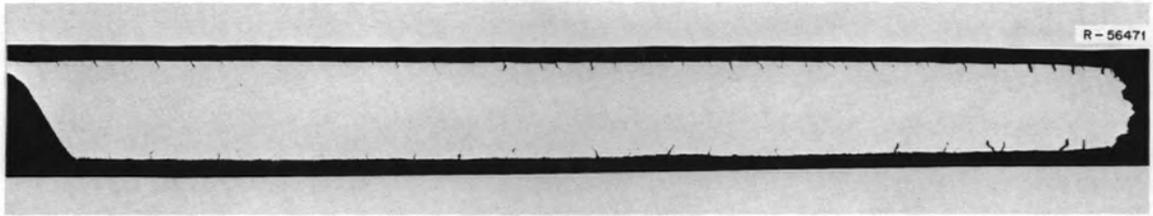
The spacer sleeve gave another opportunity to examine whether a relationship existed between salt velocity and cracking. The photomicrograph in Fig. 72 shows cracks on both sides, with more being present in the field photographed on the side where the salt was rapidly flowing. However, the composite photograph in Fig. 73 shows that the cracking is about equivalent on both sides. Cracking statistics on the side exposed to rapidly flowing salt revealed 178 cracks per inch with a maximum depth of 7.0 mils. The side exposed to restricted salt flow had 202 cracks per inch, with a maximum depth of 5.0 mils. The average depth was 3.0 mils on both sides. These observations again show that salt flow rate is not a significant factor in intergranular cracking.

Fig. 73. Composite Photograph Comparing the Density of Cracking of Sides of Spacer Sleeve Exposed to Almost Static Salt (bottom) and to flowing salt (top). 11x. The sample is 0.52 in. long.

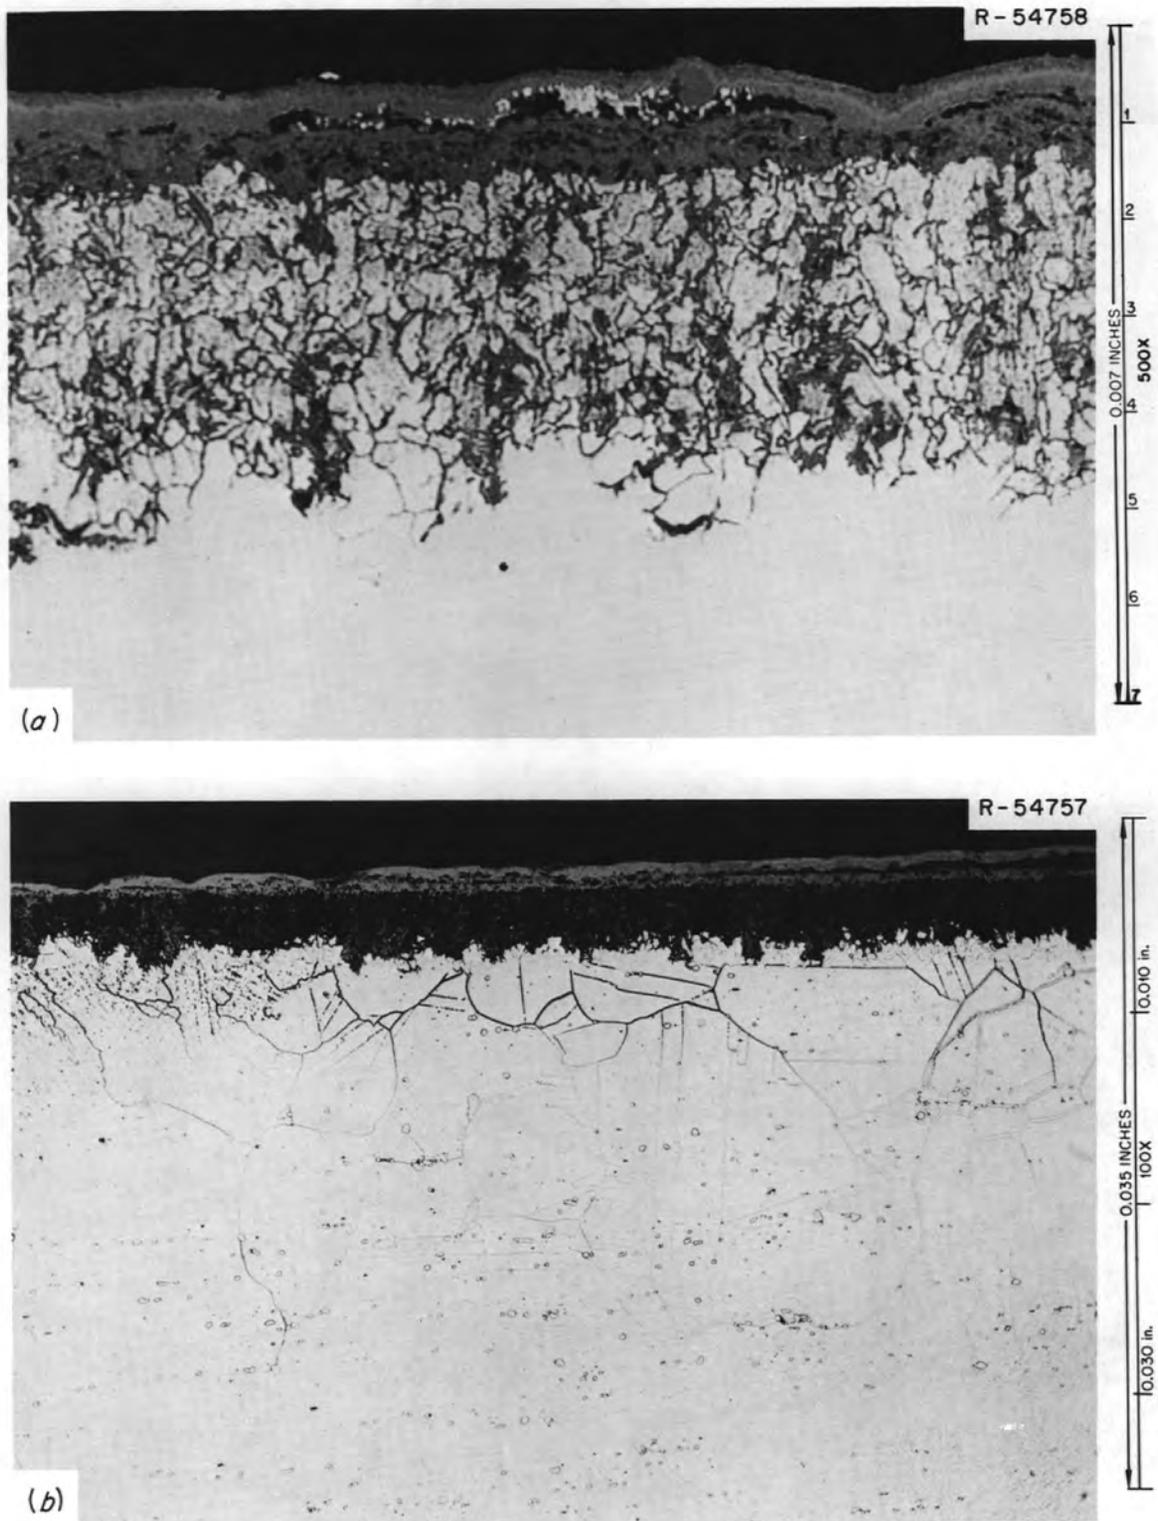
Photomicrographs of a cross section through the outer surface of the shell are shown in Fig. 76. The oxide on the outside surface is typical of that observed on INOR-8 at this temperature and extends to a depth of about 5 mils. Etching attacks the metal in the oxidized layer and etches the grain boundaries near the surface more rapidly than those in the interior. The inside surface of the shell (Fig. 77) shows some structural modifications to a depth of about 1 mil. No samples of the shell were deformed.

Fig. 76. Photomicrographs Showing the Outside Edge of the Primary Heat Exchanger Shell. This surface was exposed to 2 to 5% O_2 in N_2 . (a) As polished, showing the selective oxidation that occurred. (b) Etched view showing that the metal in the oxidized layer was completely removed. Etched with aqua regia.

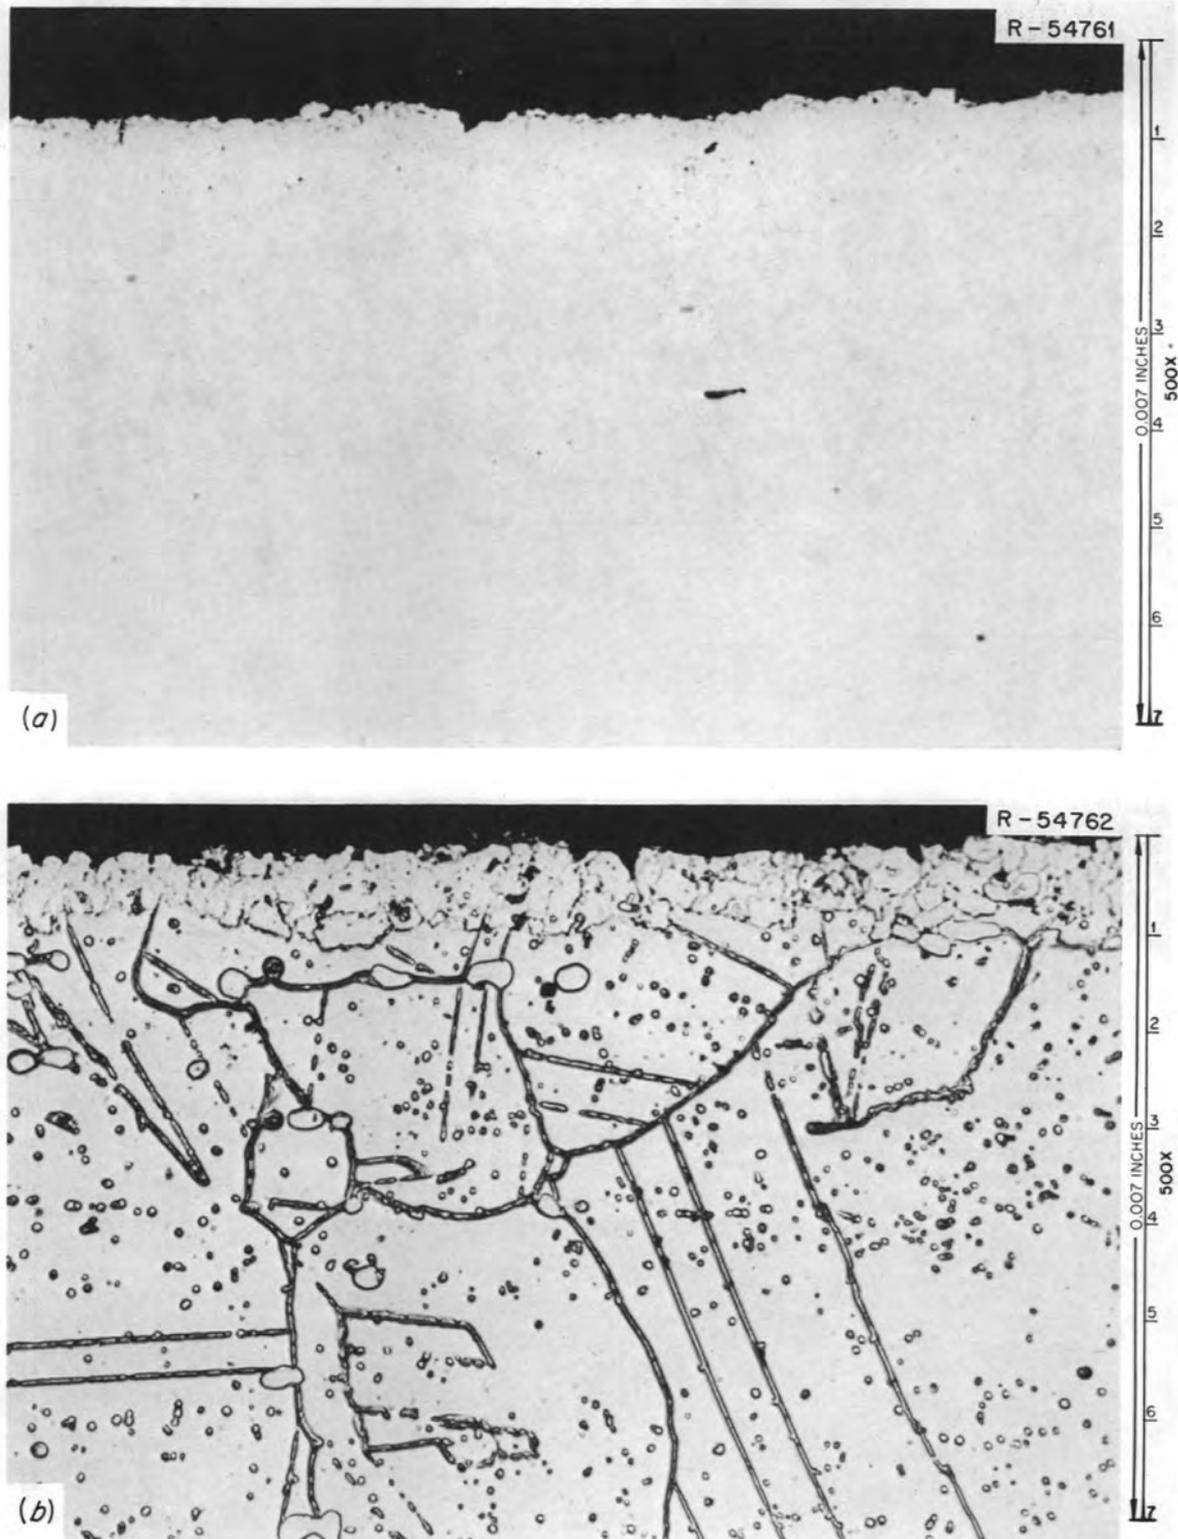
Fig. 77. Photomicrographs of the Inside Surface of the Primary Heat Exchanger Shell. The surface was exposed to fuel salt, and the modified structure to a depth of about 1 mil is apparent. (a) As polished. (b) Etched with aqua regia.

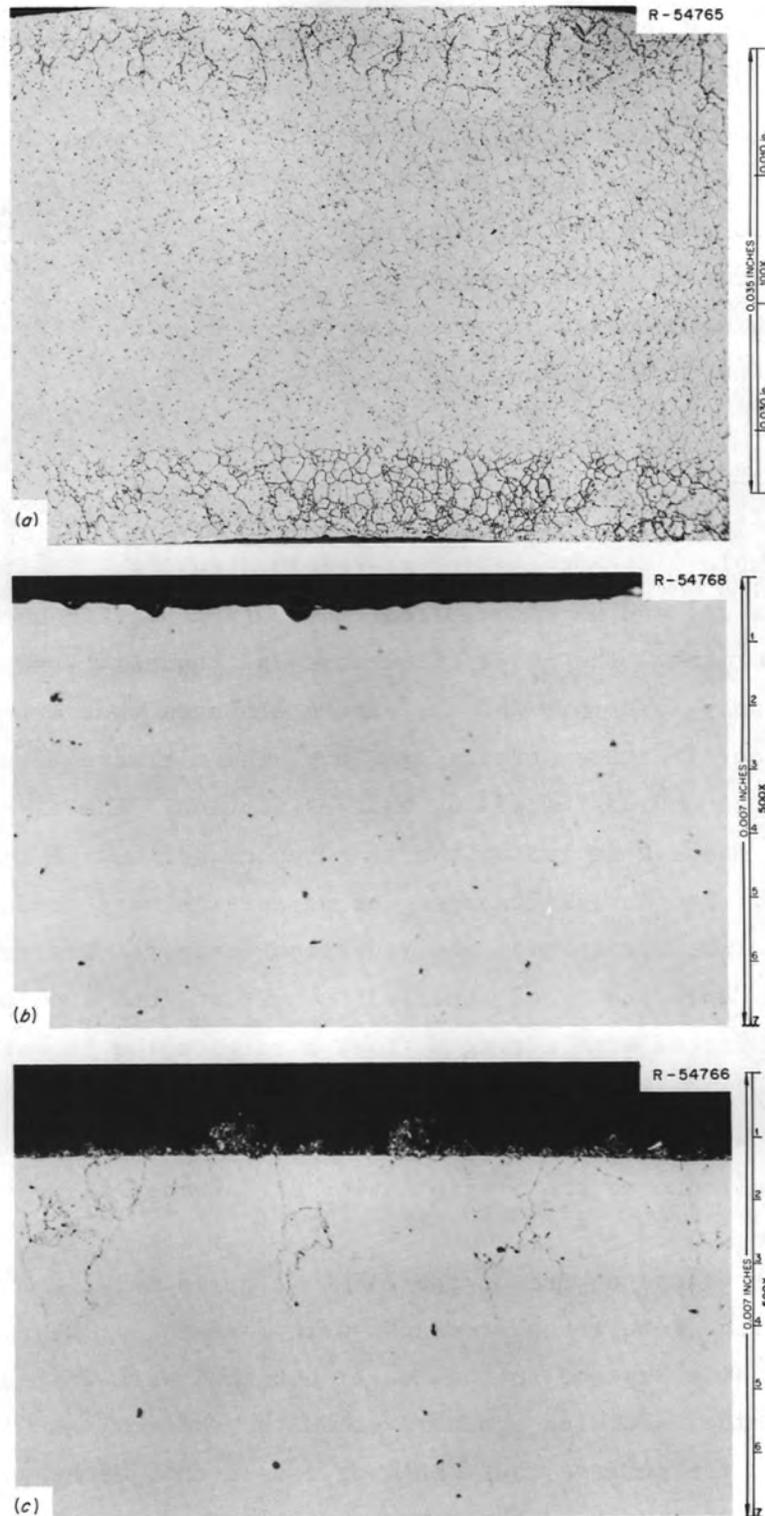
Photomicrographs of a typical cross section of the heat exchanger tubing are shown in Fig. 78. The overall view shows that both sides etch more rapidly than the center to a depth of about 7 mils. This is not unusual for a tubular product and is often attributed to impurities (primarily lubricants) that are worked into the metal surface during repeated steps of deformation and annealing. The higher magnification views in the as-polished condition show that grain boundary attack (or cracking) occurred on the surface exposed to fuel salt (outer) but not on the coolant side (inner). The temperatures under normal operating conditions were such that the fuel salt side (OD) would have been in compression.

Fig. 78. Photomicrographs of a Cross Section of an INOR-8 Heat Exchanger Tube. (a) Etched with glyceria regia. (b) Inside surface in the as-polished condition after exposure to coolant salt. (c) Outside surface in the as-polished condition after exposure to fuel salt. Reduced 34%.

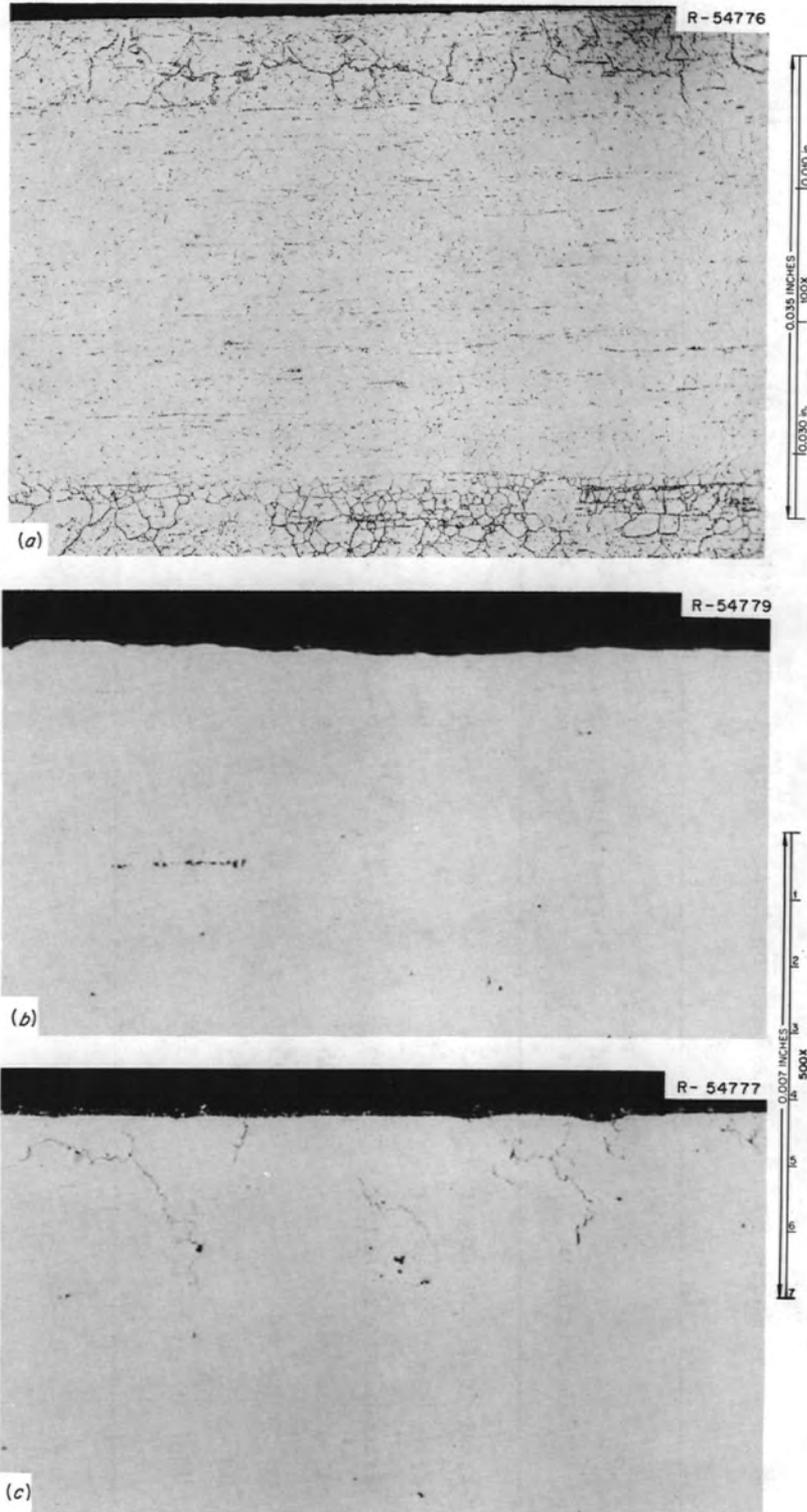
Similar photomicrographs of a longitudinal section of tubing are shown in Fig. 79. The features are quite similar to those discussed for Fig. 78. Both figures show some metallic deposits on the outside surface, which was exposed to fuel salt. These deposits are extremely small and could not be analyzed with much accuracy with the in-cell microprobe. However, they seemed to be predominately iron. Scanning across the tubing detected no concentration gradients of the major alloying elements in INOR-8.

Fig. 79. Photomicrographs of a Longitudinal Section of an INOR-8 Heat Exchanger Tube. (a) Etched with glyceria regia. (b) Inside surface in the as-polished condition after exposure to coolant salt. (c) Outside surface in the as-polished condition after exposure to fuel salt. Reduced 31%.

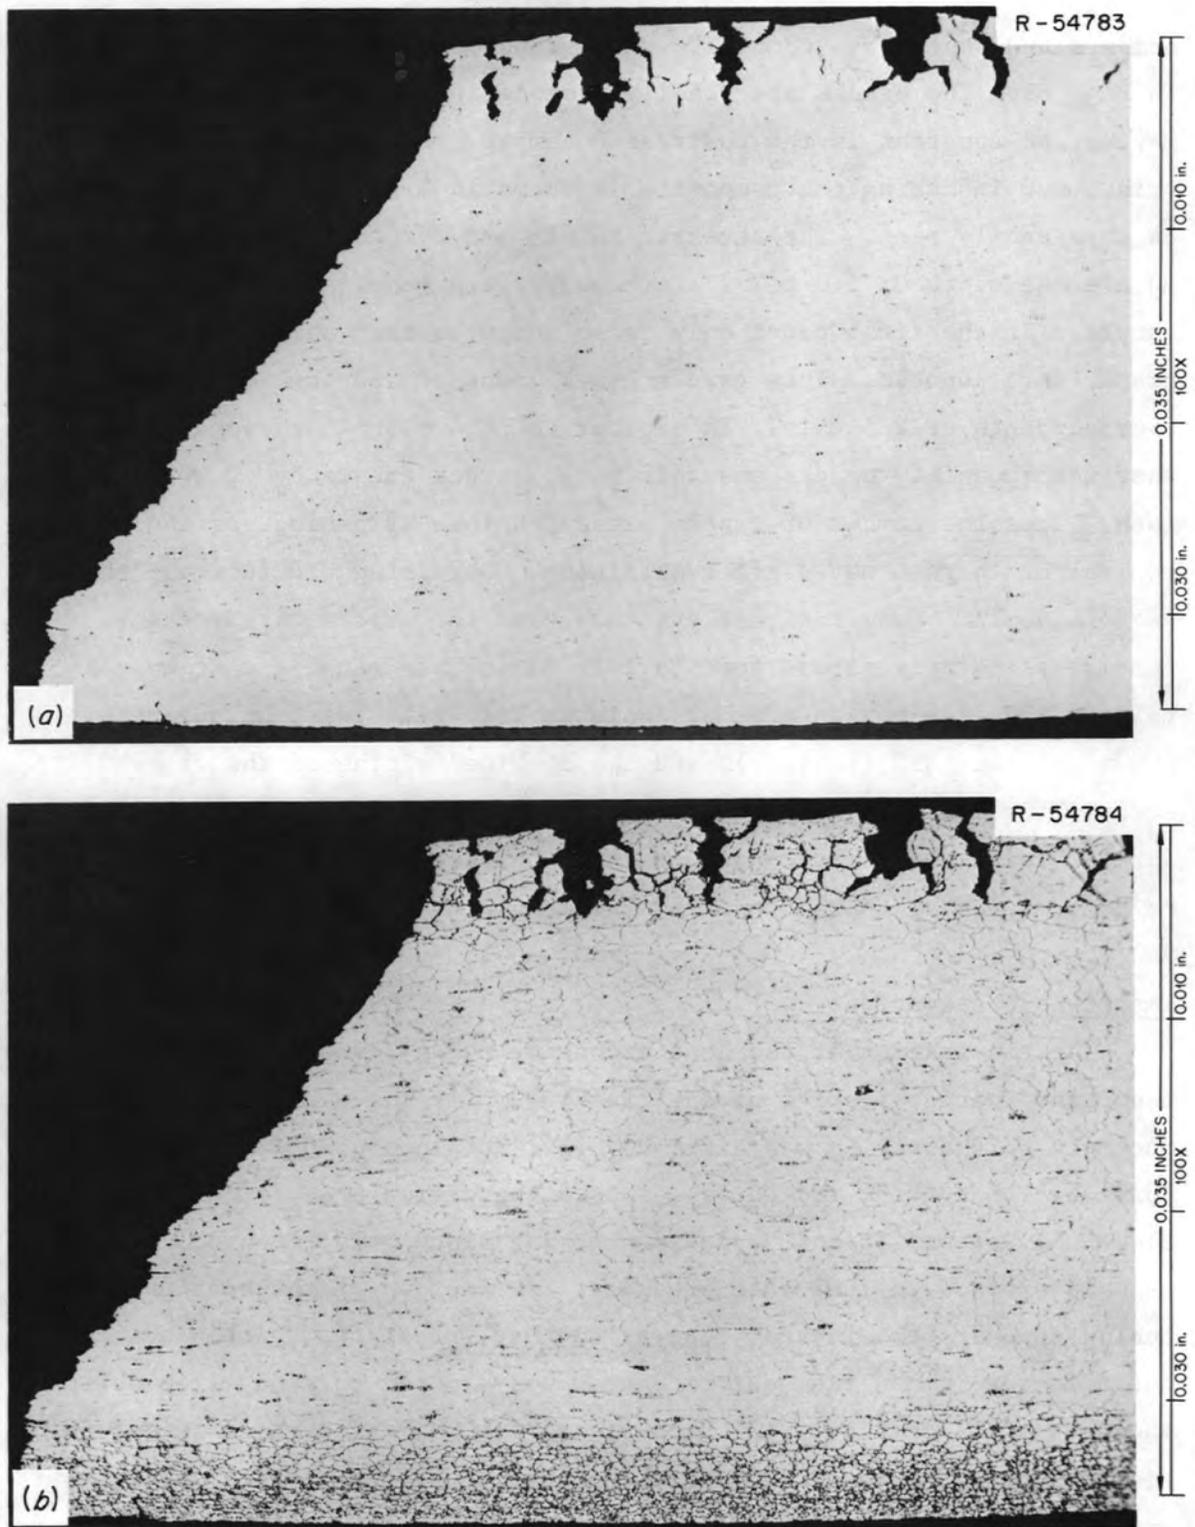
Photomicrographs of one of the tubes deformed at 25°C are shown in Fig. 80. Profuse intergranular cracks were formed to a depth of about 5 mils on the side exposed to fuel salt, but none were formed on the coolant salt side. Etching again revealed the abnormal etching characteristics near the surface, but whatever caused this etching characteristic did not result in grain boundary embrittlement.

Fig. 80. Photomicrographs of a Heat Exchanger Tube Deformed to Fracture at 25°C. (a) As polished. (b) Etched with aqua regia.

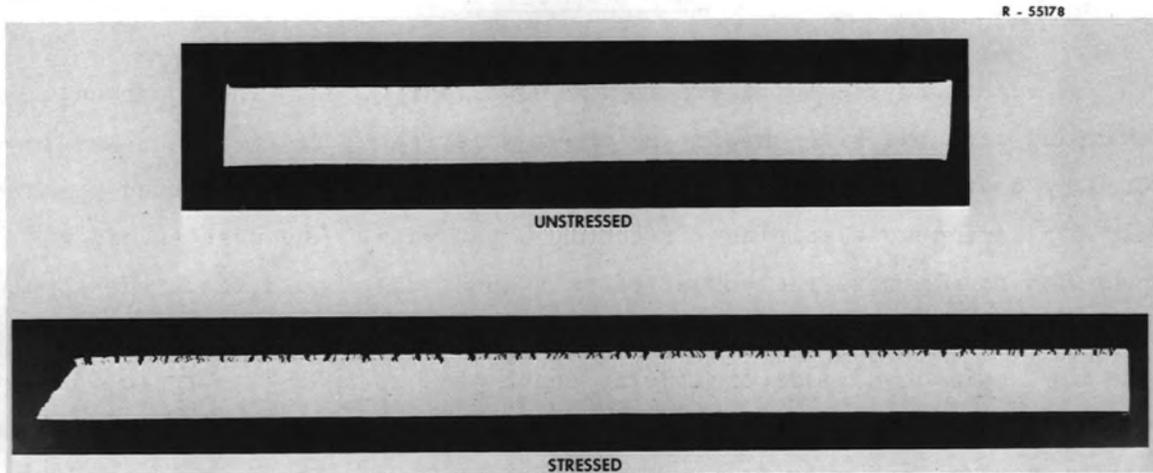
numbers and depths. A composite photograph of the two samples is shown in Fig. 81. The cracks are readily visible in the stressed sample but may not be apparent in the unstressed sample. A higher magnification print used in making the composite is shown in Fig. 82; the cracks can be more easily seen. The stressed sample had 262 cracks per inch with an average depth of 5.0 mils. Two counts were made on the unstressed sample. In the first count only those features that unequivocally were cracks were counted. This gave a crack count of 228 per inch with an average depth of 2.5 mils. In another count, we included some features that were possibly cracks and this gave a crack frequency of 308 per inch. Thus the number of cracks present before straining was about equivalent to that noted after straining. Straining did increase the *visible* depth. Some indirect evidence that the cracks were present initially and only spread open further during the tensile test was obtained from examination of the sample in Fig. 81. The sample length shown deformed 39% (Table 9), and the combined widths of the cracks account for 35% strain. Thus, the cracks widths very closely account for the total strain and indicate that the cracks formed with little or no deformation and spread open as the sample was deformed.

Fig. 81. Composite Photographs of Heat Exchanger Tubing Before and After Stressing. The width of the unstressed sample is 0.042 in.

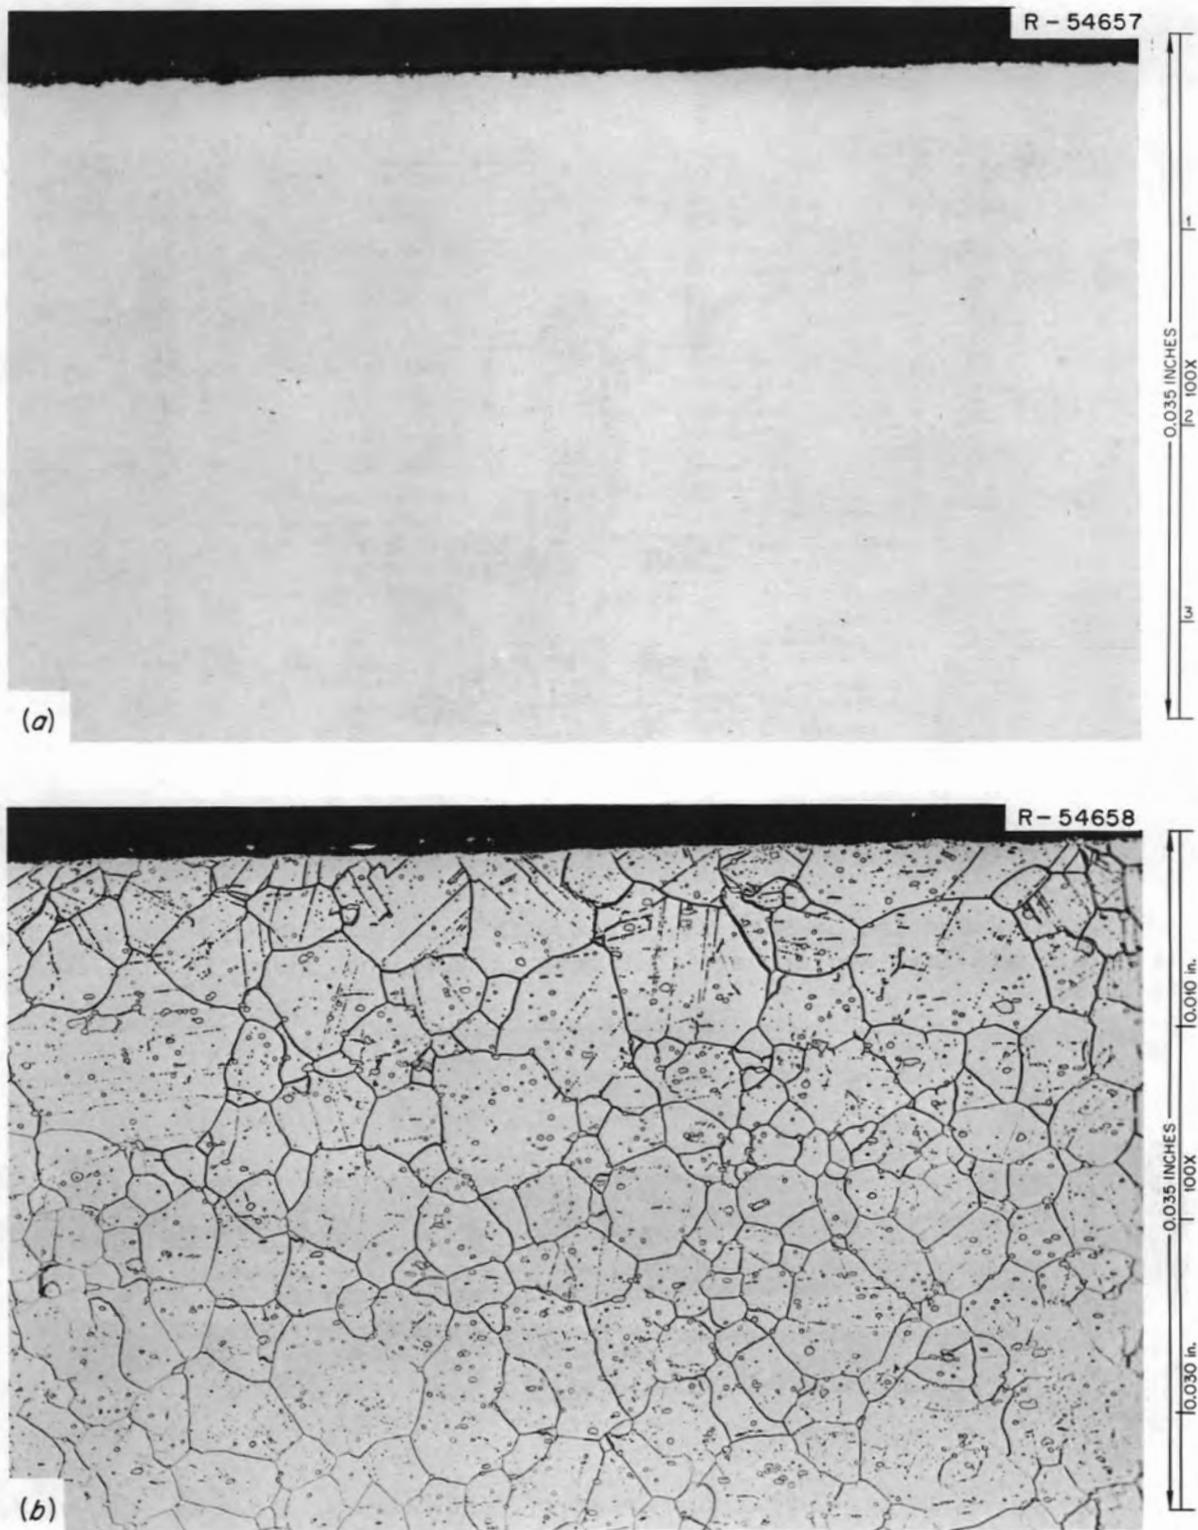
One of the sampler cage rods was examined metallographically. Photomicrographs of samples from the vapor and liquid regions are shown in Fig. 85 and 86, respectively. There is no intergranular penetration visible at this magnification. A heavy surface deposit is on the sample from the liquid region. This deposit was not examined by the electron microprobe analyzer, but a similar deposit on a copper capsule taken from

Fig. 85. Photomicrographs of an INOR-8 Rod from the Sampler Assembly Located Above the Normal Salt Level. (a) As-polished. (b) Etched with aqua regia.

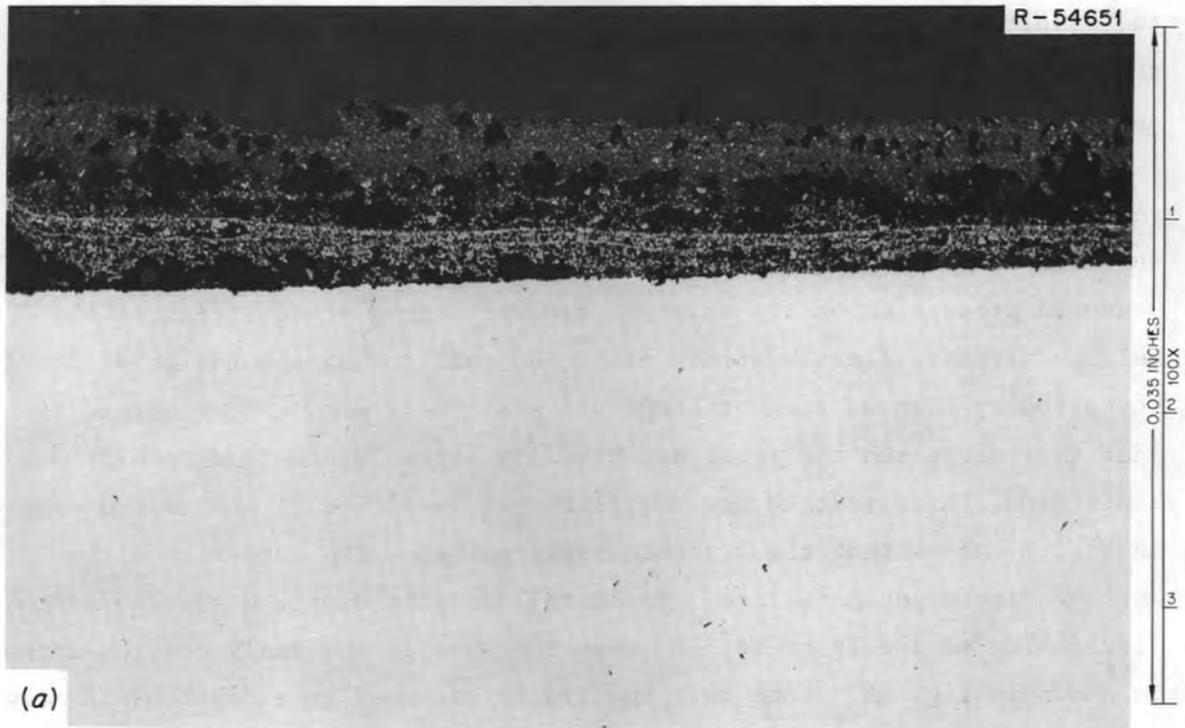
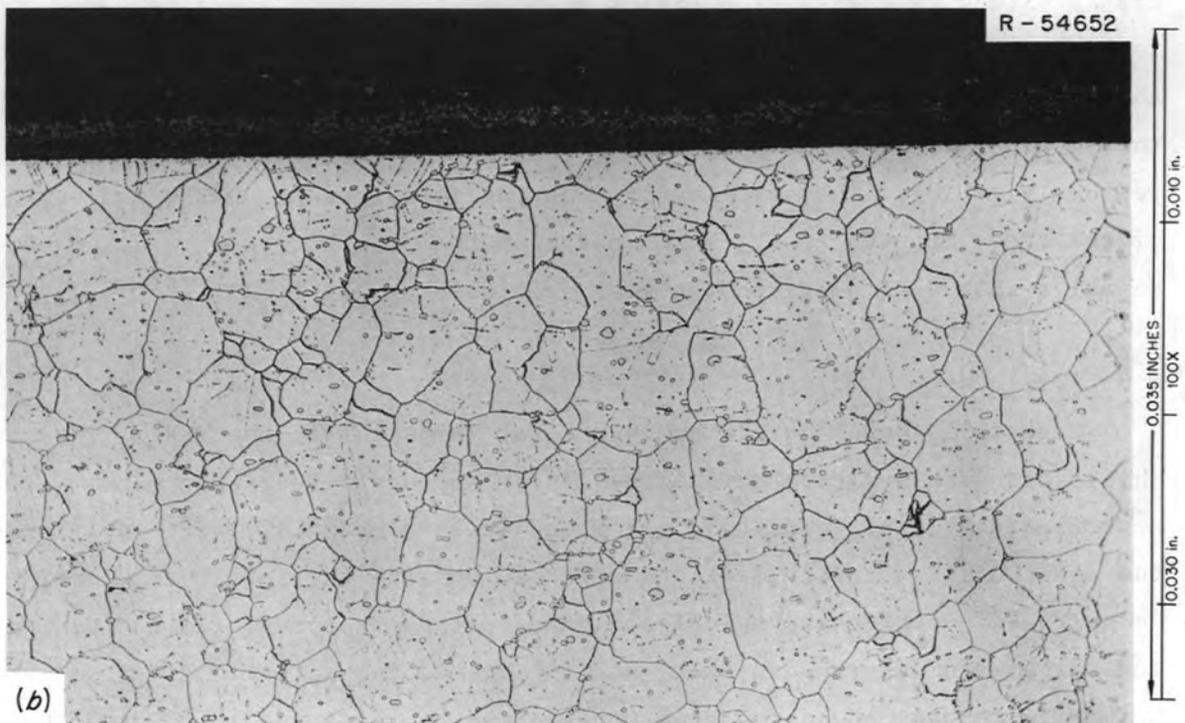
Fig. 86. Photomicrographs of an INOR-8 Rod from the Sampler Assembly. Normally located below the salt level. (a) As polished. (b) Etched with aqua regia.

the sampler region was examined. The deposit contained some salt, but had regions that were high in the alloying elements in INOR-8: Ni, Cr, Fe, and Mo.

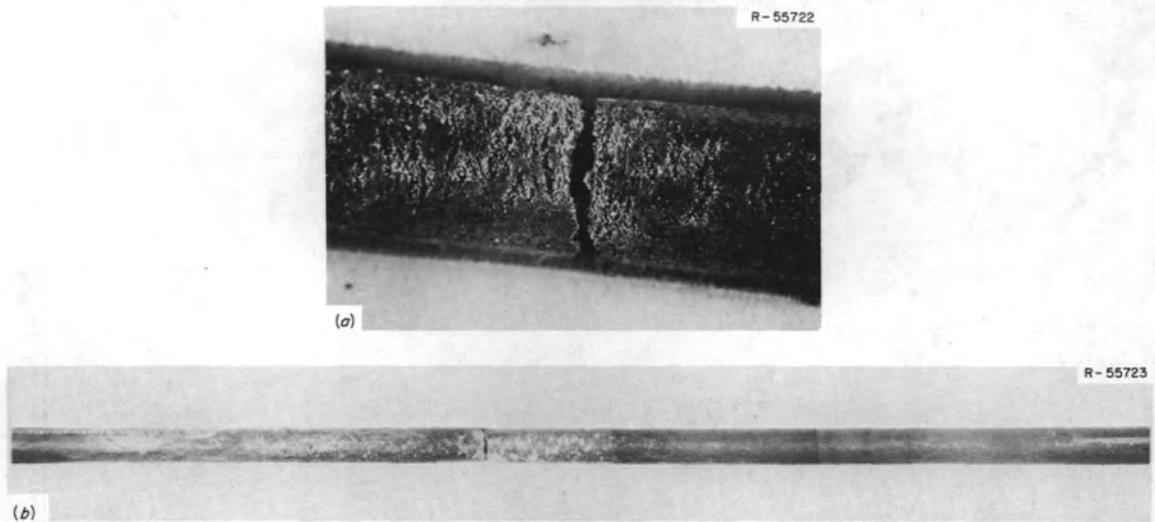
One of the sampler cage rods was pulled in tension at 25°C. The certified properties of this material were a yield stress of 51,200 psi, an ultimate tensile stress of 115,300, and an elongation of 51%. The measured properties of the sampler cage rod were a yield stress of 42,500 psi, an ultimate tensile stress of 93,400 psi, and an elongation of 35.7%. The property changes are not large and are likely due to some stress relief that decreased the yield and ultimate stress values and carbide precipitation, which reduced the ductility. A composite of the tested sample in Fig. 87 shows that the fracture occurred below the center near the average liquid-gas interface. One metallographic sample was taken on the liquid side of the fracture. A composite showing the badly cracked edges is shown in Fig. 88. Note that the cracks extended to a depth of 12 mils. A higher magnification view of an area near the fracture shows that the cracks extend in excess of 3 grains deep and that several grains have fallen out (Fig. 89). Another metallographic sample was taken 3/4 in. above the fracture. A composite of photographs along the edge shows that the depth of cracking decreases with increasing distance into the vapor region (Fig. 90). The severity of cracking is different on the two edges of the rod. Unfortunately, we do not know the orientation of the rod relative to the sampler and the mist shield.

Fig. 87. (a) Tensile-tested Sampler Cage Rod from Pump Bowl. Rupture occurred near the average liquid-vapor interface. (b) Photograph of rupture area showing extensive surface cracking. Rod diameter is $1/4$ in.

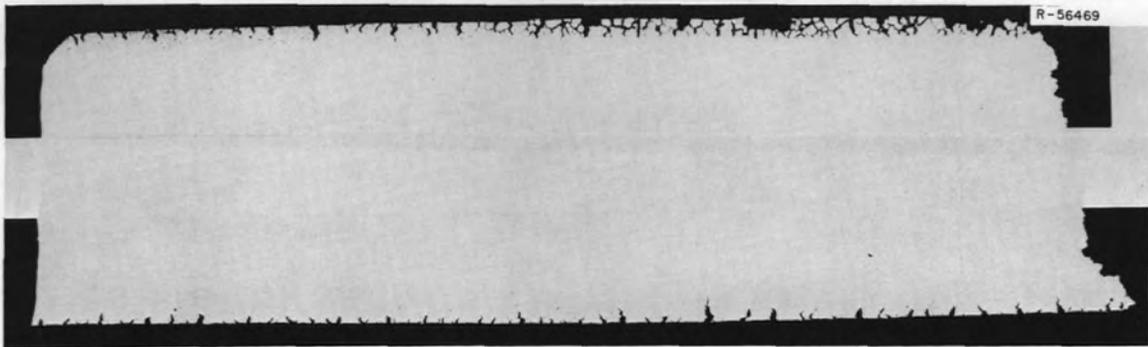
Fig. 88. Section of Sample Cage Rod that was Deformed at 25°C . $9.2\times$. The fracture (left) occurred at the salt-vapor interface. The rod is immersed further in the liquid from left to right. The length of the sample is 0.63 in.

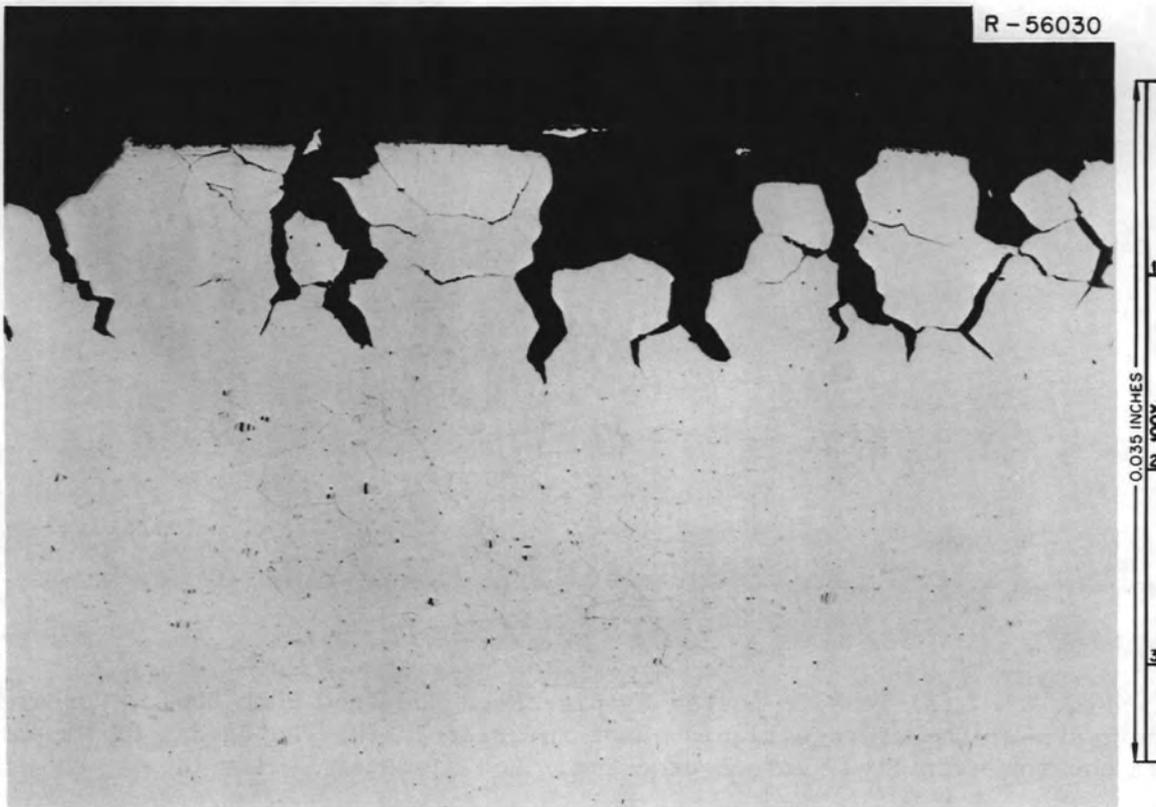
Fig. 89. Photomicrograph of Deformed Sampler Cage Rod Near the Fracture. As-polished.

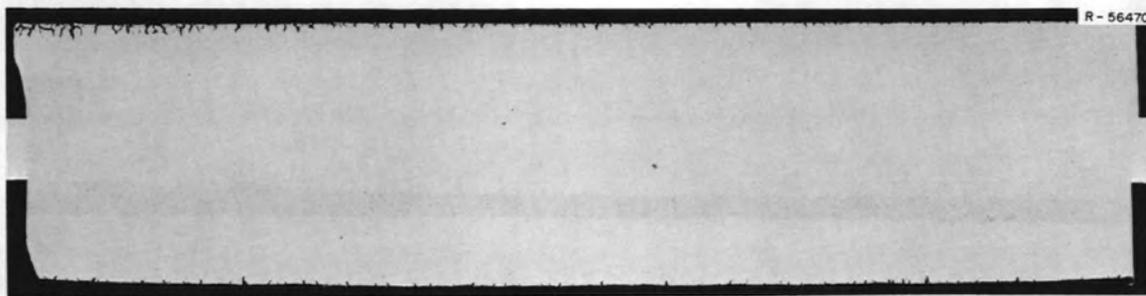
Fig. 90. Composite of Photomicrographs of Sampler Cage Rod that was Strained at 25°C. 8.2x. Left end of sample was 3/4 in. from fracture. The rod progressed further into the vapor region from left to right. The sample length is 0.72 in.

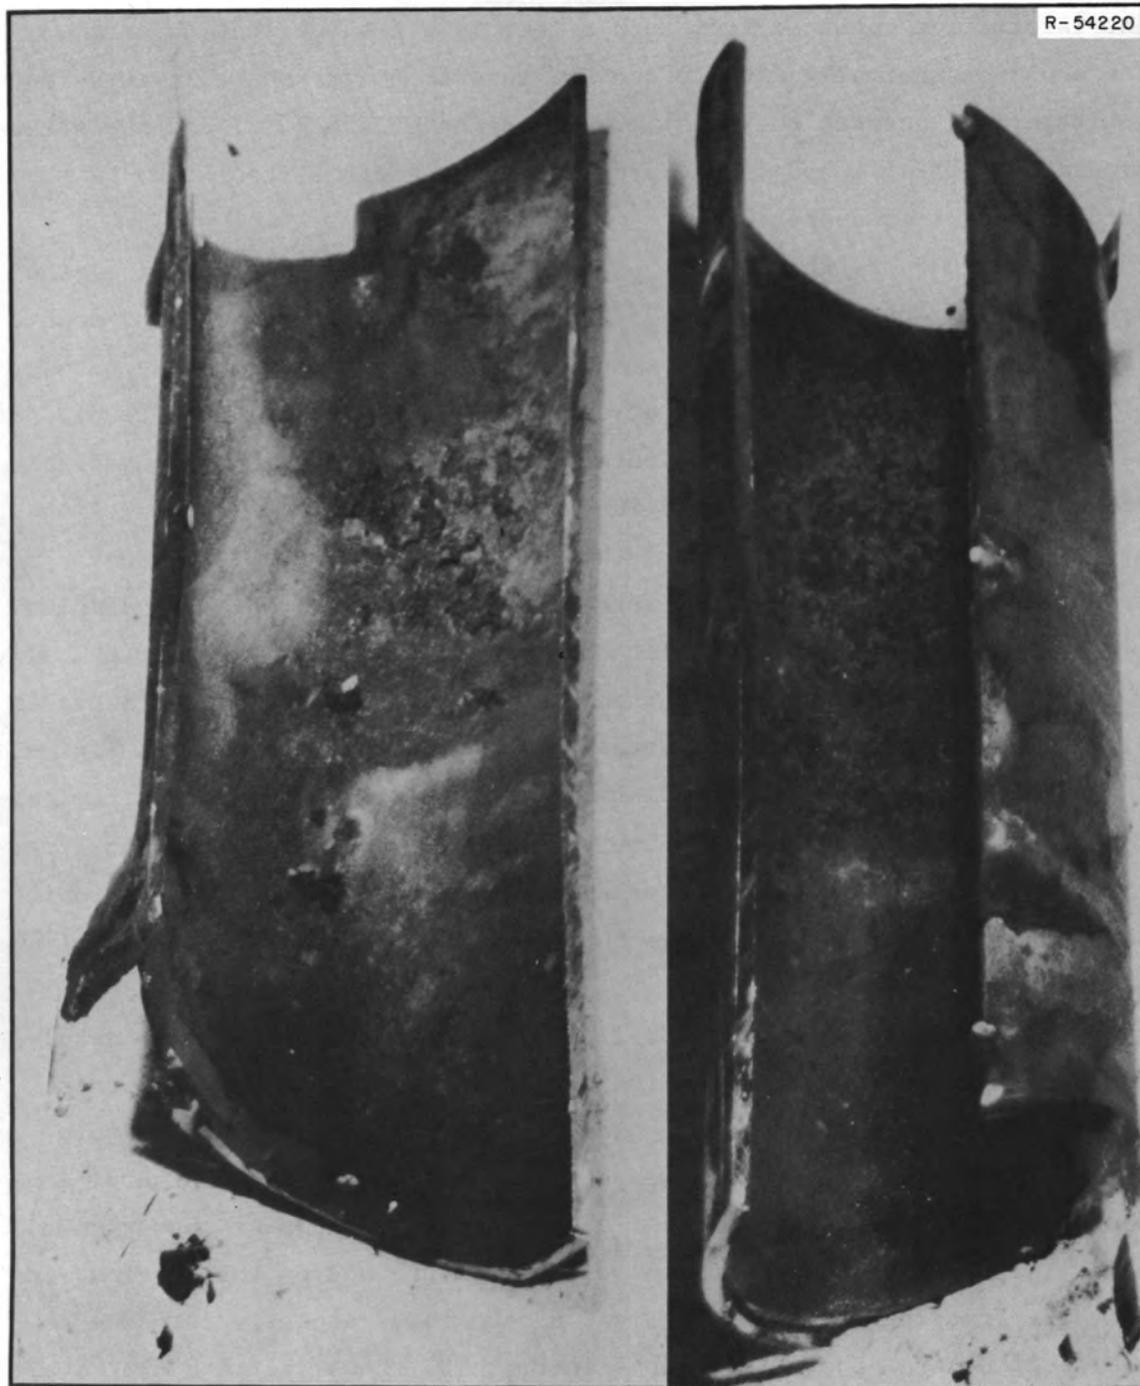
Figure 91 shows the mist shield after removal from the MSRE. The shield has been split to reveal the inside surface. Four specimens approximately 1 in. (vertical) × 1/2 in. (circumferential) were cut from the mist shield. Their locations were (1) outside the spiral and immersed in salt, (2) outside the spiral and exposed to salt spray, (3) inside the spiral and immersed in salt, and (4) inside the spiral and exposed primarily to gas. Bend tests were performed on these specimens at 25°C using a three point bend fixture.²² They were bent about a line parallel

Fig. 91. Interior of Mist Shield. Right part of right segment overlapped left part of segment on left.

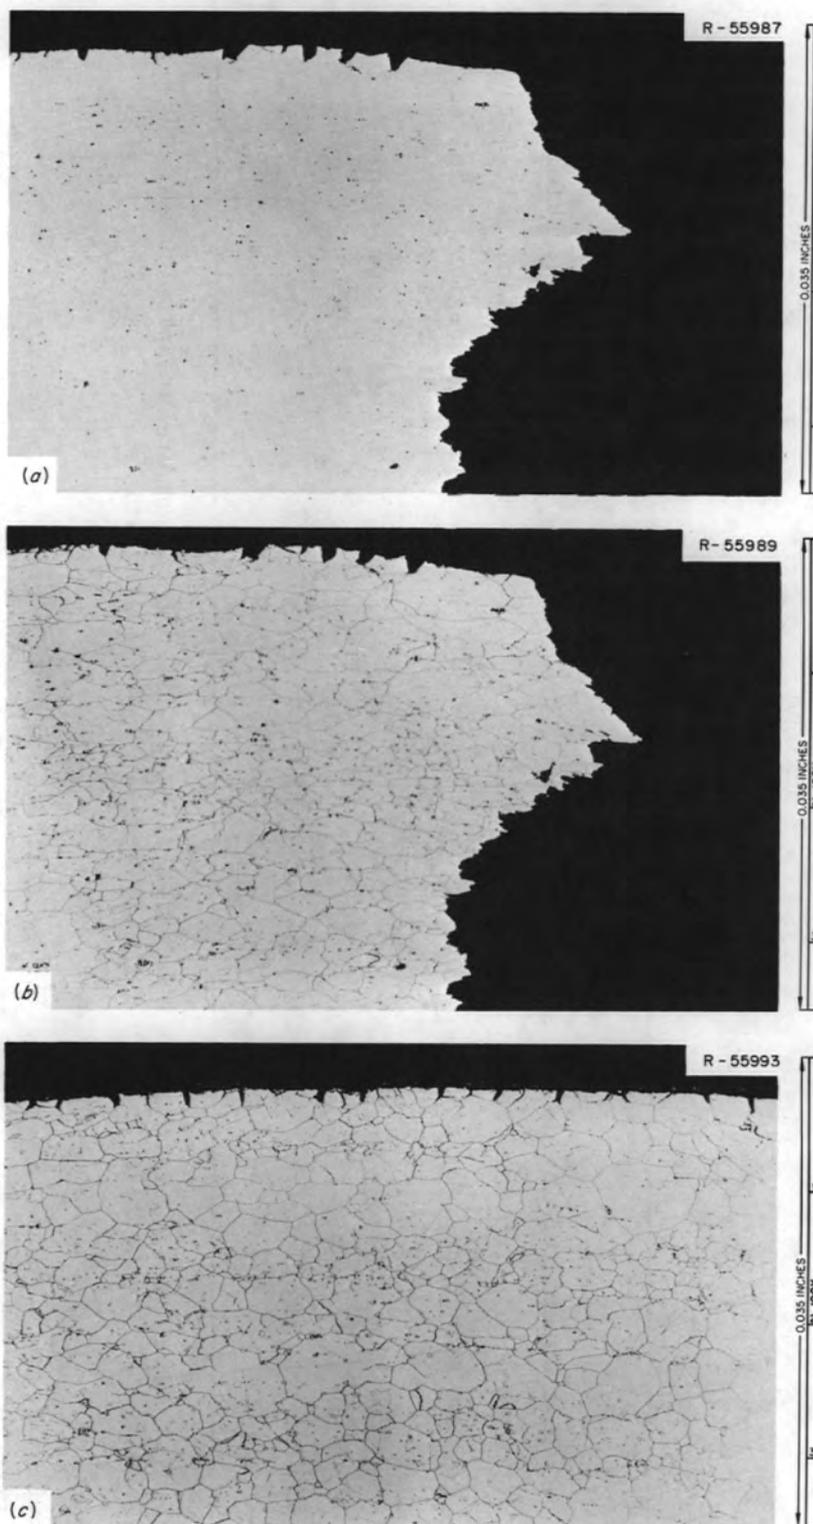
The bend samples of the mist shield were examined metallographically. Photomicrographs of the sample from the inside vapor region are shown in Fig. 92, and a composite of several photomicrographs is shown in Fig. 93. The edge cracks were intergranular and about 1 mil deep. The photomicrographs of the sample from the liquid region (Fig. 94) show that the cracks extended to a depth of about 8 mils in the liquid region. The composite photograph in Fig. 95 also shows the increased frequency and depth of cracking in the liquid region.

Fig. 92. Photomicrographs of Bend Specimen of Mist Shield from Inside Vapor Region. (a) Fracture and tension side, as polished. (b) Fracture and tension side, etched. (c) Tension side, etched. Etchant: Aqua regia. Reduced 31%.

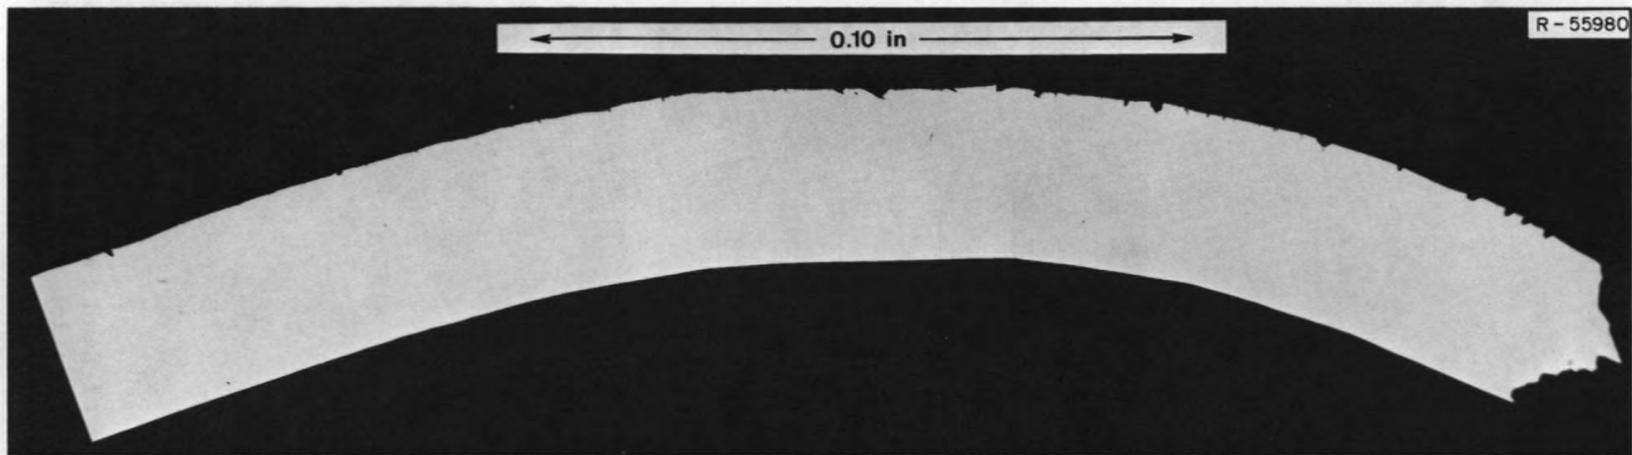
Fig. 93. Composite Photograph of the Tension Side of a Bend Sample from Inside Vapor Region of Mist Shield. Lower edge is not the compression side of the sample.

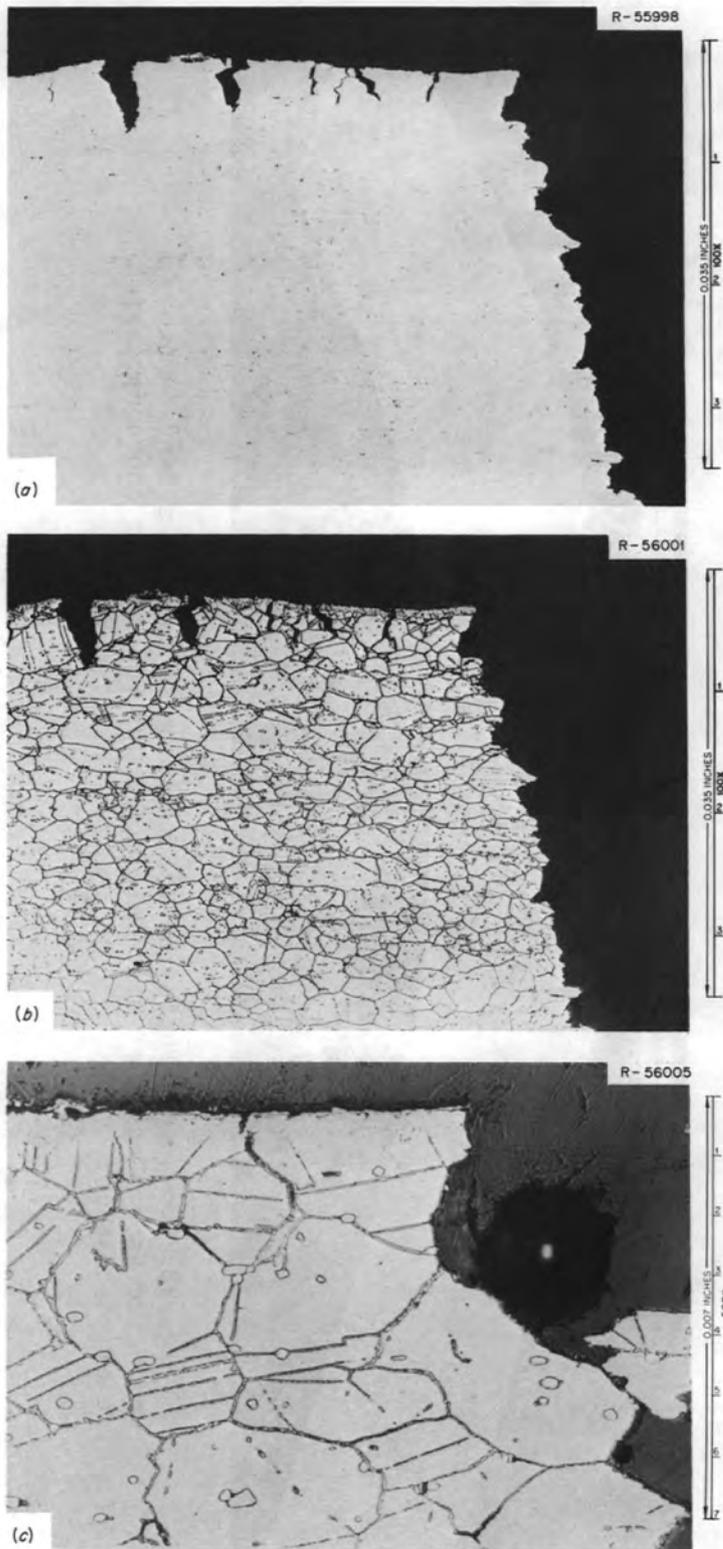
Fig. 94. Photomicrographs of Bend Specimen of Mist Shield from Inside Liquid Region. (a) Fracture and tension side, as polished. (b) Fracture and tension side, etched. (c) Fracture and tension side, etched. Etchant: Aqua Regia.

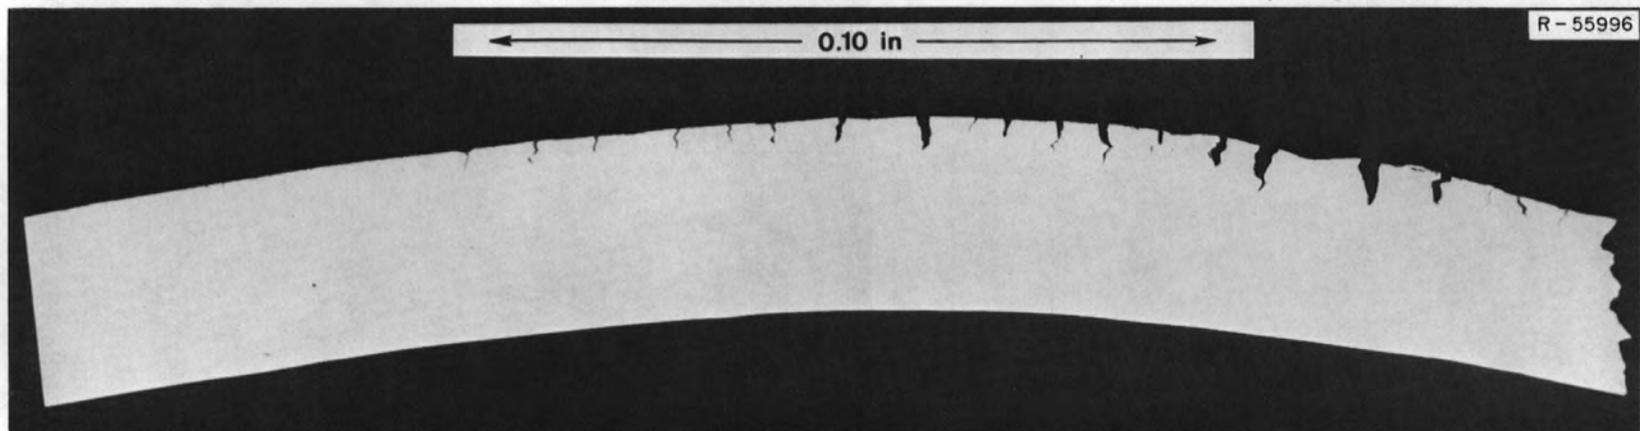
Fig. 95. Composite Photograph of the Tension Side of a Bend Sample from Inside Liquid Region of Mist Shield. Lower Edge is not the compression side of the sample.
