INTERGRANULAR CRACKING OF INOR-8 IN THE MSRE

H. E. McCoy

NOVEMBER 1972

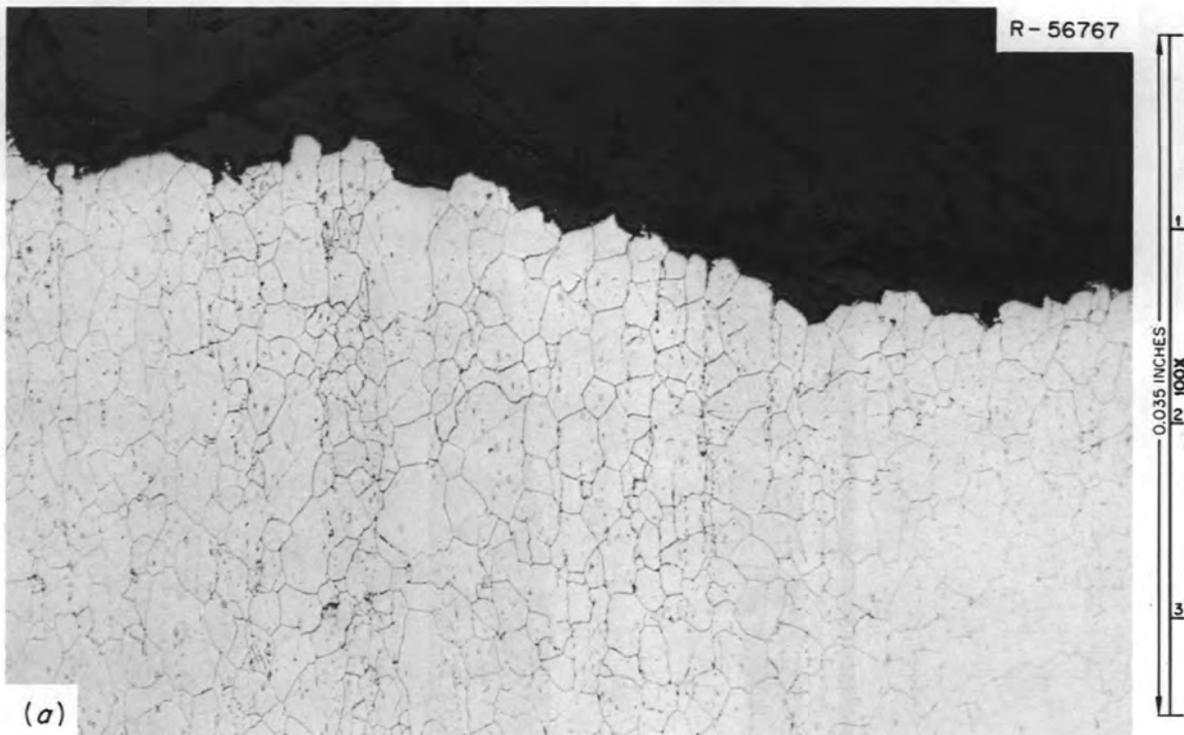
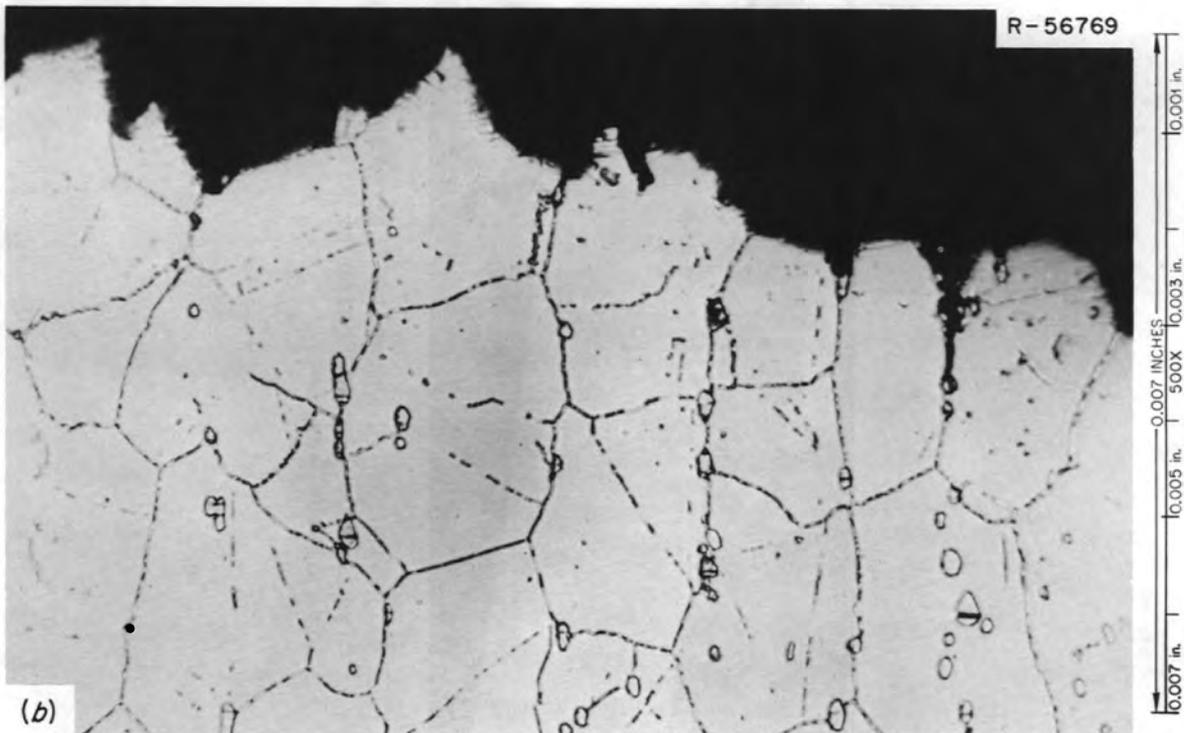
The sample from the outside liquid region was quite similar metallographically to that from the inside liquid region. Photomicrographs of the fracture and a typical region of the tension near the fracture are shown in Figs. 96 and 97, respectively. A composite of several photomicrographs is shown in Fig. 98. Photomicrographs of the outside vapor (salt spray) bend specimen at the fracture and on the tension side near the fracture are shown in Figs. 99 and 100, respectively. The composite of several photomicrographs in Fig. 101 shows that the cracks are not much deeper nor more frequent than in the liquid regions (compare Figs. 95, 98, and 101), but the tendency for grains to fall out is much greater. This is even more significant when one notes that the strain was the least in the sample from the outside vapor region (Table 10).

Fig. 96. Photomicrographs of the Fracture of a Bend Specimen from the Outside Liquid Region of the Mist Shield. (a) 100x. (b) 500x. Etchant: Lactic acid, HNO_3 , HCl .

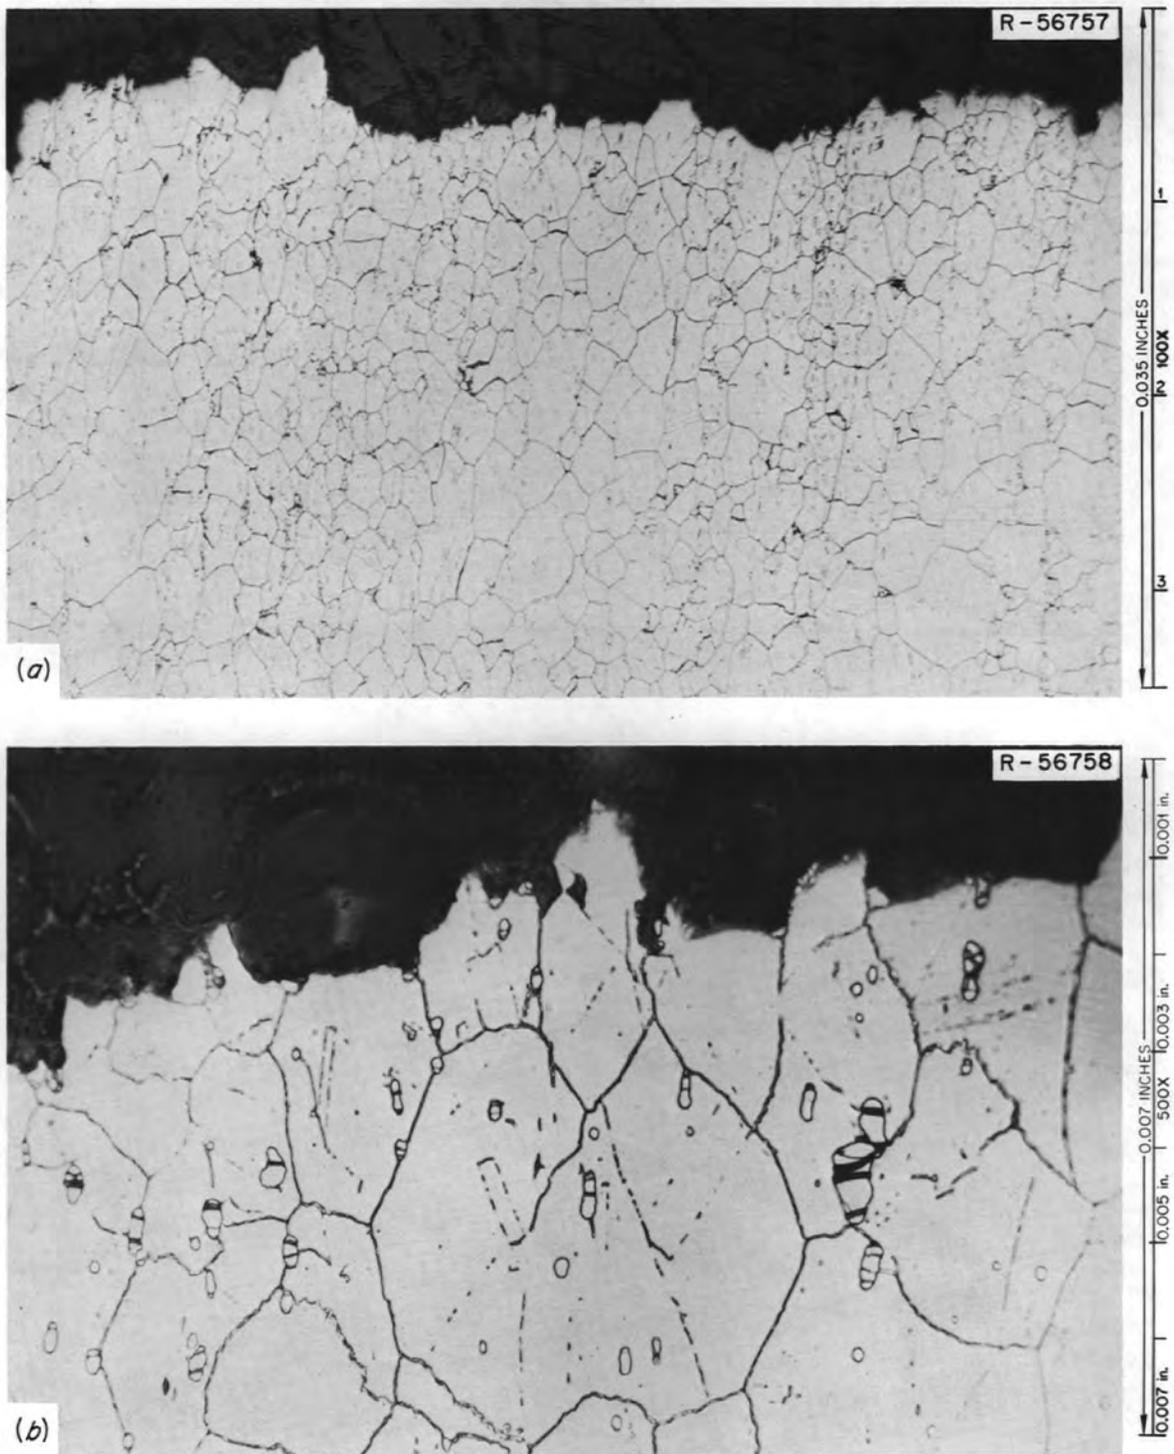
Fig. 99. Photomicrographs of the Fracture of a Bend Specimen from the Outside Vapor Portion of the Mist Shield. (a) 100 \times . (b) 500 \times . Etchant: Lactic acid, HNO₃, HCl.

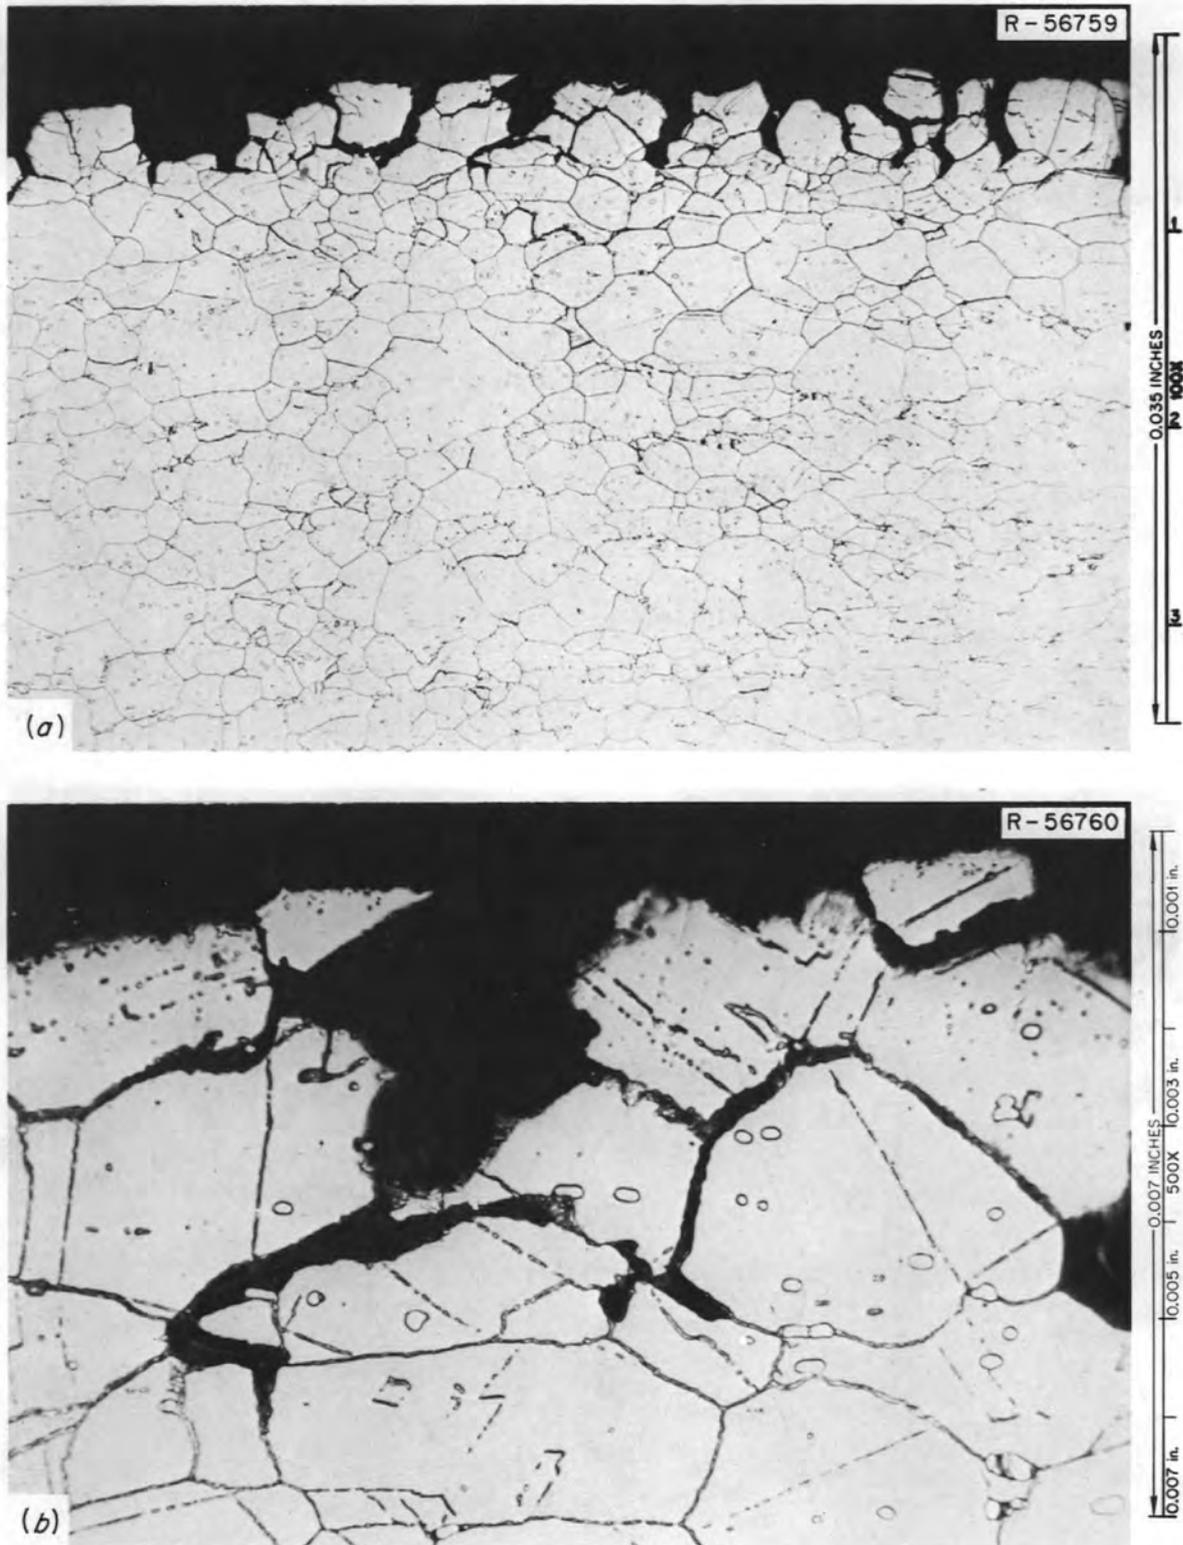
Fig. 100. Photomicrographs of the Edge Near the Fracture of a Bend Specimen from the Outside Vapor Portion of the Mist Shield. (a) 100 \times . (b) 500 \times . Etchant: Lactic acid, HNO_3 , HCl .

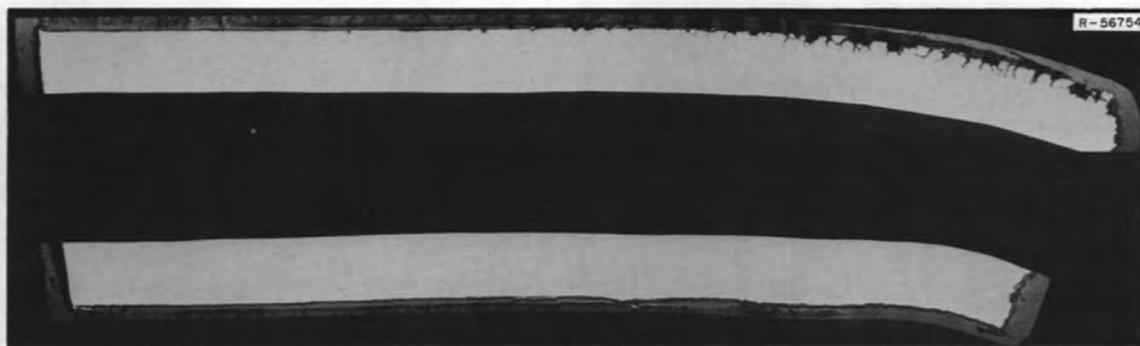
Fig. 101. Composite of Several Photomicrographs of a Bend Specimen From the Outside Vapor Region of the Mist Shield. Top portion is the tension side and the lower part is the compression side. 15 \times .

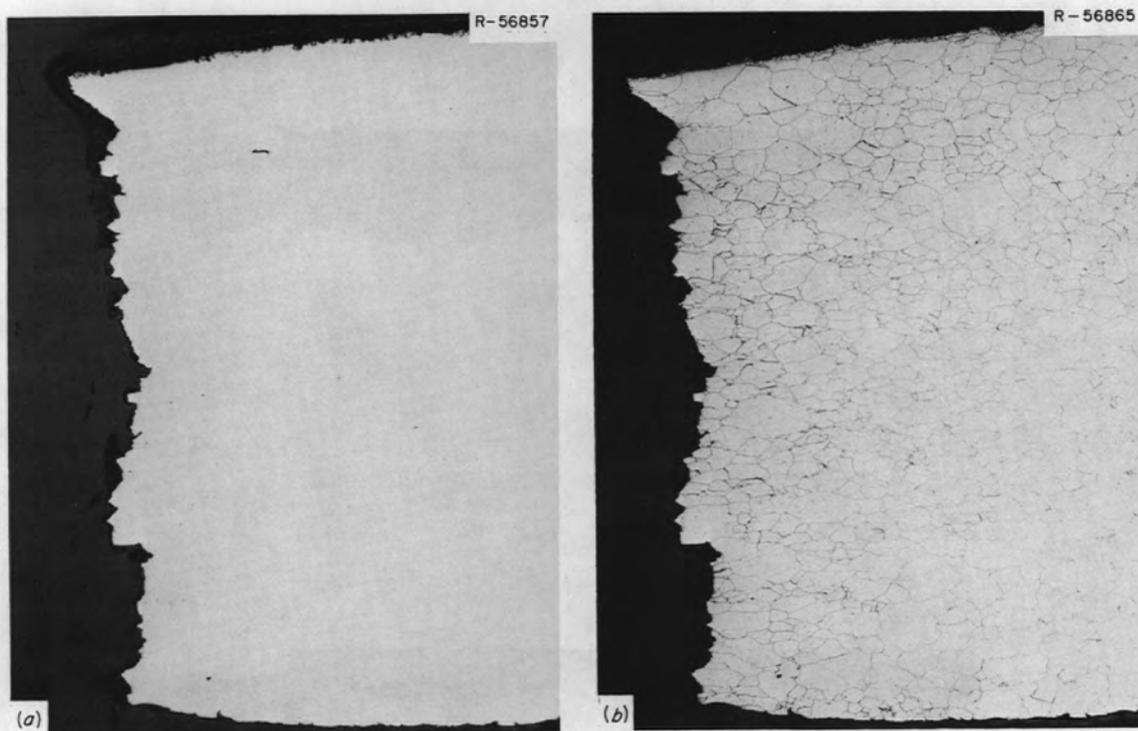
A metallographic section of one of the ring specimens is shown in Figs. 103 and 104. The fracture and both edges are visible in Fig. 103. The oxide is on the outside surface that was exposed to air (top) and shallow cracks formed on the salt side. Typical edges near the fracture are shown in Fig. 104. The cracks on the air side followed the oxide and did not penetrate further. The cracks on the salt side were intergranular and penetrated about 1 mil.

Fig. 103. Photomicrographs of the Fracture of a Ring Specimen from Freeze Valve 105 that was Deformed at 25°C. (a) As polished. (b) Etchant: Lactic acid, HNO_3 , HCl . 40 \times . Reduced 29.5%.

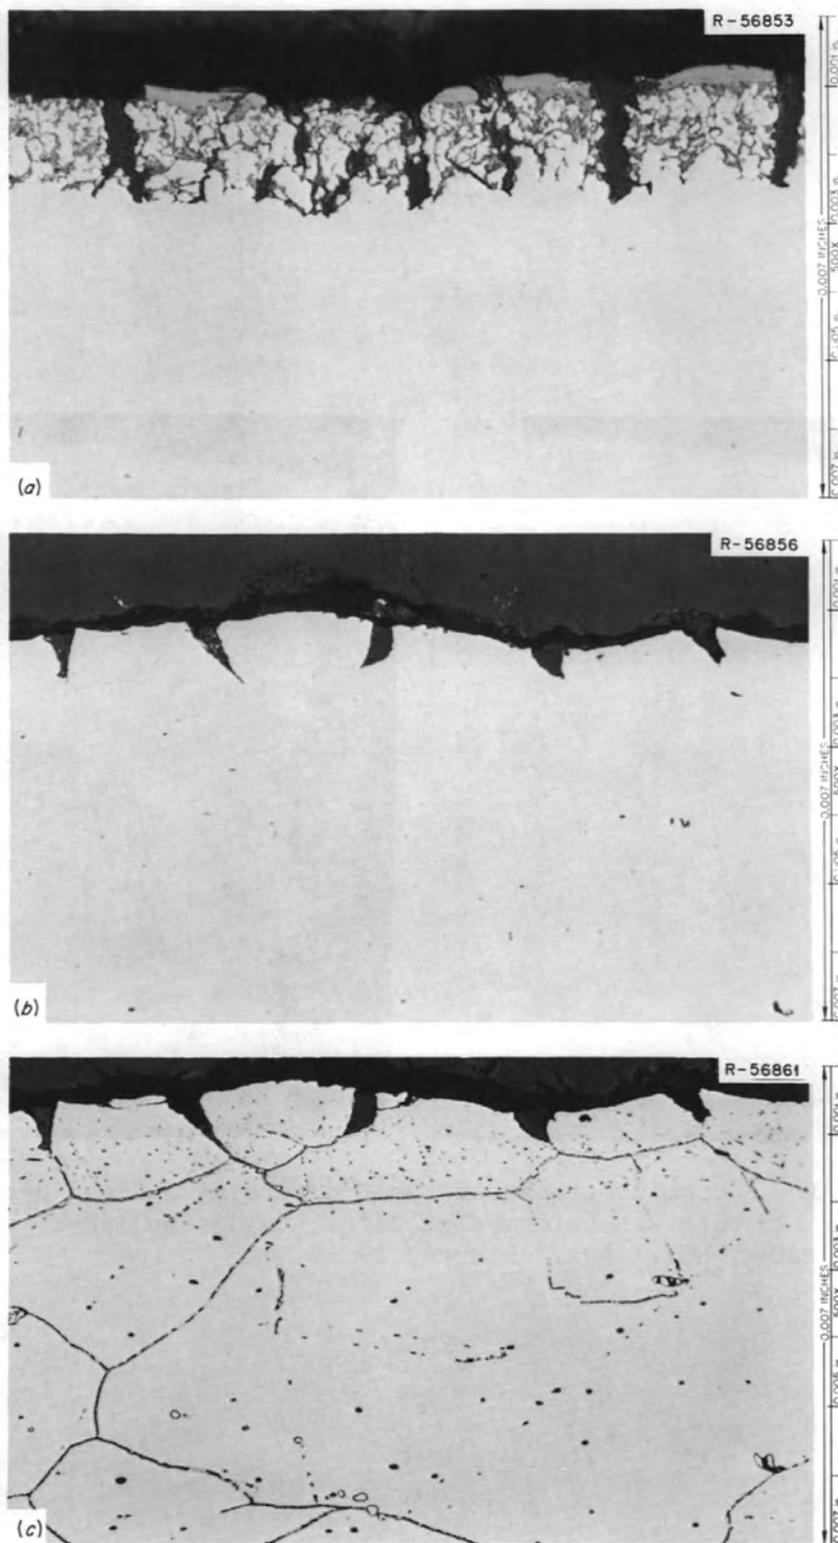
Fig. 104. Photomicrographs Near the Fracture of a Ring Sample from Freeze Valve 105 Deformed at 25°C. (a) Edge exposed to air, as polished. (b) Edge exposed to salt, as polished. (c) Edge exposed to salt, etched with lactic acid, HNO_3 , HCl . Reduced 30%.

product concentration was the one from FV 105. The fission product concentrations were generally less than on the other samples by an order of magnitude (Table 14) and the cracks were very shallow (Fig. 104).

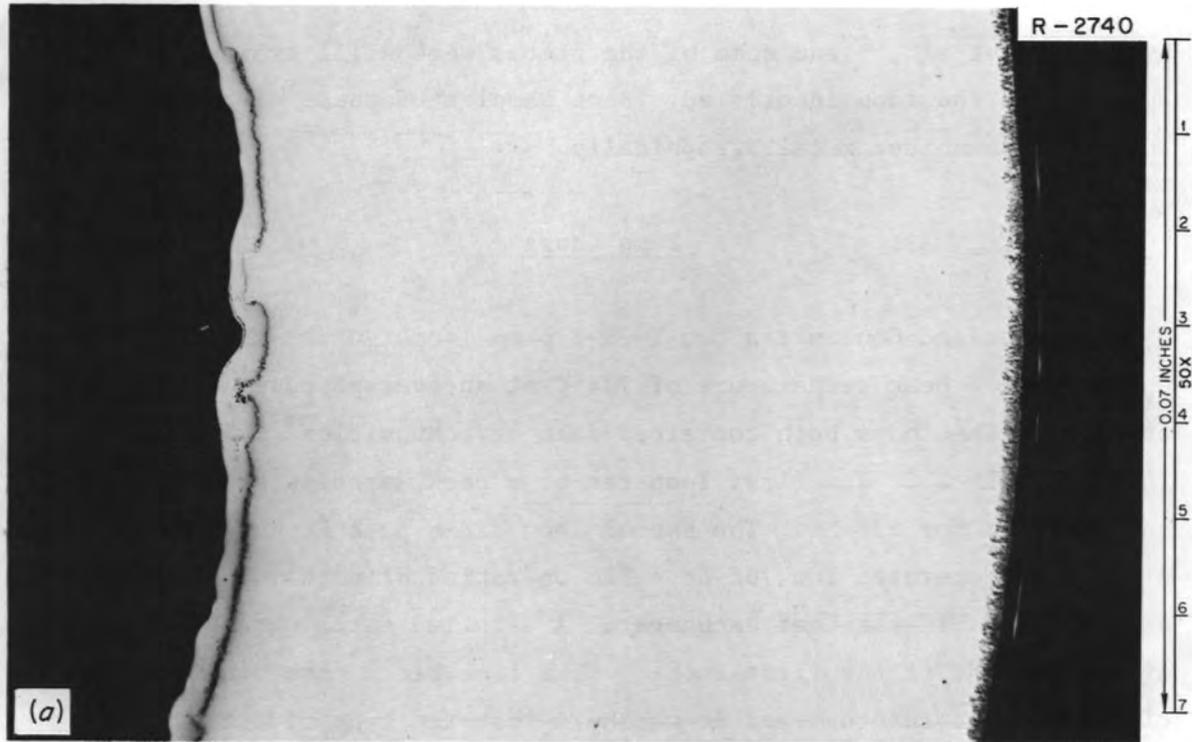
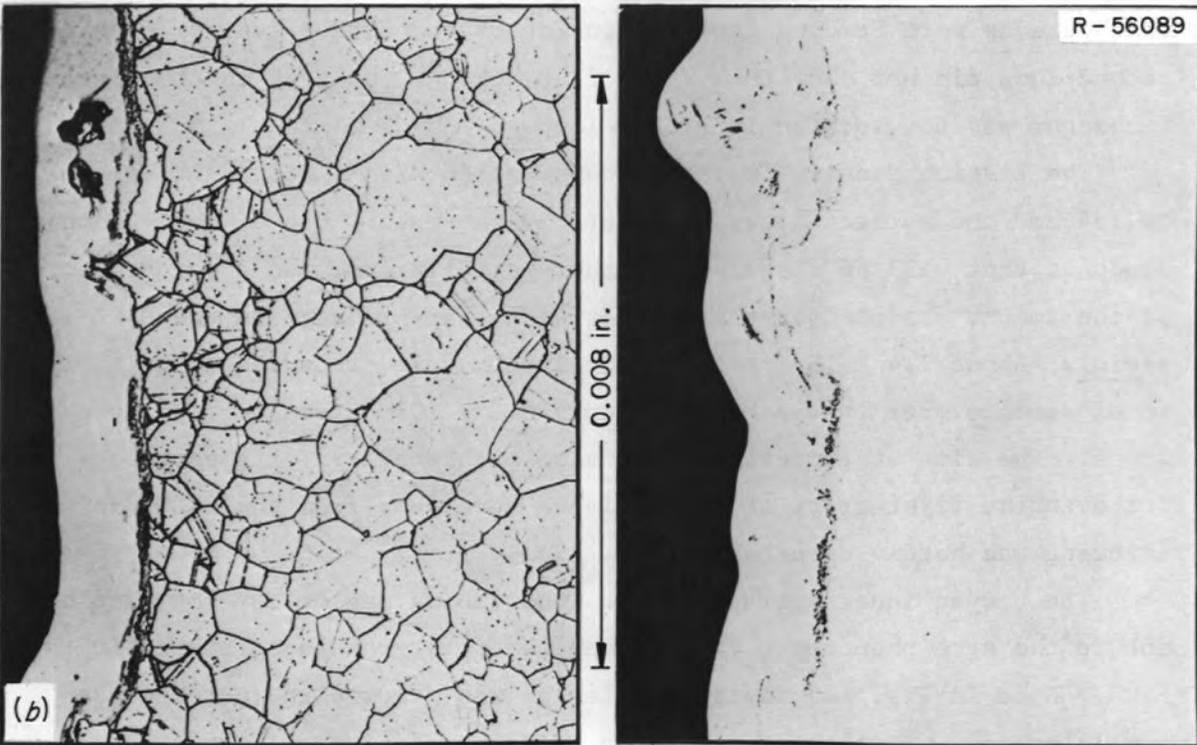
The uneven inner surface of the loop tubing may or may not have been due to the same phenomenon that caused the intergranular cracking in the MSRE. Note in Fig. 105 that the material was removed in increments of single grains. However, there is no evidence of partially cracked grains that had not been completely removed. The explanation of cavitation is also not very acceptable since the peak velocity was only about 1 ft/sec.

Fig. 105. Inside Tube Wall of INOR-8 from In-pile Loop MTR 44-1. The coating is nickel plating used for edge preservation.

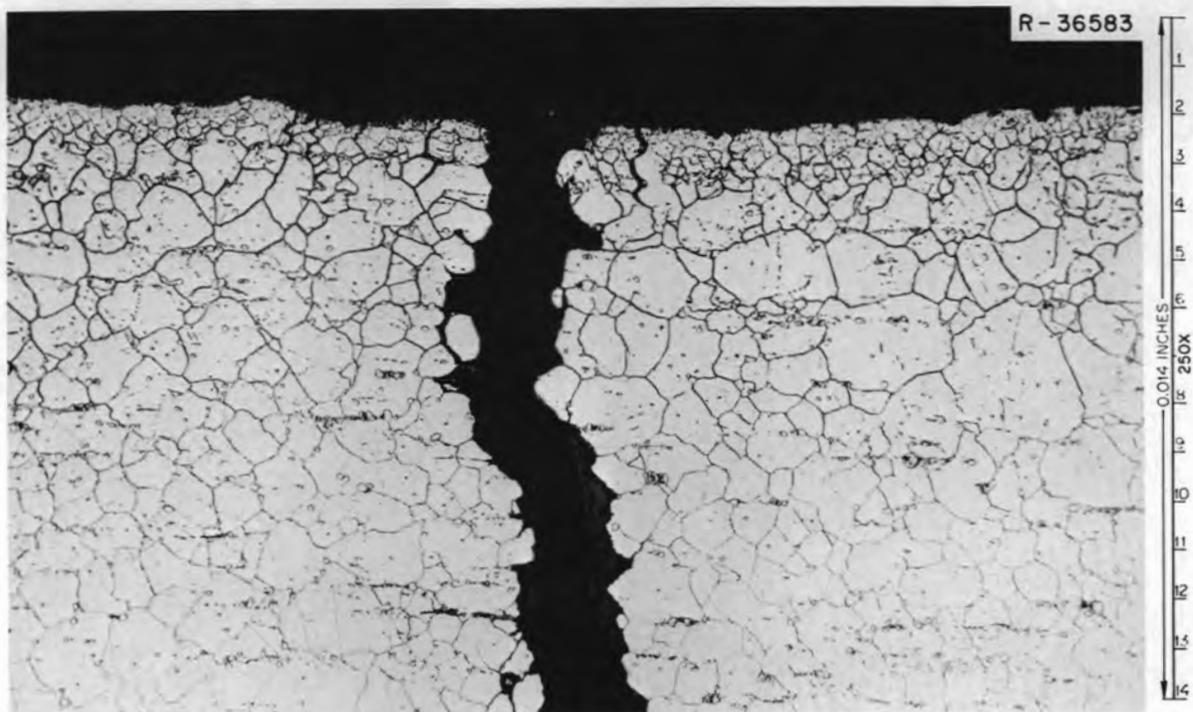
A more recent in-reactor thermal convection loop was run by Compere et al.²⁶ A schematic of the loop is shown in Fig. 106, and the pertinent operating statistics are given in Table 12. The loop was constructed of INOR-8, contained salt of composition ${}^7\text{LiF}-\text{BeF}_2-\text{ZrF}_4-\text{UF}_4$ (65.3-28.2-4.8-1.7 mole %), and had a graphite region where power densities of 150 W/cm^3 of salt were attained. The loop had maximum and minimum operating temperatures of 720 and 545°C , respectively. The loop failed at the hottest portion after 1366 hr of nuclear operation. The failure (Fig. 107) is quite typical of high-temperature failures noted previously in this material after irradiation.⁴⁻⁷ Note that the inside surface is free of cracks except very near the point of failure.

Fig. 107. Photomicrograph of a Cross Section Showing the Inner Surface and Crack in Core Outlet Pipe of In-Reactor Loop 2. Located on top side of tubing. Etchant: Aqua regia.

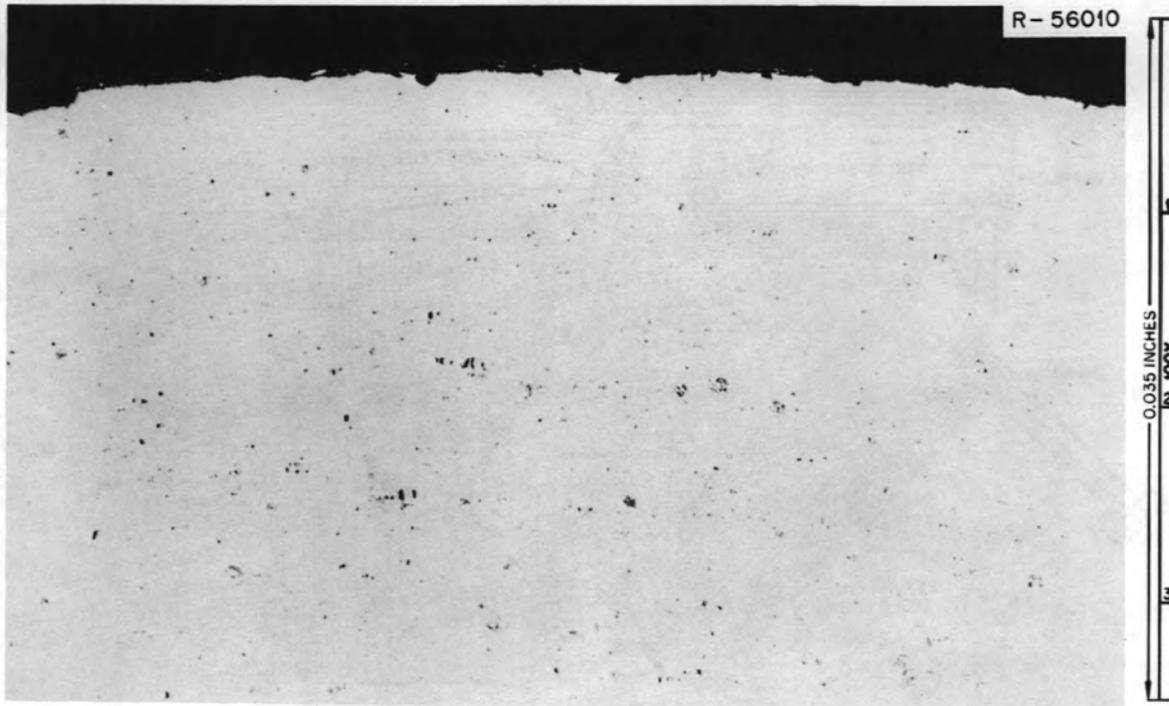
Two pieces of the loop were retrieved and tested. One sample was from the flat sheet used to fabricate the top of the "core section" where the graphite was located. A small sheet was cut, bent so that the surface exposed to the fuel salt was in tension, and examined metallographically. A typical photomicrograph is shown in Fig. 108. Surface cracks were very infrequent and extended to a maximum depth of 0.5 mil.

Fig. 108. Bend Specimen from Section of In-Reactor Loop Which Operated at 720°C. The tension side was exposed to the fuel salt.

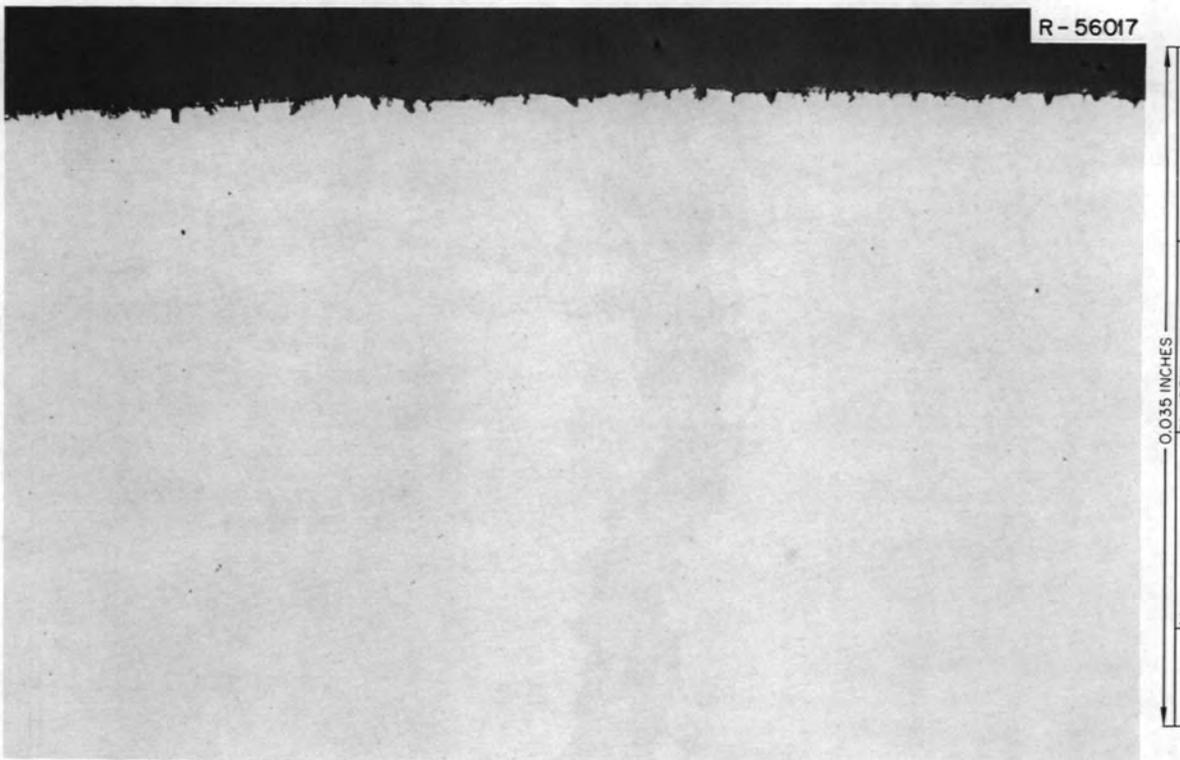
A piece of tubing was available from the coldest section, and it was deformed by crushing in a tensile machine. A typical view of the inside surface is shown in Fig. 109. Cracks occurred along almost every grain boundary, but they only extended to a maximum depth of 1 mil.

Fig. 109. Tension Side of Crushed Tubing from Coldest Part of In-Reactor Loop, Which Operated at 545°C.

The loops run by Trauger and Conlin had some regions from which grains were removed, but no intergranular cracks were visible. Strained samples of Compere's loop had shallow intergranular cracks similar to those noted in samples from the MSRE, particularly the sample exposed at 545°C (Fig. 109).

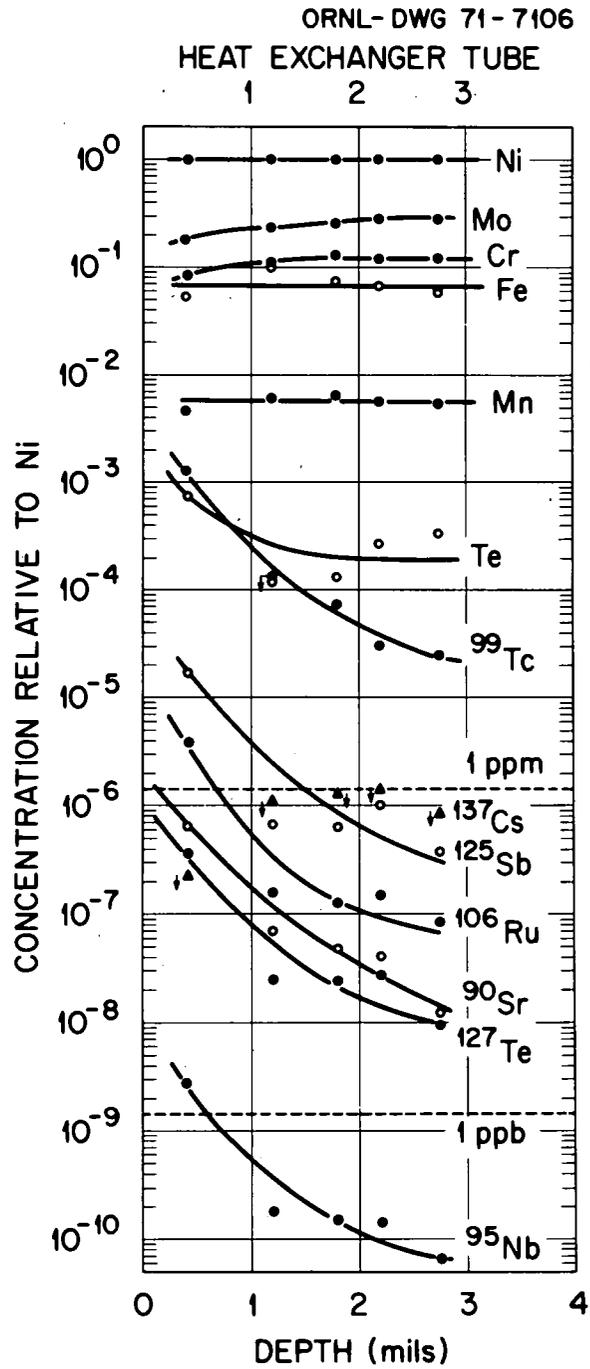
Fig. 110. Concentration Profiles from the Fuel Side of a MSRE Heat Exchanger Tube. Arrows indicate that analytical values were reported as being less than the indicated point.

1. Several of the fission products penetrated the metal to depths of a few mils (Figs. 110 and 111).

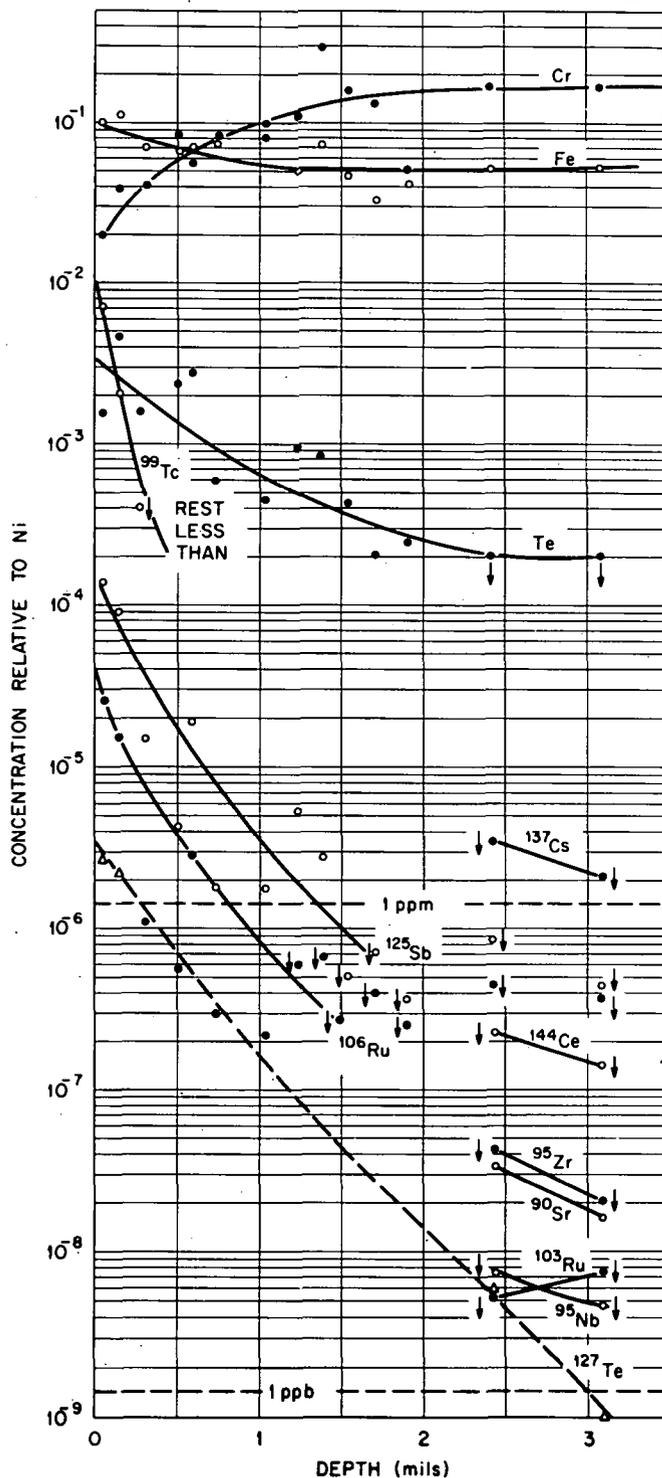
Fig. 111. Concentration Profiles from a Surveillance Sample Exposed in the MSRE for 19,136 hr. Arrows indicate that analytical values were reported as being less than the indicated point.

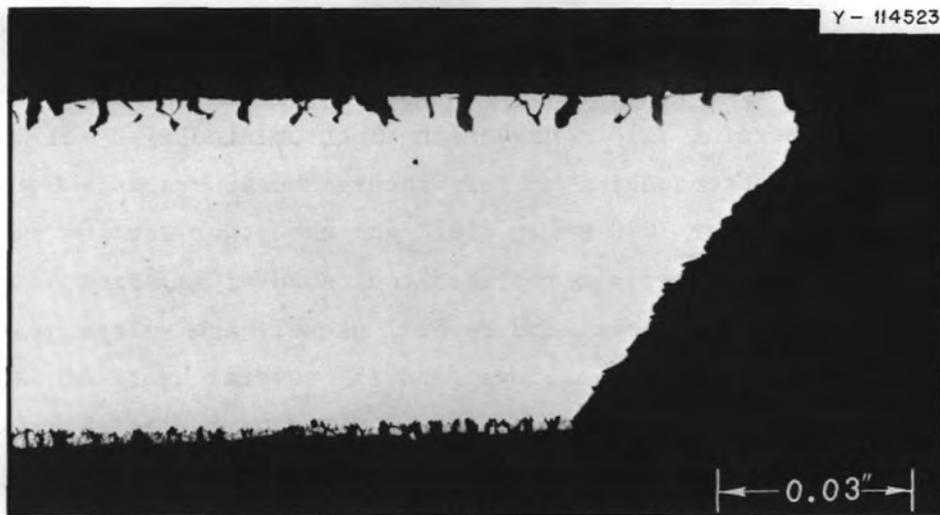
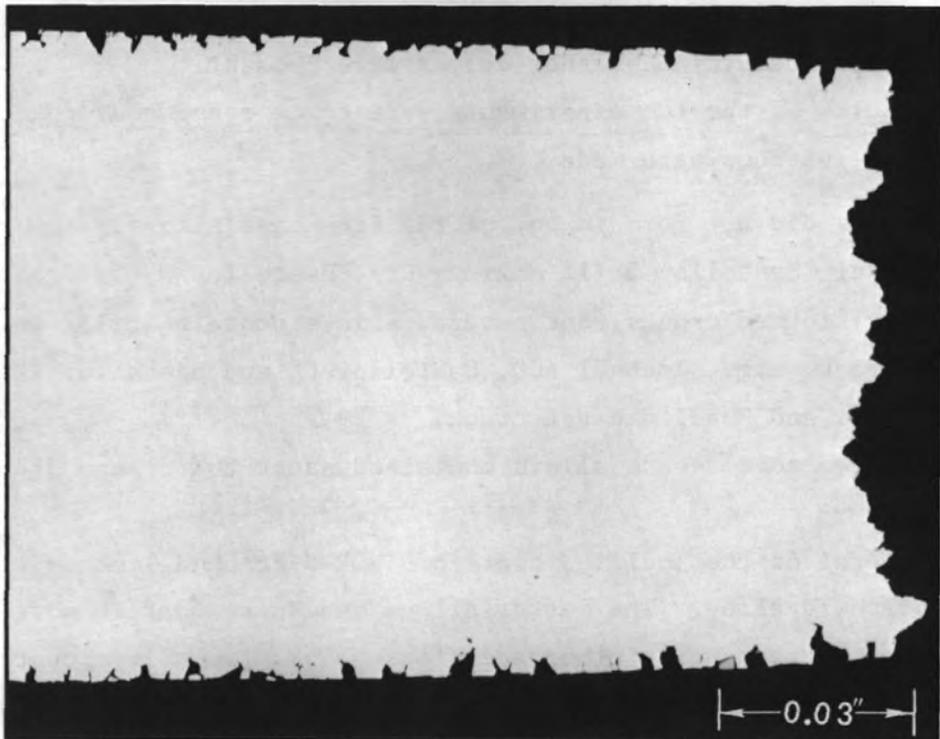
2. The cracks produced in INOR-8 by exposure to tellurium look quite similar to those formed in the material from the MSRE (Fig. 113).

MSRE Thimble - 31,000 hr in Fuel Salt at 650°C
 1.4×10^{17} atoms/cm² of Te

Vapor Plated with 5.4×10^{18} atoms/cm² of Te
 Annealed 1000 hr at 650°C

Fig. 113. Samples of INOR-8 Strained to Failure at 25°C. The upper photograph was made of a piece of the MSRE thimble. The upper side was exposed to fuel salt and cracked when strained. The lower side was exposed to the cell environment and the oxide that formed cracked during straining.
