ORNL/TM-11318

Inspection of Contaminated Hot Cell Ductwork

Publication Date: August 1989

This ductwork requires decontamination prior to release of the facility to resume sterilization activities. Due to the small size (20-in. × 24-in. cross section) and the long runs embedded in the cell roof, it was determined that remote visual inspection and preliminary radiation mapping of this ductwork was necessary. This report covers the inspection effort and evaluation of the results.

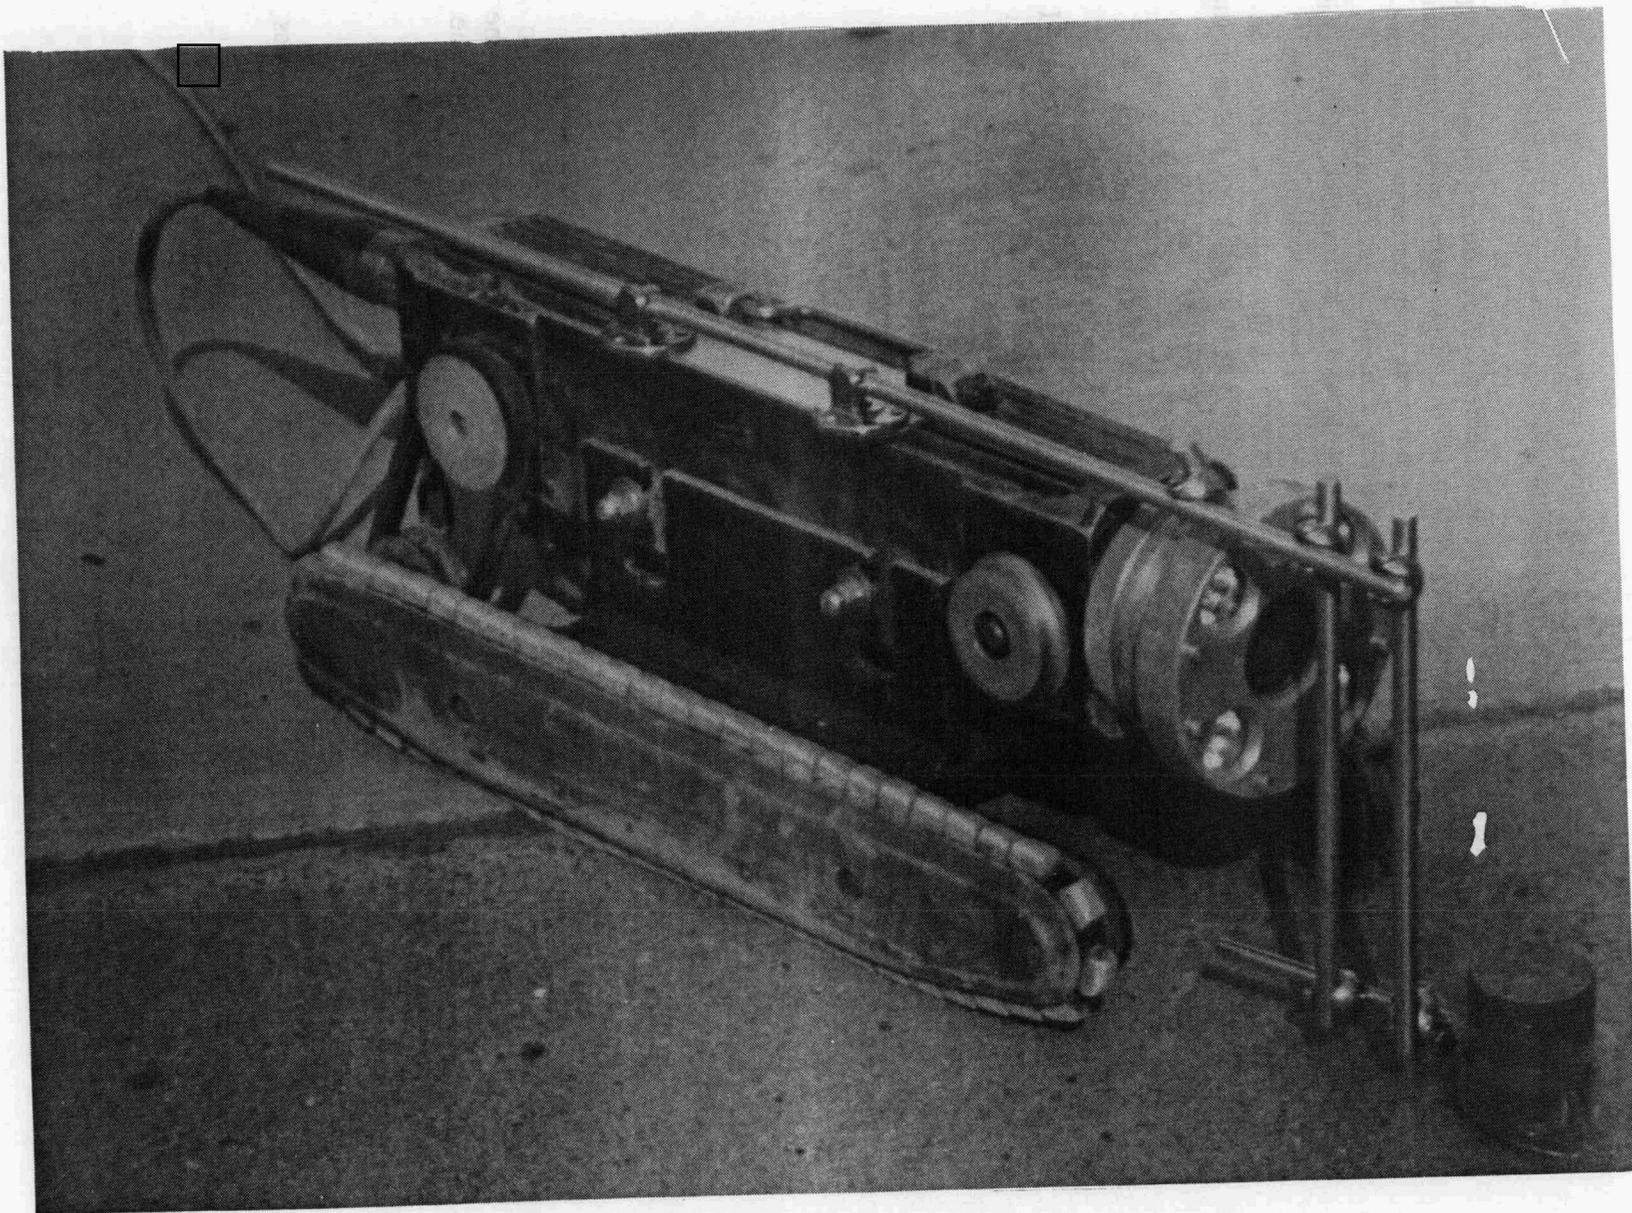
After thoroughly surveying available equipment, a camera-crawler assembly (CCA) supplied by PLS International of Cleveland, Ohio, was selected for the inspection effort. This vehicle is shown in Fig. 2, along with the radiation detector provided by ORNL. As may be seen in the figure, four lights are built into the CCA around the camera lens to illuminate the area being viewed and videotaped.

Fig. 2. Camera crawler assembly used for duct inspection.

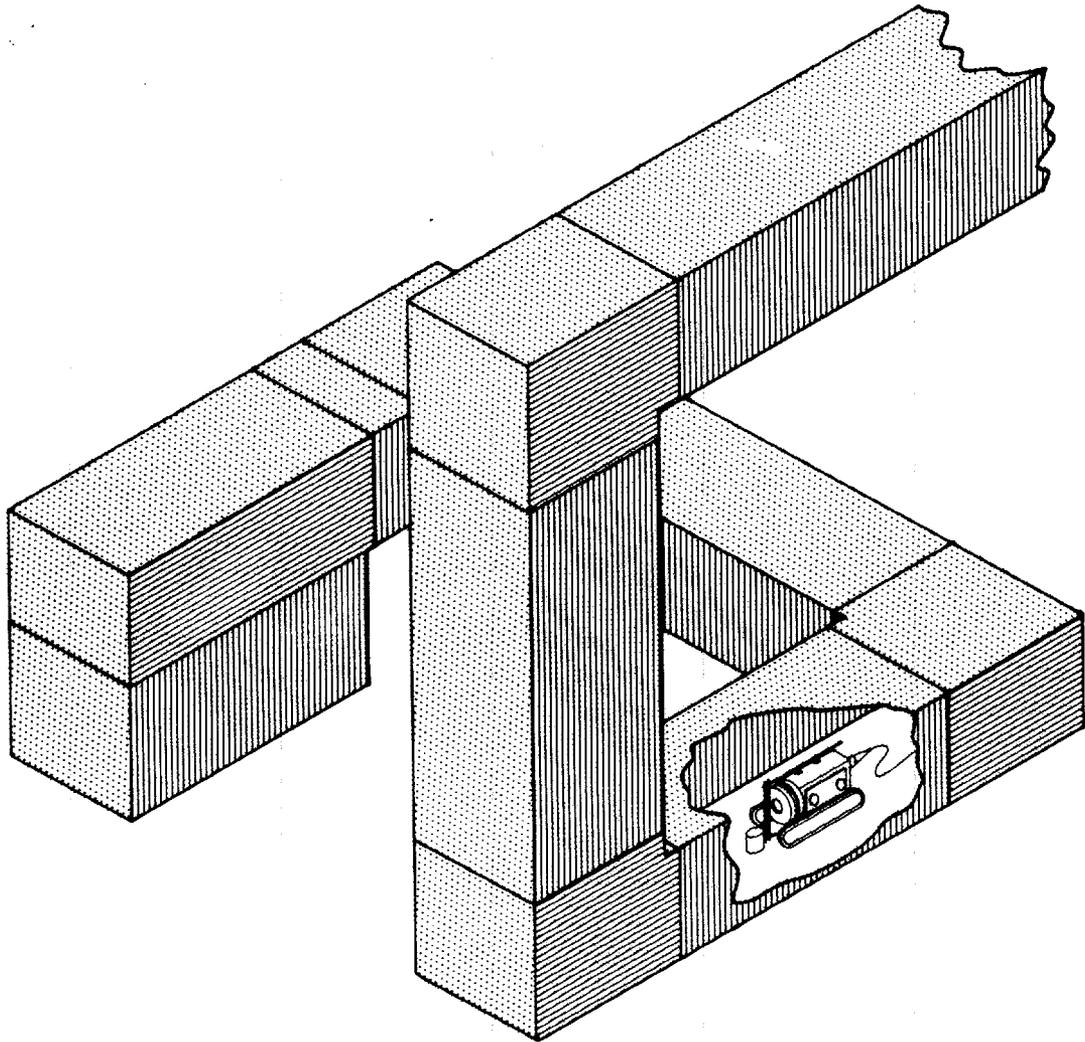
Fig. 3. Cutaway view of camera crawler assembly in duct.
