Timber-Frame Walls: Feasible with a Damaged Vapor Barrier?

Ernst Jan de Place Hansen, PhD

Erik Brandt

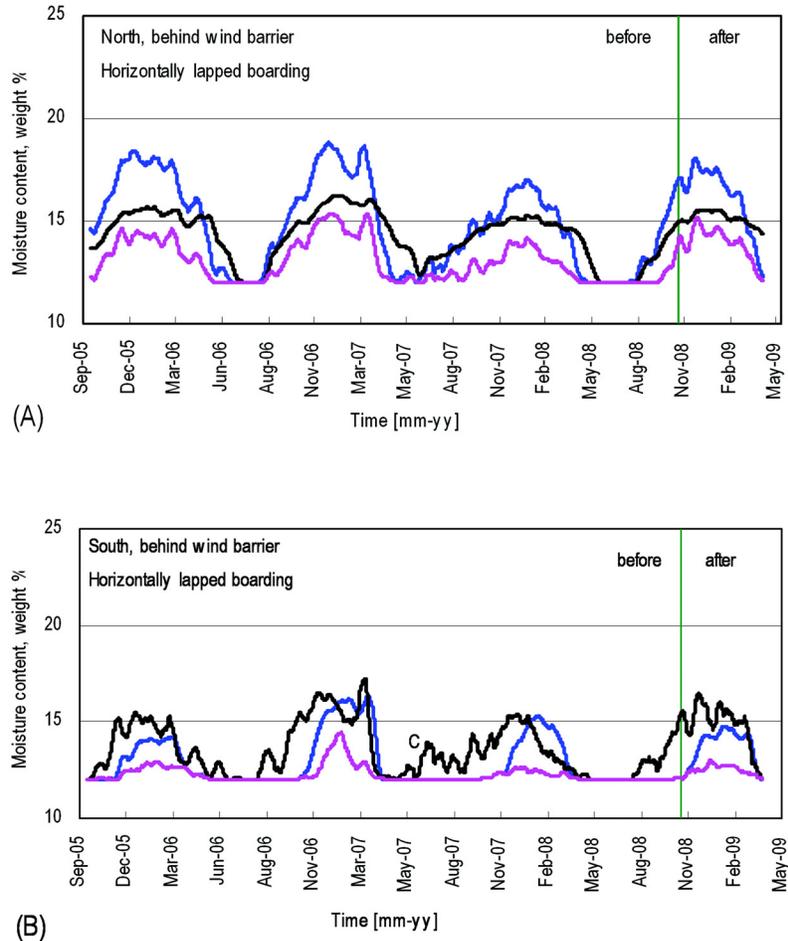
Figure 7 Moisture content (weight %) behind the wind barrier. Façade elements facing (A) north and (B) south. Horizontally lapped boarding. Ventilated cavity (cavity depth: 25 mm, element 1, black), nonventilated cavity (cavity depth: 12 mm, element 4, violet), no cavity (element 11, blue). “Before” and “after” refer to the time when holes were made in the vapor barrier.

The moisture content behind the wind barrier before and after the holes were made in the vapor barrier is shown in Figure 7 and 8. Element 11 (Figure 7) was in principle without a cavity, but because of the type of cladding (horizontally lapped boarding, see Figure 5A) there were small, isolated cavities between the wind barrier and the cladding. Element 10 (Figure 8) was partly ventilated. At the bottom was a 5 mm ventilation opening in the 12 mm deep cavity. In element 13, the type of cladding (vertical weatherboard) left no cavity at all (Figure 8). Element 13 had an intact vapor barrier.

None of the cases where holes were made in the vapor barrier showed a provable effect on the moisture content in the elements (Figures 7 and 8). This indicated that the moisture condition at the wind barrier was only slightly affected by damage to the vapor barrier (at least damage similar to that inflicted in this study). Damage that enables convection through the elements would probably have a more pronounced effect. In that case, one could question whether elements should include a ventilated cavity. Further studies are needed to explore this.

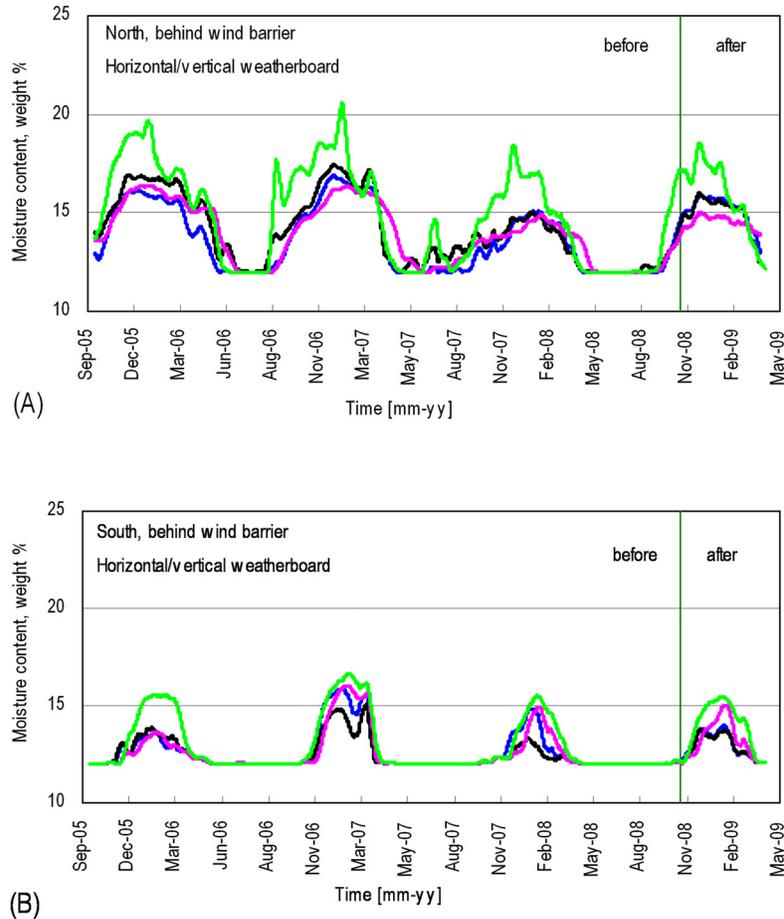
Figure 8 Moisture content (weight %) behind the wind barrier, façade elements facing (A) north and (B) south. Ventilated cavity (element 2, black), nonventilated cavity (element 6, violet), partly ventilated cavity (element 10, blue), no cavity (element 13, green). Horizontal weatherboard (elements 2, 6, and 10; cavity depth: 12 mm) and vertical weatherboard (element 13) as cladding. “Before” and “after” refer to the time when holes were made in the vapor barrier (not element 13).
