*Evaluation of Mechanical Reliability of  $\text{Si}_3\text{N}_4$   
Nozzles After Exposure in an Industrial Gas Turbine*

*H. T. Lin and M. K. Ferber*  
**Metals and Ceramics Division**  
**Oak Ridge National Laboratory**  
**Oak Ridge, TN 37831-6068**

*Mark van Roode*  
**Solar Turbines Incorporated**  
**San Diego, CA 92186**

**7th International Symposium on Ceramic Materials and Components for Engines**  
**Goslar, Germany, June 19-21, 2000**

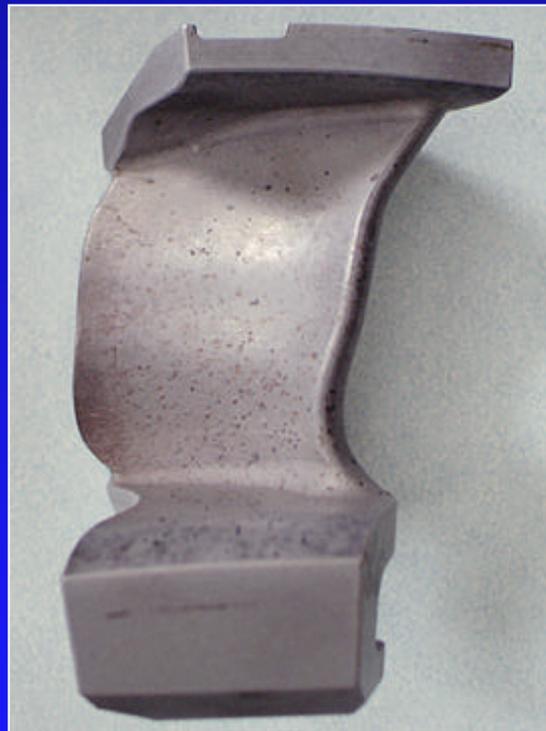
10 h test

**Crack observed after 68 h engine operation with 15 start/stop cycles**

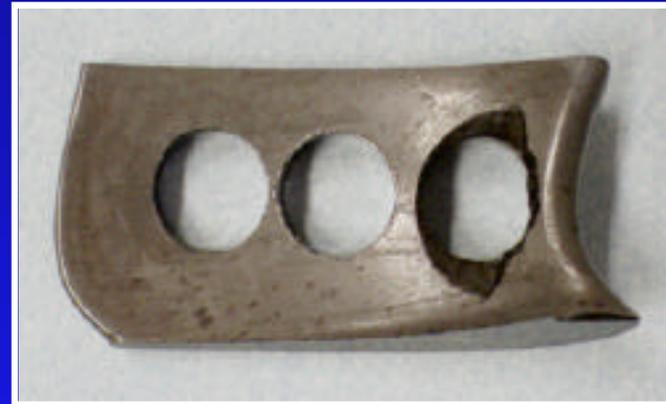
**9 h**

**Solar NGK SN88 Gas Turbine  
Nozzles After Engine Test**

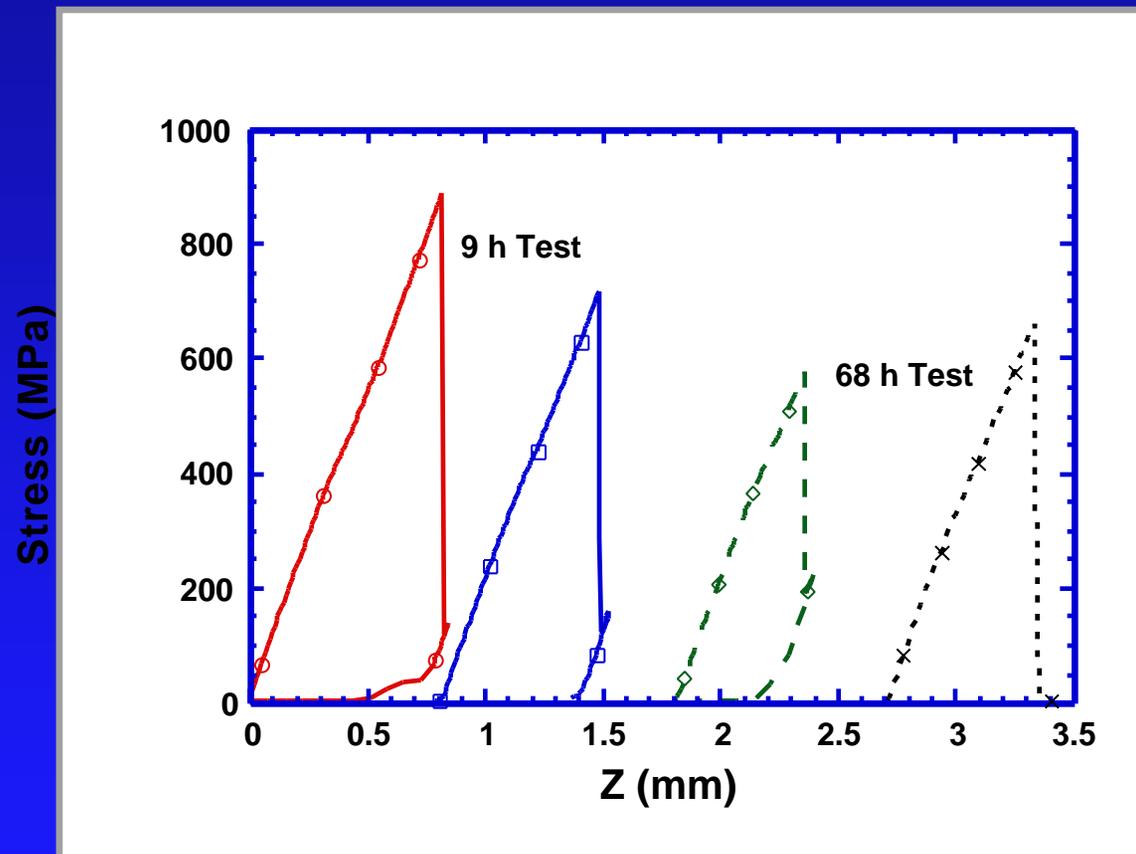
# Strength Degradation Observed in Specimens Extracted From Nozzle Airfoils After 68 h Engine Test

Exposed airfoil surfaces tested as tensile surfaces

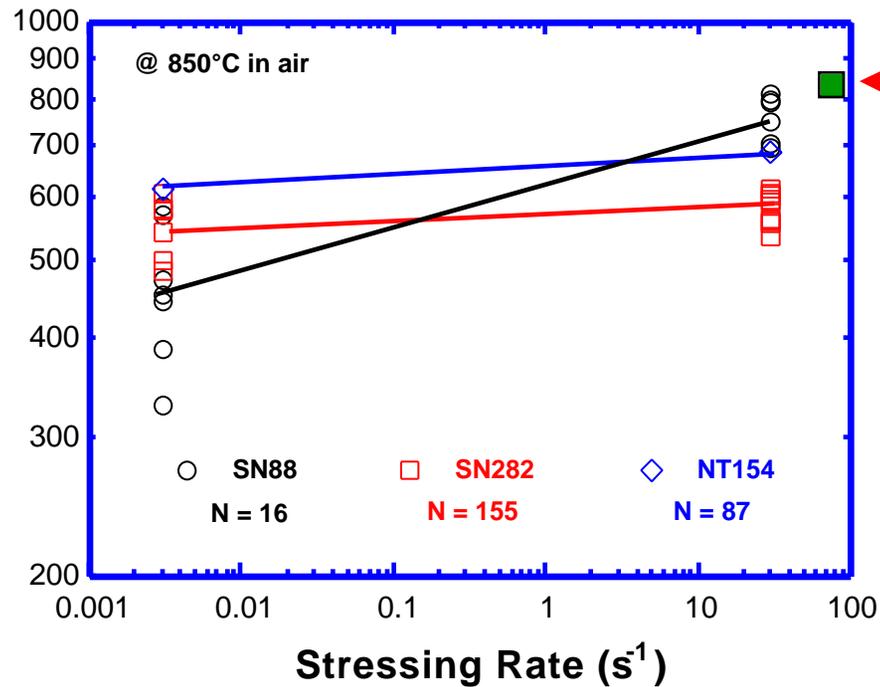
# Fracture Strength of SN88 Silicon Nitride at 850°C in Air Significantly Influenced by the Stressing Rate

Low fatigue exponent (N) of SN88 indicated a high susceptibility to slow crack growth (SCG) process

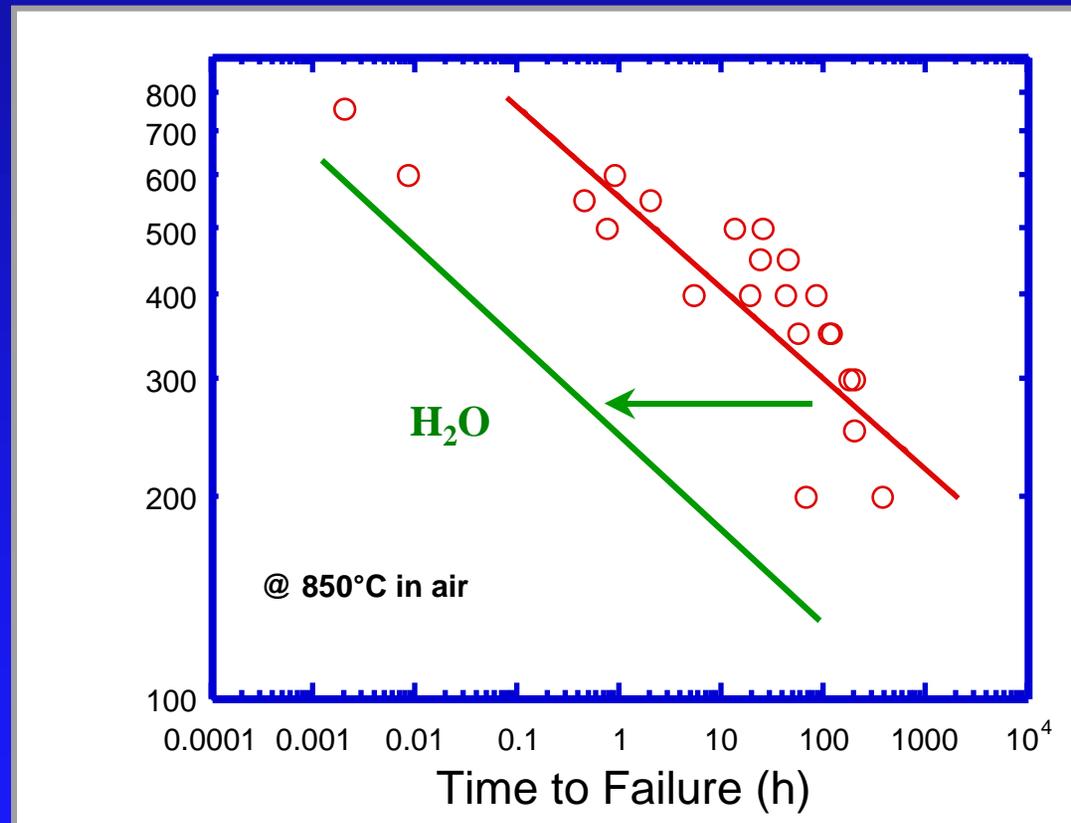
*Also, Lifetime of SN88 Silicon Nitride @ 850°C in Air Strongly Depends Upon Applied Stress Levels*

Presence of high pressure water vapor might further shorten the lifetime

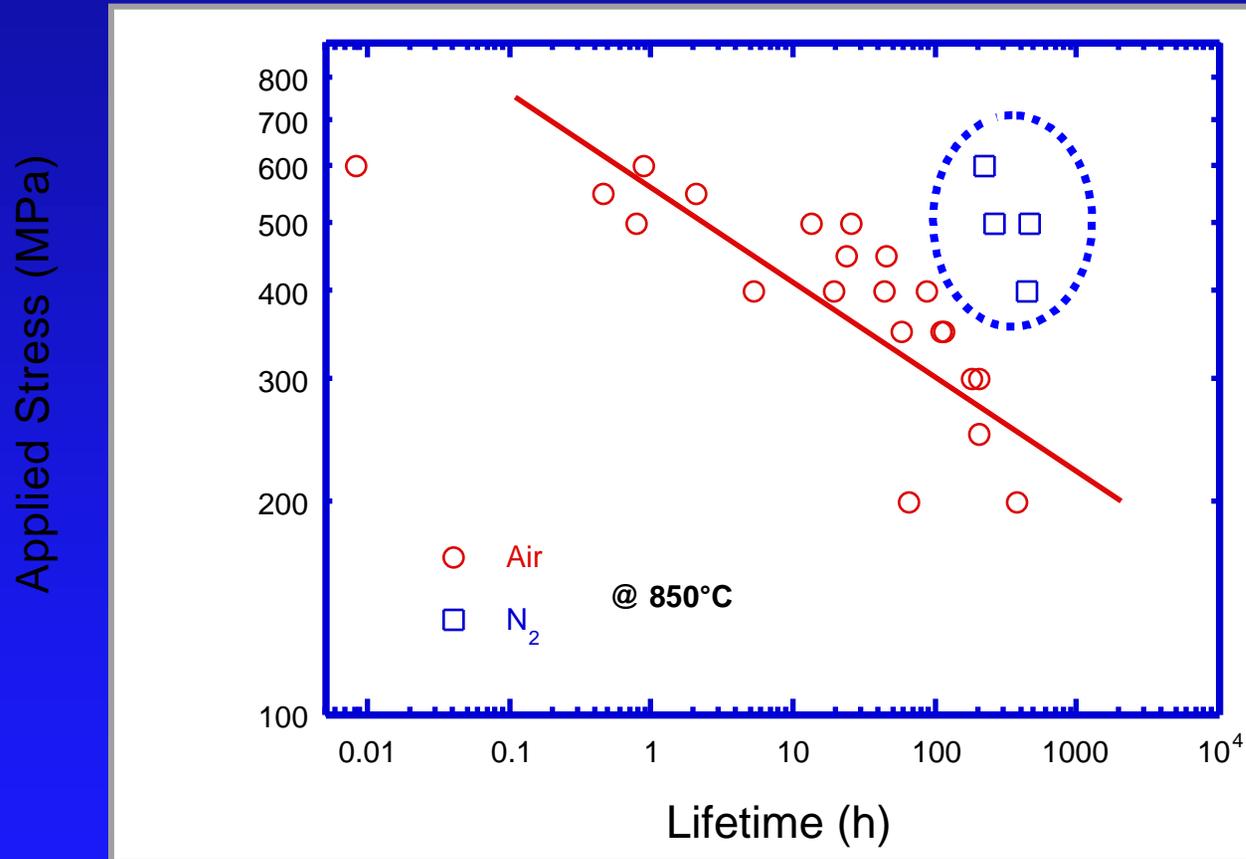
# *Lifetime of NGK SN88 $\text{Si}_3\text{N}_4$ Material Substantially Extended in $\text{N}_2$ Environment*

Strength degradation of SN88  $\text{Si}_3\text{N}_4$  is simply an oxidation-related issue

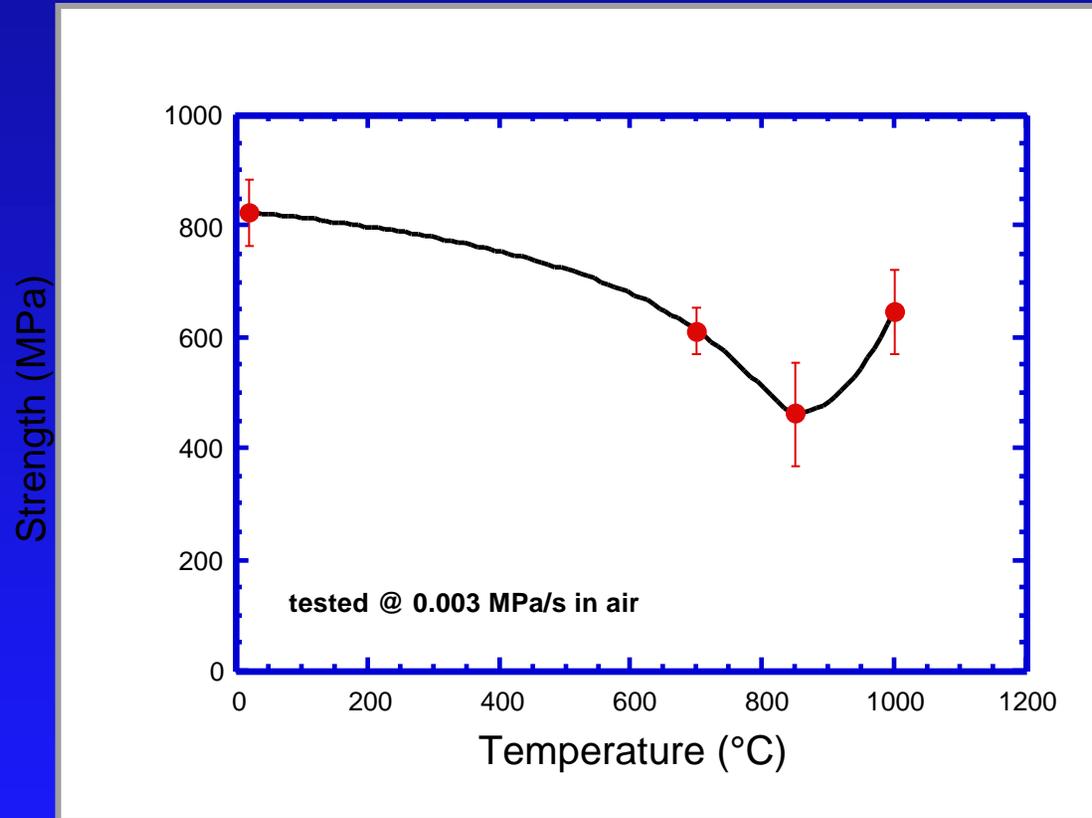
# *SN88 Silicon Nitride Material Exhibited the Greatest Strength Degradation @ 850°C in Air*

**Strength degradation is also a temperature-dependent phenomenon**

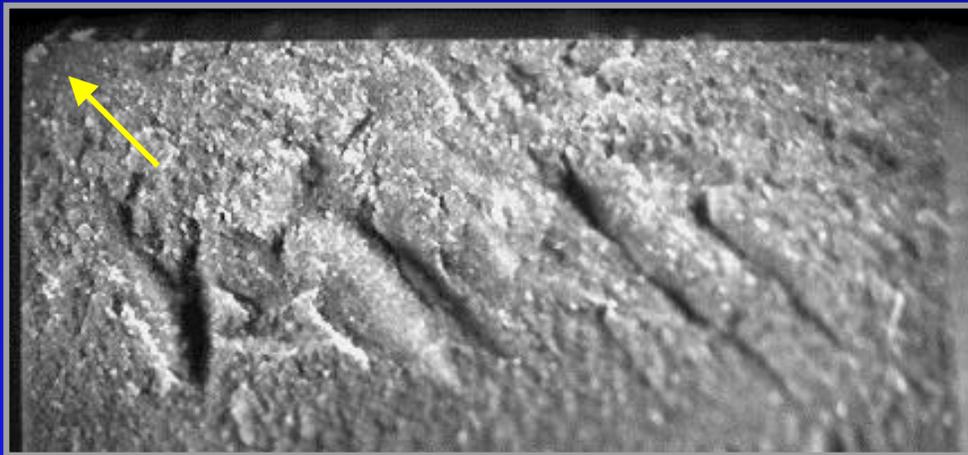
**30 MPa/s**  
**Arrow denotes**  
**fracture origin**

**Tested at 850°C in air**

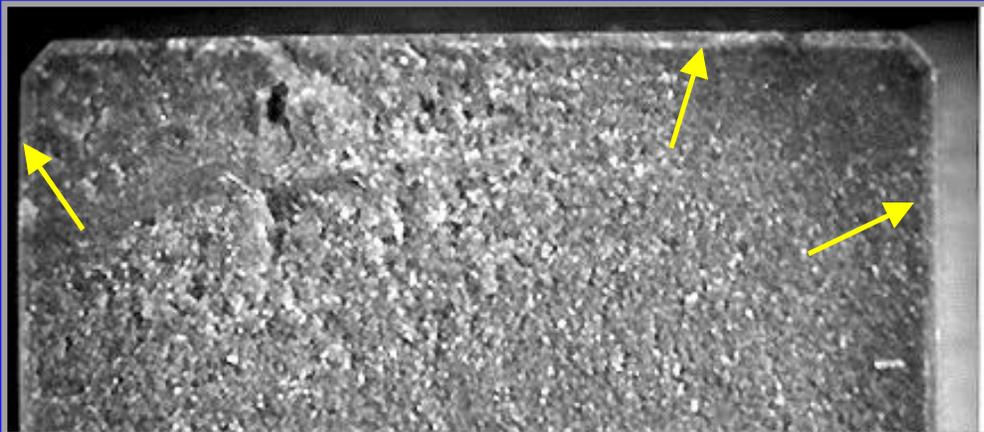
**0.005 MPa/s**  
**Arrow denotes**  
**environment-affected zone**  
**(EAZ)**

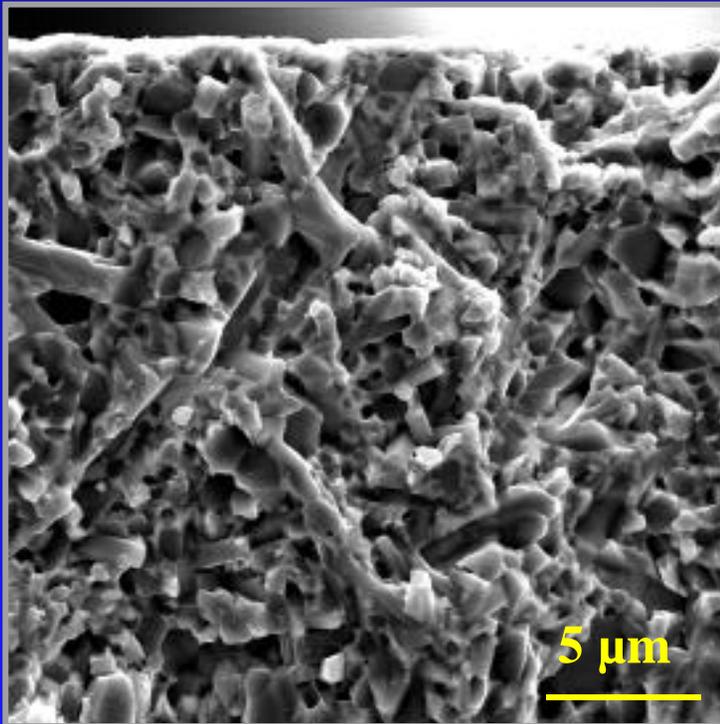
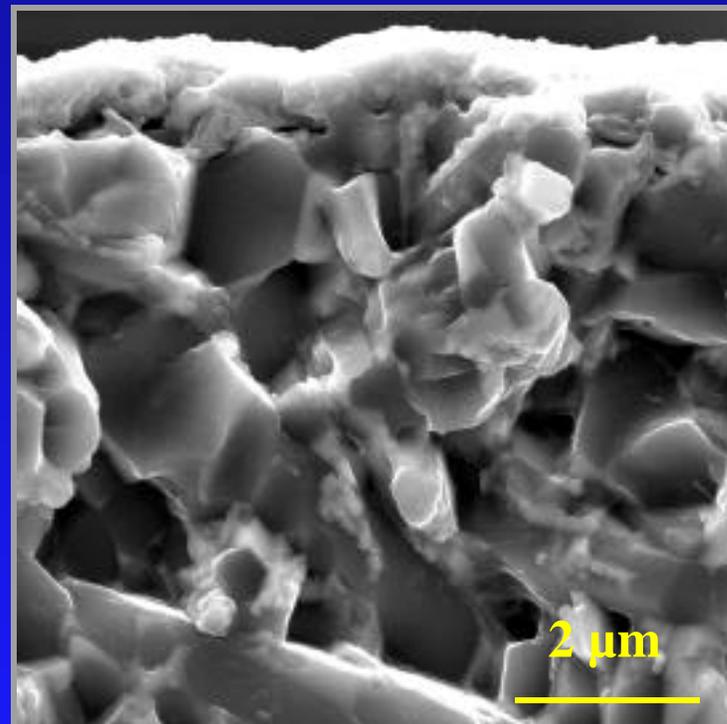
*Little Changes in Microstructure Observed in Samples  
Tested at  $850^{\circ}\text{C}/30\text{ MPa}\cdot\text{s}^{-1}$*

**SEM micrograph of fracture surface feature in tensile surface region**

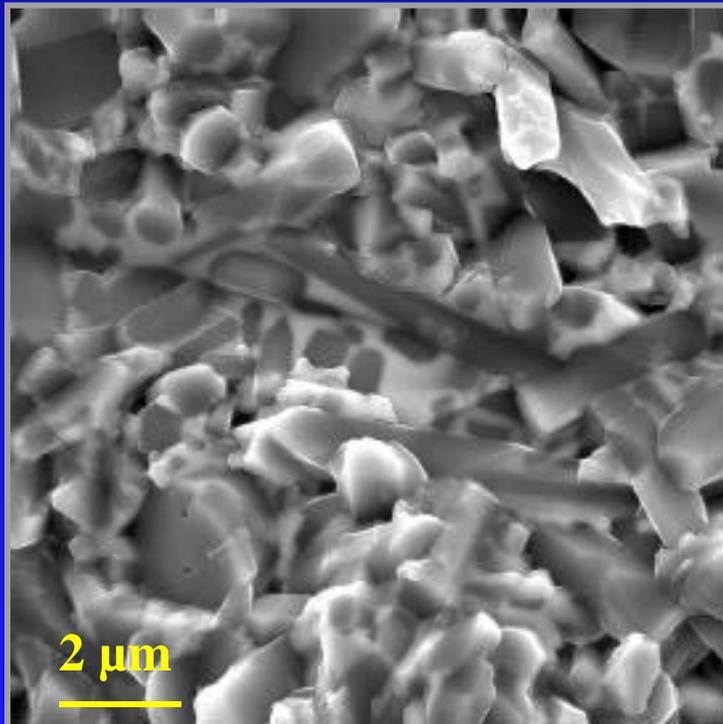
Outside EAZ

*However, Substantial Changes in Microstructure Observed in EAZ of Samples Tested at  $0.003 \text{ MPa}\cdot\text{s}^{-1}$*

No changes in microstructure characteristics outside the EAZ

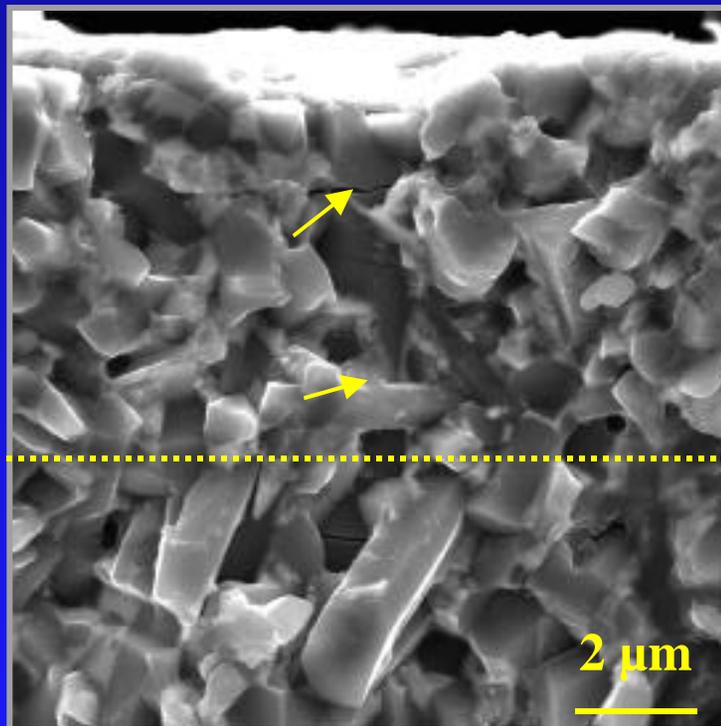
700°C

*Similar Changes in Microstructure Observed in EAZ  
of Samples Tested at 700° and 1000°C in Air*

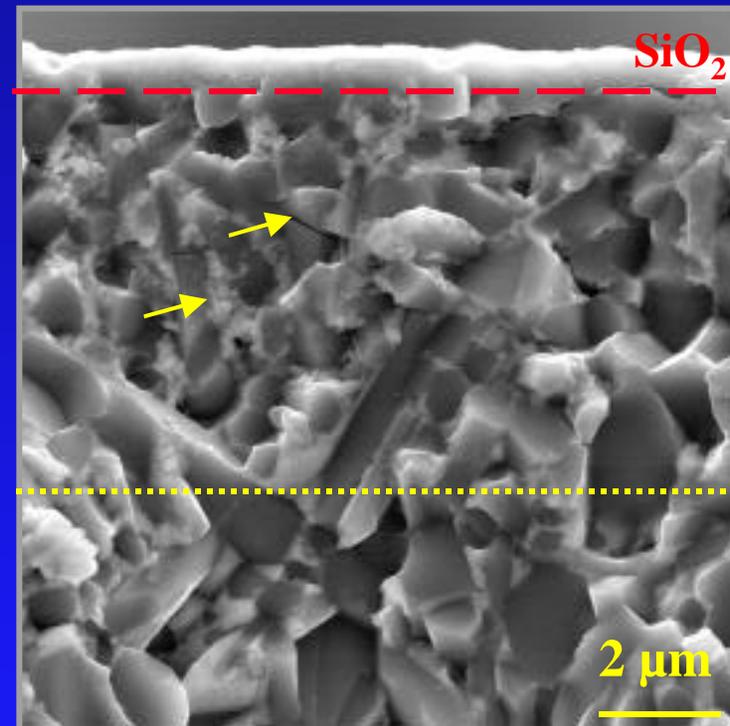
**SiO<sub>2</sub> formation at 1000°C slowed down the oxidation reaction  
and thus phase transformation processes**

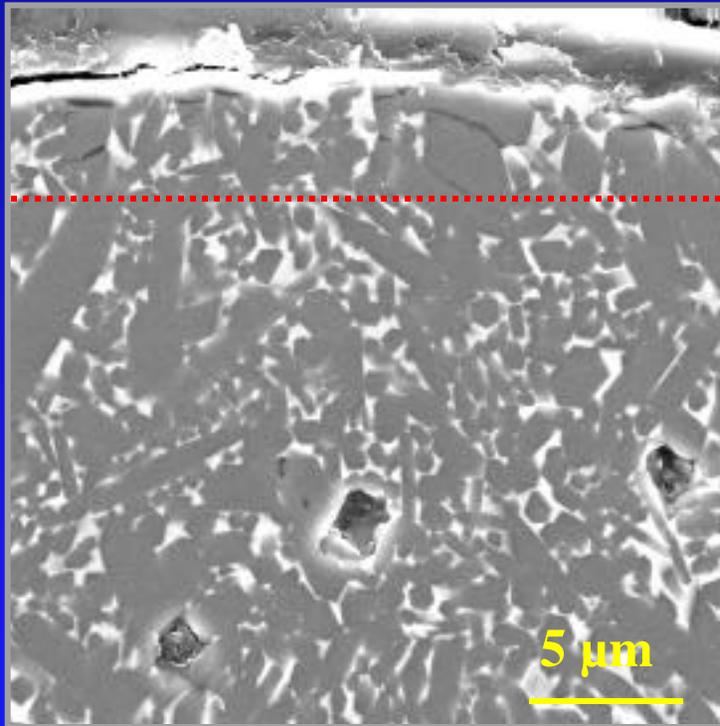
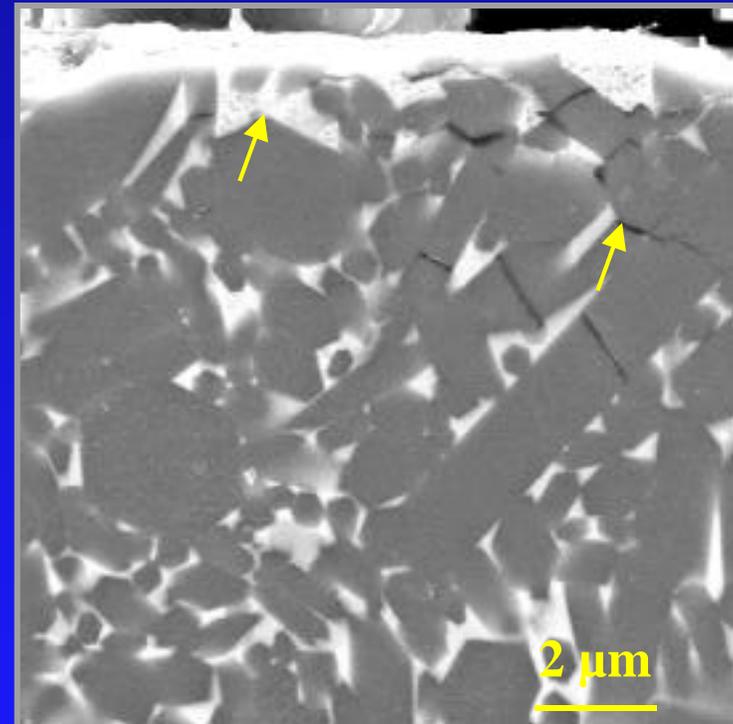
*Very Limited Microstructure Changes Observed in  
Specimens Tested @ 850°C/30 MPa•s<sup>-1</sup>*

Polished cross-section in tensile surface region

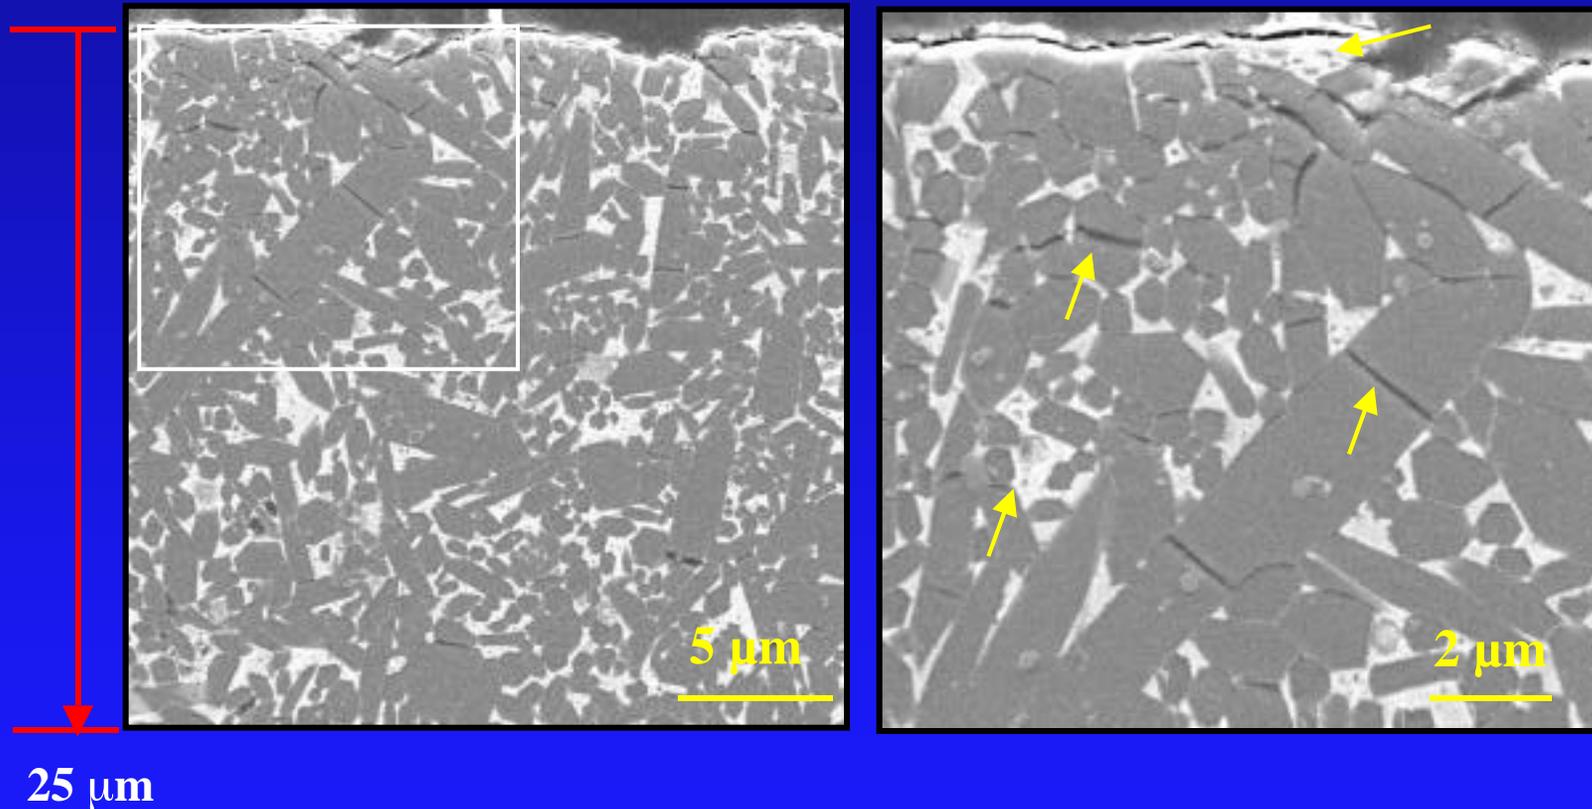
# *Substantial Cracking Associated With Pores in Secondary Phases Observed in EAZ Region*

**Tested @ 850°C/0.003 MPa•s<sup>-1</sup> in air**

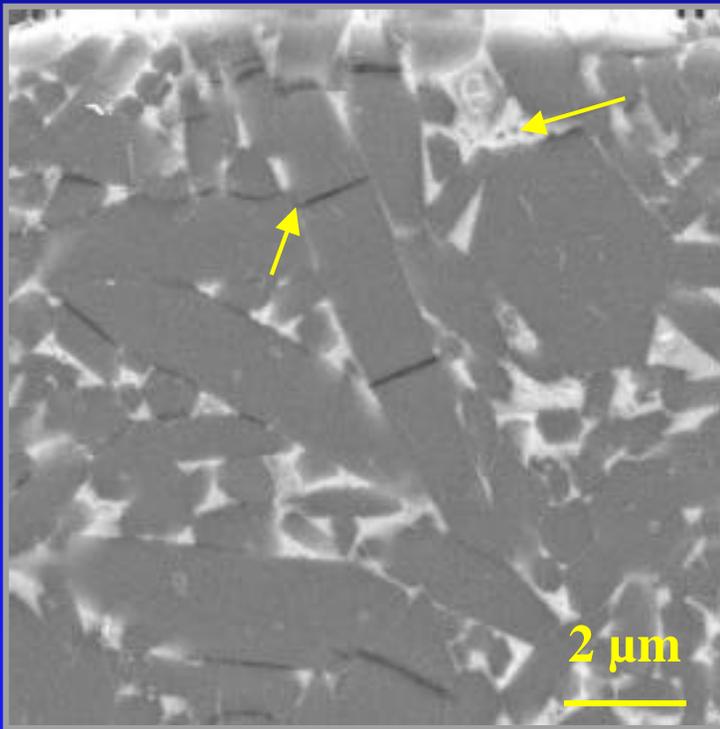
Thickness Side

*Similar Feature of Cracking and Pores in Secondary Phases Observed on All Four Side Surfaces*

Features of cracks and pores are not stress-promoted phenomena

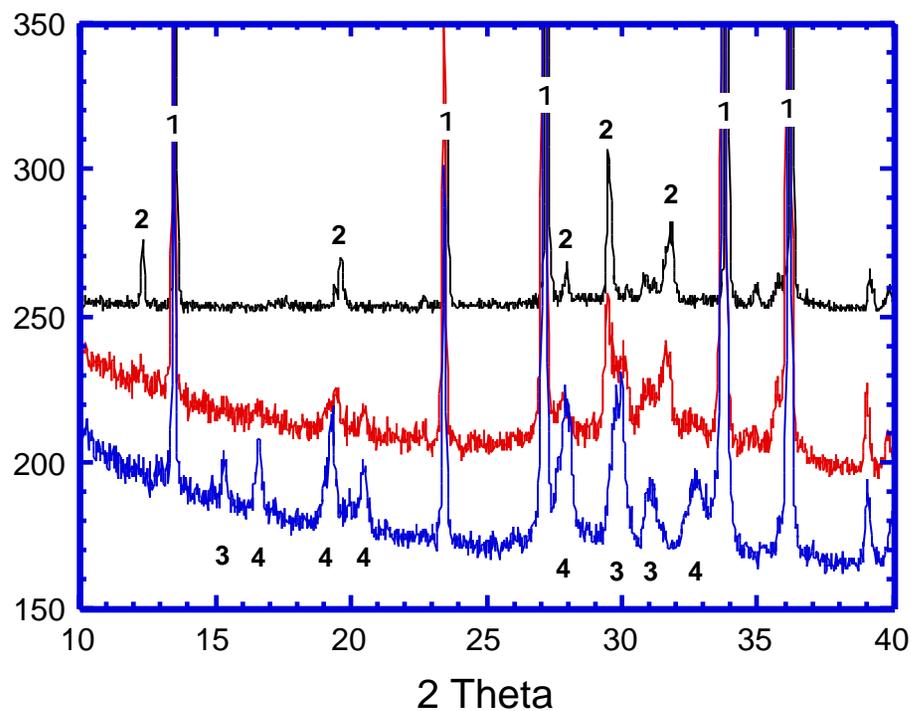
# Substantial Changes in Secondary Phase(s) Observed in Samples Tested at $0.003 \text{ MPa}\cdot\text{s}^{-1}$

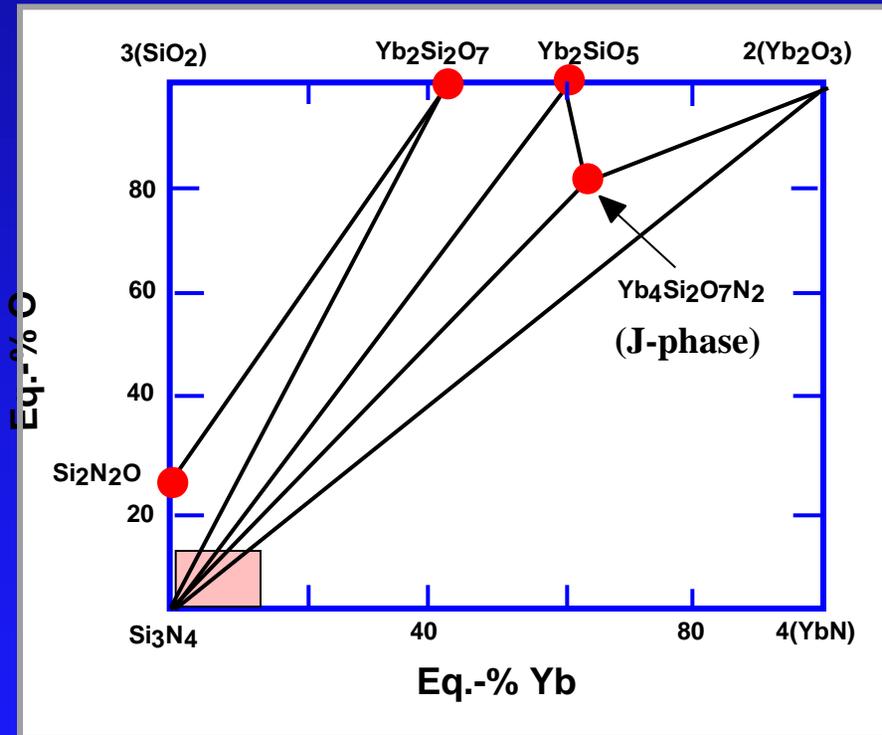
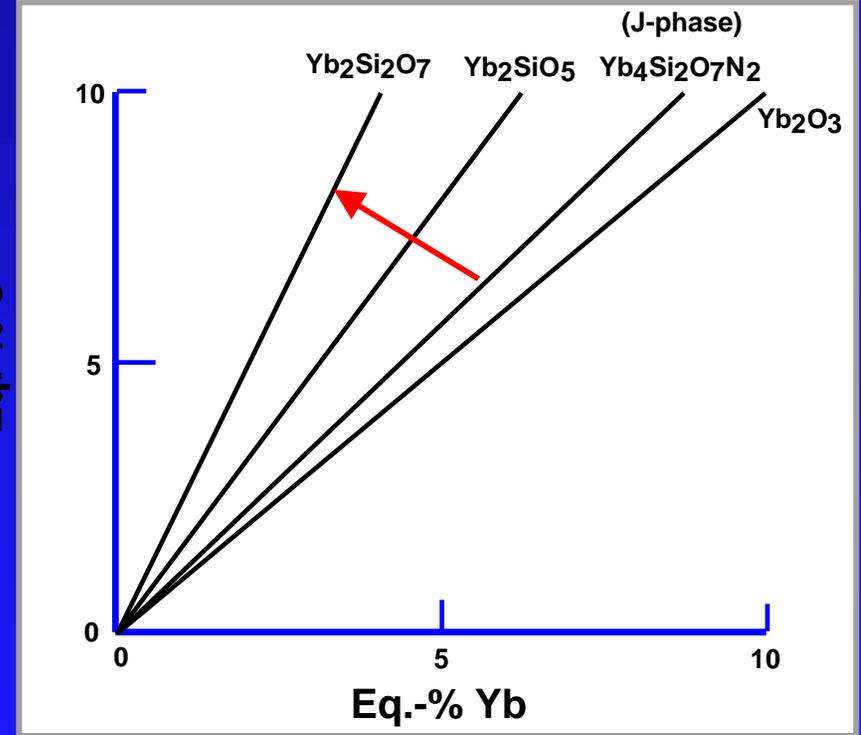
Ingress of oxygen resulted in changes in secondary phase of SN88  $\text{Si}_3\text{N}_4$
