WHY DO KRAFT RECOVERY BOILER COMPOSITE FLOOR TUBES CRACK?

James R. Keiser, Gorti B. Sarma, Xun-Li Wang, Camden R. Hubbard, Robert W. Swindeman

Oak Ridge National Laboratory
Oak Ridge, TN 37831-6156 United States

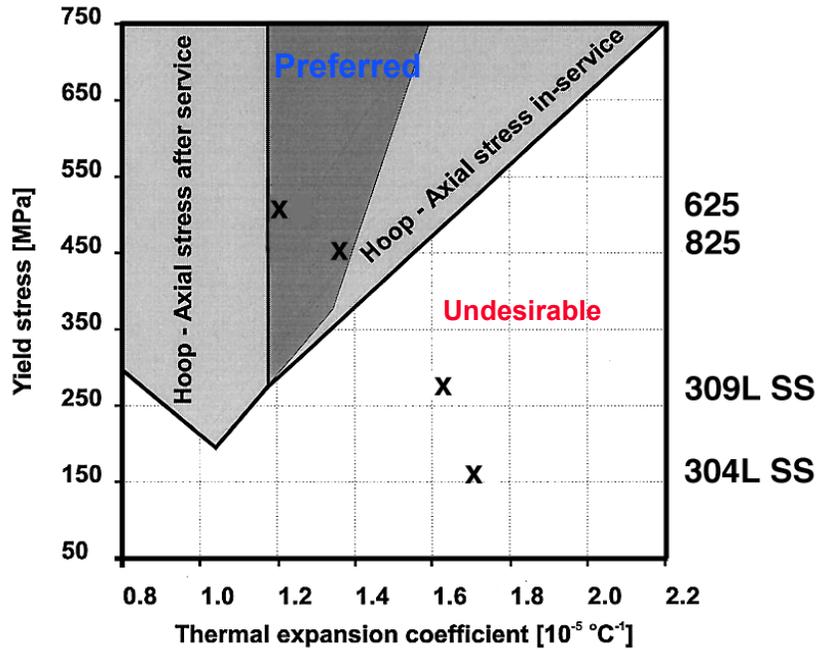
Finite element modeling to predict the stress state that would be developed in a series of alloys with a wide range of yield strengths and thermal expansion coefficients indicates that, as shown in Fig. 7, alloys with the properties of alloy 825 and alloy 625 in combination with carbon steel require more severe conditions for the stresses to become tensile in the floor tube panels.

Fig. 7. Plot of the stresses generated in co-extruded tube materials when the outer, clad layer has the thermal expansion coefficient and yield stress shown on the axes of this plot. This plot indicates that alloys 625 and 825 have properties that result in less severe stresses being developed than would be seen with 304L or 309L stainless steels.

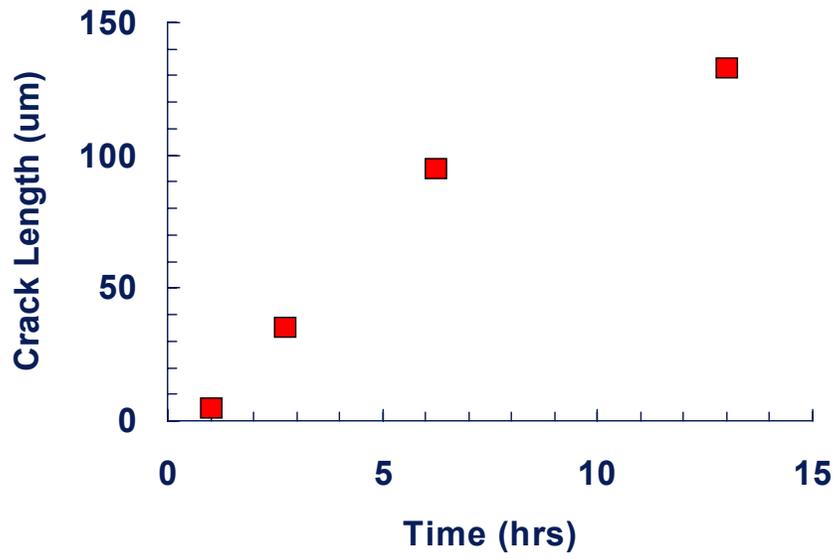
In the event that exposure of the floor tubes to wash water under a still-hot bed is unavoidable, a key question becomes how long at temperatures over 150°C (300°F) can be tolerated before damage to the floor occurs. As shown in Fig. 9, in laboratory tests cracks have been produced in 304L in about one hour's exposure at temperature to a

Fig. 9. Effect of exposure time on crack development in 304L stainless steel in a sodium sulfide 20% sodium hydroxide solution at 160°C. Note that short cracks are present after the first hour of exposure.
