ORNL/RASA-99/1

**Results of the Independent Radiological  
Verification Survey of  
Remediation at Building 14,  
Former Linde Uranium Refinery,  
Tonawanda, New York (LI001V)**

Date Issued—July 2000

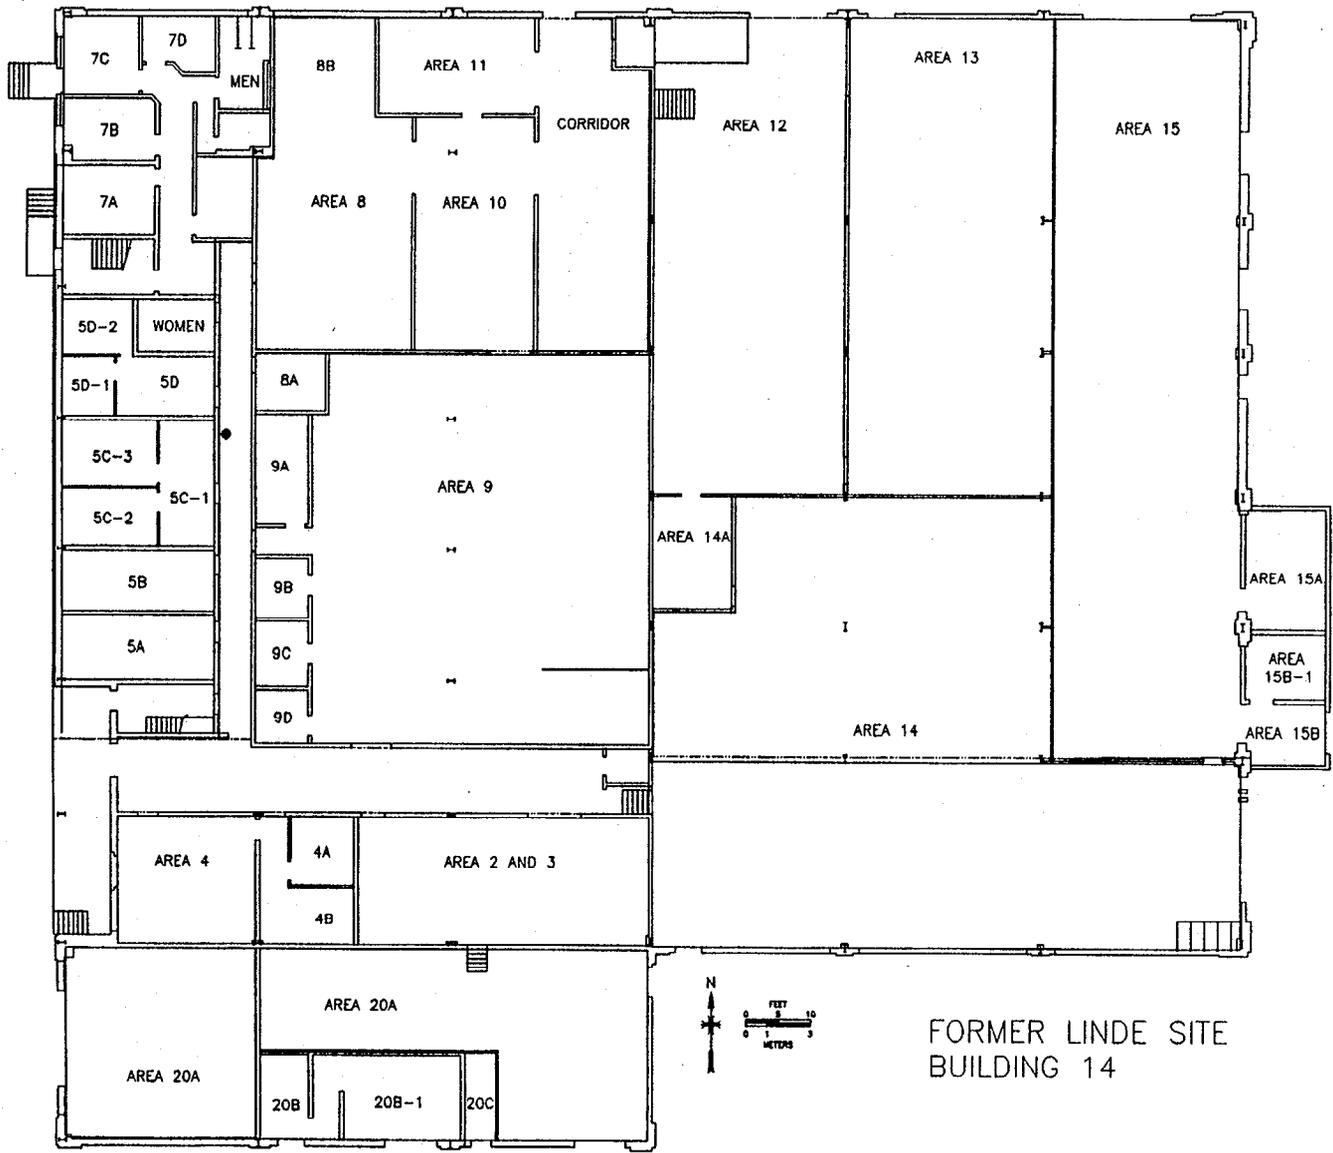
**Fig. 3. Diagram showing general layout of the first floor at Building 14.**

<sup>a</sup>Area numbers shown on Fig. 3. No second floor drawing shown.
