Report of the Investigating Team for the October 6, 2003, Radiological Event at Building 2026

November 2003

**Prepared by
Joseph P. Flynn
Team Leader**

Prepared by
OAK RIDGE NATIONAL LABORATORY
P.O. Box 2008
Oak Ridge, Tennessee 37831-6285
managed by
UT-Battelle, LLC
for the
U.S. DEPARTMENT OF ENERGY
under contract DE-AC05-00OR22725

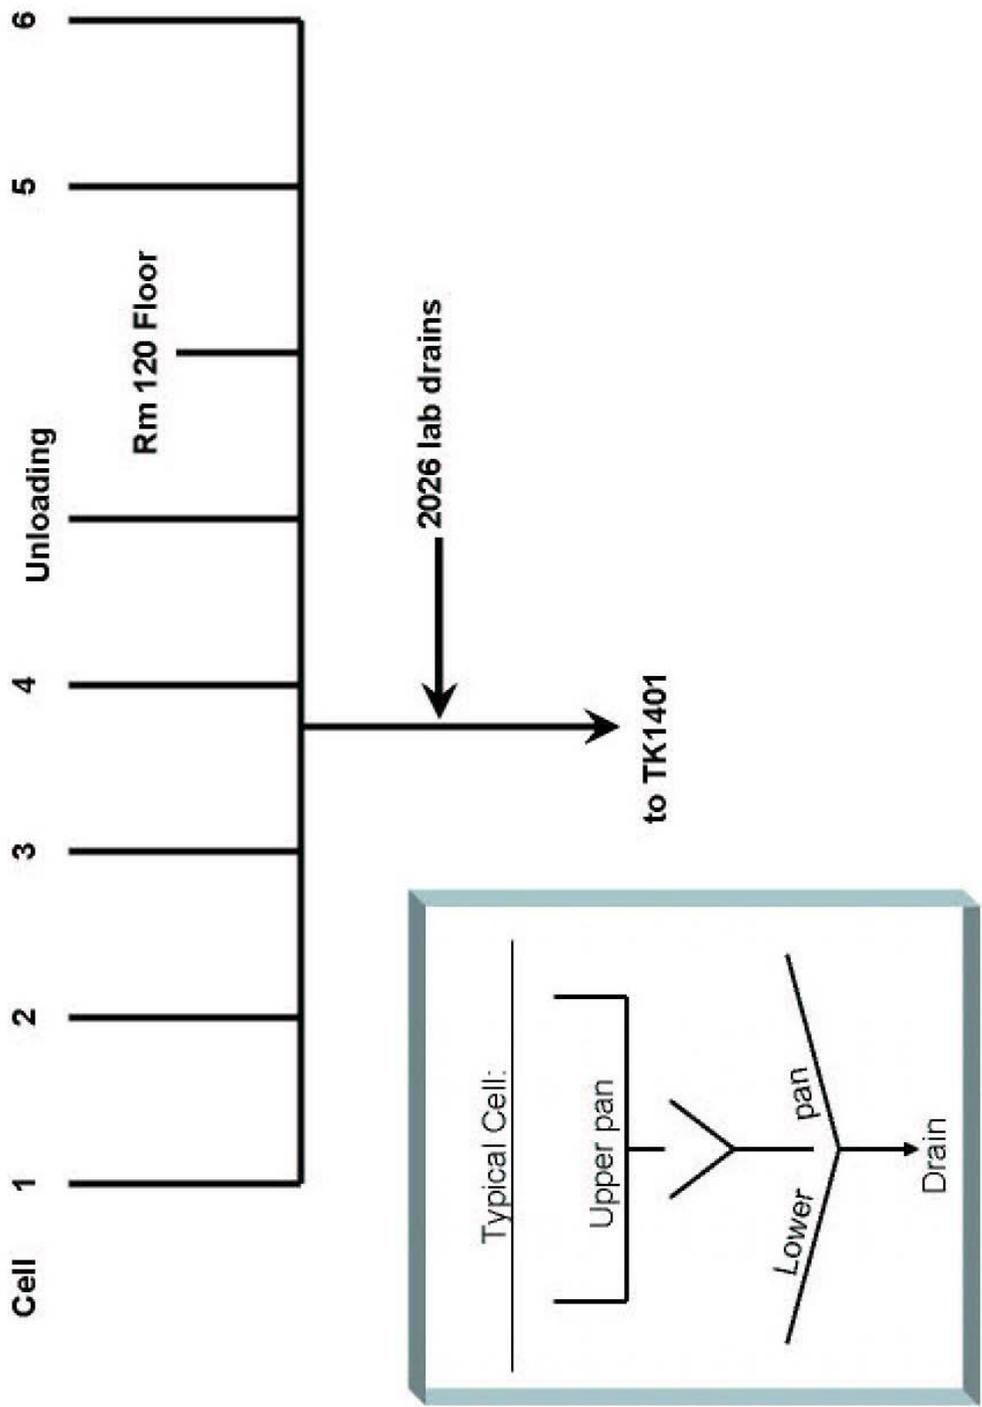
Fig. 1-1

The denatured liquid was poured into a drain line fixed to an upper cell pan (visible from the hot cell window). The line, which passed through a lower pan (not visible from the hot cell window) and then into a waste storage tank located outside of Building 2026 (See Figure 1-1). This denatured liquid was flushed with about 5-gallons of process water. After this flush, process water in the hot cell was run for about 30 minutes at a flow rate of about 1 gallon/minute. The drain was partially plugged. As a result, the liquid filled the lower cell pan in one or more of the hot cells and then flowed under the cell doors into the cell access area (Room 120).

The physical construction of the hot cells did not allow one to visually determine if liquid poured down the hot cell drain was backing up into the hot cell's lower pan. In addition, the level instrumentation in Building 2026 associated with the drain tank (tank 1401) did not provide timely or effective indication that the liquid poured down the drain was being received (See Figure 1-1).
