EVALUATING ENVIRONMENTAL BARRIER COATINGS ON CERAMIC MATRIX COMPOSITES AFTER ENGINE AND LABORATORY EXPOSURES

Karren L. More, Peter F. Tortorelli, and Larry R. Walker
Oak Ridge National Laboratory, Oak Ridge, Tennessee

ABSTRACT

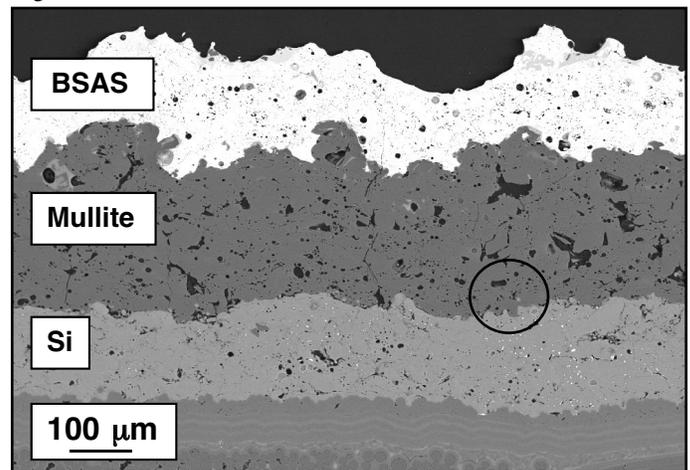
Fig. 1. Typical as-processed microstructure of three layer EBC having a mullite intermediate layer.

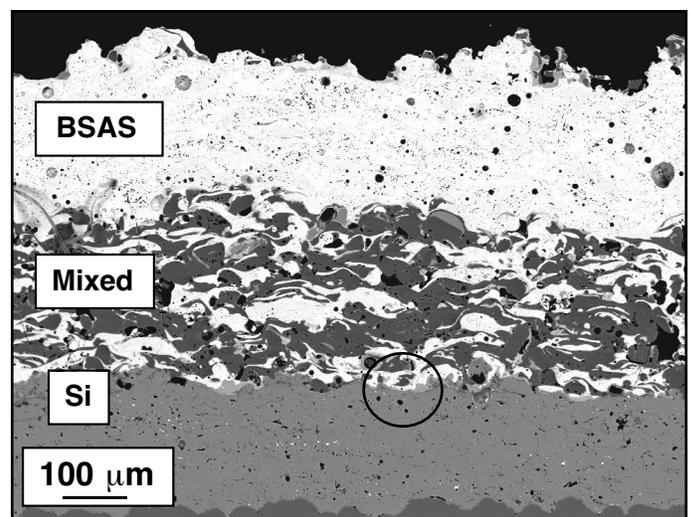
Fig. 2. Typical as-processed microstructure of three layer EBC with "mixed" (mullite+BSAS) intermediate layer.

With this in mind, differences in the protective capability of each of the two EBCs became apparent in the early stages of exposure in the Keiser Rig. After 1500h at $1200^\circ C$ and 1.5atm H_2O , imaging the Si/mullite (area circled in Fig. 1) or the Si/(mullite+BSAS) (area circled in Fig. 2) interfaces of the EBC revealed oxidation of the Si bond coat which resulted in the formation of SiO_2 at the interfaces during exposure. Differences between the amount of SiO_2 formed after 1500h for the two EBC formulations are shown in Fig. 4 and Fig. 5 for the Si/mullite/BSAS and Si/(mullite+BSAS)/BSAS mixed-layer EBCs, respectively. Note that the amount of SiO_2 formed in the Si/Mullite/BSAS EBC (Fig. 4) was $\sim 5X$ thicker than that formed in the mixed-layer EBC (Fig. 5) indicating that the protective capability of the mixed-layer EBC was superior. In fact, exposure of the Si/mullite/BSAS EBC/CFCC coupon in the Keiser Rig was suspended after 3000h because excessive oxide formation at the Si/mullite interface led to some EBC spallation at this interface. The primary reason for the greater degree of oxidation for the Si/mullite/BSAS EBC is attributed to excessive micro-cracking and porosity within the mullite intermediate layer after EBC processing. The (mullite+BSAS) intermediate layer in the mixed-layer EBC did not show excessive micro-cracking in the as-processed condition. Exposure of the mixed-layer EBC/CFCC coupon was continued for a total exposure time of 6500h. The Si/(mullite+BSAS) interface in the mixed-layer EBC/CFCC after 5000h at $1200^\circ C$ and 1.5atm H_2O is shown in Fig. 6. A comparison of Fig. 5 and Fig. 6 shows only slow thickening of the SiO_2 at extended times, further demonstrating the superiority of this EBC compared to the Si/mullite/BSAS EBC.

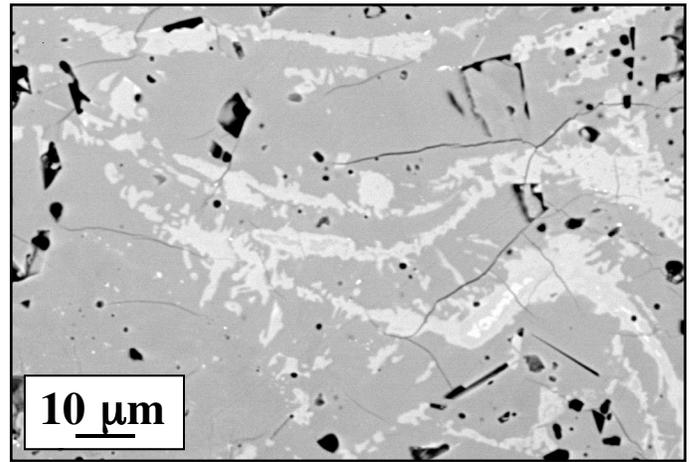
Fig. 11. SEM image of the as-processed BSAS top coat showing a two-phase structure consisting of BSAS (matrix) and a discontinuous Sr-enriched phase (brightly imaging).
