CORROSION ISSUES IN BLACK LIQUOR GASIFIERS

James R. Keiser, Roberta A. Peascoe and Camden R. Hubbard
Oak Ridge National Laboratory
Oak Ridge, Tennessee 37831

J. Peter Gorog
Weyerhaeuser Company
Federal Way, Washington, 98477

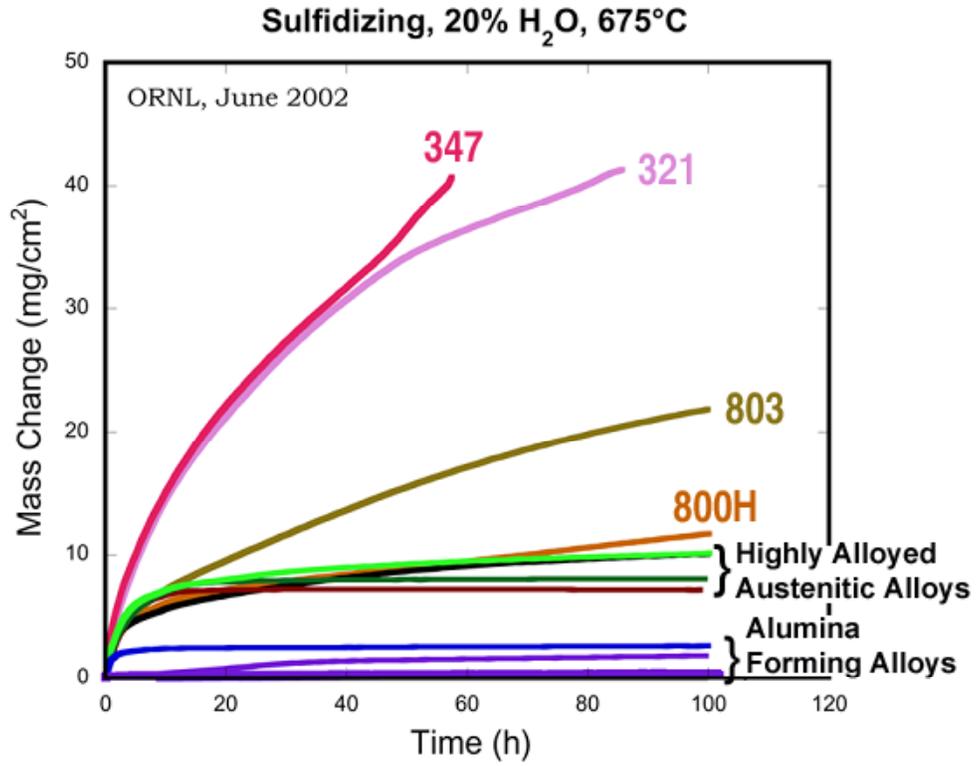
Fairly recently, a series of 100-h microbalance tests has been conducted in an H_2 - H_2S - H_2O gas mixture to help evaluate potential bed tube materials for use in a LTLP reformer/gasifier for a mill operating on the sulfite pulping process. A plot showing weight change versus exposure time is presented in Fig. 21. It is clear that the standard stainless steels and many of the conventional chromia-forming alloys have initial rates of weight gain that suggest these alloys may not be suitable for application in such a system. Relatively small weight changes were seen for the alumina forming alloys that were tested, but cost, fabricability and weldability could be issues for these materials. Two recently funded DOE projects will be generating more extensive information on the performance of materials in soda, kraft and sulfite mills.

Figure 21. Mass change versus exposure time for samples tested in the simulated environment of a reformer gasifier operating at a sulfite mill.
