Current Understanding Of Cracking Of Recovery Boiler Primary Air Port Composite Tubes

James R. Keiser*, Douglas L. Singbeil**, Gorti B. Sarma*, Joseph R. Kish**, Kimberly A. Choudhury*, Laurie A. Frederick**, Jerry Yuan†, François Jetté‡, Camden R. Hubbard*, Robert W. Swindeman*, Preet M. Singh††

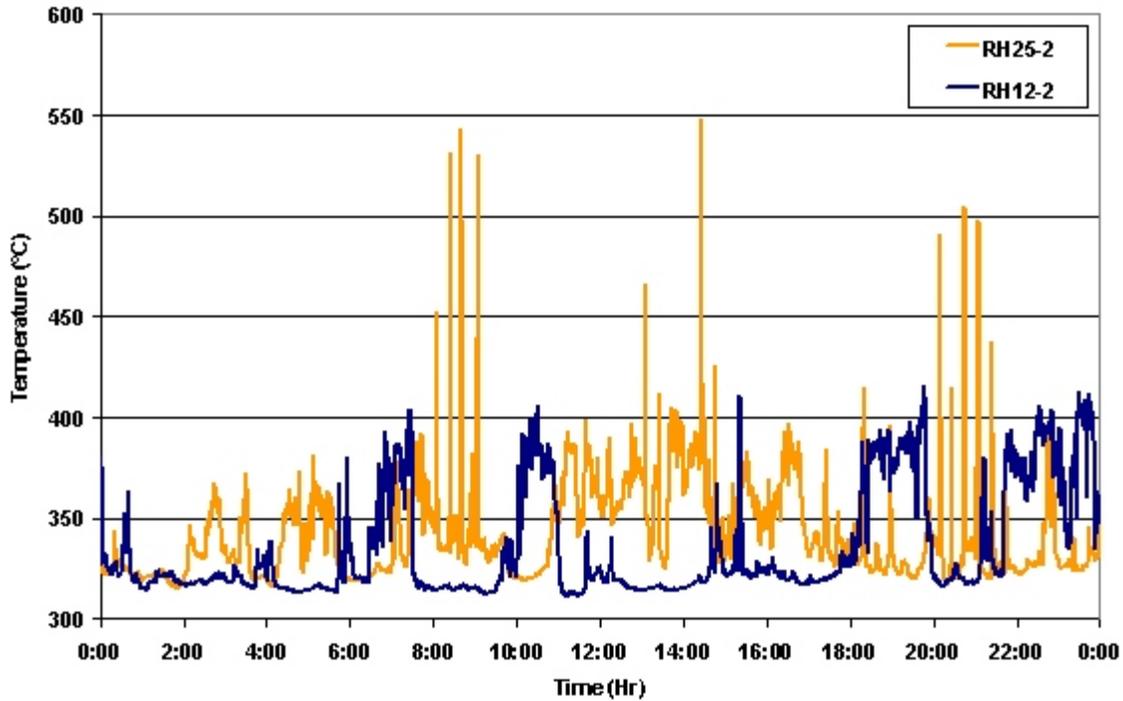
11. Temperature measurements made on composite tubes that form longer, narrower type primary air ports in a boiler initially constructed with shorter, wider type of primary air ports.

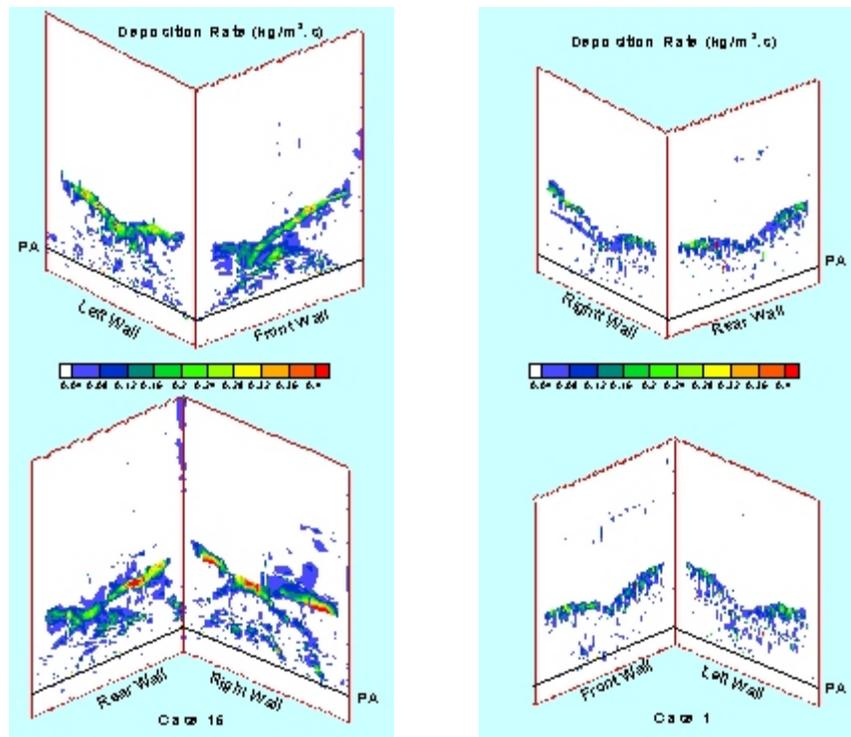
14. Black liquor deposition rate calculated for two boilers - boiler #1 that has experienced primary air port cracking and boiler #2 that has not shown significant amounts of primary air port cracking.
