**Technical Evaluation
of the In Situ Vitrification Melt Expulsion
at the Oak Ridge National Laboratory
on April 21, 1996,
Oak Ridge, Tennessee**

Date Issued—August 1996

Environmental Management Activities at the
OAK RIDGE NATIONAL LABORATORY
Oak Ridge, Tennessee 37831-8169
managed by
LOCKHEED MARTIN ENERGY SYSTEMS, INC.
for the
U.S. DEPARTMENT OF ENERGY
under contract DE-AC05-84OR21400

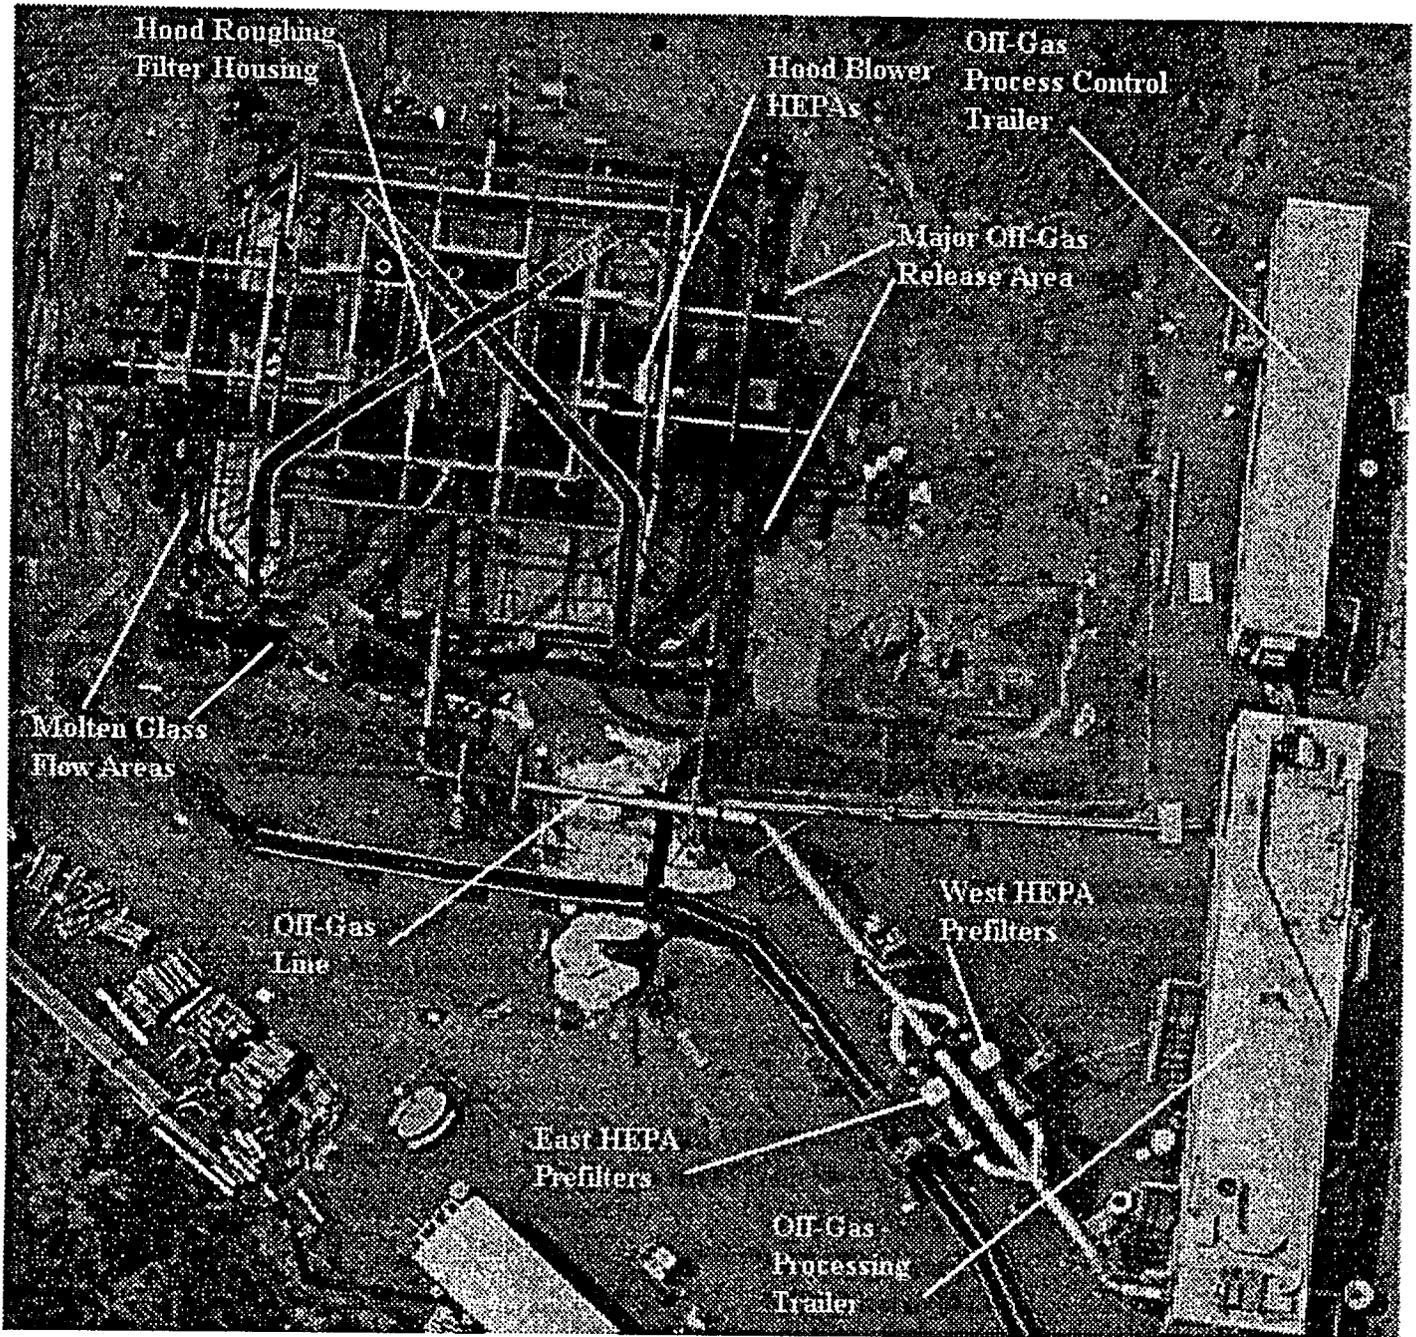
Fig. 1. Aerial photograph of ORNL ISV site on April 22, 1996, with notations showing locations of key equipment and pertinent incident areas.

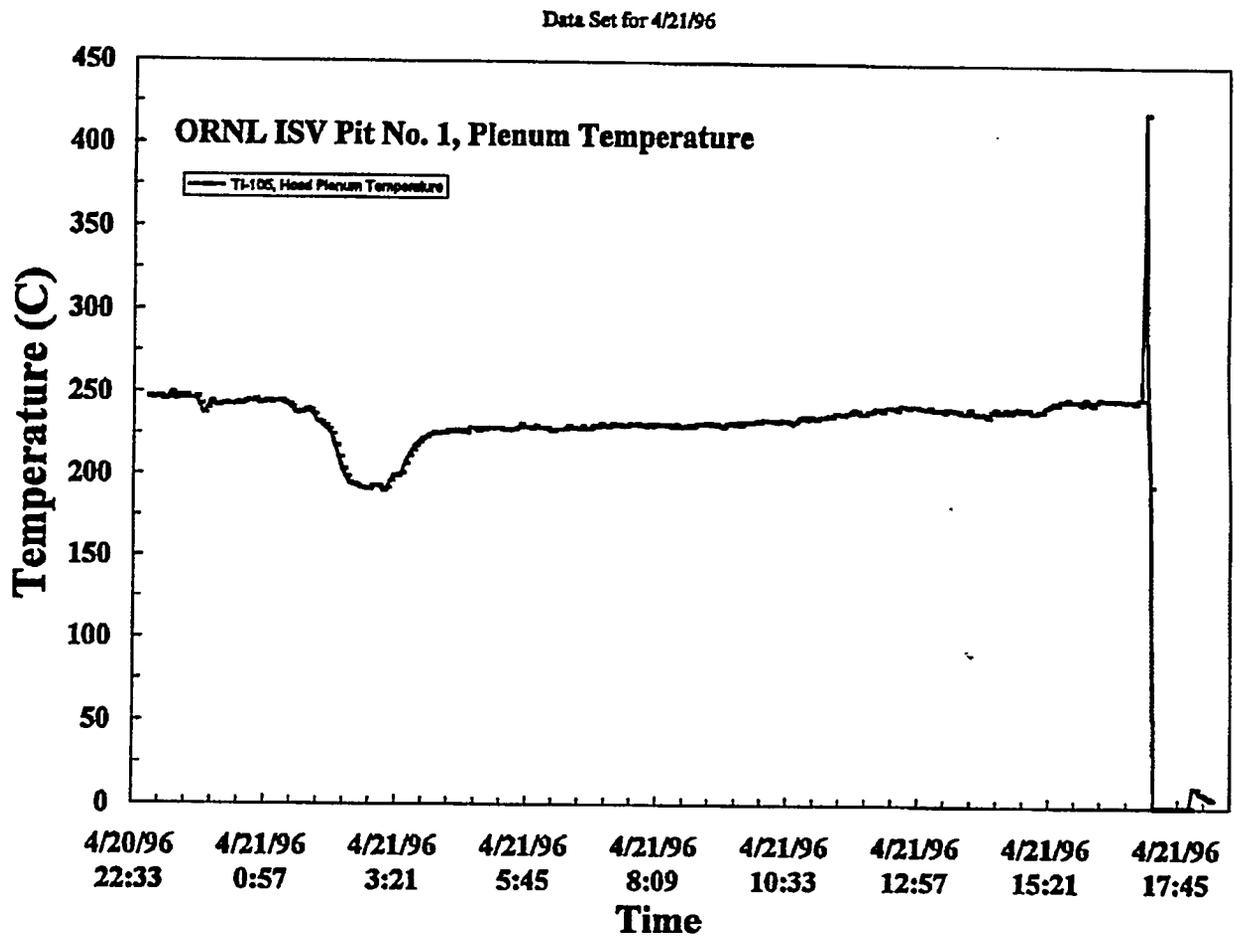
The archived data are useful to determine if trends indicating something unusual was about to occur were apparent. However, the data both in the short term and over the entire length of ISV operations at pit 1 show no obvious indicating trends. For example, the temperature of off-gas in the hood plenum (Fig. 15) indicated quite stable conditions during the 20 hr prior to the event. Small fluctuations like that which occurred around 3:21 p.m. on April 21 were the result of adjustment of the hood's air-intake valve (PIC-101) or a change in HEPA prefilters. There is no trend of increasing or decreasing hood off-gas temperature prior to the melt expulsion. The "spike" in the off-gas temperature near the end of the data collection period shows the influence of increased off-gas temperature on a 4-min average, much-dampened intensity.

Fig. 15. Off-gas hood plenum temperature during the 20 hr immediately before the ISV melt expulsion incident of April 21, 1996, 6:12 pm.

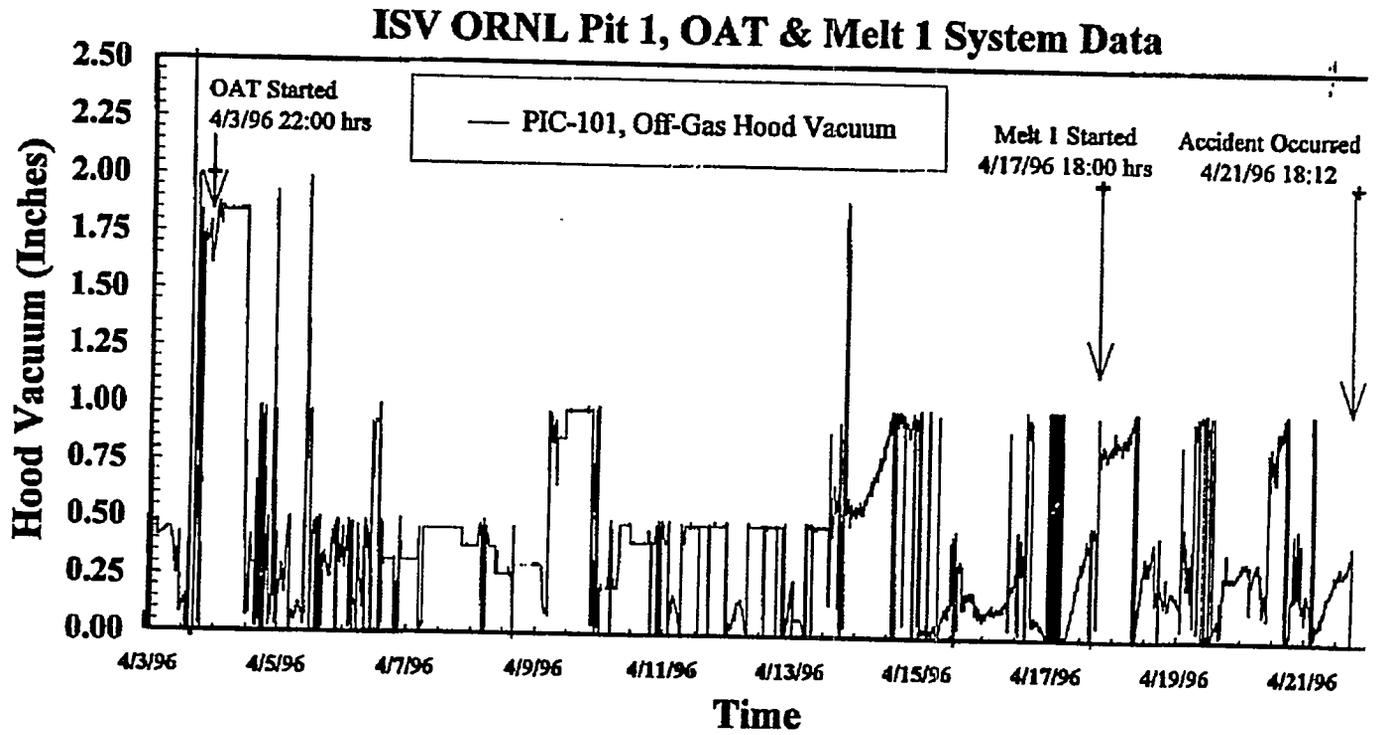
The vacuum in the off-gas collection hood obviously went considerably positive (pressure) when the hood was lifted off the ground during the expulsion event. Routinely, the hood was maintained under slight vacuum (i.e., 0.25-0.50 in. of water column). As can be seen from Fig. 16, hood vacuum varied over the duration of the melt operations from operator adjustment of the air-inlet valve or application of water by hose or rainfall to the soil and sand around the hood base to improve its seal to the ground. Examination of detailed data during the 20 hr prior to the melt expulsion (Fig. 17) reveals the same lack of indicating trend prior to the melt expulsion incident.

Fig. 16. Vacuum in the ISV off-gas collection hood over the entire duration of the ORNL pit 1 ISV operations.

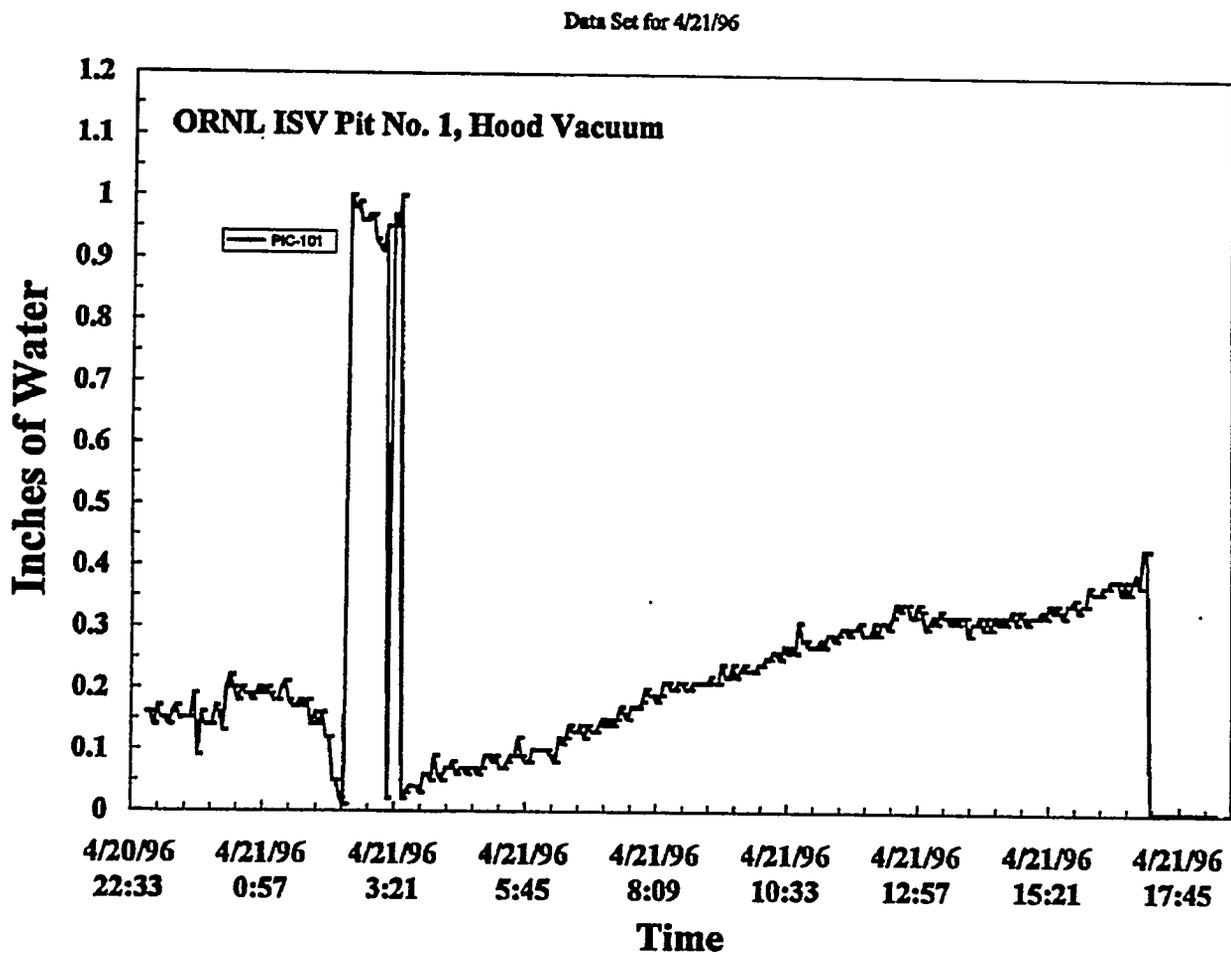
Fig. 17. Vacuum within the ISV off-gas collection hood during the 20 hr preceding the ORNL ISV incident of April 21, 1996, 6:12 p.m.

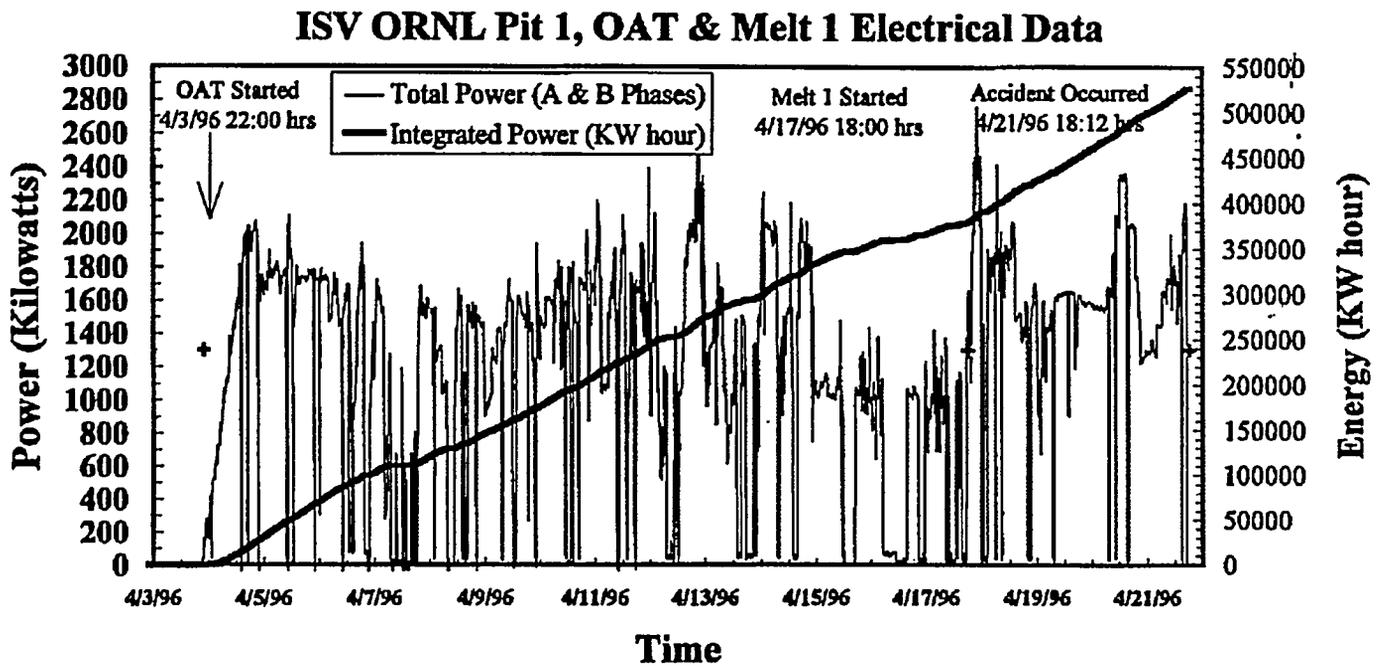
The cumulative power delivered to the melt can also be seen in Fig. 20. As discussed previously, cumulative power is useful for estimating melt mass. More importantly, the slope of cumulative power versus time is a more convenient indicator of energy to the melt because it avoids the shorter-term fluctuations apparent in the actual power data. It can be seen from Fig. 20 that the slope of the cumulative power at the time of the melt expulsion was not significantly different than at other times during the 18-day interval.

Fig. 20. Electrical power and cumulative energy applied to the ORNL ISV melt over the duration of operations.

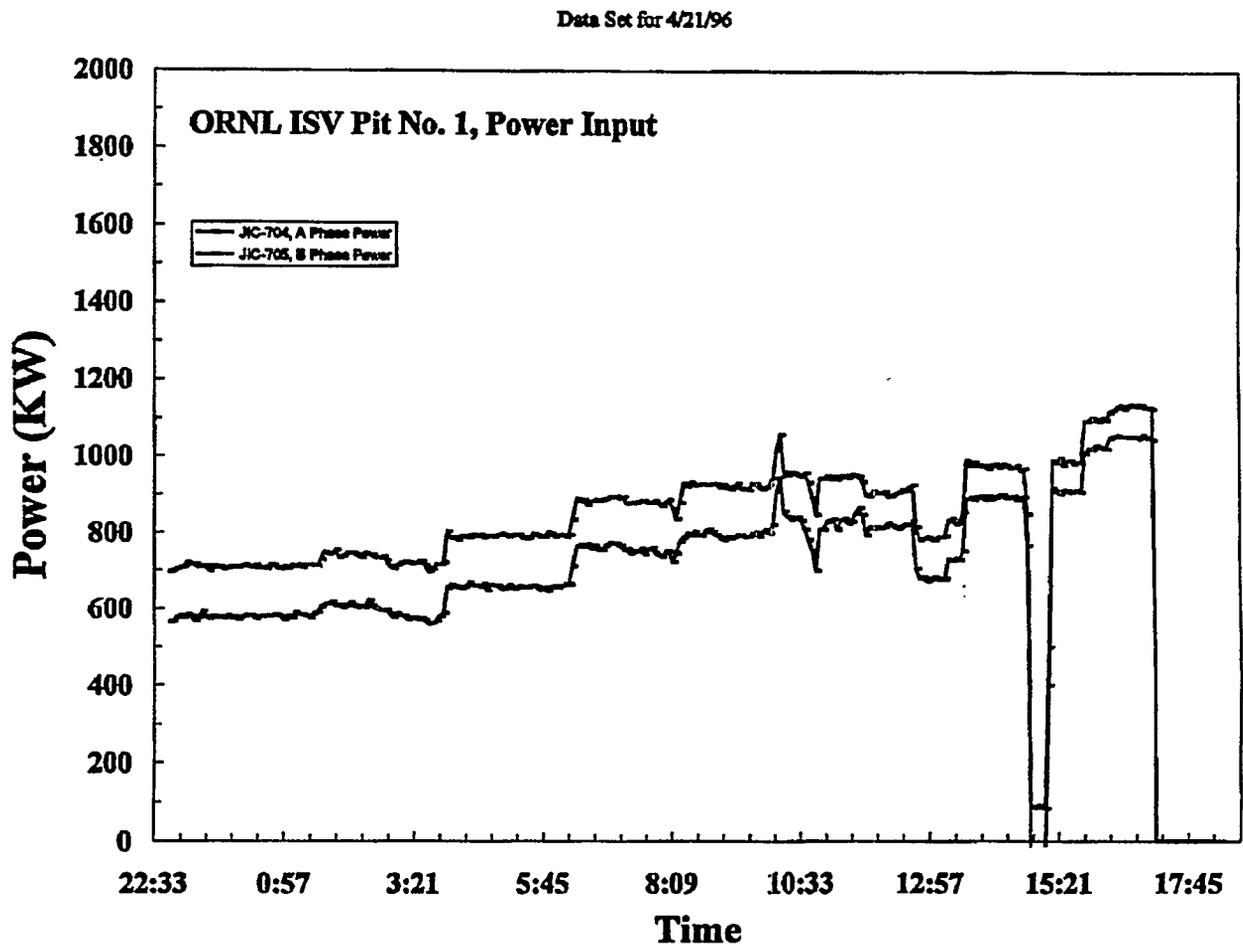
Examination of electrical power characteristics during the 20 hr immediately prior to the melt expulsion (Fig. 21) reveals no obvious trend other than a gradual stepping-up of power. The brief period of power outage at about 2 hr before the melt expulsion was due to entry to the hood's work platform to perform a radiation survey and to adjust electrodes. Four personnel were on the work platform at that time, and this graph indicates that they could have selected a slightly later time to complete their tasks and been present during the melt expulsion.

Fig. 21. Electrical power applied to the ORNL ISV melt during the 20 hr preceding the expulsion event of April 21, 1996, 6:12 p.m.

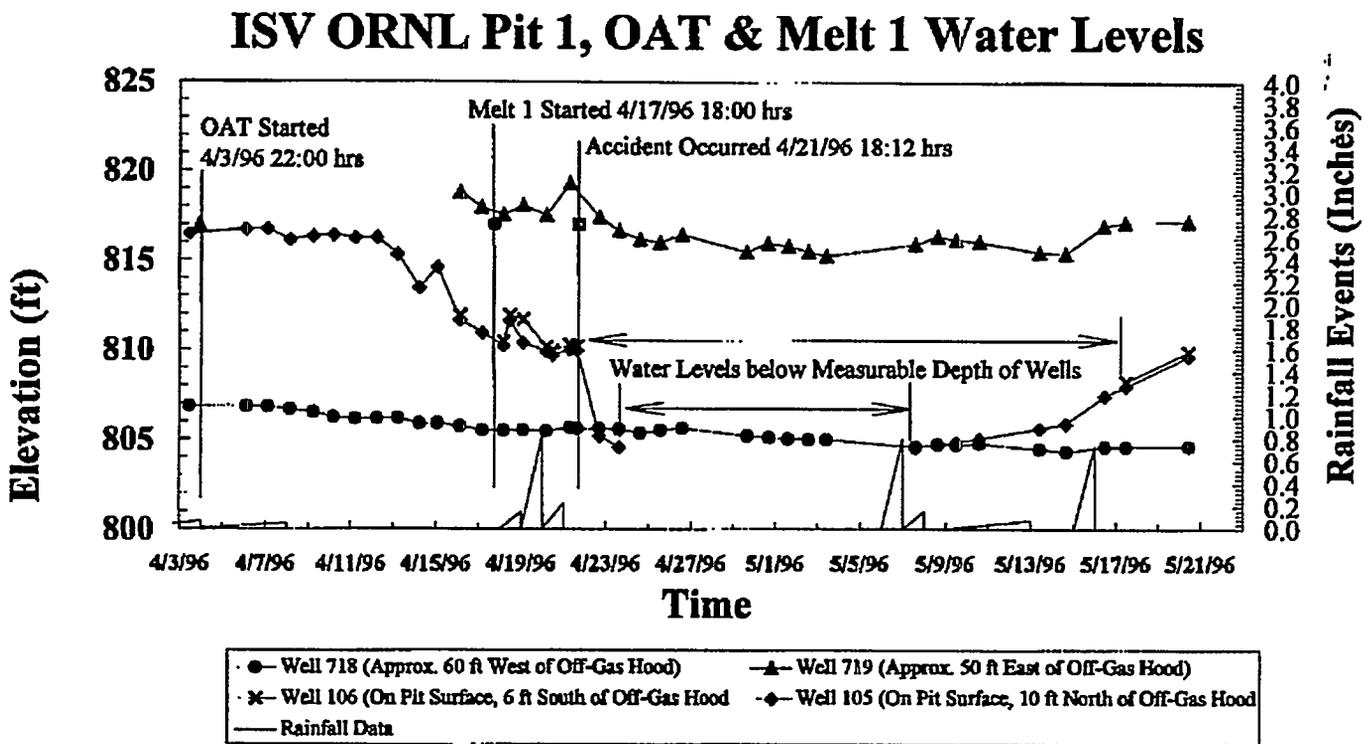
leading up to the melt expulsion (Fig. 24). However, when measurements of the water levels in the two wells immediately north and south of the off-gas hood were attempted on the day after the melt expulsion, no water was found in either well indicating that the levels had dropped at least 6 ft since the previous day's measurement to below the bottom of the each well.

Fig. 24. Water table elevations within and around ORNL pit 1 and precipitation during ISV operation relative to the April 21, 1996, expulsion incident.

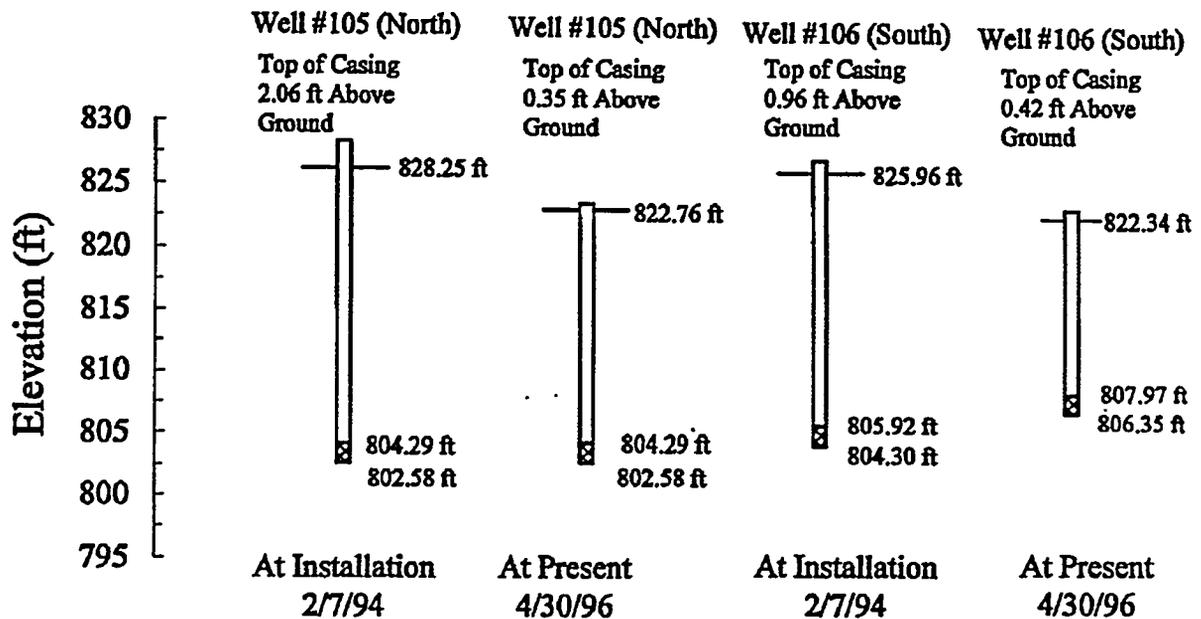
In contrast, water levels in the two wells outside pit 1 to the east and west of the pit indicated no fluctuation relative to the melt expulsion incident. Water levels as of May 30, 1996, have now returned high enough to cover the top of the melt surface in the residual startup trench/subsidence crater. The two wells on the north and south sides of the off-gas hood were subjected to several elevation manipulations, (a few sections of Geoprobe rod were removed and the wells were lifted up slightly) required because of the pit 1 surface sculpting in March 1995 and to protect their protruding heads during off-gas hood assembly on the pit surface in July-September 1995. The differences between the original installation elevations and the final configurations are summarized in Fig. 25.

Fig. 25. Variation in configuration between installation and final use of two driven wells in pit 1 immediately north and south of the ISV melt body.

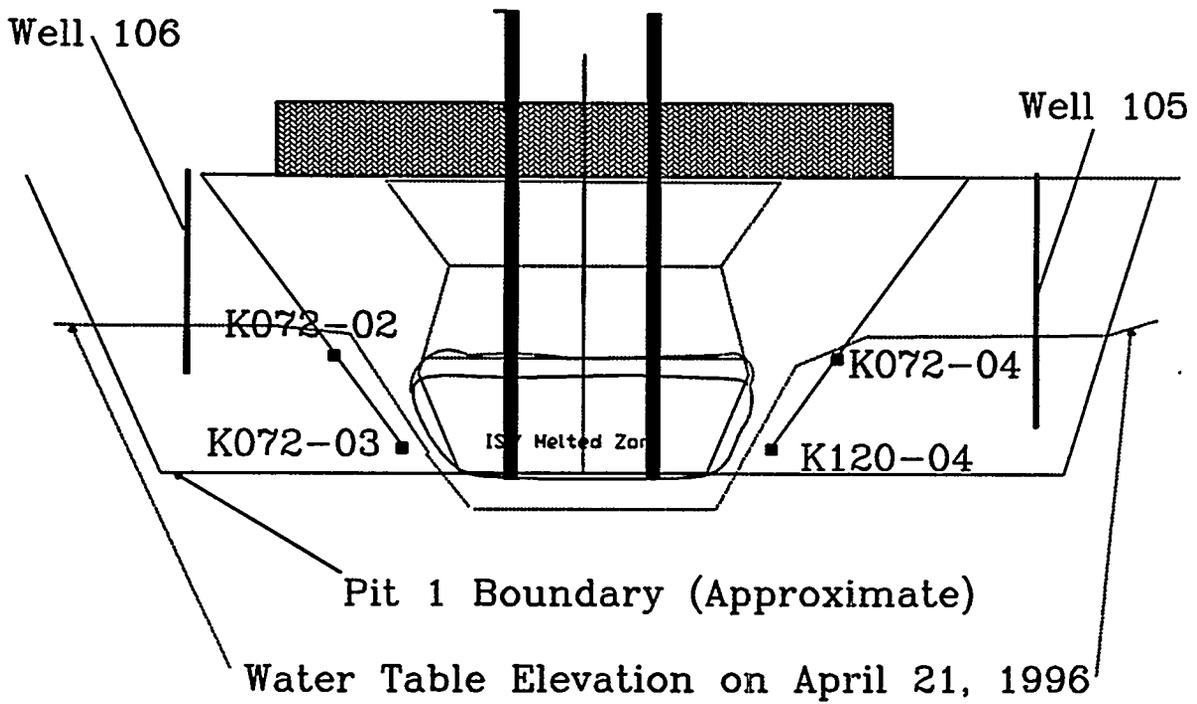
The purpose of these additional thermocouples was to provide warning if the ISV melt body were to approach a diameter similar to the width of the off-gas hood. Thermocouples were positioned at approximately 5 and 10 ft inside the wall of the hood at depths of 14 and 22 ft below ground surface, respectively (Fig. 26). All four thermocouples were connected to the data acquisition system in the project office/break area portable building; data from these thermocouples were collected beginning 4 days prior to the event and for about 2 weeks after. Power for this DAS was not interrupted as was the process control trailer's DAS during the fire. None of the four thermocouples indicated any thermal influence from the melt body. Thus, the disappearance of water from these two wells further away from the melt body would not have been caused by hot pressurized steam flowing away from the melt. The disappearance of water must represent flow towards the melt body probably into dried soil around the melt which, prior to the event, must have contained sufficient pressure to counter the hydrostatic head of perched water in these wells.

Fig. 26. Cross-section of ORNL pit 1 showing melt depth, perched groundwater, monitoring wells, and thermocouple positions immediately before the incident of April 21, 1996.

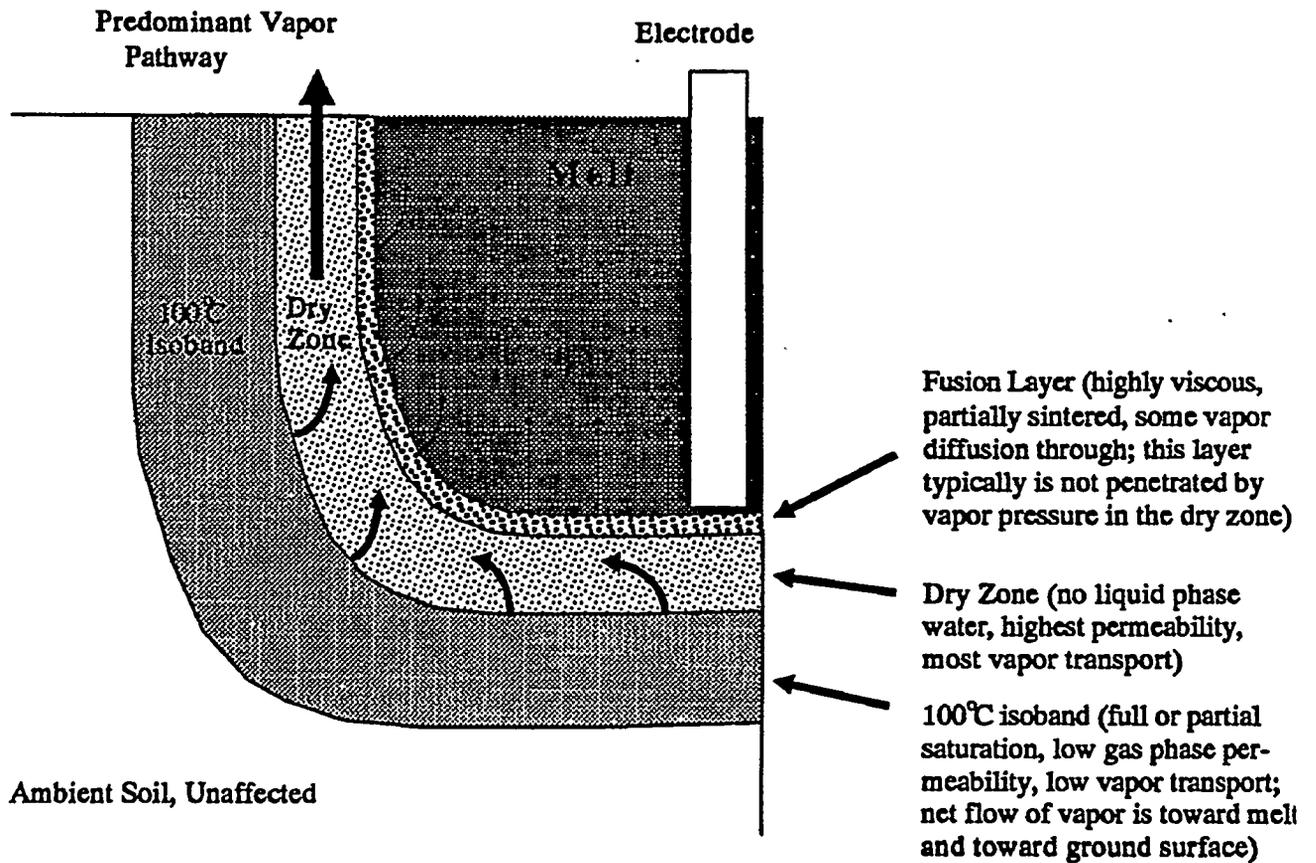
Fig. 27. Conceptual model of ISV off-gas vapor pathways around a body of molten soil.

Perhaps the only salient difference between the conceptual model in Fig. 27 and actual conditions in ORNL pit 1 is that the unaffected soil zone would have been completely saturated with water. This difference could be a significant factor in contributing to the expulsion incident in pit 1. As depicted in Fig. 28, pressurization of steam in the dry zone has an additional potential release through the saturated 100°C isoband zone into ambient unsaturated soil requiring only a nominal pressure to displace the narrow band of water in this limited saturated zone. However, in the case of pit 1, the unaffected soil was saturated; thus, it had no residual gas-filled porosity through which to conduct any steam. Obviously, some residual gas-filled porosity in the unaffected soil, i.e., unsaturated conditions, would be a desirable condition to maintain this potential pressure venting pathway.
