**Environmental Health and Safety
Independent Investigation
of the In Situ Vitrification Melt Expulsion
at the Oak Ridge National Laboratory,
Oak Ridge, Tennessee**

Energy Systems Environmental Restoration Program

Date Issued—July 1996

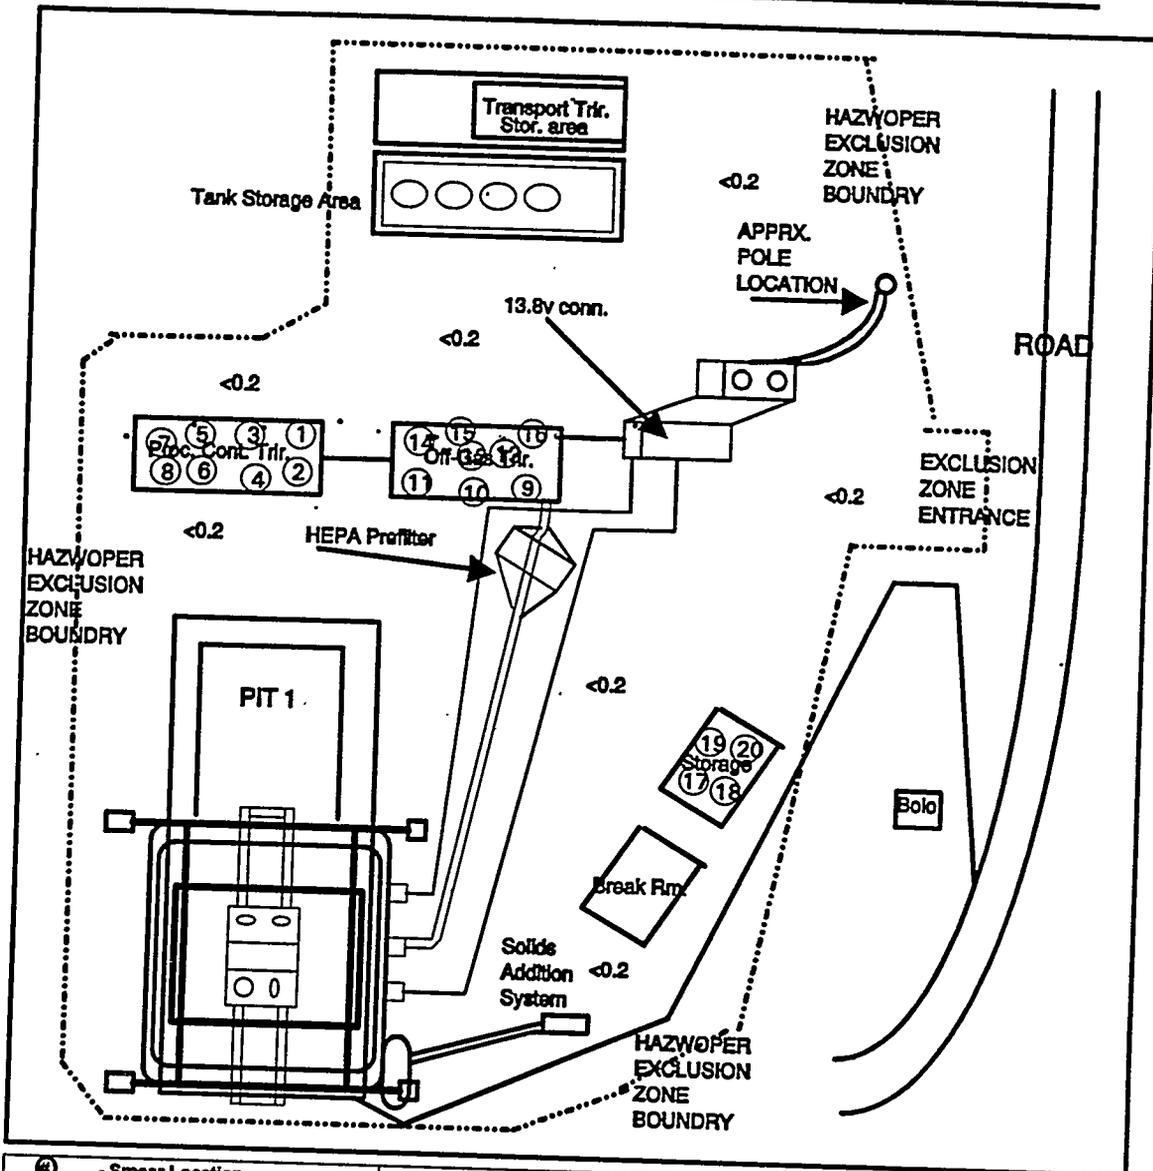
Radiological survey maps from April 20, 1996 through April 23, 1996, were compared to determine the changes in radiological conditions resulting from the event. Small pieces of solidified glass were found over and around the immediate site (50 ft–100 ft). These pieces of “angel hair” (Fig. 4) did not exceed the surface contamination limits specified in the ORNL *Radiological Protection Procedures Manual*. Radiological Control personnel found many of these pieces by looking for them at night with a flashlight, rather than utilizing radiation detecting instruments. The radiation levels emitted by individual small pieces were too low to be detected using the instruments.

Fig. 6. Oak Ridge National Laboratory radiological survey data (before the event).
