**Microstructural Banding and Biaxial Fracture Toughness Tests
in a Specially Heat-Treated Reactor Pressure Vessel Steel**

ABSTRACT

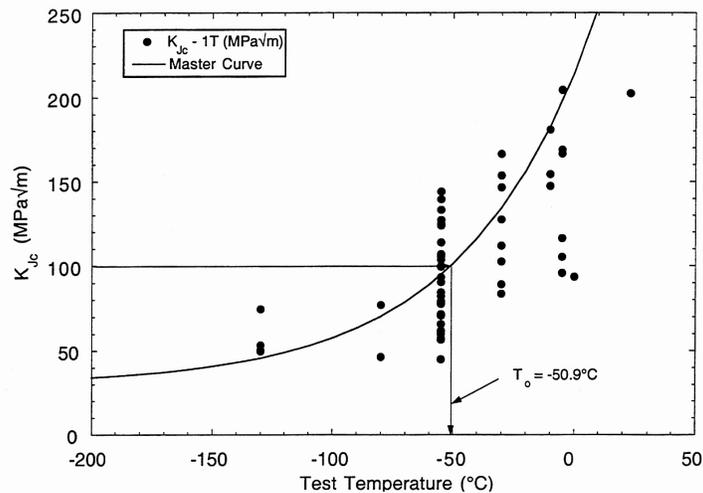
Figure 1. Fracture toughness data from 0.5T compact specimens of heat-treated HSST Plate 14A showing Master Curve and data. All data are adjusted to 1T size in this figure.

specimen size adjustment according to ASTM E-1921, the T_0 value was determined to be -37°C (-35°F). Subsequently, additional 0.5T specimens were machined from five different blocks of the heat treated plate and the overall T_0 value was determined to be -51°C (-60°F). Fig. 1 shows the detailed test results.

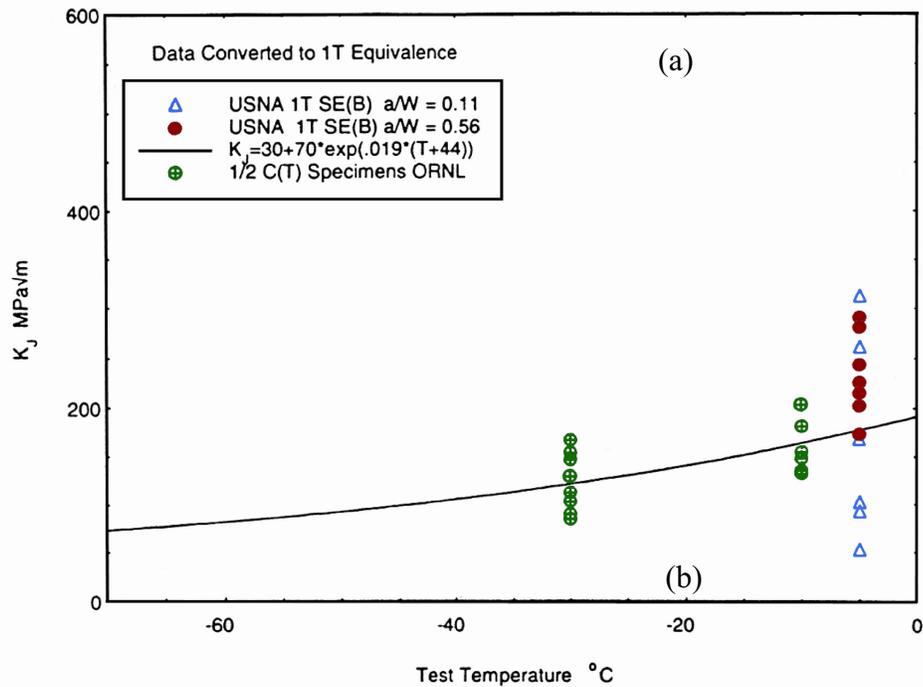
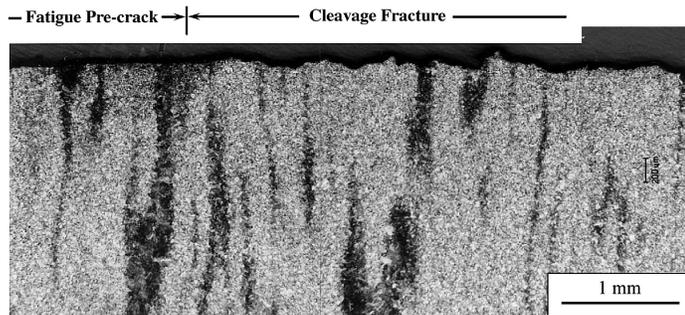
Specimen P14S7 (USNA)

Figure 2. Plot of fracture toughness data from 1T three-point bend specimens of heat-treated HSST Plate 14A, and composite micrograph of 1T bend specimen P14S7 (data and micrograph provided by USNA and NSWC).

[1TSE(B)] tests [the tests were conducted for NSWC by the United States Naval Academy (USNA)]. Eight shallow-flaw and seven deep-flaw specimens were tested at -5°C . The results of those tests are shown in Fig. 2 [Ref. 2]. Shallow-flaw specimen P14S7 was tested at -5°C and gave the lowest fracture toughness ($51\text{MPa}\sqrt{\text{m}}$) at that temperature and was significantly lower than the next lowest result ($90.7\text{MPa}\sqrt{\text{m}}$). Furthermore, a number of the shallow-flaw specimens exhibited lower fracture toughness than the deep-flaw specimens tested at the same temperature, an unexpected result. Micrographs of that specimen and others were prepared by NSWC and provided

to ORNL by NSWC; they showed varying degrees of dark bands which were assumed to be due to microstructural banding. Fractography was also performed by NSWC and indicated that the fatigue crack fronts were in regions of banding in some cases. The micrograph for specimen P14S7, shown in Fig. 2, exhibited very dark bands and that observation provided the postulate that the banded regions may be the cause of the low fracture toughness results. At the same temperature, another NSWC tested shallow flaw specimen (P14S4) also exhibited apparent banding, albeit not so heavy as P14S7, and gave the highest fracture toughness ($311\text{MPa}\sqrt{\text{m}}$) in the scatter band.

A composite micrograph for specimen P14S7 (tested by USNA) was provided by NSWC and was shown earlier in Fig. 2; the etchant used by NSWC was 2% nital. NSWC also provided a portion of that specimen to ORNL so it could be examined, re-polished, and etched in the same manner as the ORNL specimens. The SEM examination was not successful in identifying a single cleavage origin, and concluded that multiple origins existed along the crack front. Because the fracture toughness of specimen P14S7 was so low, 51.5 MPa \sqrt{m} , there was no ductile tearing and the cleavage origin is undoubtedly just slightly ahead of the fatigue crack. Such an observation is common for specimens which fail at relatively low fracture toughness. Although the relationships between the microstructural features and the fatigue crack front are somewhat different in the two micrographs, both views result in the existence of bands near the crack front and associated with the cleavage origin, which is presumed to be just slightly ahead of the crack front, at least at the specific location in the specimen thickness. Another view at a different position through the thickness of the specimen, however, revealed no areas of banding in the region of the crack front, demonstrating the varying relationship between the crack tip and the microstructural features..

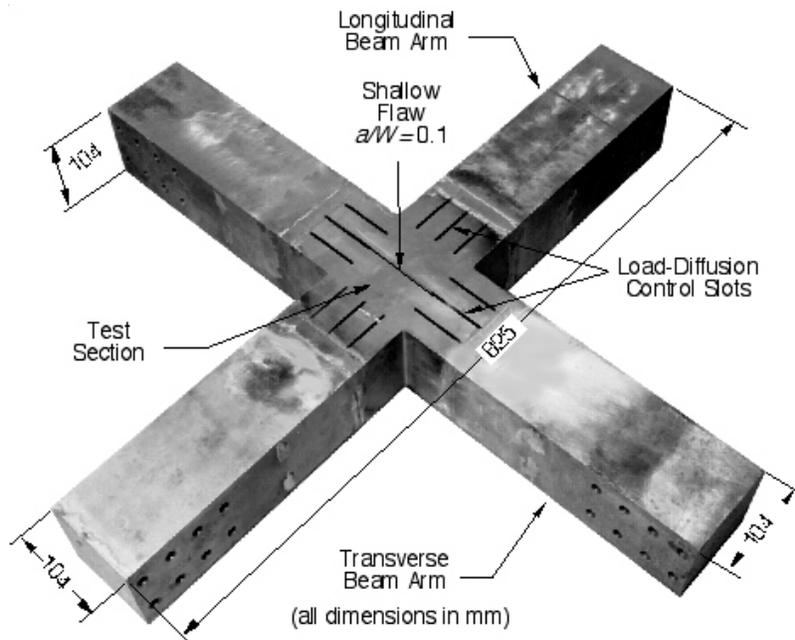
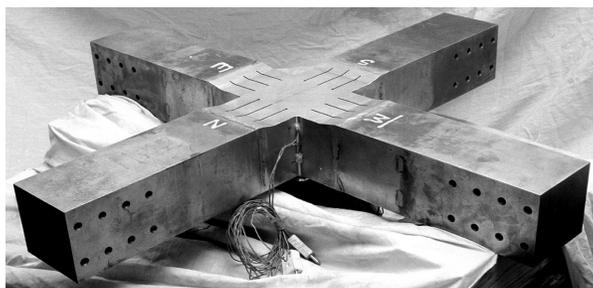
Figure 3. Geometry of the cruciform shallow-flaw biaxial fracture toughness test specimen (type A): (a) schematic drawing showing various features of the specimen, and (b) photograph of a typical specimen prior to testing.

Figures 3(a) and (b) shows a schematic drawing with dimensions and a photograph, respectively, of the intermediate size cruciform biaxial specimens with nominal thickness of about 100 mm [1]. The fracture toughness results from these tests will be

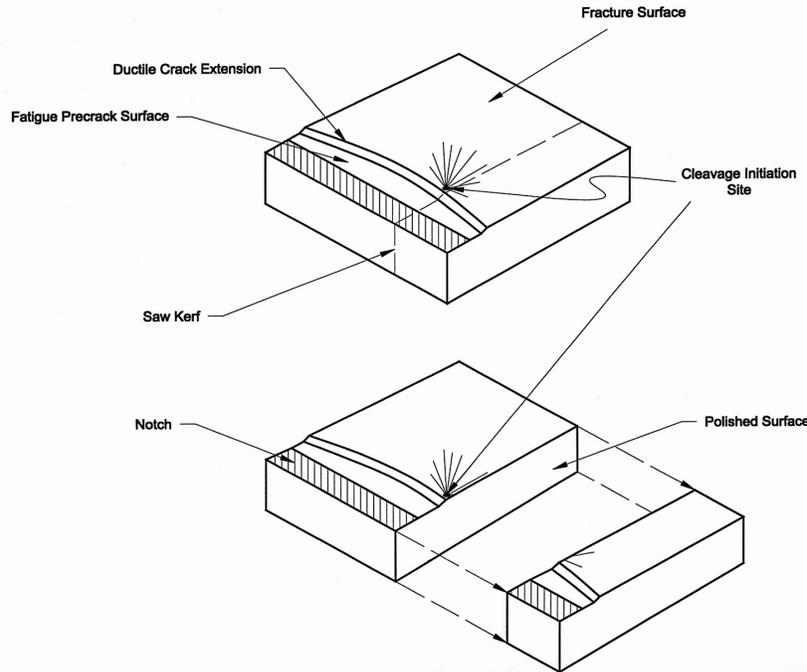
Figure 4. Schematic diagram showing procedure for preparing metallographic sample to examine relationship of fracture surface features and microstructures in heat-treated HSST Plate 14A.

the fatigue crack length, any precleavage ductile crack extension, and distance from the crack tip to the cleavage origin were performed on the SEM. The fracture surface was then sectioned perpendicular to the surface near the cleavage origin and submitted for metallography. Figure 4 is a schematic representation of the process. Grinding and polishing were followed by a number of trials with various etchants and etchant combinations; 4 grams picric acid with 100 ml ethanol and immersion for about 3 min. was chosen as the best

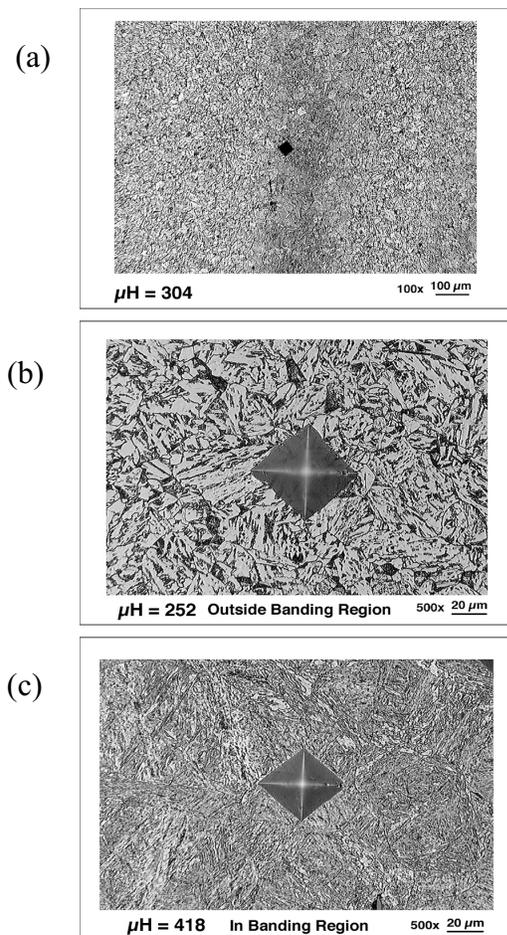
Figure 5. Microhardness of various regions in microstructure of 0.5T compact specimen JP-06 from heat-treated HSST Plate 14A, showing microhardness comparisons in (a) light-etching band, (b) matrix outside bands, and (c) dark-etching band.

wide range of microhardness in the microstructure and a significantly higher hardness in a darkly etching banded region of the microstructure, 418 μH , compared with the matrix hardness, 252 μH . Figure 5(a) shows an intermediate hardness of 304

Figure 5 presents the results of microhardness tests on 0.5TC(T) specimen JP-06 and shows a

μH in a lighter etching banded region. the microstructure outside of the banded regions is representative of an as-quenched microstructure because the temper treatment given this material was very slight. The microstructure contains some proeutectoid ferrite with what are likely martensite-austenite constituents and carbides in a banded microstructure, although transmission electron microscopy is needed to verify that supposition. In the segregated regions, the microstructure is finer with less proeutectoid ferrite and appears to have a more martensitic appearance, which also corresponds to the much higher hardness compared with the nonsegregated regions.

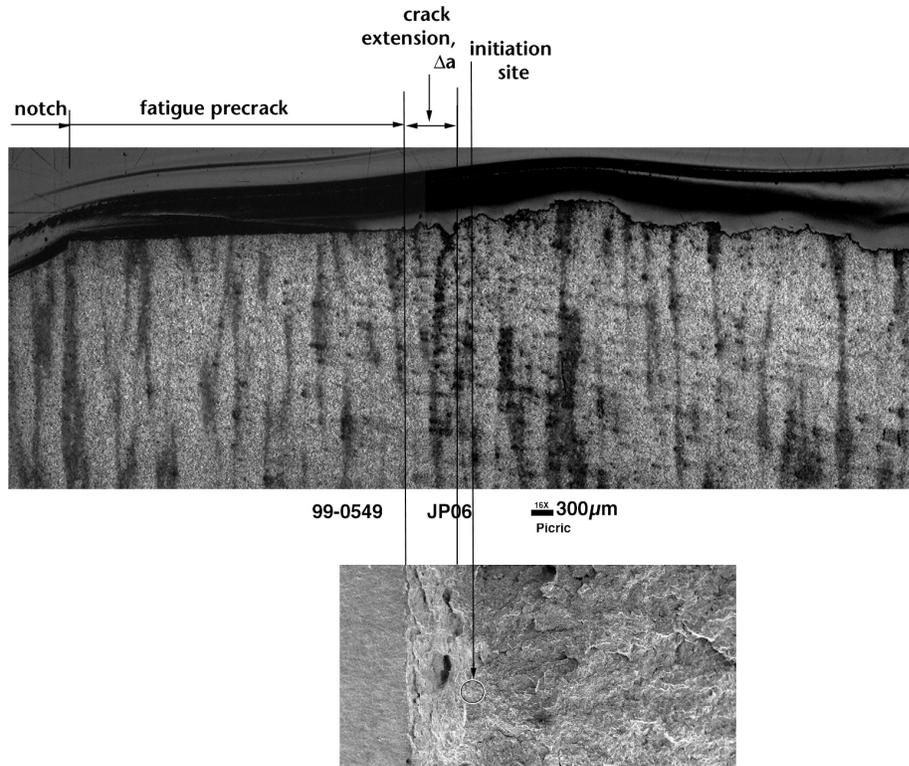
Figure 6. Composite micrographic pan (top) and scanning electron fractograph (bottom) of 0.5T compact specimen JP-06 from heat-treated HSST Plate 14A, showing relationship between fracture surface features and the microstructure in the vicinity of the cleavage initiation site.

Scanning electron fractography of 0.5TC(T) specimens JP-01 and JP-06 confirmed the observations of prefracture stable tearing and that the fracture mode in each case was cleavage. Fractographic examinations of the 1T bend specimens by NSWC revealed similar observations [1]. For specimen JP-06, Fig. 6(a) provides a low magnification fractograph that shows the fatigue precrack, precleavage ductile crack extension, and the region of the cleavage origin, while Fig. 6(b) provides a view of the cleavage origin at higher magnification. Similar fractographs for specimen JP-01, showed that specimen exhibited no precleavage ductile crack extension. Note on Fig. 6(a) that the crack extended through a relatively heavy band and that the cleavage origin does not appear to be associated with a region of banding. For JP-01, however, similar micrographs show that there is a heavy band just in front of the crack tip and the cleavage origin appears to be close to that band.

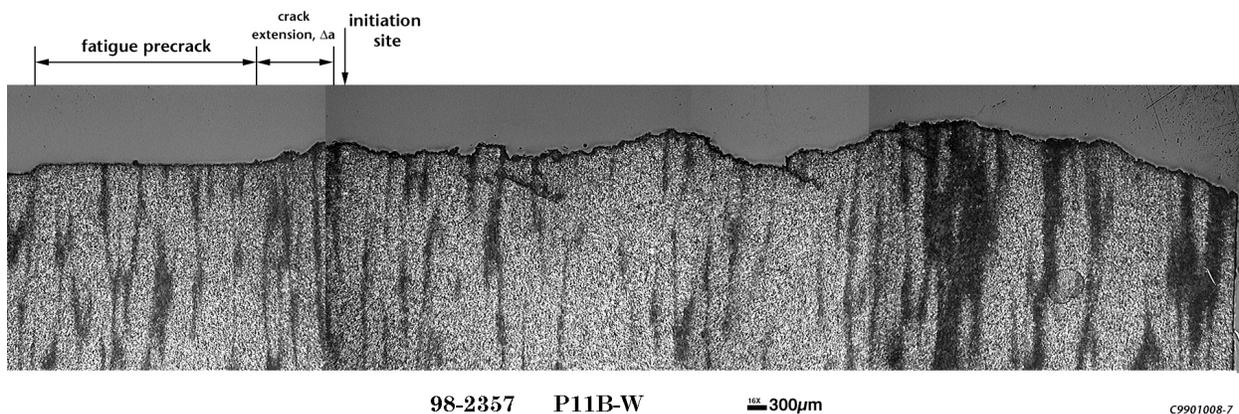
Figure 7. Composite micrographic pan of shallow-flaw biaxial specimen P11B of heat-treated HSST Plate 14A tested with a biaxial ratio of 1.0 at 16°C.

The following example illustrates the process. Figure 7 for specimen P11B shows that the crack front coincides with a band in this specimen, but the cleavage origin is not associated with a band. Thus, Table 3 indicates a “Y” and a “N” for the first two columns related to existence of bands. Since the distance $0.75X$ is greater than the distance for X , then a band does exist within the distance $0.75X$ as well as within the distance $2X$, and the last two columns indicate “Y.” Figure 8 is shown for specimen P4A because it demonstrates contrast with that of figure 7 for P11B in that the cleavage origin is associated with a band. Both specimens (biaxial ratios of 1) had bands between the crack tip and origin, but gave K_{Jc} results of 141.2 and 325.5 Mpa√m, respectively.

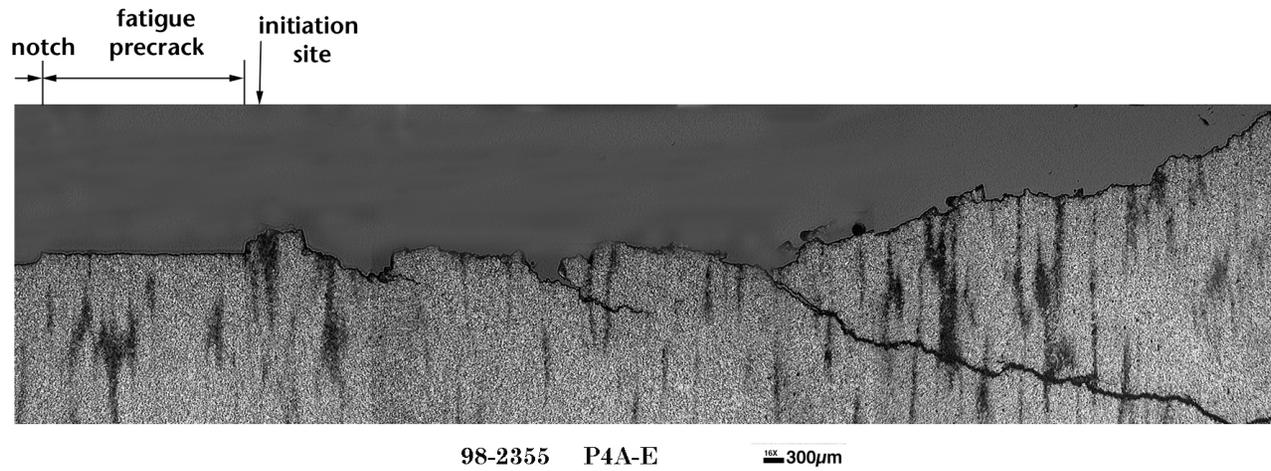
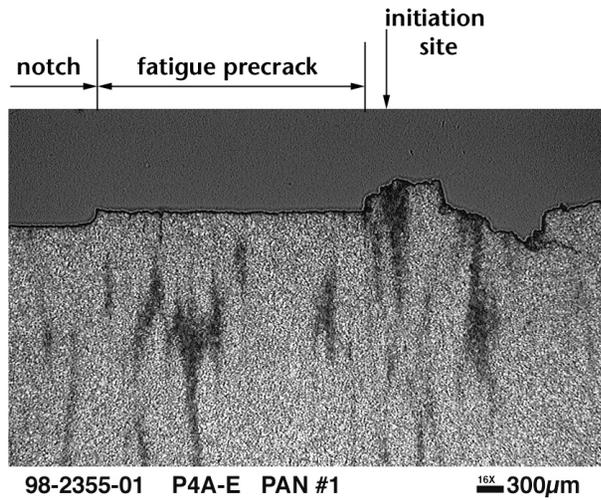
Figure 8. Composite micrographic pan of shallow-flaw biaxial specimen P4A of heat-treated HSST Plate 14A tested with a biaxial ratio of 1 at -30°C.

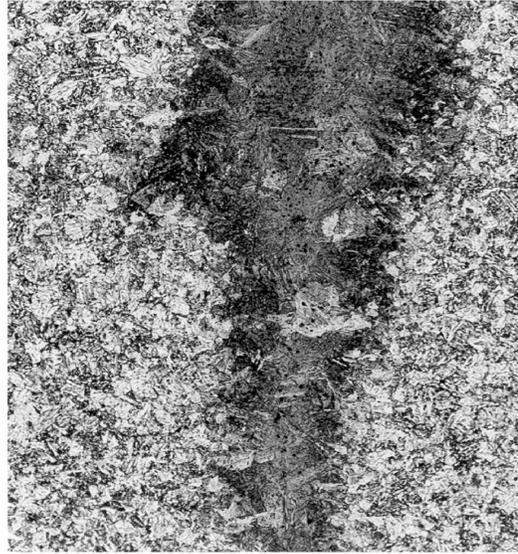
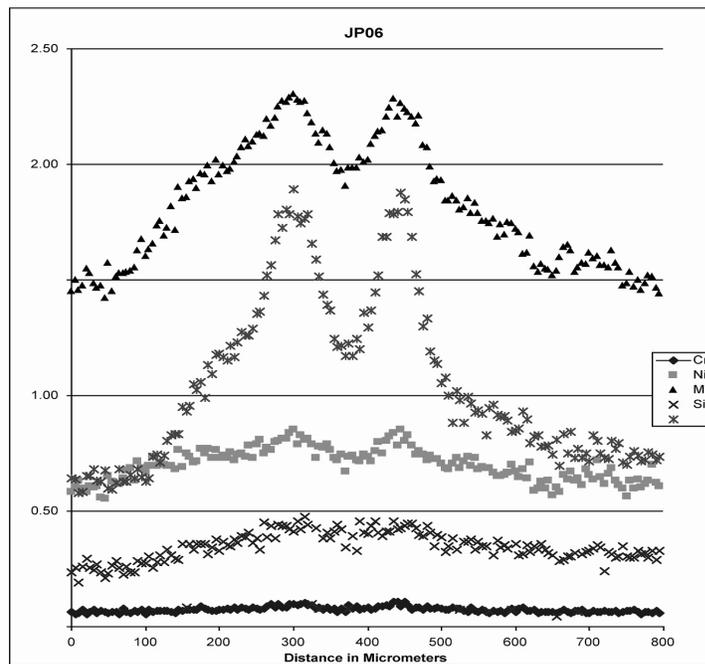
Figure 9. X-ray compositional microanalysis results across large area of segregation in 0.5T compact specimen JP-06 from heat-treated HSST Plate 14A.

as in carbon steels, but we will refer to the phenomenon in this steel as banding in any case because it is descriptive of the microstructural observations. Figure 9 shows one example with specimen JP-06. Quantitative wavelength- and energy-dispersive X-ray spectroscopy microprobe scans across the segregated regions show that they are much richer in molybdenum and manganese relative to the surrounding ferritic

matrix. Substantial enrichment in nickel and silicon are also evident, but chromium and copper do not appear to be segregates. Similar analyses show the degree of segregation is lower in the lighter etching regions than in the darker etching regions. These elements are substitutional alloying elements that are rejected into the liquid phase of the steel during the initial solidification and casting process, and can be retained interdendritically as well as in the center of an ingot. The subsequent mechanical processing (e.g., hot rolling) and heat treating procedures will affect the degree of microsegregation and macrosegregation which results. However, the spacial resolution of the electron beam and corresponding X-ray excited volume (at 20 KV) do not allow the composition of individual carbide particles to be measured. This analysis alone cannot determine whether the carbides are rich in molybdenum and/or manganese or whether the matrix is enriched in those elements.

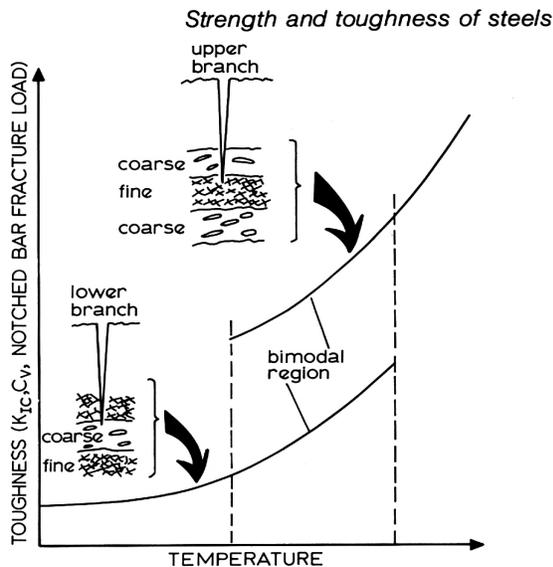
Figure 10. Schematic diagram of "bimodal" toughness behavior and suggested explanation in terms of coarse (brittle) and fine (tough) phases and their location with respect to the crack tip (Ref. 22).

In a study of HY-80 steel heat treated to produce a mixed microstructure of tough martensite and brittle bainite, Hagiwara and Knott [22] observed that the K_{Ic} values showed particularly large scatter with a bimodal distribution. They reported that fractography showed the upper branch of the fracture toughness distribution corresponded to the presence of the tough phase at a calculated critical distance ahead of the crack tip, while the lower branch was associated with the brittle phase in that position. This observation is shown schematically in Fig. 10. Knott [23] further stated "The general principles involved would appear to have application to a wide variety of mixed microstructures, including banded plate and weld metals."

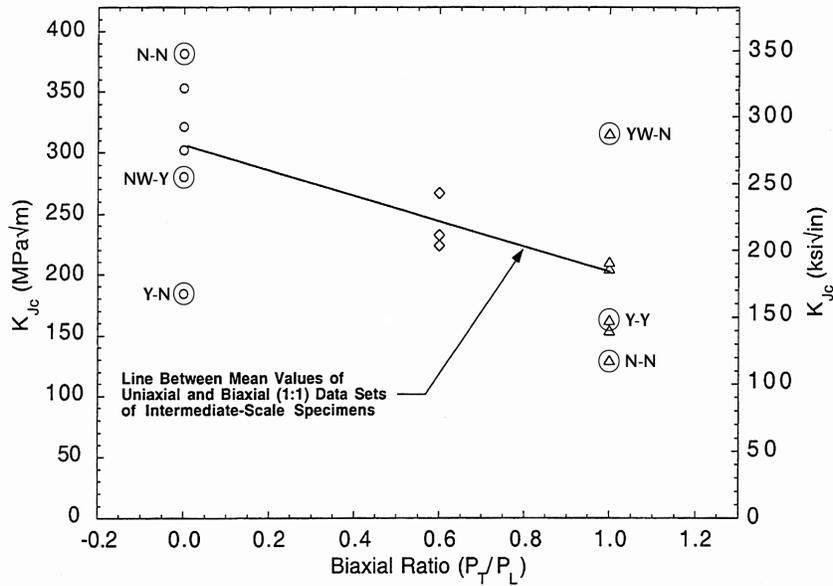
Figure 11. The effect of biaxial load ratio on fracture toughness determined for heat-treated HSST Plate 14A tested at -5°C (23°F). The Y and N annotations relate to the apparent association or lack thereof between the crack front and cleavage origin, respectively (see Table 3).

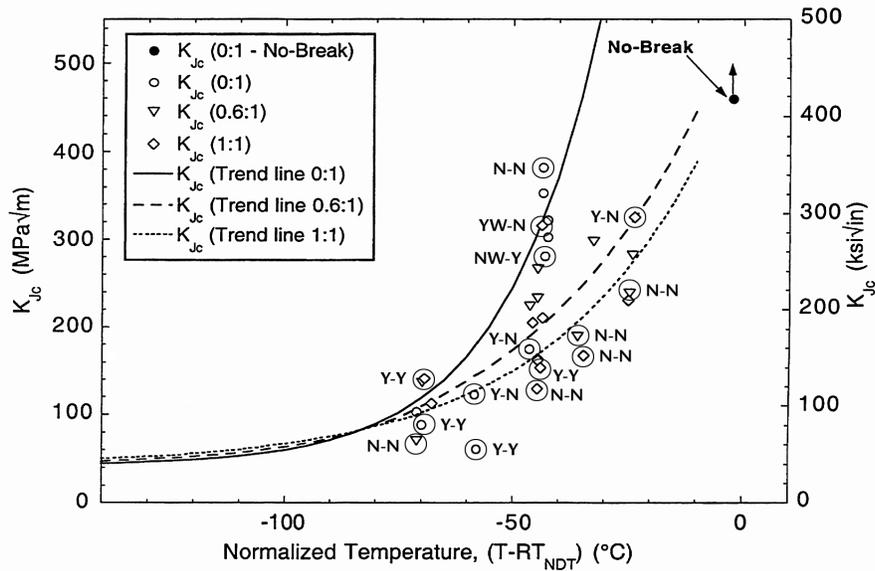
Figure 12. A summary of all heat-treated HSST Plate 14A cruciform data presented as a function of normalized ($T - RT_{NDT}$) test temperature. Trend curves fitted to data provide a visual interpretation of relationship between biaxial loading and temperature. The Y and N annotations relate to the apparent association or lack thereof between the crack front and cleavage origin, respectively (see Table 3).

Simply from a qualitative perspective, the fracture toughness results discussed earlier for 1T bend bars would lead one to the conclusion that the heavily segregated microstructure of heat-treated HSST Plate 14A resulted in some unusually low cleavage fracture toughness values. However, as stated earlier, the primary issue in the current investigation is whether the fracture toughness results obtained from the biaxially loaded specimens were influenced by the steel microstructure in a biased manner. The results presented in Table 3 regarding the relationship between the specimen crack front, the cleavage origin, and a specified volume of material ahead of the crack front are used for such an evaluation in the following manner. In Fig. 11, the data points corresponding to the biaxial specimens tested at -5°C have been annotated with the results contained in the first two columns of Table 3 for the crack front/microstructure relationship (i.e., the "bands between crack tip and origin" and the "origin in band"). The fracture toughness results indicate the lack of a biaxial effect at a temperature near the lower shelf (Figure not shown), as well as a measurable biaxial effect in the transition region (Fig 11). The crack front/microstructure observations appear to be mixed in the sense that both low and high values of fracture toughness are associated to some degree with the segregated microstructure. Relative to the overall results, Fig. 12 shows a similar plot of all the cruciform specimen

data with annotations as in the previous figures. Again, the crack front/microstructure observations appear to be mixed at both low and high values of fracture toughness. There are a number of relatively low fracture toughness results which do not appear to be associated with regions of microstructural segregation. Moreover, the mixed results occur for all three biaxial load ratios. Additionally, a number of the results with (N, N) annotations also do not have bands between the crack front and the peak stress location ($0.75X'$) nor the volume ahead of the crack at a distance of $2X'$. Thus, this evaluation points to an unbiased effect of the segregated microstructure on the observations regarding biaxial effects on fracture toughness.
