ORNL/TM-2019/2117
CRADA/NFE-17-06604

Comparison of Electron Beam and Laser Beam Powder Bed Fusion Additive Manufacturing Process for High Temperature Turbine Component Materials, Phase II

**CRADA FINAL REPORT
NFE-17-06604**

Materials Science and Technology Division
Advanced Manufacturing Office

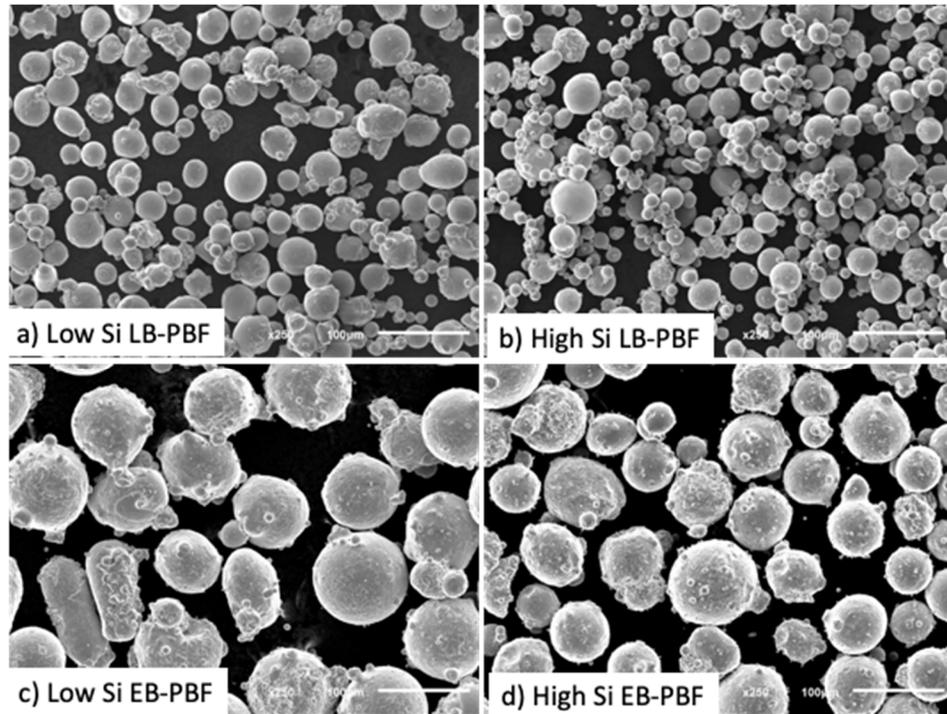
Figure 1: SEM images of metal powders showing nominally spherical particles with the regular occurrence of satellites and irregularly shaped particles, a) low Si, LB-PBF, b) high Si, LB-PBF, c) low Si, EB-PBF, d) high Si, EB-PBF

The particle size distribution (PSD) was measured using commercially available laser diffraction equipment and physical sieves. The results are summarized in Table 2. The PSD for both the EB-PBF and LB-PBF processes were consistent with the targeted PSD, with a slight variation for the LB-PBF process between the low and high Si powders. The scanning electron microscopy (SEM) micrographs shown in Figure 1 revealed for all type of powders the occurrence of satellites on spherical particles, with also a few irregularly shaped particles.

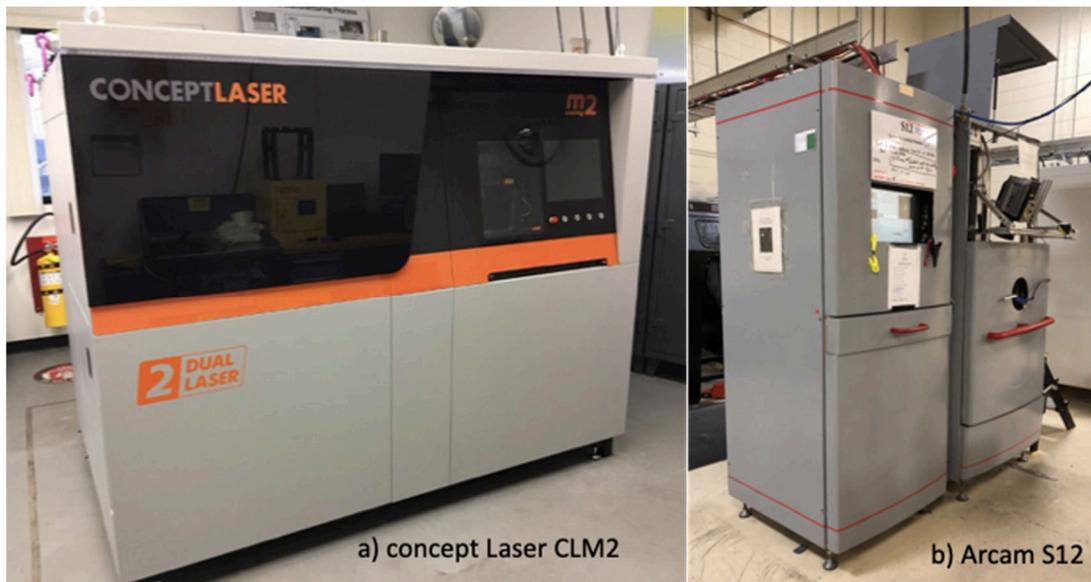
Figure 2: a) LB-PBF Concept Laser M2 machine, b) EB-PBF Arcam S12 machine

AM Machines: A Concept Laser M2 machine was used for the LB-PBF fabrication at Solar Turbines, while an Arcam S12 machine was used at ORNL for the EB-PBF specimens and artifacts (Figure 2). It is worth noting that a LB-PBF 3D Systems ProX300 machine was used for the phase I of the project, so new M2 specific fabrication parameters were used for phase II. For the EB-PBF process, the fabrication parameters optimized during the phase I were used for all the builds fabricated during phase II.

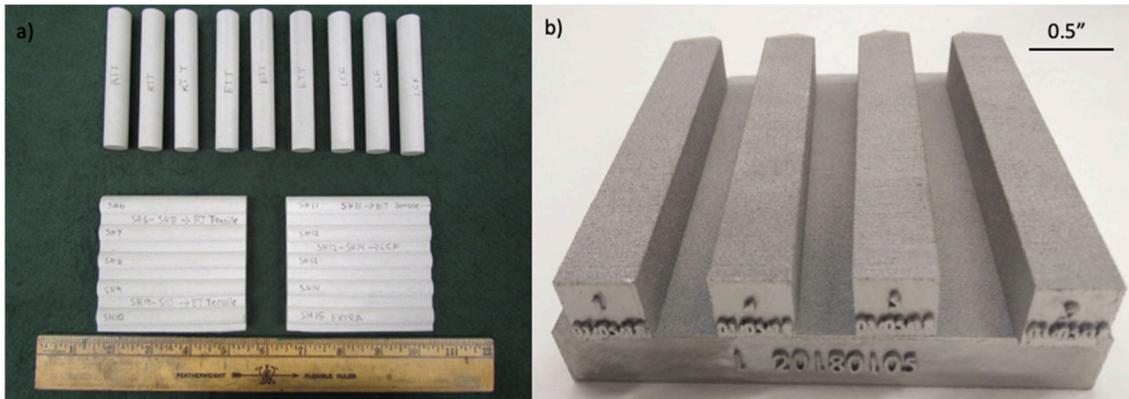
Figure 3: Mechanical test bar builds: a) LB-PBF Vertical and horizontal test bars, b) EB-PBF vertical bars and large plates to machine specimens perpendicular to the build direction

Test Bars and Artifacts: Examples of the test bars and plates fabricated by LB-PBF and EB-PBF using the high Si and low Si powders are shown in Figure 3. To conduct mechanical testing perpendicular to the build direction, horizontal LB-PBF bars were produced while large rectangular plates were fabricated by EB-PBF.

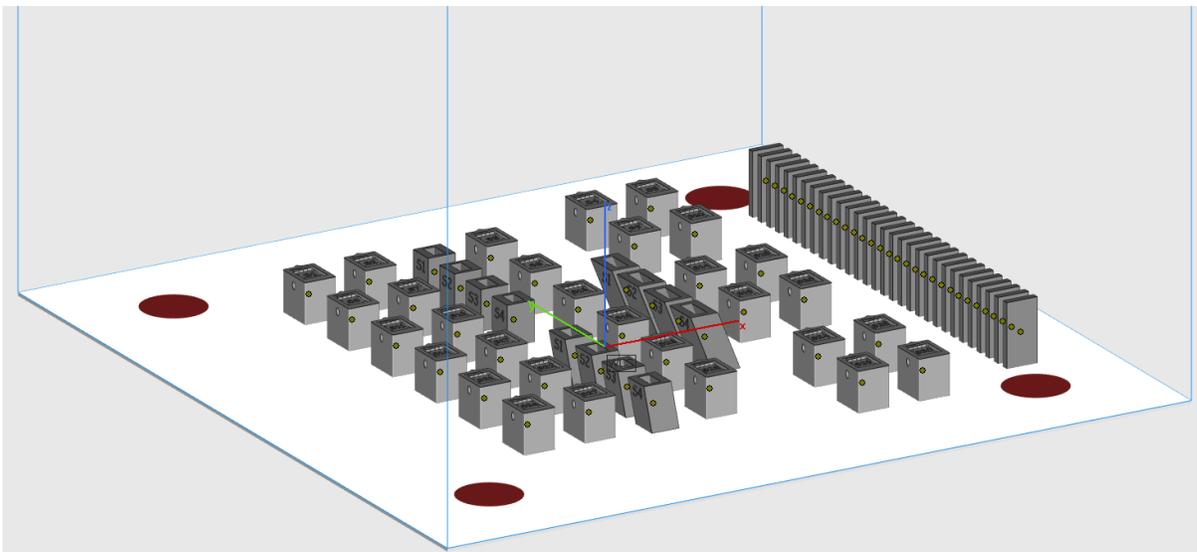
Figure 4: LB-PBF build plate layout for geometry (cube, vane), microstructural (cubes), and oxidation testing (panels)

Hollow cube and vane artifacts representative of features in gas turbine components were also fabricated to assess the geometry capability of the LB-PBF and EB-PBF machines. In addition, thin walled specimens, 1 to 1.5mm thick, were fabricated for oxidation testing. An example of the artifacts and thin wall build configuration for the LB-PBF machine is displayed in Figure 4.

Oxidation testing was conducted at 1472°F (800°C) in air on as-fabricated rectangular coupons ~0.4x0.8x0.06-0.08 inch in size. The LB-PBF oxidation coupons were fabricated along with the artifacts (Figure 4), while the EB-PBF coupons were machined from builds such as the one shown in Figure 18a. Half ring coupons ~0.080 inch (2mm) thick were also machined from cast Nickel Alloy X components to serve as a reference. The specimens were weighed every 100 hours and the specimen mass change curves are shown in Figure 18b. The EB-PBF coupons exhibited higher mass gains compared to the LB-PBF and cast Nickel Alloy X coupons. Spallation appeared to be minimum for all the specimens tested up to 2,000h. For both the LB- and EB-PBF alloys, increasing the Si content of the powder led to faster oxidation rates, particularly in the first 500 hours of testing. Coupons were interrupted after 1,100 hours of testing for microstructure characterization, and the coupon cross-sections are shown in Figure 19. The very rough surface finish of the EB-PBF coupons compared to the LB-PBF coupons is obvious in Figure 19a-d. A very convoluted interface was, indeed, observed for the EB-PBF coupons, with a larger convolution amplitude for the EB-PBF low Si. The high surface roughness for the EB-PBF specimens led to a higher surface in contact with the environment which certainly contributed to the higher specimen mass changes. In addition, Figure 19e-k show that the

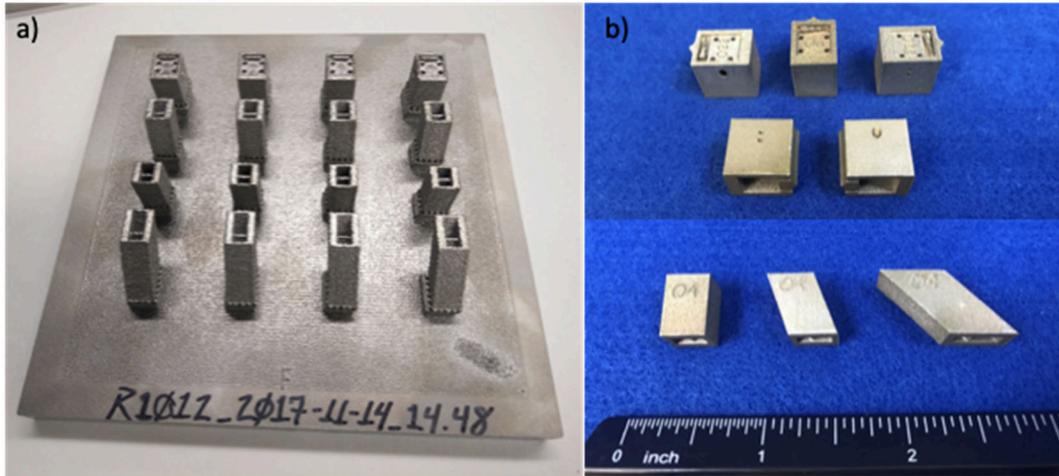
Figure 5: Artifact fabrication: a) Example of an artifact EB-PBF build, b) Top view of the 4 types of artifacts fabricated by LB-PBF: hollow cube with features, 0° vane, 20° vane and 45° vane artifacts

AM Artifact Overview: Examples of the artifacts fabricated by EB- and LB-PBF processes are shown in Figure 5. Four different artifacts representative of gas turbine component features were built using both the high Si and low Si powders: one hollow cube with representative holes and thin walls of various thicknesses, and 0°, 20° and 45° vane artifacts. No significant differences were noticed between the high Si and low Si artifacts fabricated by LB-PBF. No characterization of the low Si EB-PBF artifacts was conducted due to the presence of large cracks in the alloy, as will be discussed later. The macroscopic top views of the cube artifacts presented in Figure 6 highlight the much better resolution achievable via LB-PBF compared to EB-PBF. For example, a step-function decrease of the thin wall thickness can be observed for the LB-PBF cube, as expected from the CAD drawing, while a uniform thickness is observed for the EB-PBF cube. The shape of the 4 holes is also more accurate for the LB-PBF artifact.

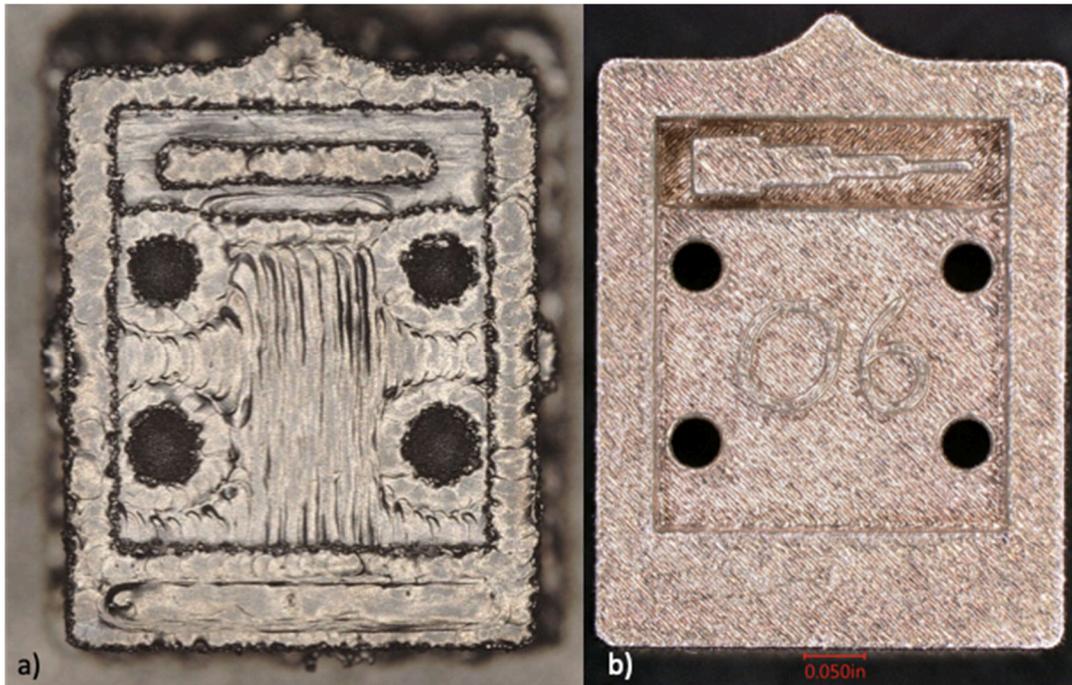
Figure 6: Comparison of the macroscopic top view for the cube artifacts, a) EB-PBF and b) LB-PBF showing the relative differences in geometric and surface finish capability between the two processes.

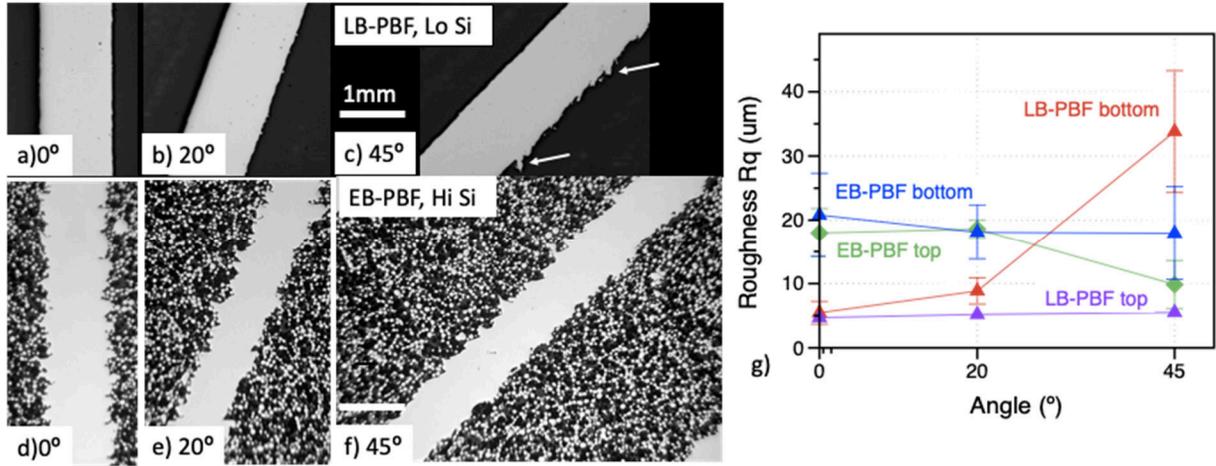
Figure 7: a-f) Cross-section optical micrographs of the vane artifacts, a) 0° LB-PBF, b) 20° LB-PBF, c) 45° LB-PBF, d) 0° EB-PBF, e) 20° EB-PBF, f) 45° LB-PBF, g) Rq values versus vane angle.

AM Artifact Surface Roughness: One of the main goals of the vane artifact fabrication was to assess the geometry capability of the EB-PBF and LB-PBF machines for angled thin walls. Measurement of the wall roughness was therefore conducted by image analysis on cross-section micrographs such as the one presented in Figure 7a-f. Images were imported in Python to determine the R_q values for the top and bottom walls, and the results are summarized in Figure 7g.

The roughness values from the LB-PBF vane artifacts were much lower than the roughness values calculated for the EB-PBF vane artifacts except for the bottom wall of the 45° LB-PBF vane

artifact. This is mainly due to the presence of a few large defects highlighted by white arrows in Figure 7c. It is also worth noting that the center walls of the EB-PBF vane artifacts are surrounded by unmelted powder particles trapped inside the artifacts. For EB-PBF component fabrication a procedure to remove the trapped particles would have to be incorporated.

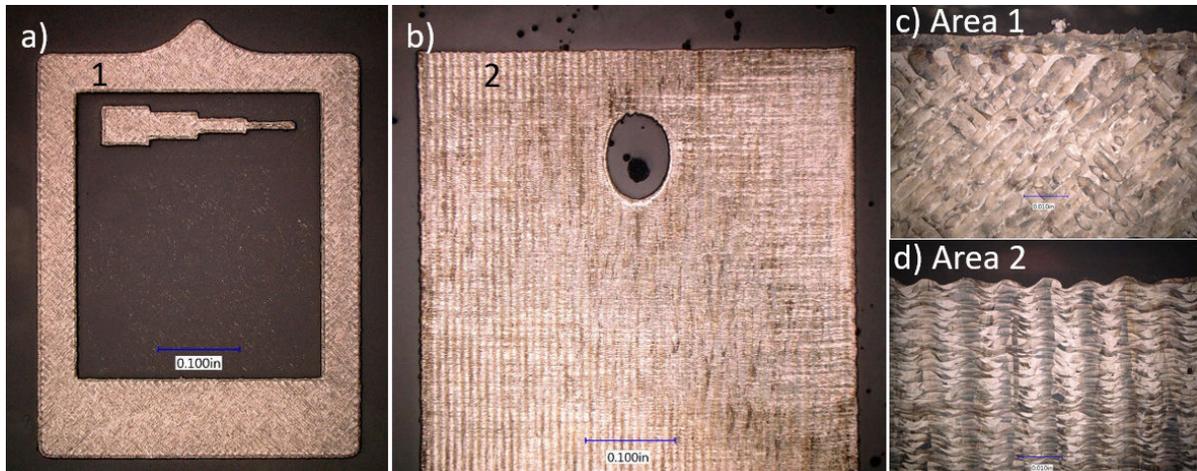
Figure 8: Optical micrograph of a representative LB-PBF cube sample in the as-printed heat treat condition showing typical microstructure of overlapping hatch patterns in the X-Y plane (a,c) and micro-weld profiles the Y-Z plane (b, d)

LB-PBF Microstructure: Microstructure characterization of the LB-PBF in the “as printed” condition (e.g. no heat treatment) revealed an overlapping hatched pattern typical of the LB-PBF process (Figure 8). The effect of powder composition on micro-cracking is shown in Figure 9. The low Si LB-PBF alloy was resistant to micro-cracks, but the high Si LB-PBF alloy displayed micro-cracking, with many of the cracks preferentially oriented along the build direction (i.e. vertical orientation).

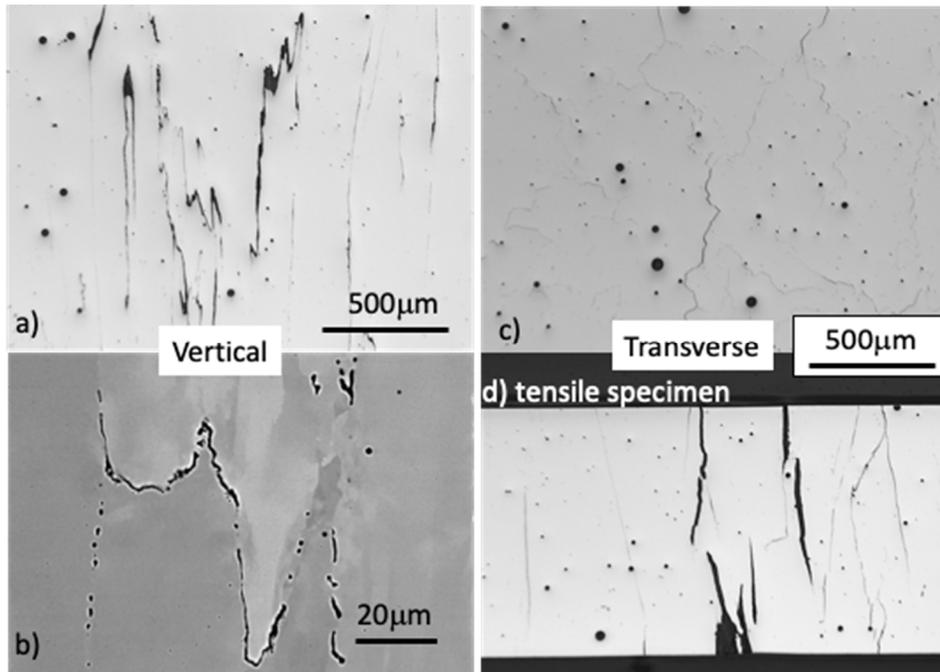
Figure 10: Cross-section micrographs of the Low Si EB-PBF alloy showing the presence of large cracks, a) optical micrographs of Y-Z plane (vertical orientation), b) SEM micrograph of Y-Z plane, c) Optical micrograph of X-Y plane (horizontal orientation), d) optical micrograph of a ruptured tensile specimen machined perpendicular to the build direction and tested at room temperature

EB-PBF Microstructure: Microstructure characterization of the EB-PBF low Si alloy was conducted on vertical test bars and representative microstructures are shown in Figure 10. Contrary to what was observed with LB-PBF, the alloy with decreased Si content exhibited very long hot-tear cracks located at grain boundaries. In addition, no precipitates were observed inside the grains or at grain boundaries. This might be an indication that the cooling rate after fabrication was relatively high and could have played a role in crack formation. Figure 10-d highlights the significant impact of these cracks on the tensile fracture mechanisms when tested perpendicular to the build direction. Due to the abundance of defects in the microstructure of the low Si EB-PBF alloy, it was decided to focus on the high Si EB-PBF alloy for the microstructure characterization and mechanical testing tasks.

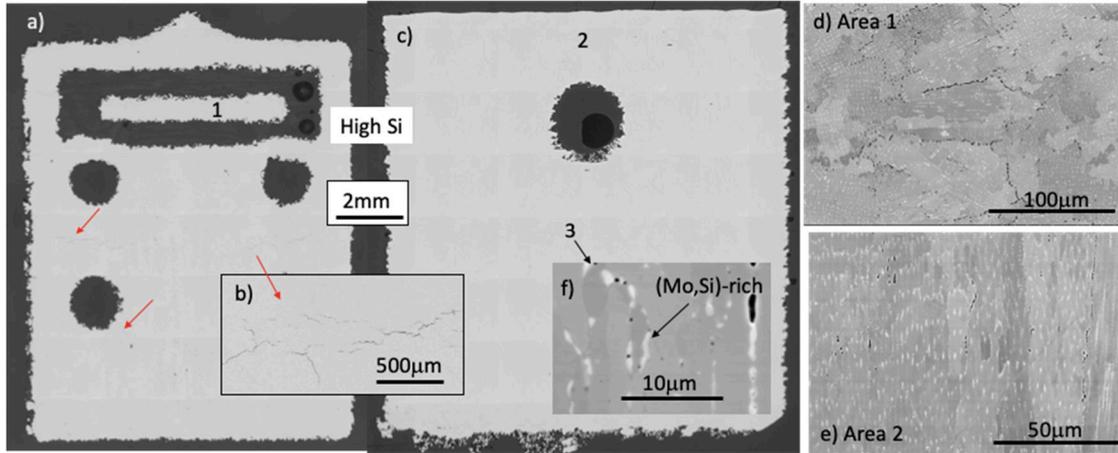
Figure 11: Cross-section micrographs of EB-PBF artifacts, a) General top view optical pictures of a cube artifact, b) Higher magnification optical pictures showing cracks, c) General side view of a cube artifact, d) SEM pictures of cube artifact showing defects at grain boundaries, e) SEM pictures of a cube artifact highlighting elongated grains along the build direction, f) High magnification SEM pictures showing the presence of (Mo,Si)-rich precipitates at grain boundaries

Cross-section of two different cube artifacts, one polished from the top (X-Y plane) and the other one from the side (Y-Z plane), are shown in Figure 11. Red arrows highlight the presence of cracks (Figure 11b), typically observed close to the holes or in-between two holes. The location of these cracks is likely due to the specific artifact geometry. The SEM pictures shown in Figure 11d and 11e show elongated grains along the build direction with the presence of small cracks at some grain boundaries. A quite homogeneous dispersion of (Mo,Si)-rich precipitates were observed both in the grains and at grain boundaries. It is worth noting that cracking was not observed with the high Si EB-PBF material fabricated in phase I, and it was decided to process the phase II high Si EB-PBF material through the HIP treatment described previously (3h 2125°F/14.75Ksi) before mechanical testing. Another difference between the two high Si EB-PBF materials is the preferential formation of continuous (Mo,Si) precipitates at grain boundaries in the Phase I alloy. The microstructure of the High Si EB-PBF alloy after HIP'ing is shown in Figure 12. The HIP treatment successfully removed all the cracks and only micron-size voids were still present. HIP'ing did not impact the grain structure, but comparison between Figure 11e and Figure 12b highlights that a significant coarsening of the (Mo,Si) precipitates took place during HIP'ing.

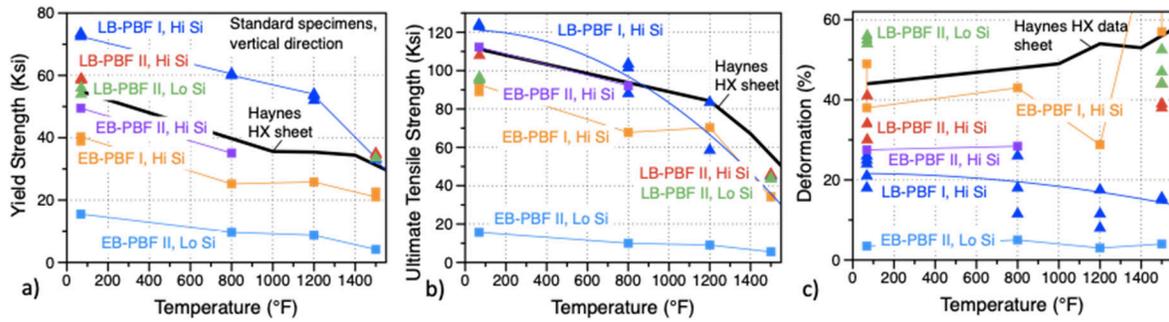
Figure 13: Comparison of the tensile properties between LB-PBF and EB-PBF alloys with low and high Si content, a) Yield strength, b) UTS and c) elongation at rupture

Tensile Properties: Figure 13 compares the tensile properties along the build direction of the annealed LB-PBF and as-fabricated EB-PBF alloys with a high Si or low Si content. Data from the high Si LB-PBF and EB-PBF alloys produced during phase I were added as well as average data for wrought Hastelloy X provided by Haynes International [1,3]. The LB-PBF high Si and low Si Nickel Alloy X alloys exhibited similar 0.2% yield (YS) and ultimate (UTS) tensile strength at room temperature and 1500°F, but the ductility of the LB-PBF low Si was superior at room temperature. These tensile data were close to the tensile data for wrought Hastelloy X. The strength of both alloys was lower compared to the high Si phase I alloy, but the ductility was much higher. It is worth noting that two different LB-PBF machines were used for phase I and phase II and the annealing time was shorter for phase I (15 minutes) compared to phase II (1 hour).

The high Si phase II EB-PBF alloys showed superior YS and UTS compared to the phase I alloy, with UTS values similar to the UTS values measured for the LB-PBF phase II alloys. The alloy ductility was, however, quite low. A very brittle behavior was observed for the low Si EB-LBF alloy with low YS, UTS and ductility due to the presence of the large cracks.

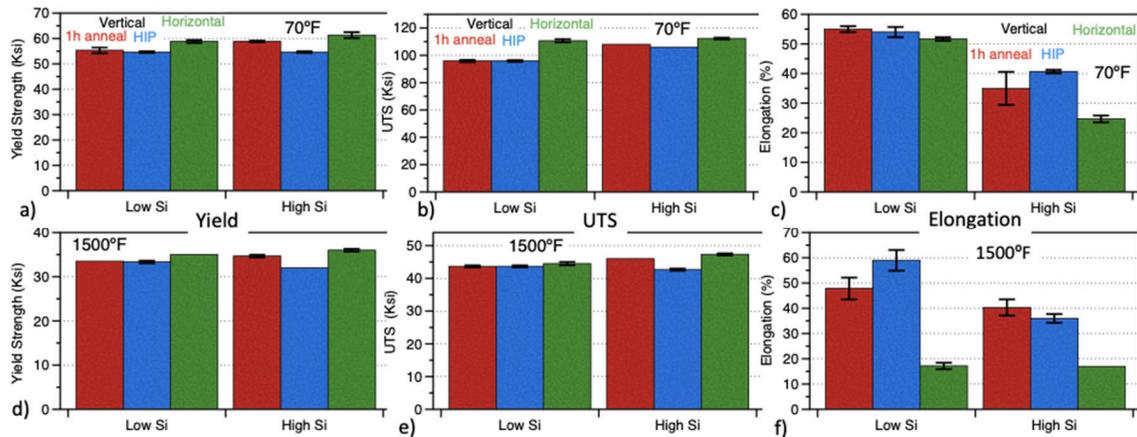
Figure 14: Comparison of the tensile properties of LB-PBF alloys along and perpendicular to the build direction, a) YS at 70°F, b) UTS at 70°F, c) Elongation at rupture at 1500°F, d) YS at 1500°F, e) UTS at 1500°F, f) Elongation at rupture at 1500°F

As can be seen in Figure 14, HIP'ing had no effect on the tensile properties of the low Si LB-PBF alloy at room temperature and led to a slight increase of the alloy ductility at 1500°F. For the high

Si LB-PBF alloy, limited decreases of the YS and UTS at room and 1500°F were observed after HIP'ing, and a slight improvement of the ductility was observed at room temperature. Figure 14 also compares the properties of the LB-PBF alloys after annealing along and perpendicular to the build direction. For both the high Si and low Si LB-PBF alloys, the YS and UTS at room and 1500°F were similar or slightly higher perpendicular to the build direction. A significant decrease of the ductility for the specimens machined from the horizontal bars was, however, observed for the high Si alloy both at room temperature and 1500°F. For the low Si LB-PBF alloy the decrease in ductility was observed only at 1500°F. The lower ductility perpendicular to the build direction for the high Si alloy was attributed to the presence of cracks aligned along the build direction (Figure 9f).

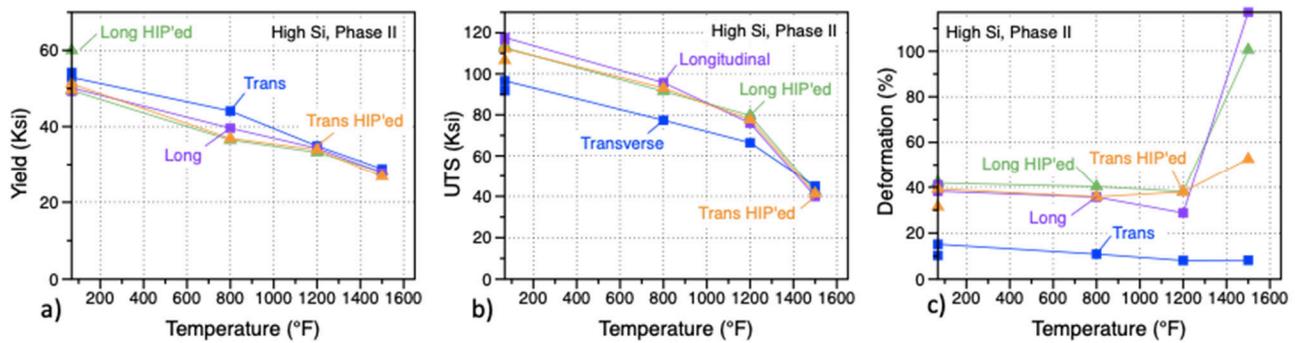
Figure 15: Tensile properties of dog-bone EB-PBF specimens along and perpendicular to the build direction in the as-fabricated and HIP'ed conditions, a) Yield strength, b) UTS and c) elongation at rupture

For the high Si EB-PBF alloy, the effects of HIP'ing and specimen orientation on the mechanical properties of 0.080 inch (2mm) thick dog-bone tensile specimens are shown in Figure 15. A significant decrease of the UTS and ductility was observed for the specimens machined perpendicular to the build direction compared to the specimens machined along the build direction, which is again attributed to the preferential orientation of cracks along the build direction. HIP'ing had no effect on the tensile properties along the build direction of the high Si EB-PBF alloy, but resulted in a significant improvement of the UTS and ductility perpendicular to the build direction leading to relatively isotropic tensile properties for the HIP'ed material. These results are consistent with the crack removal observed after HIP'ing (Figure 12).

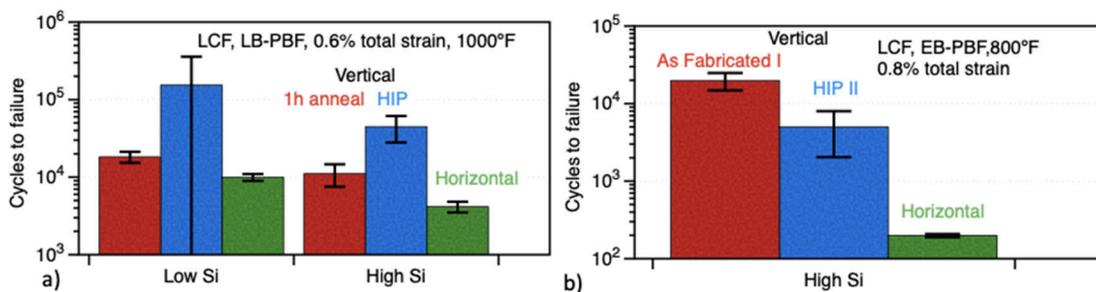
Figure 16: Number of cycles to failure, a) LB-PBF specimens tested at 1000°F with a total strain of 0.6%, b) EB-PBF specimens tested at 800°F with a total strain of 0.8%

Fatigue Properties: A summary of the fatigue tests conducted on the LB-PBF and EB-PBF HX alloys is shown in Figure 16a and b, respectively. Fatigue tests on the LB-PBF were conducted at 1000°F with a total strain of 0.6% on high Si and low Si alloys while the tests on the EB-PBF alloys were conducted at 800°F with a 0.8% total deformation on the high Si alloy only. Due to the very low tensile properties of the low Si alloy, fatigue tests were not performed on this material. The low Si LB-PBF alloy exhibited better fatigue performance, with a significant increase of the number of cycles to failure (Nf) for both LB-PBF alloys after HIP'ing. Fracture surface analysis revealed a switch from crack initiation at defects inside the specimen after annealing to crack initiation at an oxide inclusion or at the specimen surfaces after HIP'ing (Figure 17). A decrease of Nf by a factor of two was observed for both alloys with annealed specimens machined perpendicular to the build direction.

Even after HIP'ing, the Nf values for the high Si phase II EB-PBF specimens were still lower than the Nf values measured for the as-fabricated high Si phase I EB-PBF. As expected, very early failures were observed for the specimens machined perpendicular to the build direction, again because of the presence of elongated cracks along the build direction.

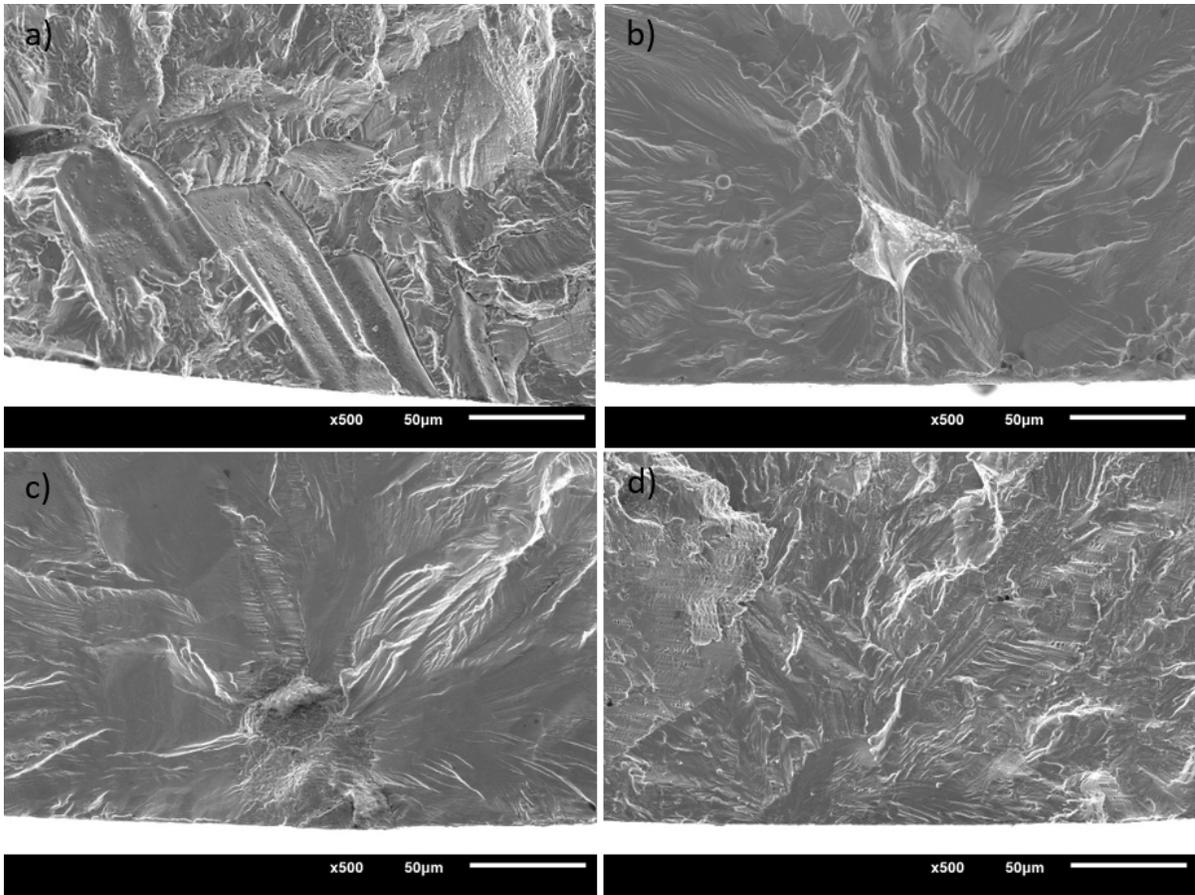
Figure 17: SEM images of the fracture initiation sites for LB-PBF LCF tests, a) “Vertical Annealed” High Si specimen, b) “Vertical Annealed” Low Si specimen, both showing irregular shaped discontinuities, c) “Vertical HIP’ed” low Si specimen and d) “Vertical HIP’ed” high Si specimen

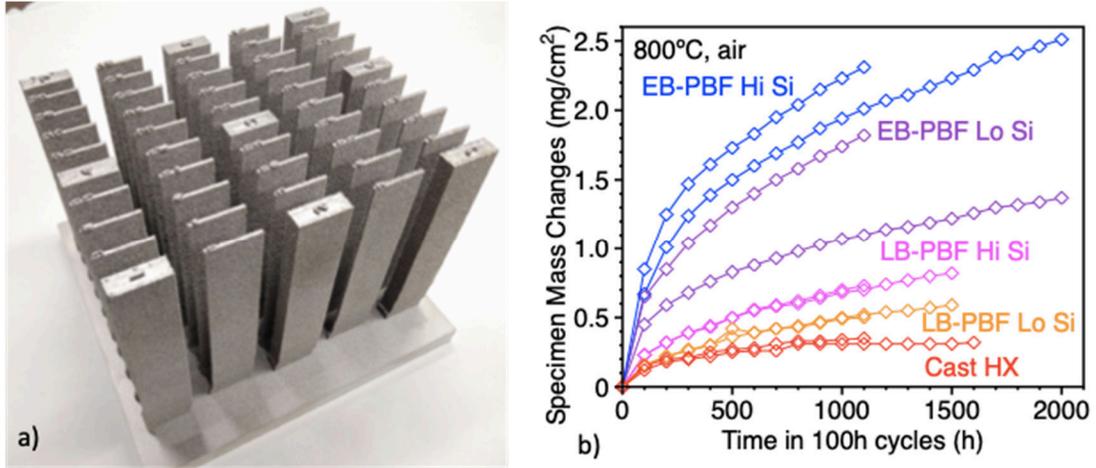
Figure 18: a) Thin-walled EB-PBF plates and b) Specimen mass changes of high Si and low Si LB-PBF and EB-PBF coupons for specimens exposed in air at 1472°F (800°C) for up to 2,000h

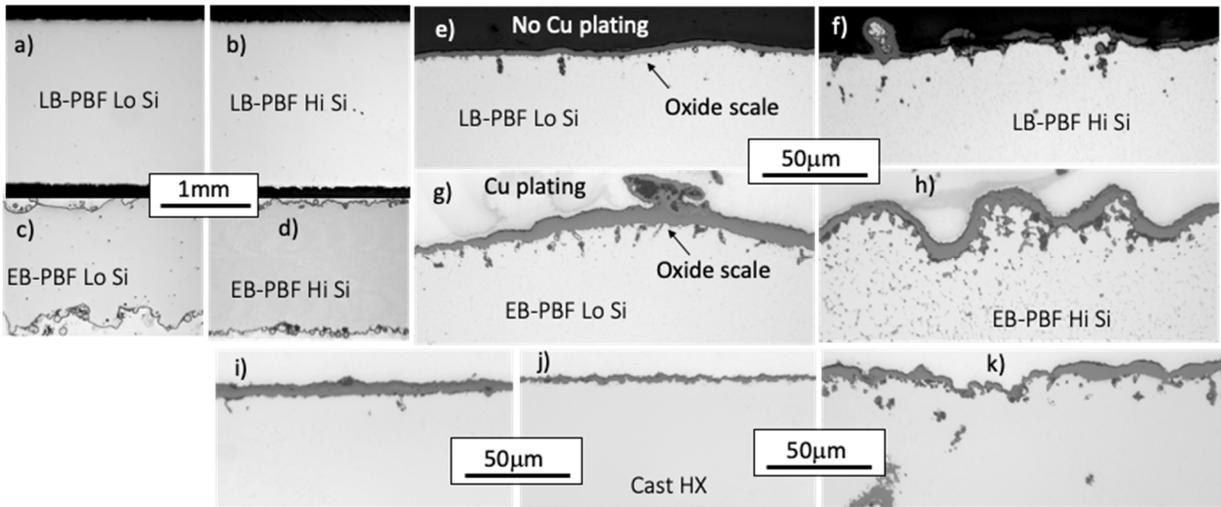
Figure 19: Optical cross-section micrographs of oxidation coupons exposed for 1100h at 1472°F (800°C), a) and e) LB-PBF low Si, b) and f) LB-PBF High Si, c) and g) EB-PBF low Si, d) and h) EB-PBF High Si, i) to k) Cast Nickel Alloy X

oxide scale at the surface of the EB-PBF coupons was thicker compared to the scale at the surface of the LB-PBF or cast Nickel Alloy X coupons. The thickness of the scale on the cast coupons varied from one location to another. Many small voids were also observed beneath the oxide scale for the EB-PBF alloys, but only a few of these voids were observed for the LB-PBF and cast Nickel Alloy X coupons.

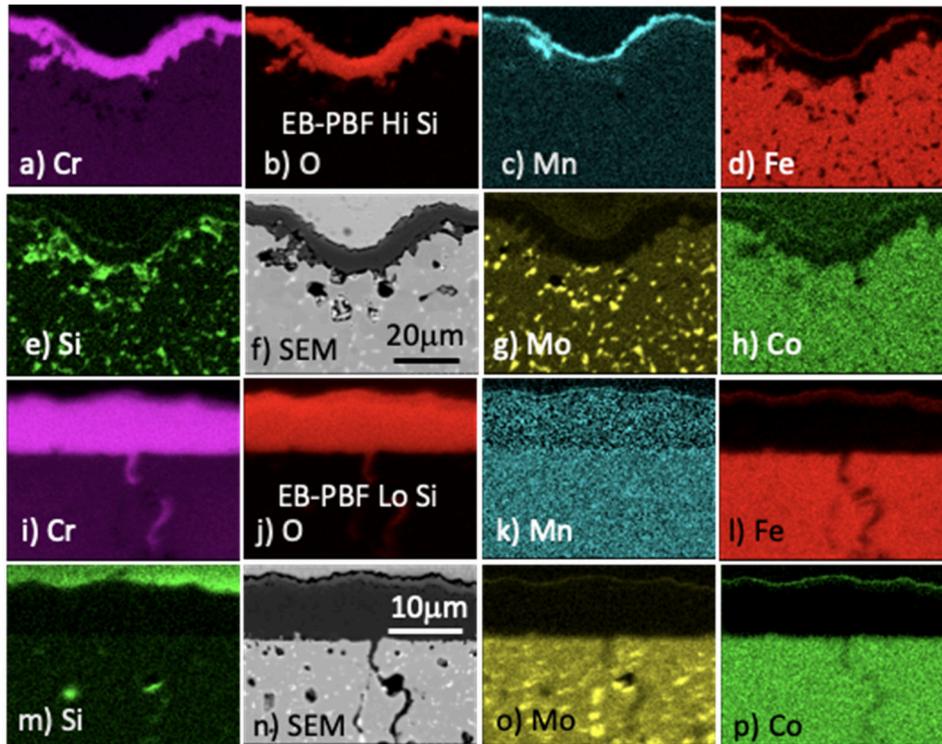
Figure 20: Chemical maps of the oxide scale formed at the surface of the EB-PBF alloys tested for 1100h at 1472°F (800°C) in air, a-h) High si alloy, i-p) low Si alloy

Finally, chemical maps for the high Si and low Si EB-PBF coupons exposed for 1100 hours at 1472°F (800°C) are shown in Figure 20. For the high Si alloy, significant segregation of Si was observed at the alloy/scale interface with the formation of SiO₂ precipitates, while the high Mn content resulted in the formation of an outer Mn-rich scale. It is also worth noting that Mo-rich precipitates formed in the low Si alloy during exposure at 1472°F (800°C).
