Sensitivity of low sloped roofs designs to initial water and air leakage

Achilles Karagiozis, Ph.D
Senior Research Engineer,
Oak Ridge National Laboratory
1 Bethel Valley Rd,
Oak Ridge TN, 37831-6070

ABSTRACT

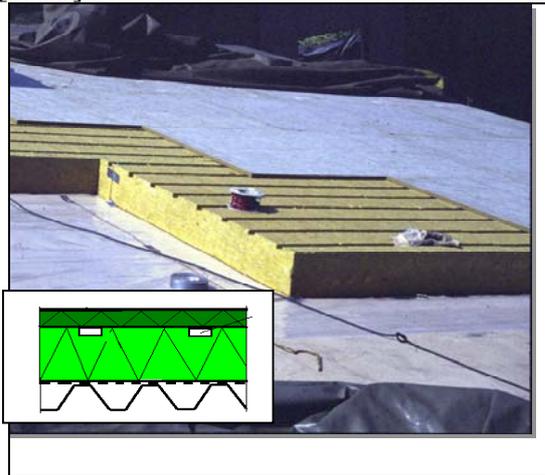
Figure 1. Low-sloped roof cross section. Ventilating insulation layer.

was to provide a negative pressure (suction) in the insulation, thereby allowing drying of a wet roof through these vents. In the passive set-up, the drying process was however quite slow due to uneven distribution of the limited air flow and took years to dry a wet roof system. The so called grooved ventilation flat roof system appeared in the market in the early 1980's, and got adopted by many Northern European countries. A range of grooved systems has appeared since that period, with different grooved shapes and insulation systems. The main purpose of these grooves has been to improve the ventilation by providing a direct passage for air flow through the grooves, thus improving moisture drying potential. This improved ventilation augmented the moisture mass transfer by forced convection and lead to drier roof systems. In a recent field survey, low-sloped roofs did not have a sufficient drying potential through breather vents. To improve the hygrothermal performance of low-sloped roofs, new methods for ventilating the roof structure were introduced in the 1980's. One such approach employed small ventilation grooves in the insulation layer as shown in Figure 1. The ventilation grooves were connected to breather vents by connecting channels.

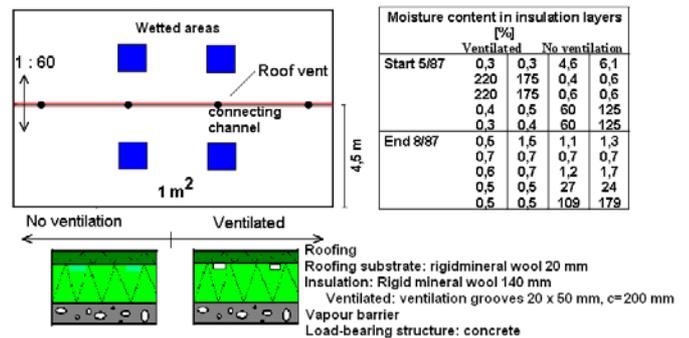
Figure 2. An example of a drying test at VTT's test house. Wet insulation was installed into the roof, and drying of the roof was monitored by samples.

Results showed that a wetted low-slope roof can dry out in a sufficient time. Figures 2 and 3 show that ventilation rates varied between 0.005 and 0.1 m³/h per m² depending on the ventilation details, size of

Altogether 40 samples were taken from the wetted areas and other parts of the roof at the end of the test. The tables shows the measure moisture contents in May and August in the ventilated and non-ventilated areas of the roof.

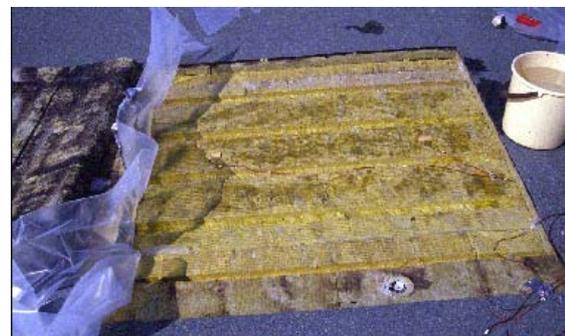
Figure 3. Wetting of a test roof of about 1000 m². Initial moisture content in this test case was 20% of dry weight through the whole insulation layer. The roof dried out during one summer.

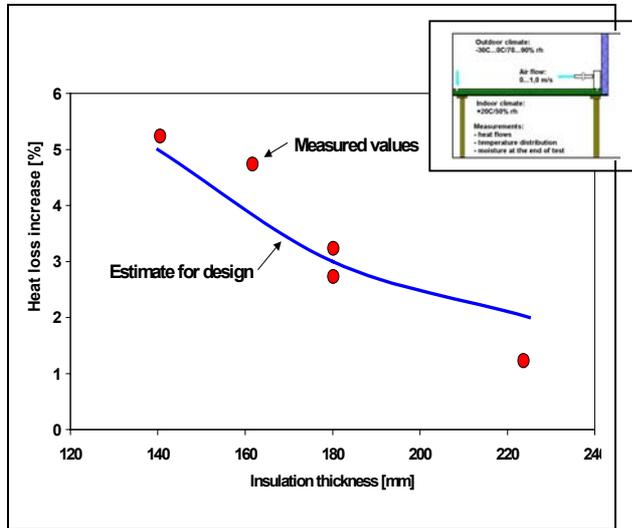
Figure 4. The effect of ventilation on the heat loss of a low-sloped roof according to insulation thickness. The measured values are 24 hour averages of a winter day.

becomes less important. Field measurements showed that the measured average increase in heat flow was close to 3 % compared to the non-ventilated part of the roof for an insulation thickness of 180mm.

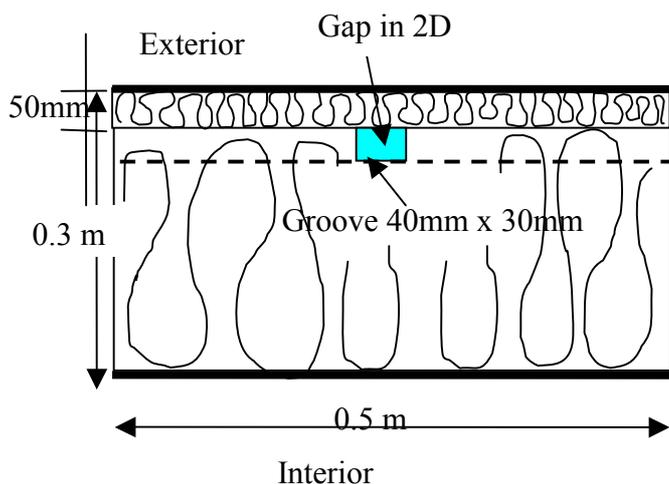
Figure 5. A schematic figure of the simulated roof section. The length of the simulated roof section was 10 m.

The loss of moisture in the roof section as a function of time and ventilation rate was calculated for the 3-dimensional wall section with the 3D-model for a period approximately a full year. Thirty years of hourly weather data from the National Climatic Data Center (NCDC) were analyzed and a moisture year was chosen for the simulations. A 2-D cross section of the simulated roof segment is shown in figure 5.

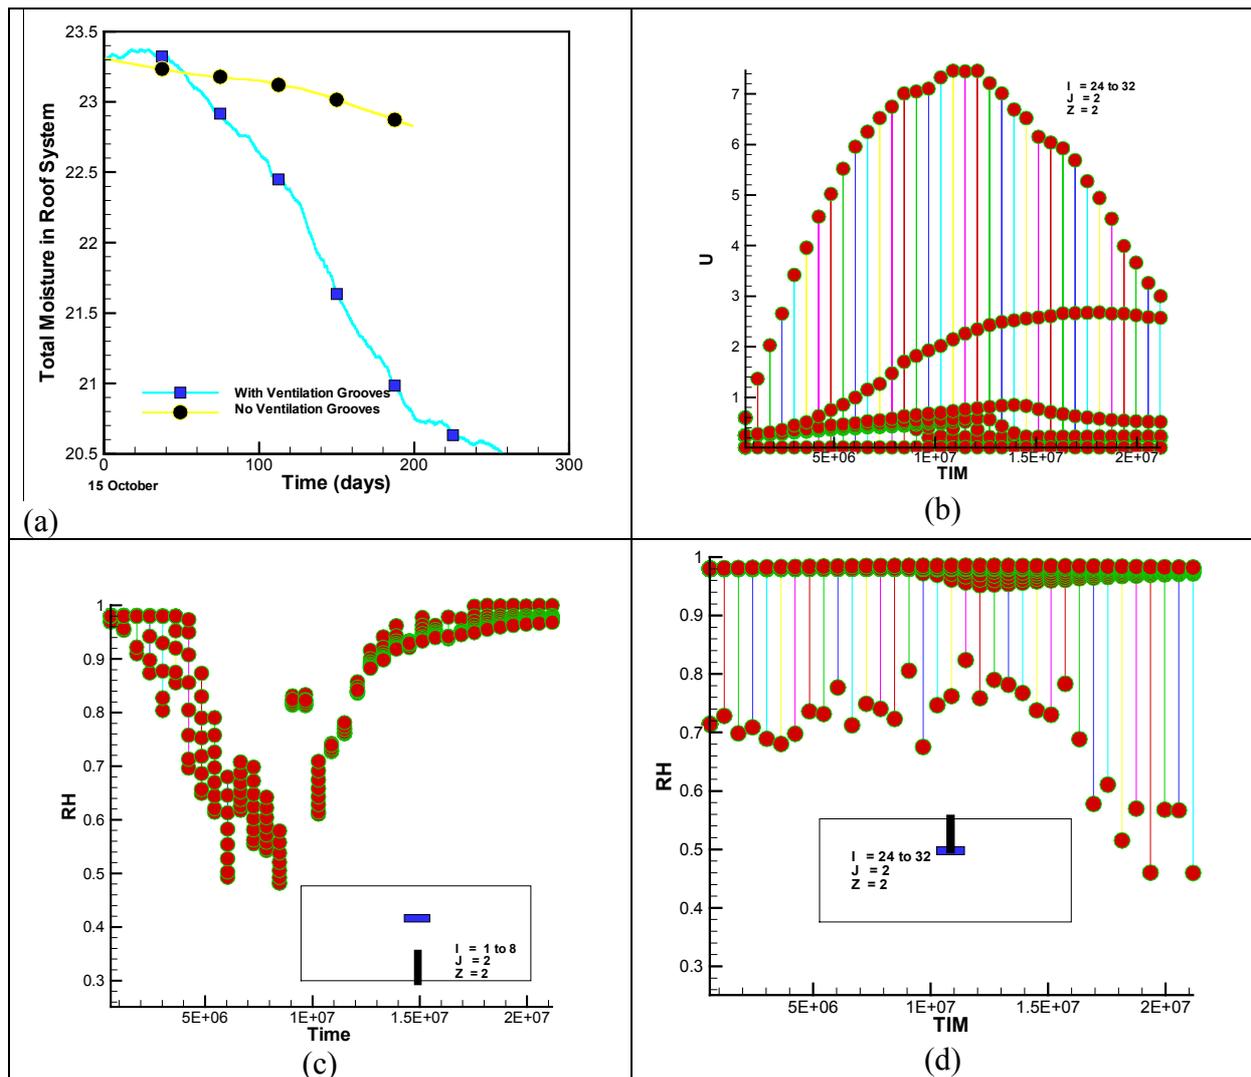
Figure 6. (a) Total moisture content as a function of time (Figure 6a) for 3-dimensional case with and without ventilation. (b) The moisture content in the insulation layers along the length of the ventilation groove at 10 weeks (Dec. 15) (c) The relative humidity distribution after 10 weeks (Dec. 15). (d) The relative humidity after 10 weeks of drying at another cross section (Dec 15)

Drying rate of the roof section depends on the airflow rate, increase in temperature on the exterior side of the roof due to solar radiation and also on the air permeability of the insulation layer. The development of the total moisture content as a function of time is shown in Figure 6a for the simulated period. Two cases are plotted out in Figure 6a corresponding to a roof

system with and without ventilation grooves. Both systems had a vapor retarder installed at the interior surface of the roof. The roof with the ventilation grooves exhibits a significant difference in drying performance. With the exception of the first two weeks, a continuous drying performance is exhibited by the ventilated roof system. The initial hump is explained by the seasonal moisture ingress during an initially humid period. In the case without the ventilation grooves, water is migrating out of the roof system, however at a very slow pace. The drying out potential is very limited in the non-ventilated case as moisture is trapped between the two vapor retarders. In figure 6b the moisture content is plotted out for the ventilated system at a spanning mid-center through the ventilation groove and the exterior surface of the roof. The transient behavior of the elements close to the exterior surface of the roof shows the yearly cycle effects (cold and summer conditions). In Figure 6c and 6d the temporal and spatial distribution is shown during the 10th week since October 1. Here the relative humidity distribution shows the strong 2-D effects close to the exterior and interior side of roof. The roof seems to have higher moisture accumulations near the exterior and is drying out close to the interior for this instant in time (00:00, midnight). In Figure 7 the 3-D snapshot in time is depicted for the ventilated and non-ventilated roof assembly. The influence of ventilation is depicted in Figure 7a to 7c, while 7d has no ventilation. Results show that there are localized gradients in moisture distributions in the insulation layers, these gradients are more substantial at the inlet of the grooves. Depending on the wind-speed and orientation of the building and wind the flow direction can occur at either opening. However, the ventilated grooved case increased the drying out potential of the roof system compared to the non-ventilated roof system. During a warm day when the sun

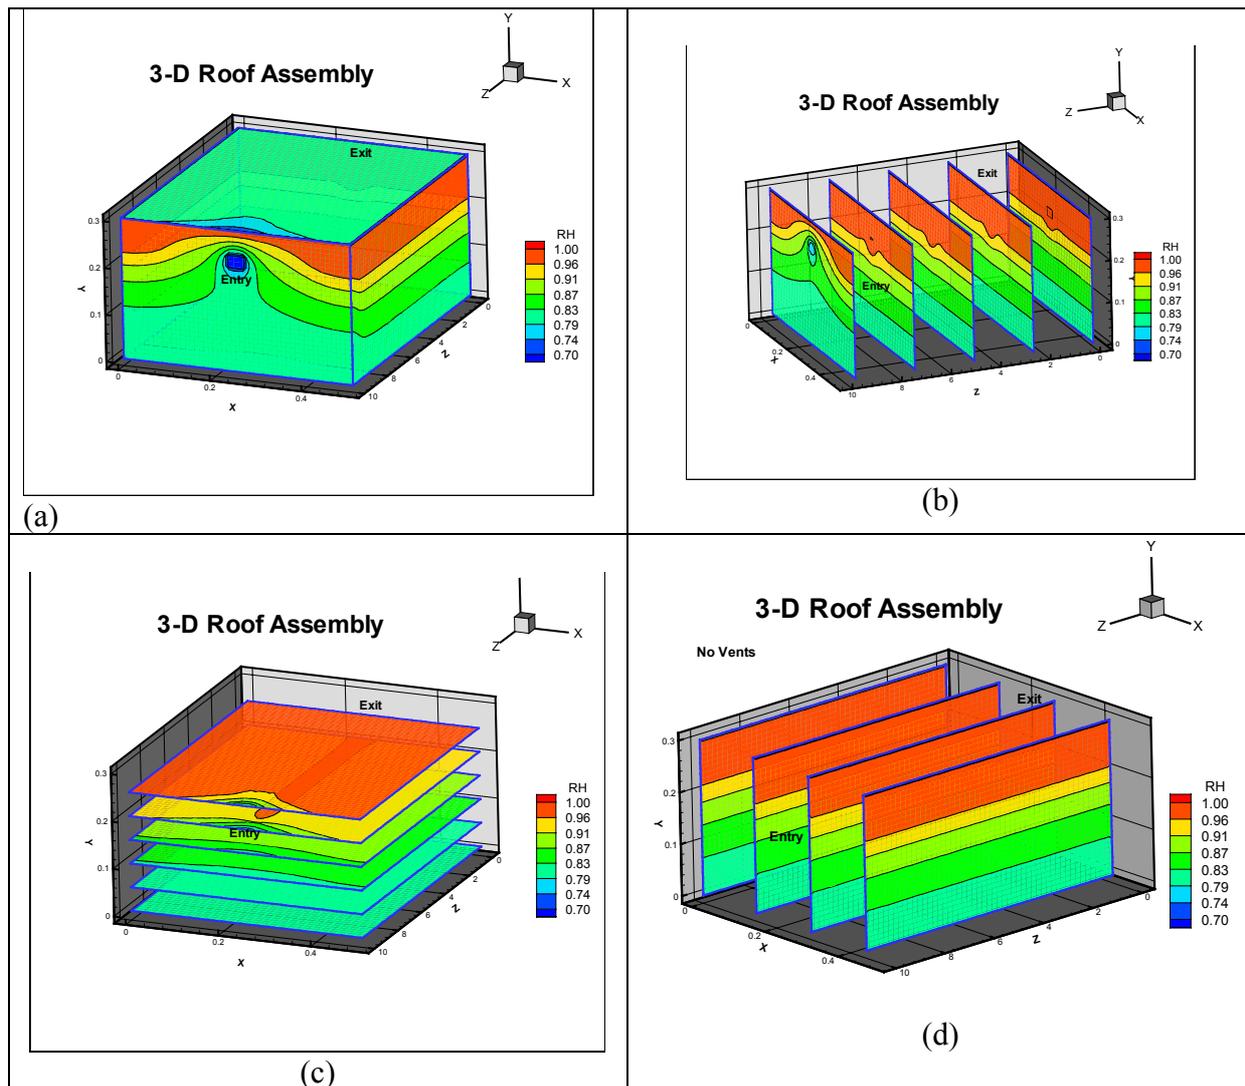
Figure 7. (a) 3-D face RH distribution (Dec. 15).
 (b) RH distribution in the ventilated roof system (Dec. 15) Direction of airflow is from left to right.
 (c) RH distribution in the ventilated roof system (Dec. 15) Direction of airflow is from left to right.
 (d) RH distribution in the non-ventilated roof system (Dec. 15) No airflow).

warms up the roof (afternoon) the airflow through the roof insulation dries out moisture. The ventilation air reaches its maximum moisture content already within the first two meters of flow path through the ventilation groove. When the airflow rate doubles (V_2) the air gets saturated after approximately 3 m from the eaves. During the night the ventilation air can slightly humidify the roof when the outdoor air is more humid than the dry insulation inside the roof after a warm day. The spacing between the grooves affects the drying rate and the moisture distribution around the grooves. The spacing of 0.5 m allows the groove ventilation to dry out approximately half of the moisture that the gap ventilation dries out (Figure 7a). The relative humidity distribution after 3 days of drying shows the uneven pattern of drying due to the oversized spacing of grooves. When the groove spacing is reduced to 0.2 m, the difference between gap and groove ventilation becomes insignificant. Ventilation can also increase the moisture contents in the dry insulation layer after summer drying during cold seasons. However, this wetting occurs only up to the humidity level of the exterior air.

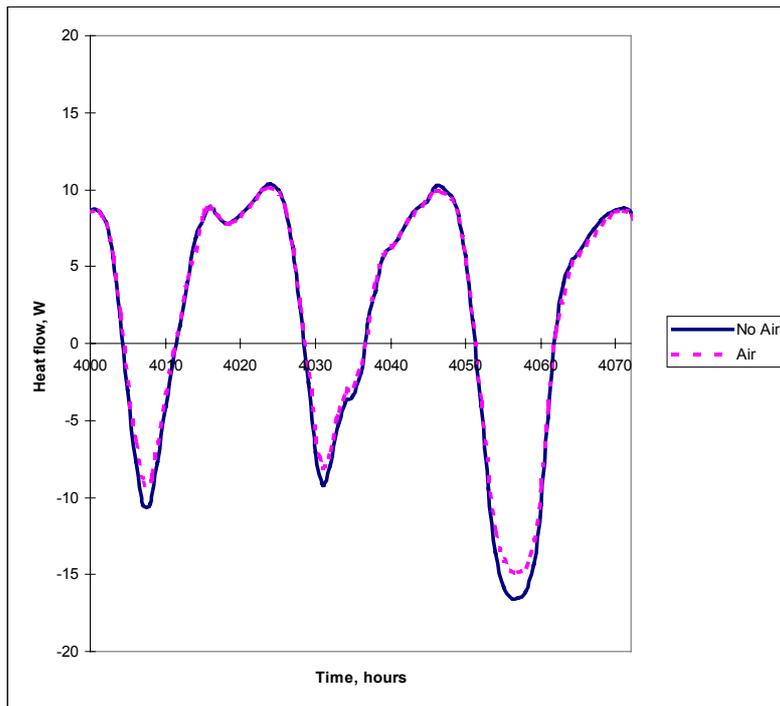
Figure 8. Heat flow through the ventilated and non-ventilated roof for a few days. Negative flow is toward the interior (heat load)

4.3 Thermal performance. The heat flows for a few days through the interior surface of the roof are plotted for the non-ventilated case and the ventilated grooved cases in Figure 8. The ventilation through the grooves increases the heat loss through the roof only slightly. Drying the roof and the insulation - on the other hand - decreases the heat loss by improving the

thermal effective thermal conductivity of the insulation layer. For the first 4770 hours since October 1, ventilation seems to lower the heat load of the roof slightly more than what it increases the heat loss. This is due to cooling of the roof by ventilation

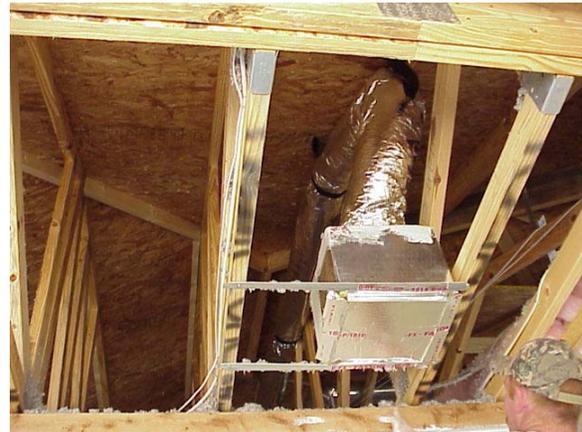
Figure 1 OA Intake Duct in Back Porch

The OA duct is located in the back porch (Figure 1) or in the soffit (Figure 2). The OA is filtered through a 12"x12" filter (which is readily available) located in a grill (Figure 3) which is attached to the OA duct box. The flex OA duct size varies depending on the system size - 4" for up to 2.5 tons, 5" for 3 to 4 ton and 6" for a 5 ton system. The OA duct terminates in the return air plenum after a manually adjustable butterfly damper (Figure 4).

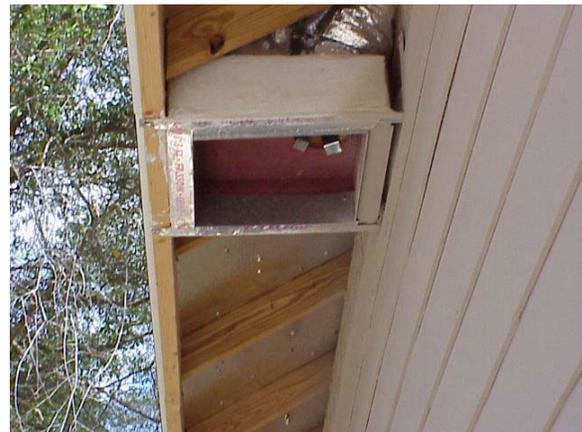
Figure 2 OA Intake Duct in Soffit

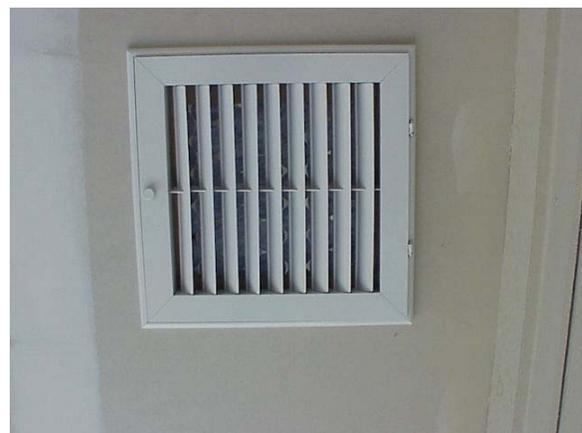
Figure 3 Filter Backed Grill Covering the OA Intake

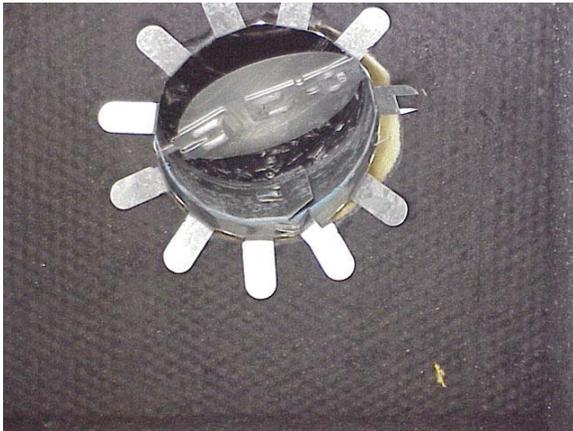
Figure 4 Butterfly Damper for OA control

The damper can be set during commissioning and closed by the homeowner in case the OA quality is poor (e.g. forest fire). This system introduces filtered and conditioned ventilation air only when the cooling or heating system is operational. The ventilation air also positively pressurizes the house. Data on the amount of ventilation air or positive pressurization is not available from a large sample of homes. A few measurements indicate that about 25 to 45 cfm of ventilation air is provided which pressurizes the house in the range of +0.2 to +0.4 pascals.

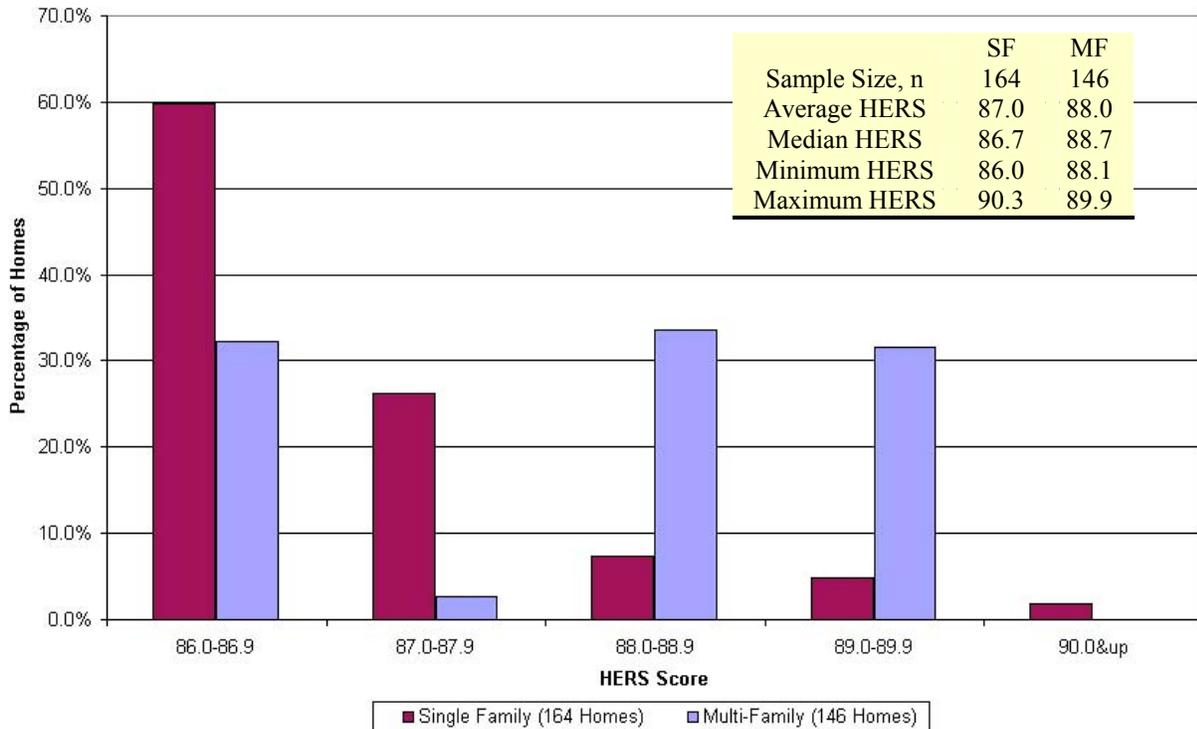
Figure 5 HERS Scores for FL H.E.R.O. Homes

Measured Home Energy Ratings (HERS) and airtightness on these FL. H.E.R.O. homes is presented next in figures 5 through 8. Data is presented for both single family detached (SF) and multifamily homes (MF). See Table 2 below.

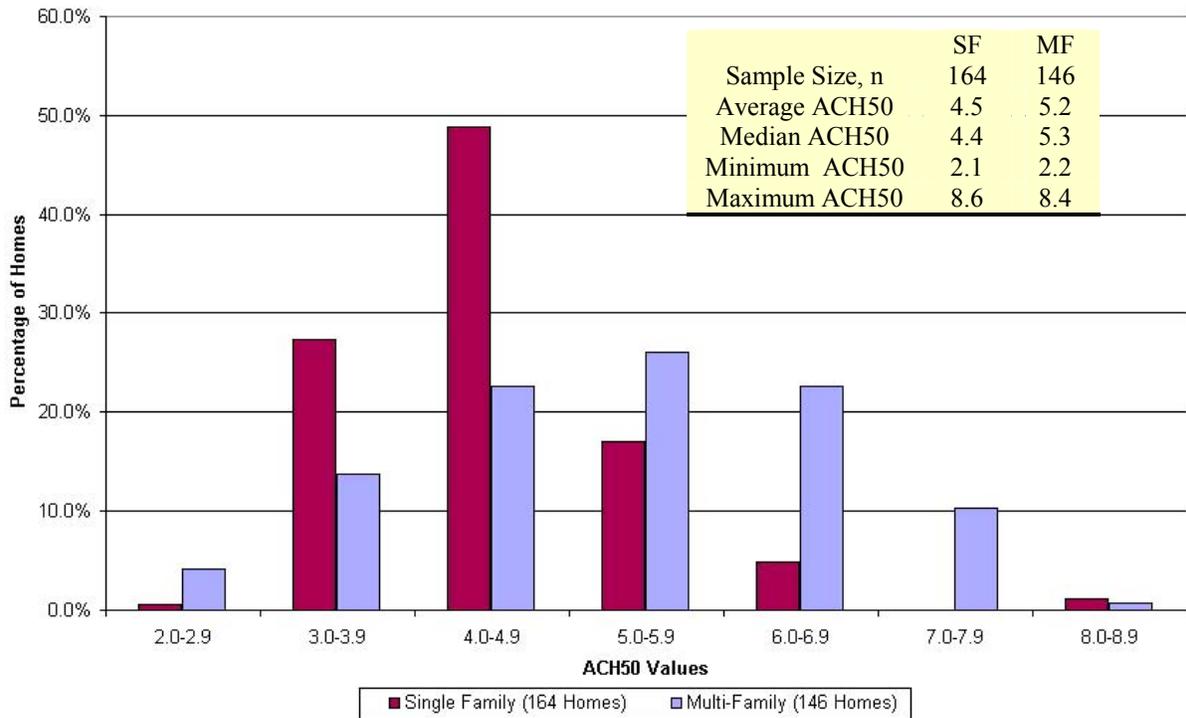
Figure 6 ACH50 Values for FL H.E.R.O. Homes

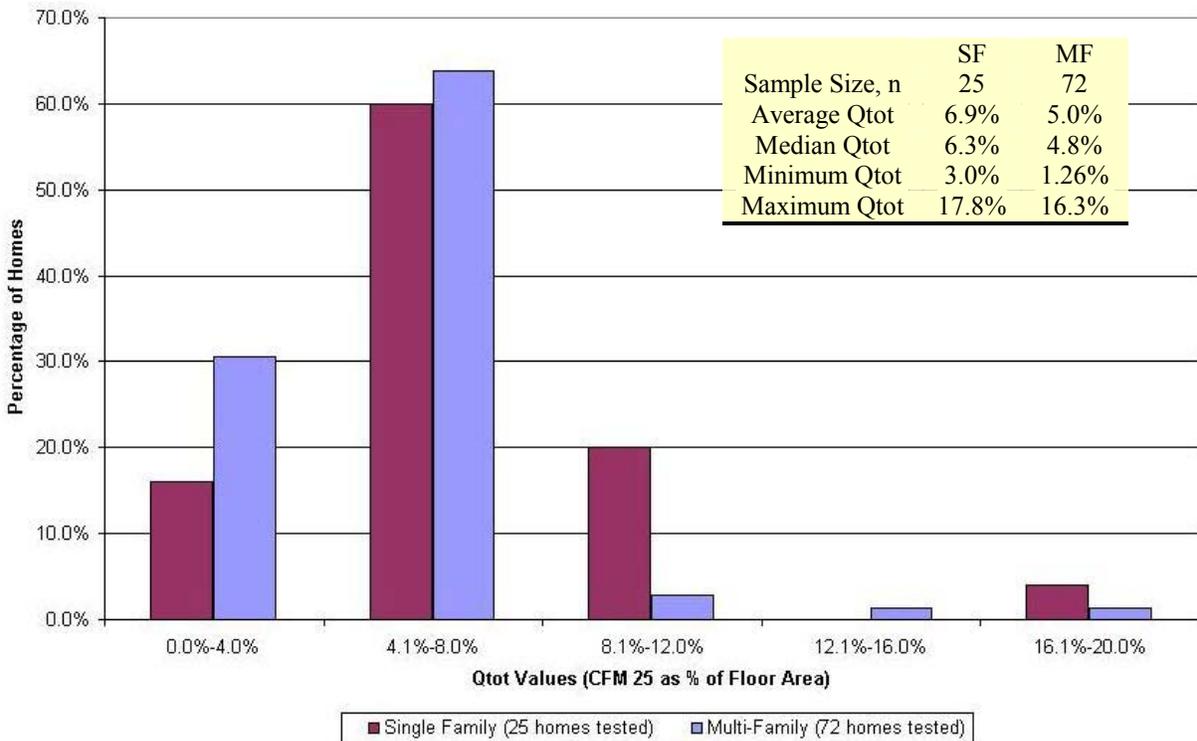
Figure 7 Qtot Values for FL H.E.R.O. Homes

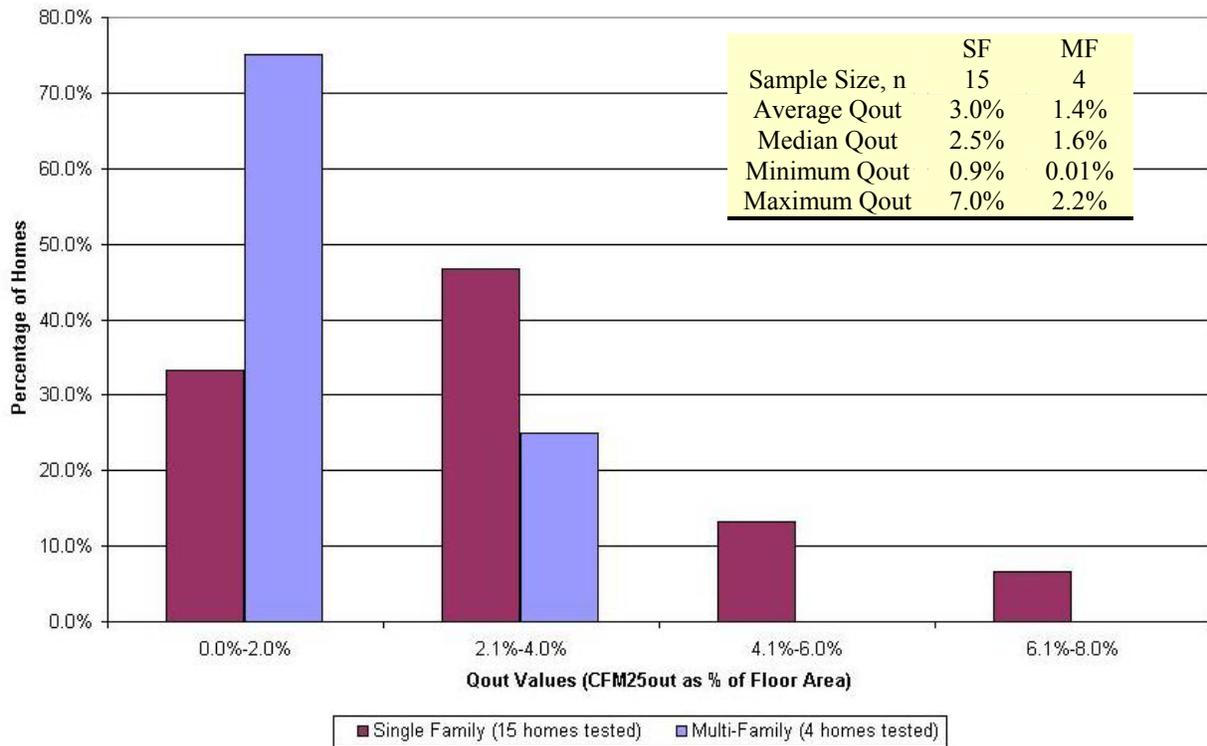
Figure 8 Qout Values for FL H.E.R.O. Homes
